In re: Emergency Complaint and Petition
Requesting Initiation of Show Cause Proceedings
Against Verizon Florida, LLC for Willful
Violation of Rules 25-4.036 and 25-4.038, Florida
Administrative Code by Bright House Networks
Information Services (Florida) LLC and Bright
House Networks, LLC

**EMERGENCY COMPLAINT AND PETITION
REQUESTING INITIATION OF SHOW CAUSE
PROCEEDINGS FOR WILLFUL VIOLATION OF RULES
25-4.036 AND 25-4.038, FLORIDA ADMINISTRATIVE CODE**

SUMMARY OF INSPECTION OF VERIZON FiOS FACILITIES IN WESTCHESTER COUNTY FOR UNSAFE AND NONSTANDARD SUBSCRIBER INSTALLATION PRACTICES.

**SUMMARY OF INSPECTION OF VERIZON FiOS FACILITIES IN
THE COUNTY OF NASSAU FOR UNSAFE AND NONSTANDARD
SUBSCRIBER INSTALLATION PRACTICES.**

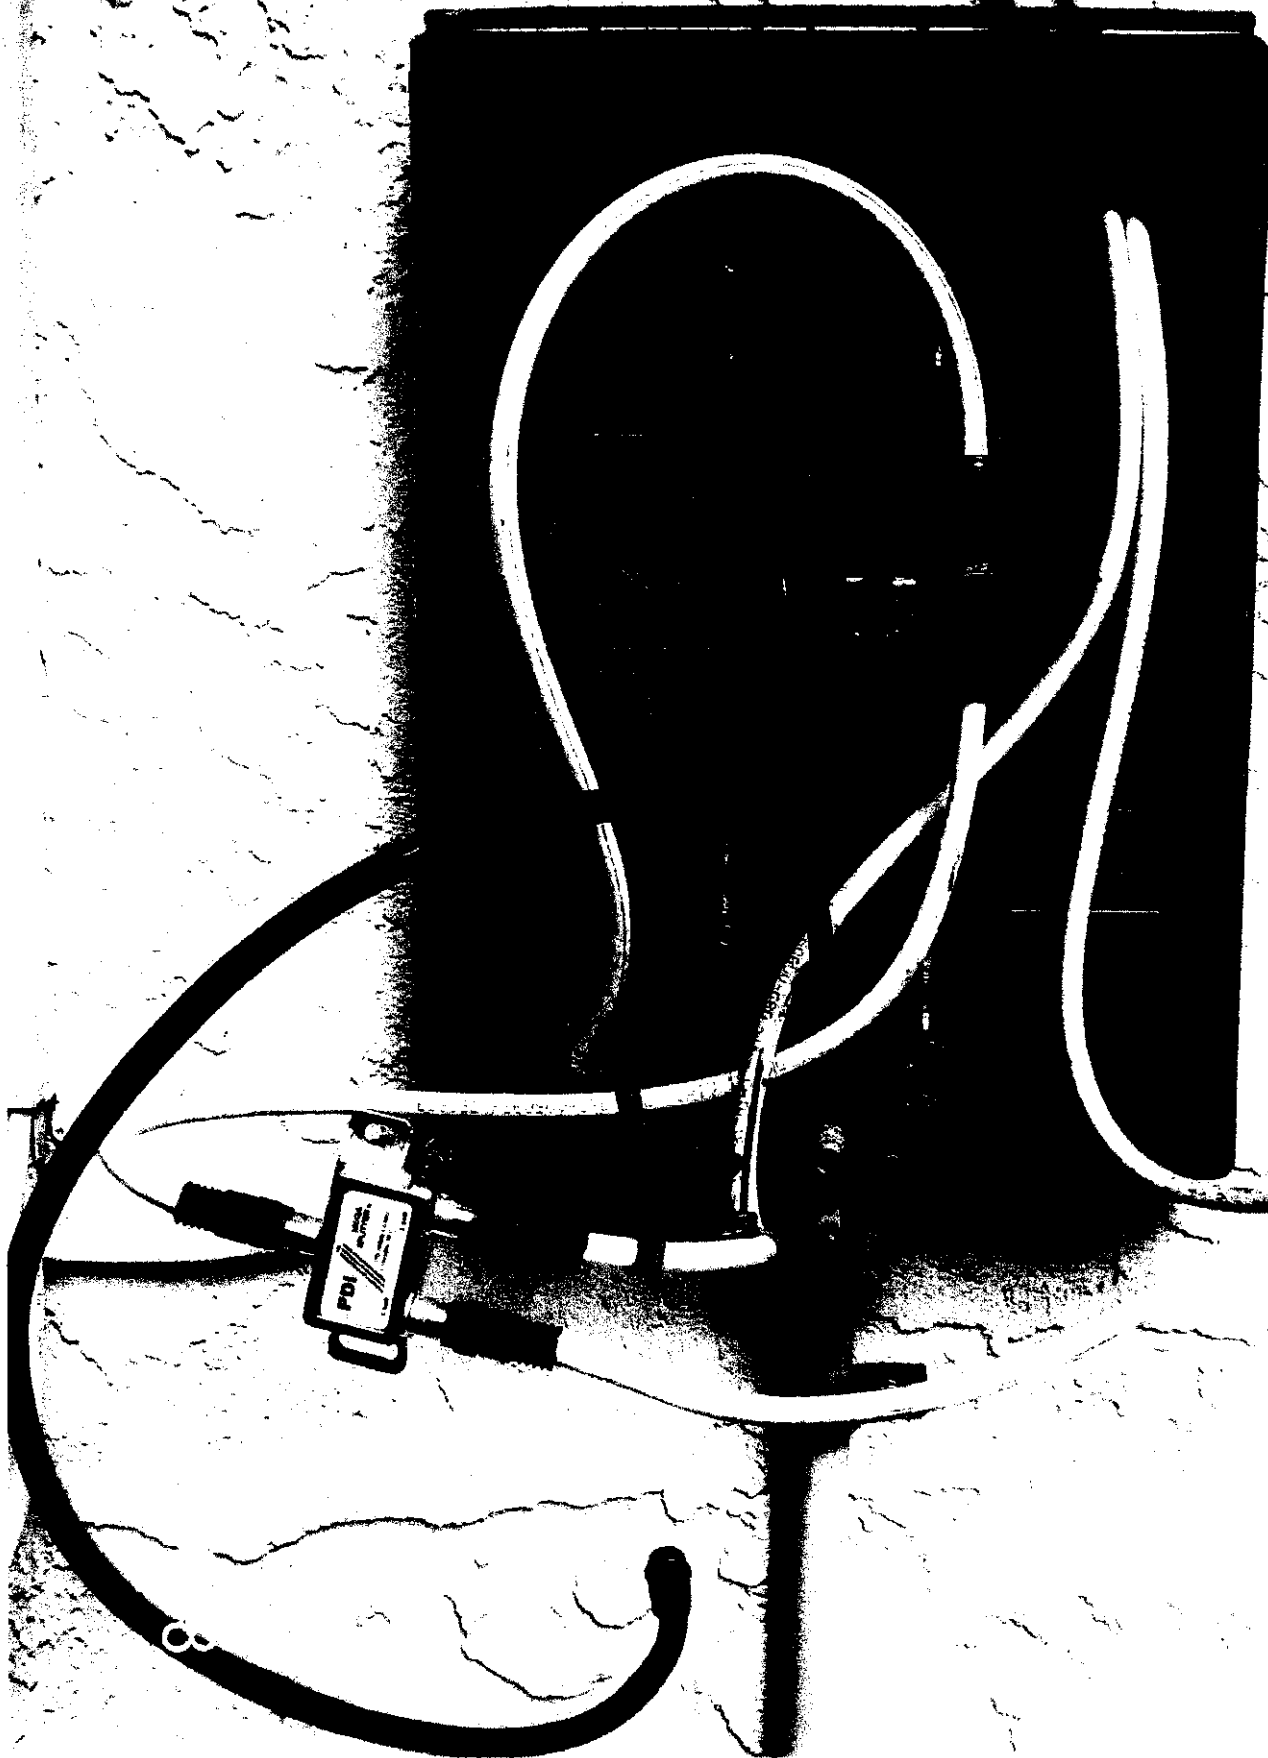
Here are two more examples of connection through our grounding device. This is troubling to me as the ones that we are finding are on take backs from Verizon to Bright House. I have to wonder how many more are this way serving your customers. Do you have a new contracting company doing installs? I can't believe this is recommended practice in connecting service as it is leaving our service drop ungrounded -

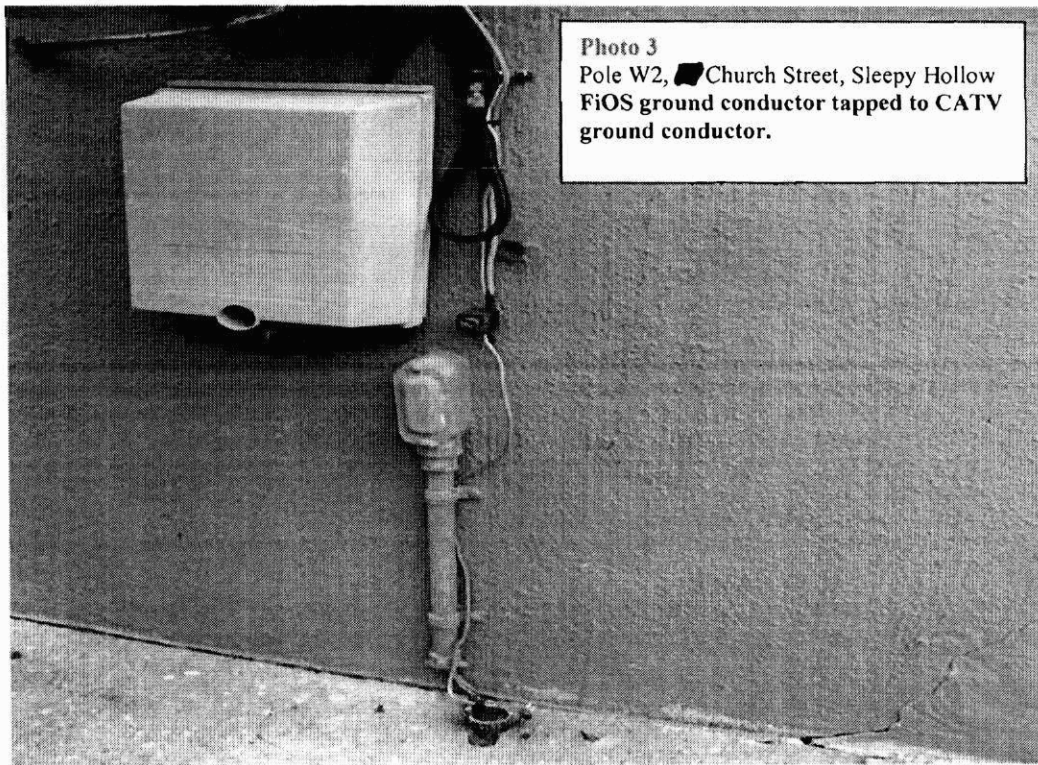
- 70. Pole 9, [REDACTED] Church Street in Sleepy Hollow
**Broken CATV box with coax cable removed for use with FiOS.
(Photo 27)**
- 71. Pole W2, [REDACTED] Church Street
**FiOS ground conductor tapped to CATV ground conductor.
(Photo 3)**

Photo 3
Pole W2, Church Street, Sleepy Hollow
FiOS ground conductor tapped to CATV
ground conductor.

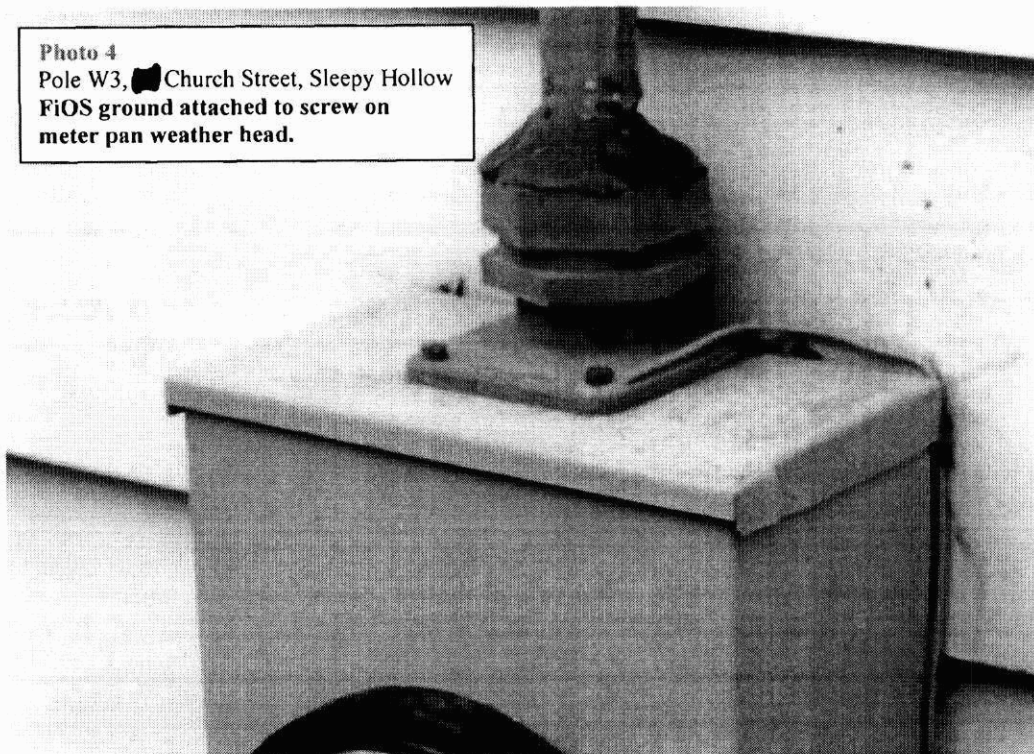
Photo 4
Pole W3, Church Street, Sleepy Hollow
FiOS ground attached to screw on
meter pan weather head.

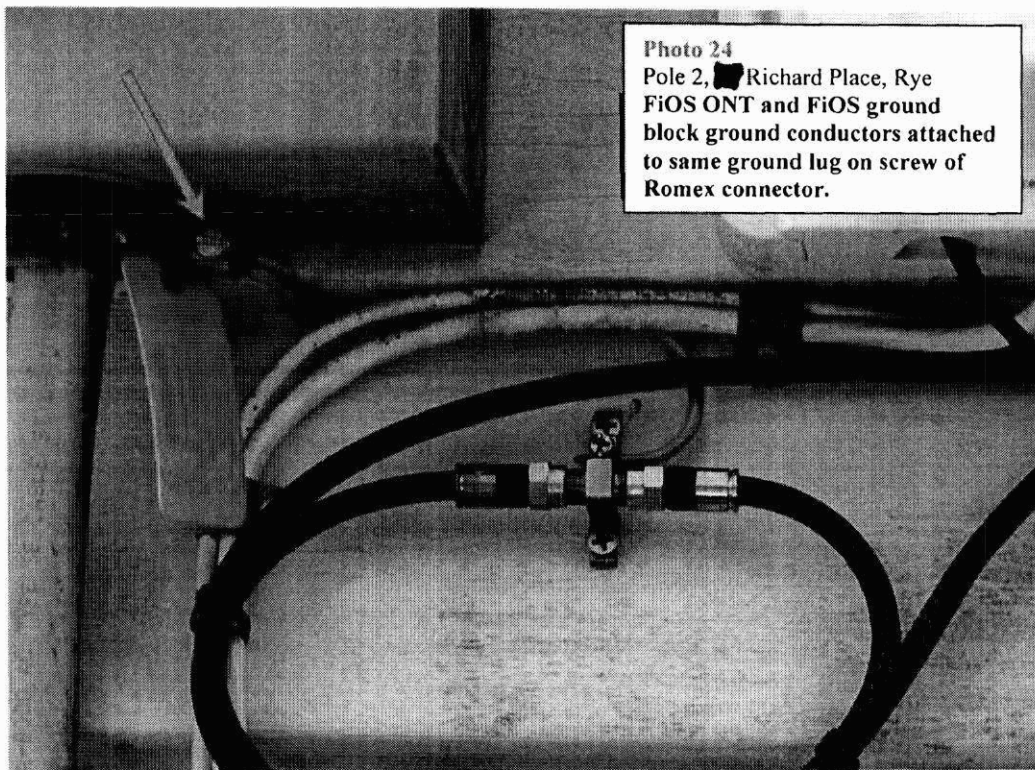
Photo 24
Pole 2, ■ Richard Place, Rye
FiOS ONT and FiOS ground
block ground conductors attached
to same ground lug on screw of
Romex connector.

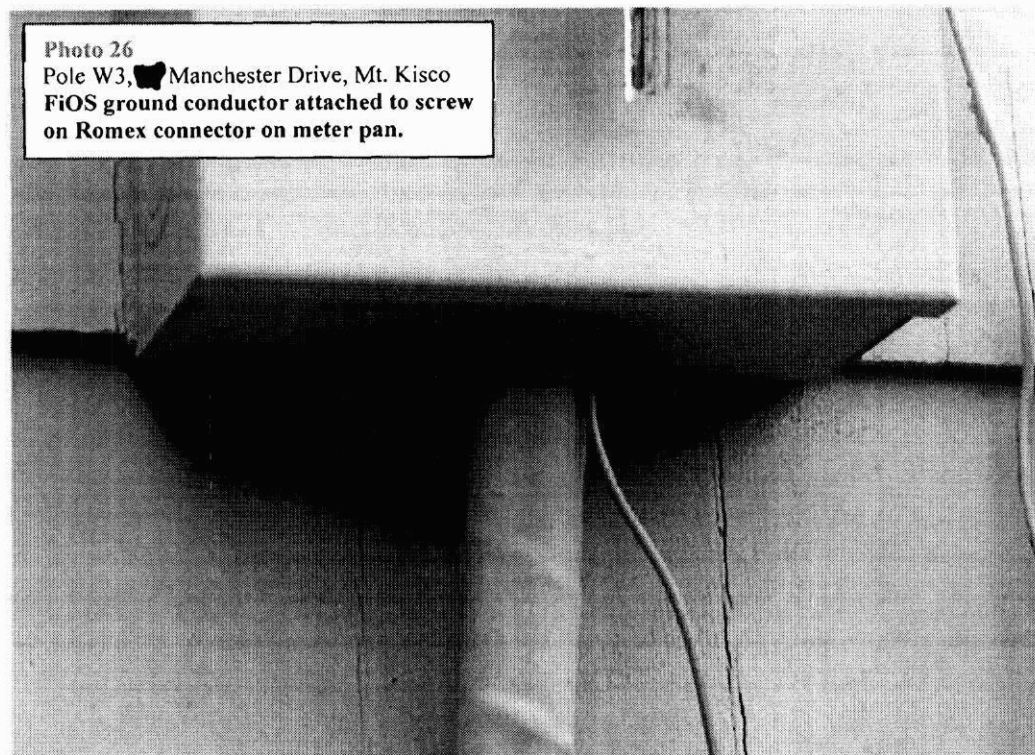
Photo 26
Pole W3, ■ Manchester Drive, Mt. Kisco
FiOS ground conductor attached to screw
on Romex connector on meter pan.
