BEFORE THE FLORIDA PUBLIC SERVICE COMMISSION

In re: Florida Power & Light Company's)
Petition for Issuance of a Storm Recovery)
Financing Order)

DOCKET NO. 060038-EI
Filed: March 31, 2006

JAMES S. BYERLEY, P.E.

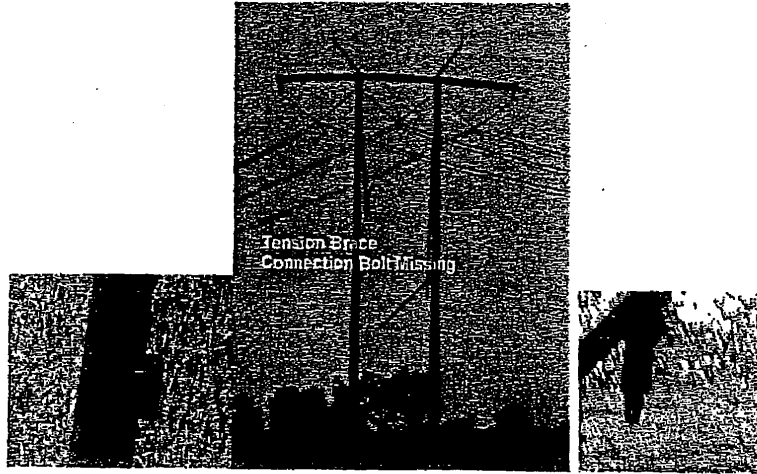
Figure 7 Structure #16Z5
Looking South

One bolt on the X-brace tension member is missing at **Structure #16Z5** (Figure 7). This is one of the three tallest structures in this 500 kV line, and it is near a populated area. A follow up helicopter inspection revealed that the cross-arm is also damaged at this location and needs to be replaced.

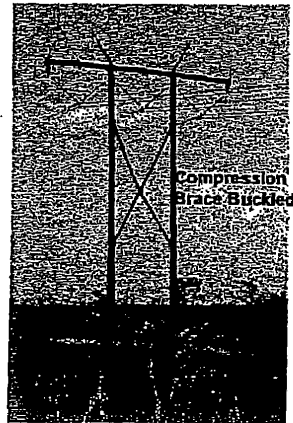
Figure 8 Structure #16Z59
Looking West

The X-brace member buckled at **Structure #16Z59**, (Figure 8). Due to accessibility problems near the surrounding area, the root cause of the failure can not be identified at this time. From visual inspection, no bolt is missing from this structure.

At both locations, the X-brace member failure did not propagate into a structural failure or a cascade event.

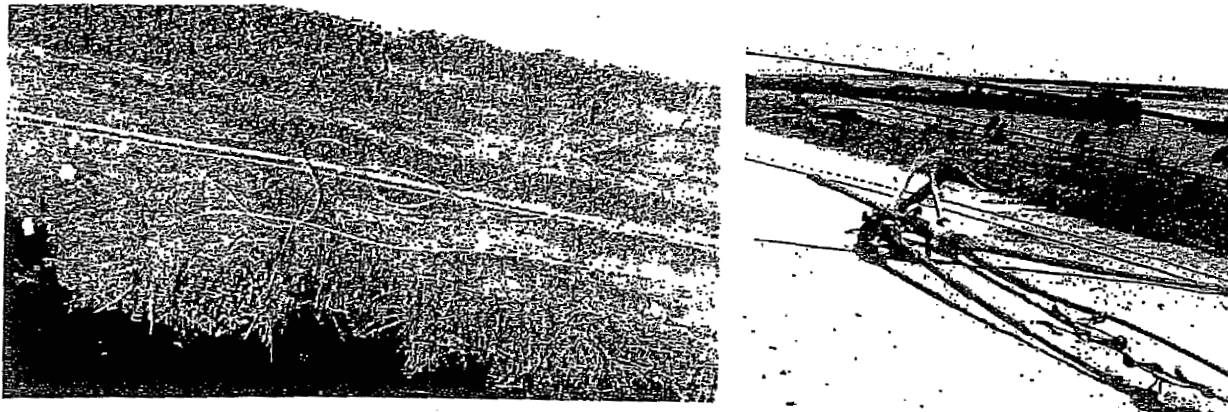
Figure 16 Broken Conductor Phase

Both overhead ground wires (OHGW) and conductors broke in this line section. Some wires were broken in many places, and several locations have multiple broken wires (Figure 16). Most of the broken wires are secondary failures caused by structural collapse. However, in at least one location, a sub-conductor was broken by high tension.

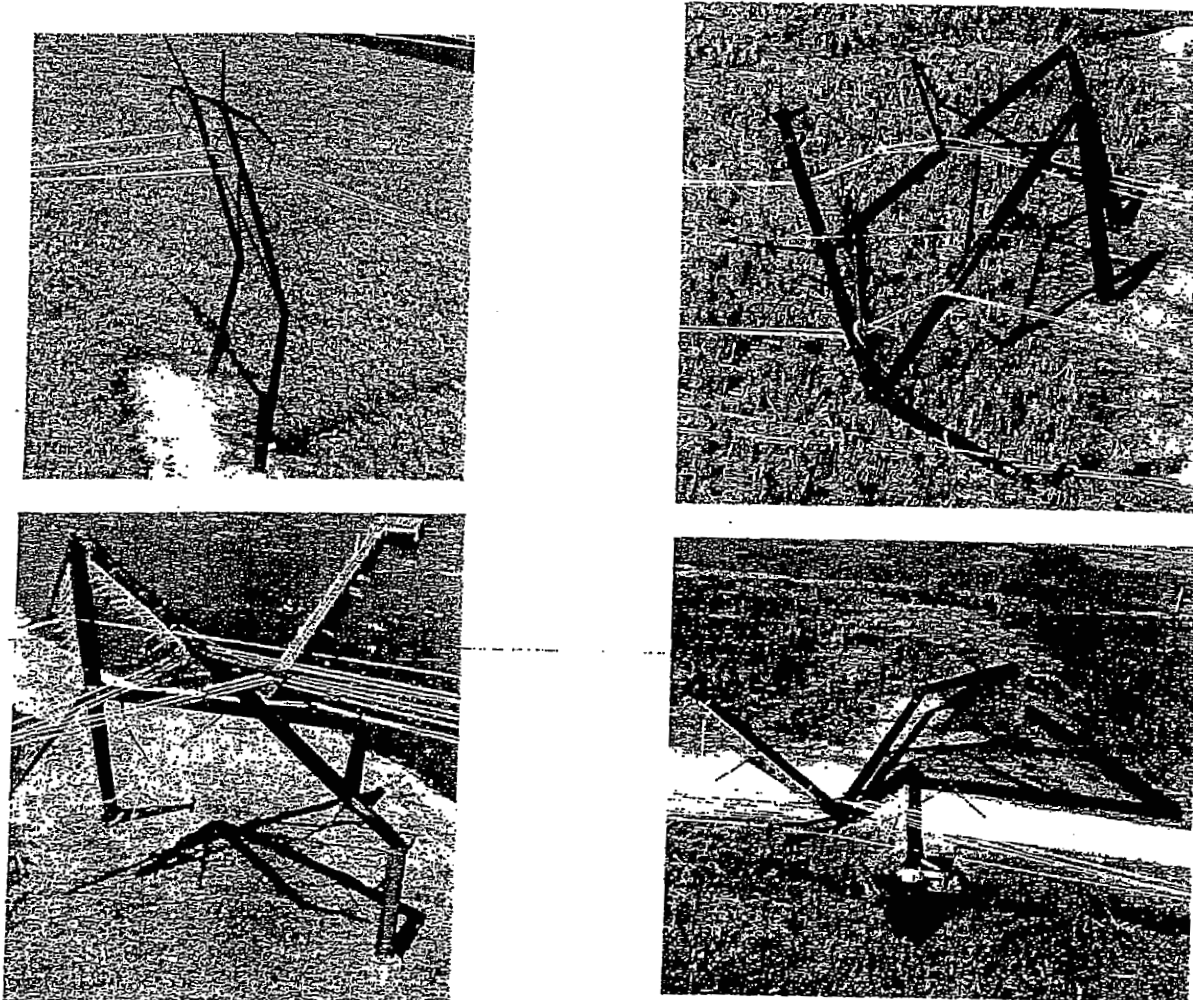
Figure 17 Structural Cascade Failures

The failure elements in this area are all mangled together, which makes it very difficult to identify the precise sequence (Figure 17). The interactions between the wire system and the structural support were highly influential with each other and rather dynamic. Root causes cannot be clearly identified without assumptions. However, from the evidence presented, the duration of the initial destruction and follow up cascade must be reasonably short, within minutes. In addition, the evidence supports that missing bolts at the critical connection is, no doubt, a major contributor to the failure of these structures and generated the cascade events.

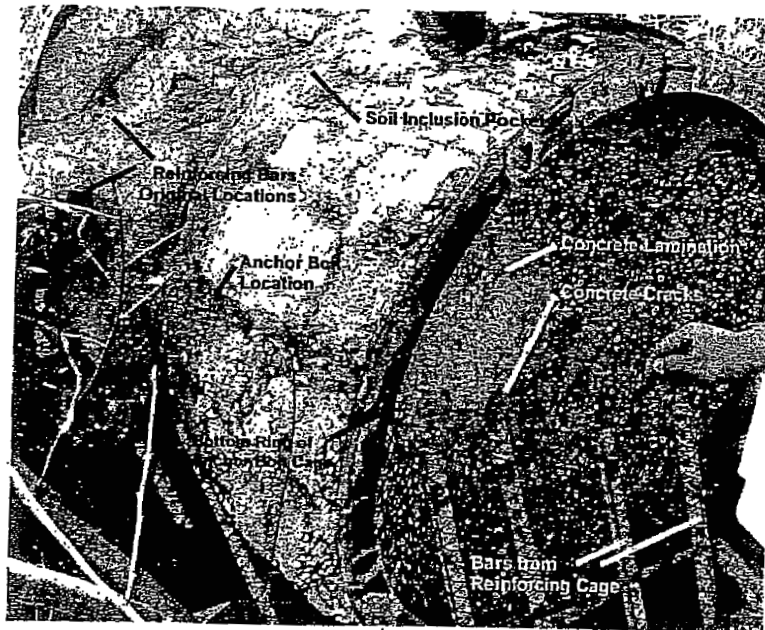
Figure 18 Caisson Foundation Separation
Structure #16Z212

From Figure 18, bond strength was never developed between the anchor bolt cage and the reinforcing cage. The exposed reinforcing bars are so clean that there is hardly any trace to show that concrete has ever been adhered to them. There are also indications of soil inclusions (Figure 19) and cold joint lamination (construction delays of any kind that cause previously poured concrete to reach initial set, Figure 18).

Without a high quality concrete placement to provide a solid connection between the cages, effective foundation size is basically the same as the size of anchor bolt cage (6'-9" into ground on a 47" bolt circle diameter). This significantly smaller size foundation cannot and did not survive the storm. In essence, the northwest (tension) leg of this structure was pulled out of the ground due to the lack of solid concrete bond. The fail of this foundation triggered a series of transverse cascade events.

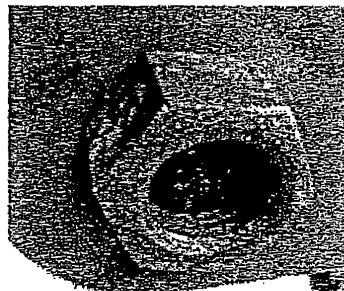
Figure 20 Loosened Connection

A follow up inspection (10/31/2005) after the storm revealed that three (3) more locations in this line have missing bolts (no structural damage observed). In addition, twenty-eight (28) locations have loose bolts.

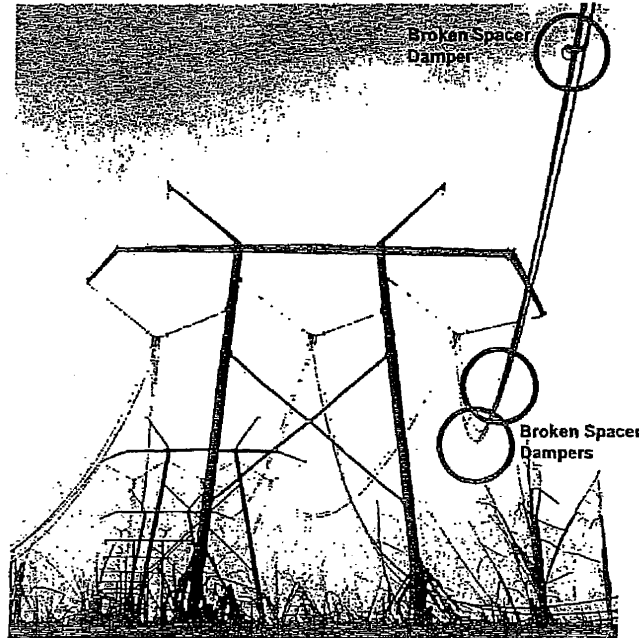
Figure 23 Spacer-Damper Damages

An effective damping system need to be developed and implemented for the entire transmission line. It is estimated that 75% of the original spacer-dampers were damaged during this storm. The damper replacement program should not be restricted only at the damage locations. Observations or measurements should be made, in regular intervals, to ensure the adequacy of these damping devices.
