Appendix A

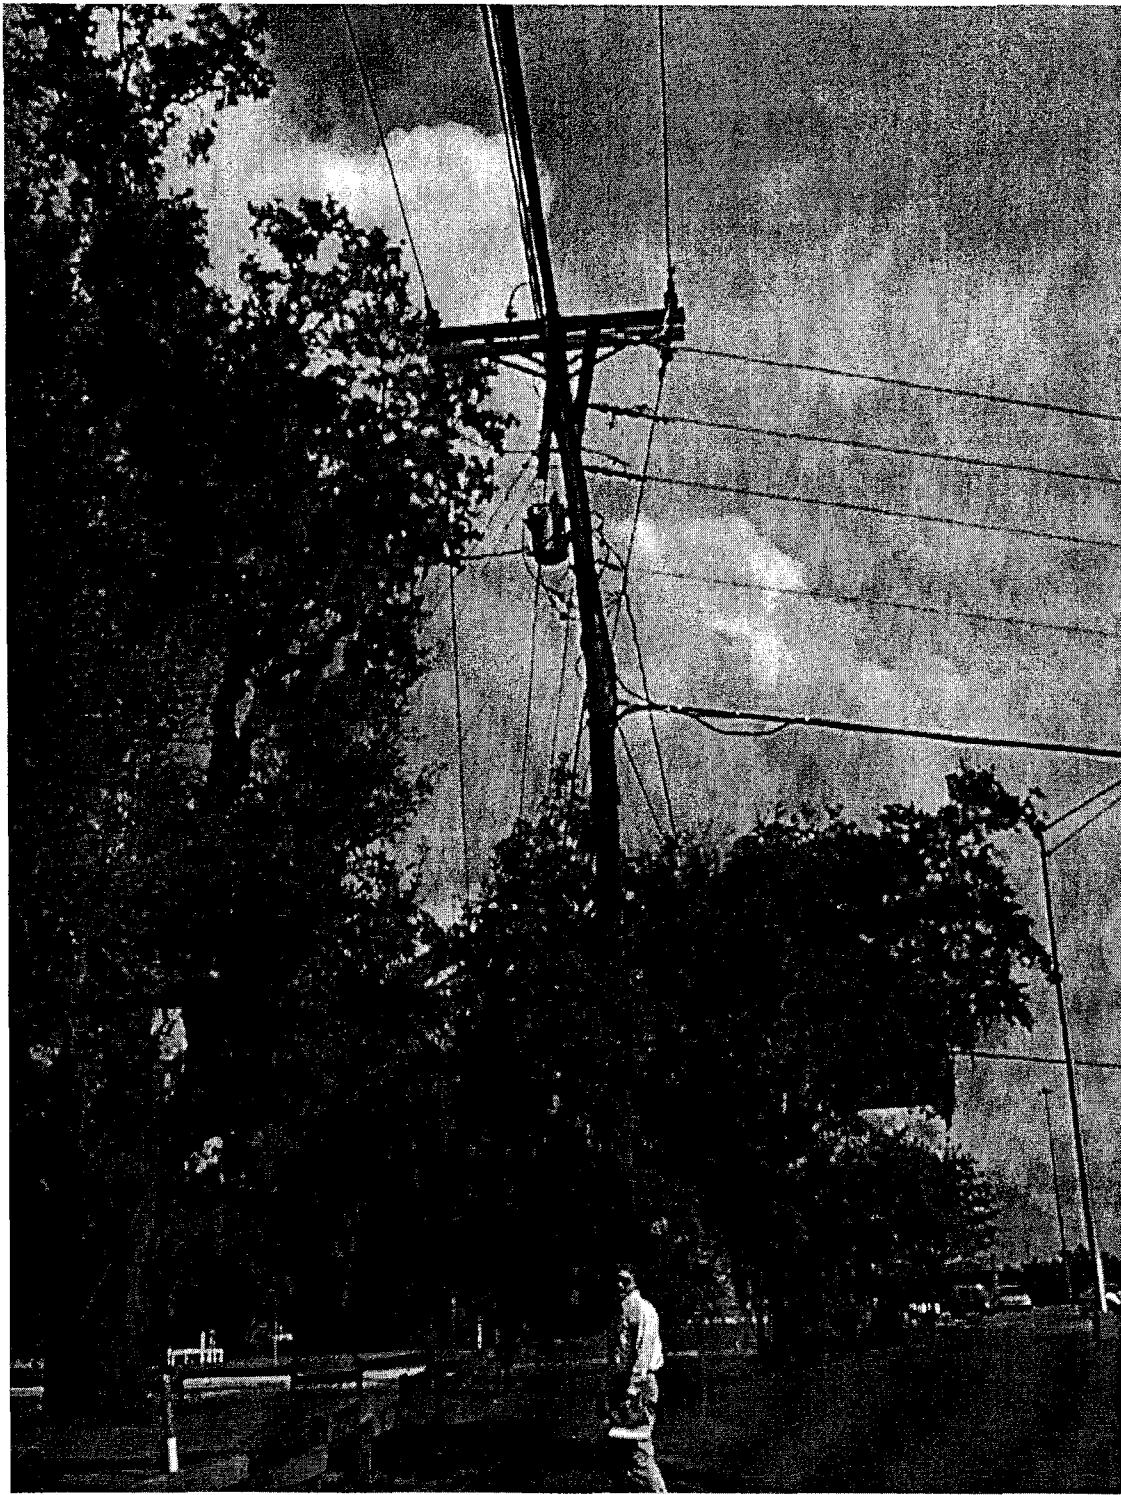
This is a pole found in the field while working on another project. It is obvious that the attachment is overloading the pole, but a loading analysis proved that a CATV company overloaded the pole by a) installing a 300 foot span of cable over 8 lanes of vehicle traffic with two additional over lashings of fiber, and b) the cable had inadequate guying to hold up the additional weight of the cable and caused the pole to split. The original pole was a 45ft class 4 wood pole.
