Environmental Consulting & Technology, Inc.

June 30, 2011
090213-0100

**Re: Phase I Environmental Site Assessment (ESA) Summary
Celia Site
John Castleberry Parcel
1571 Cox Road
McDavid, Escambia County, Florida**

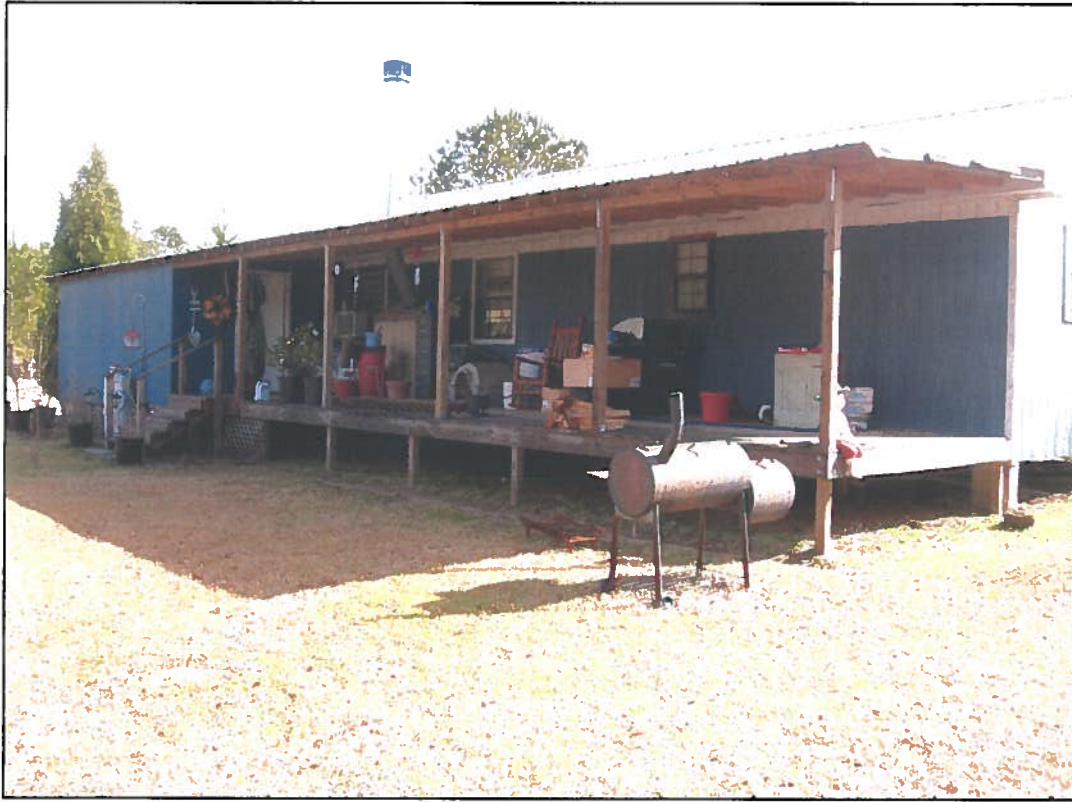
Photograph No. 1.

View of the onsite residence located at 1571 Cox Road in unincorporated (McDavid) Escambia County, Florida.

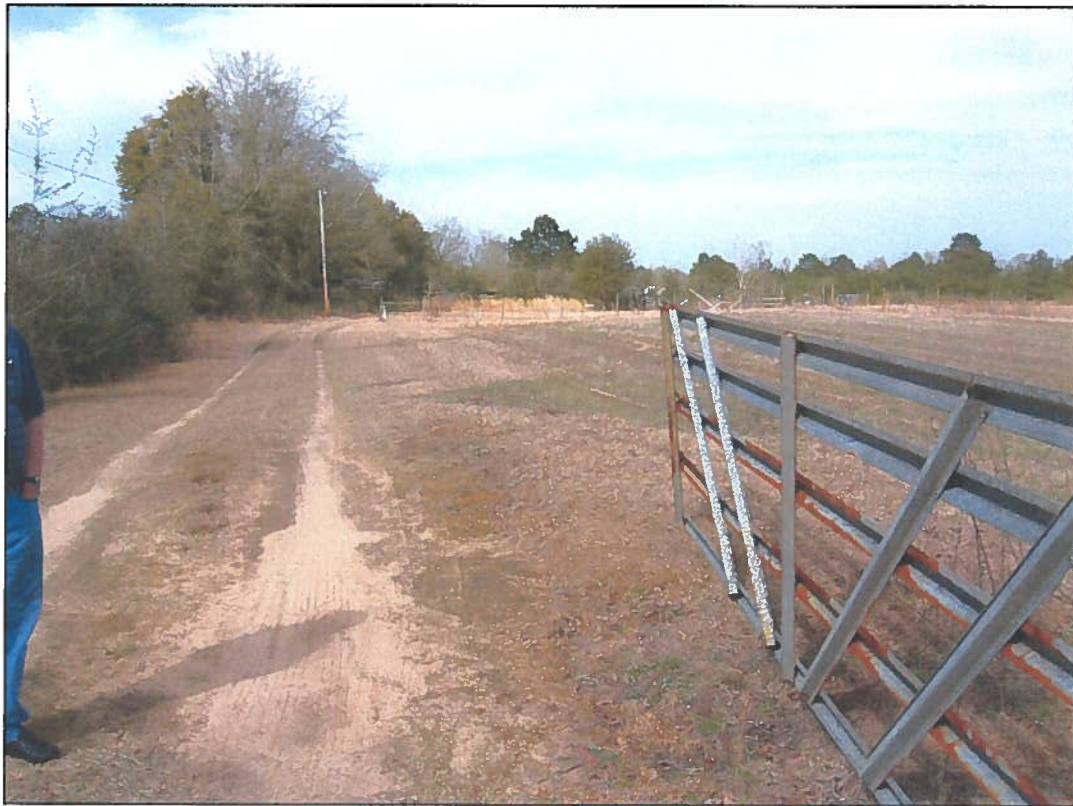
Photograph No. 2.

View, looking west, of the driveway off Cox Road at the southeastern corner of the subject property.

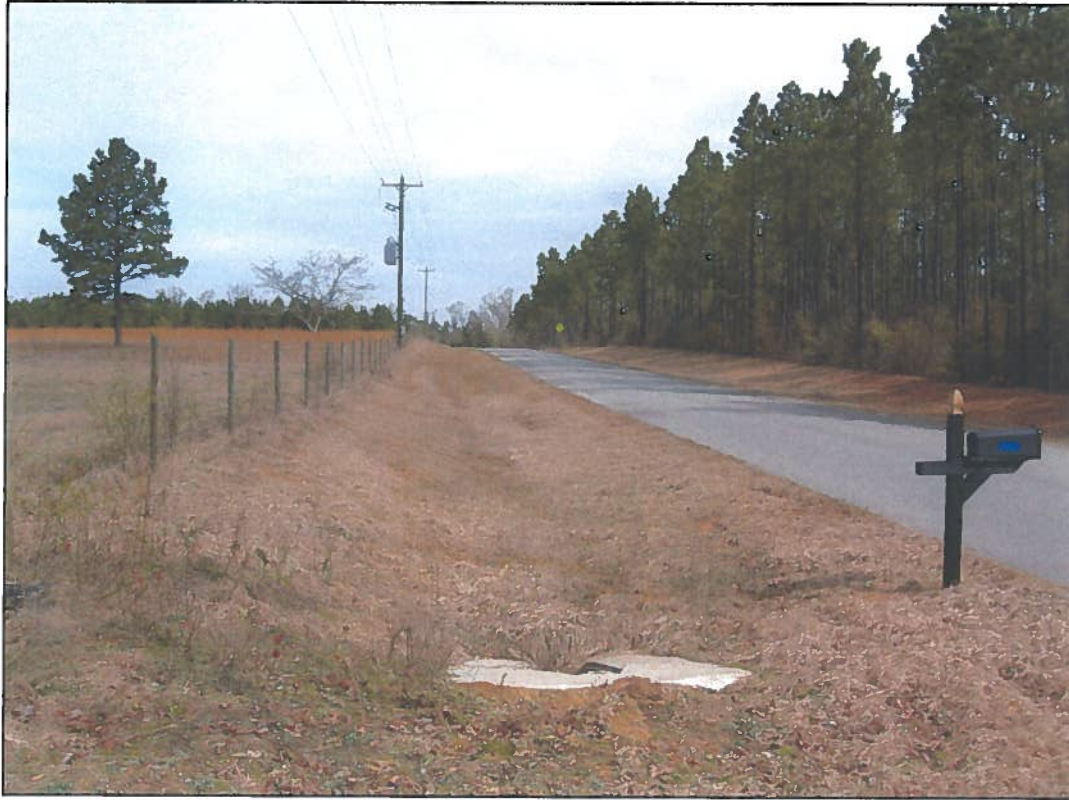
Photograph No. 3. View, looking north, of the eastern boundary of the subject property, along Cox Road.

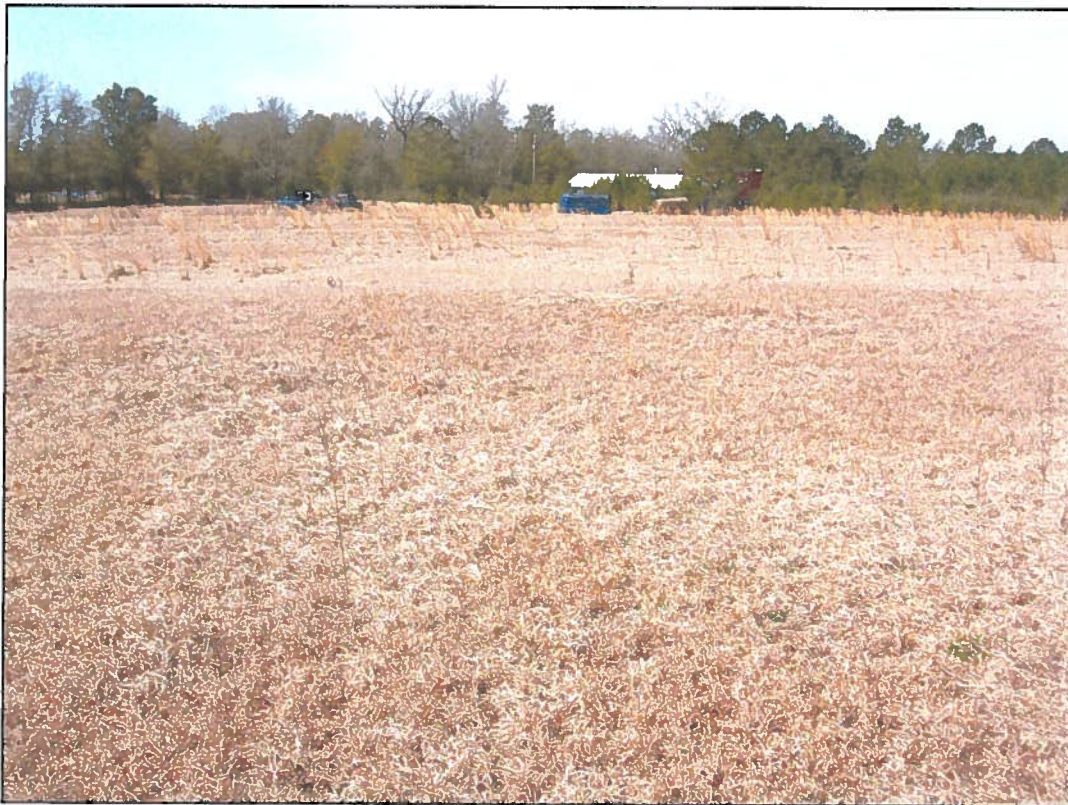
Photograph No. 4. View, looking southwest, of the pasture located on the eastern portion of the subject property.

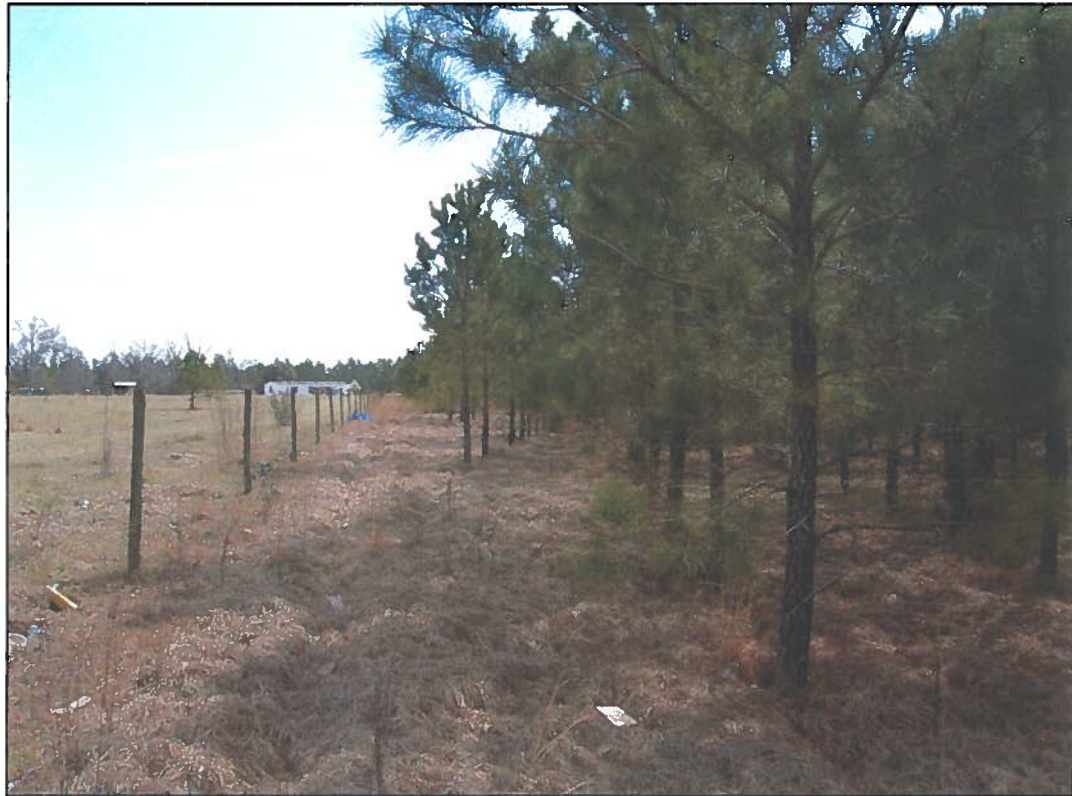
Photograph No. 5. View, looking east, of the northern boundary of the subject property.

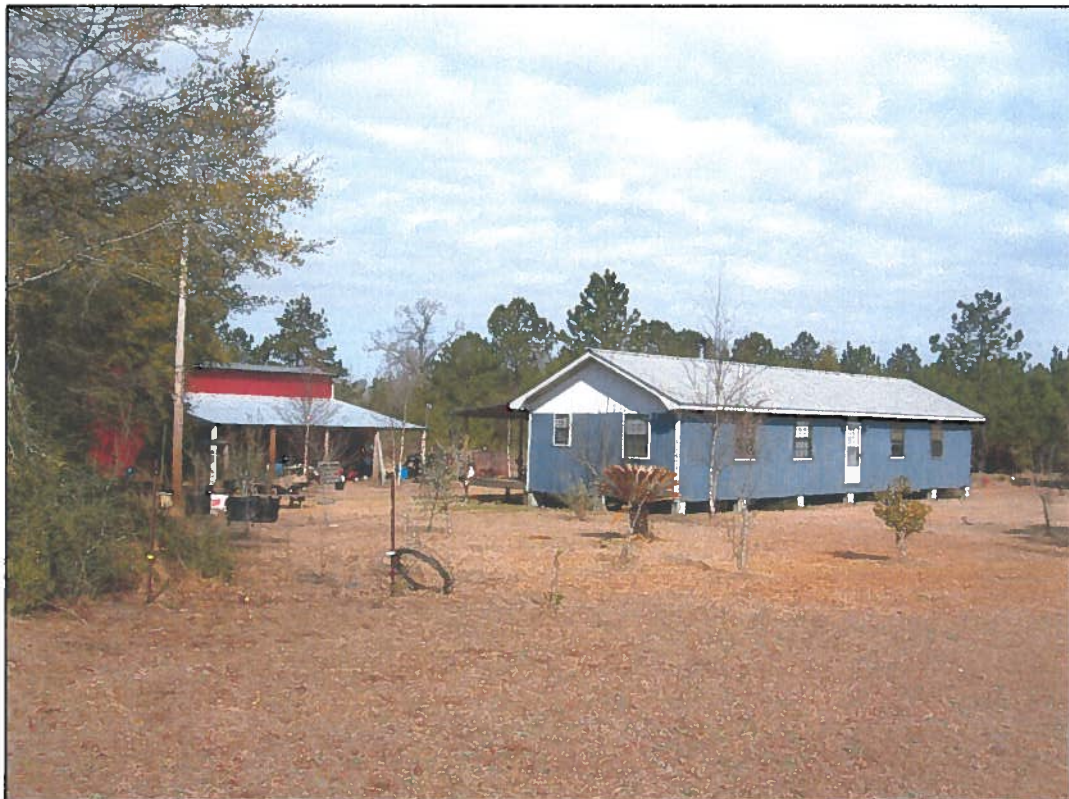
Photograph No. 6. View, looking northwest, of the residence and barn located on the south-central portion of the subject property.

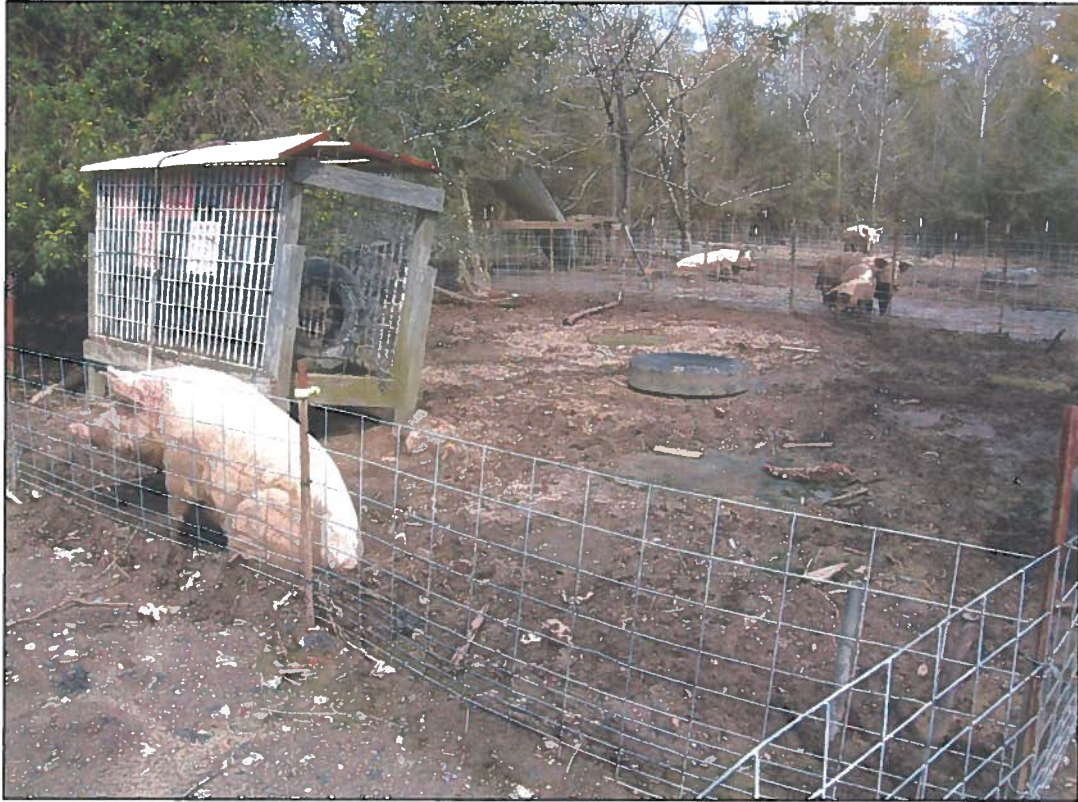
Photograph No. 7.

View of pig pens located on the central portion of the subject property.

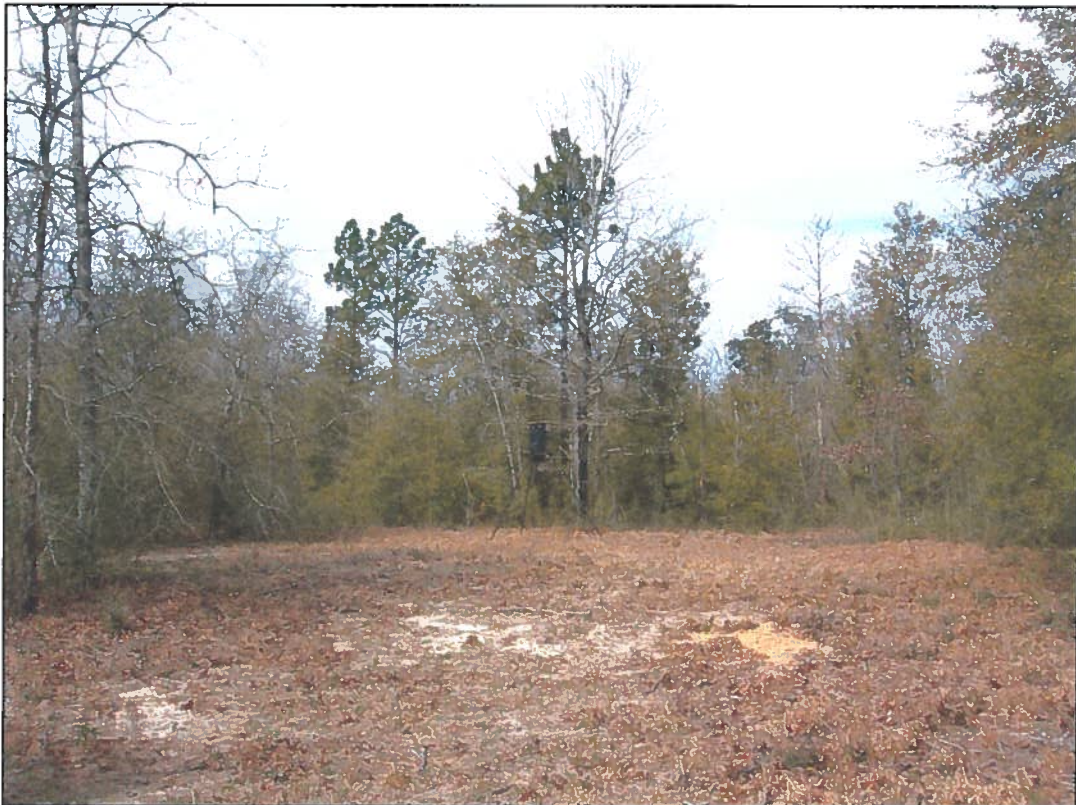
Photograph No. 8.

View of a feeder/hunt plot located on the western portion of the subject property.

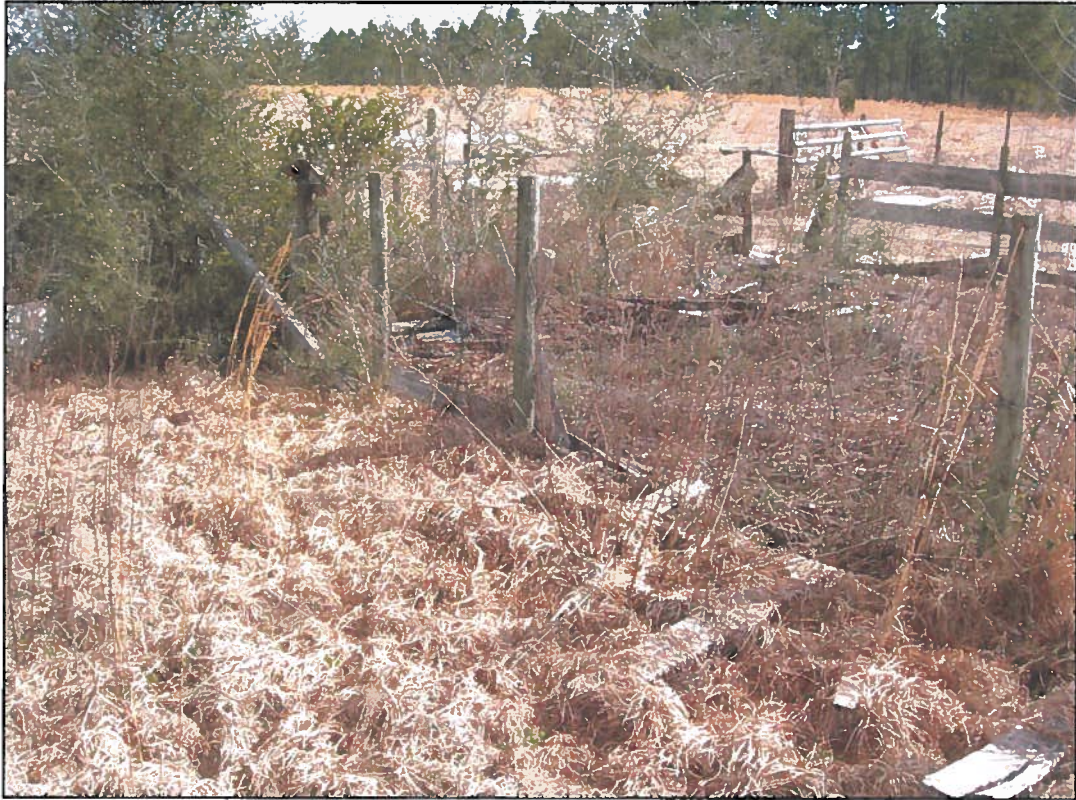
Photograph No. 9. View, looking northeast, of the cattle pens located on the southeastern portion of the subject property.

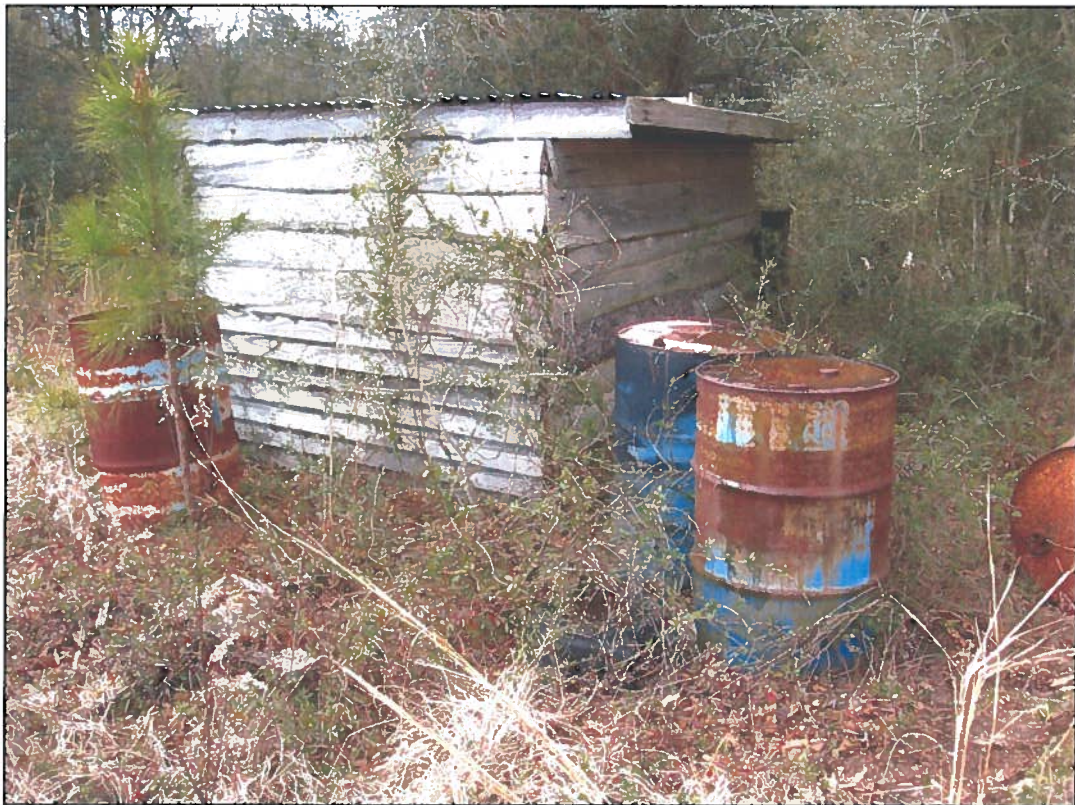
Two sheds are located in the southeastern portion of the subject property, near the cattle pens. Several (<10) 55-gallon drums were observed around the perimeter of the sheds. Visible soil staining was observed at the base of two adjacent drums. Other miscellaneous debris was observed in and around the cattle pen area. Wooden poles were observed stored along the southern property boundary, between the residence and the cattle pen area. The wood appeared to be treated (creosote) and a noticeable odor was detected in the vicinity. There is a covered drum storage area located to the southwest of the barn. The drums are used for fueling tractors. The drums are stored on wooden pallets beneath a covered awning. Some staining was observed on the pallets. Debris was observed throughout the central portions of the property (residence, barn, and pig pen

Photograph No. 10. View of a shed located near the cattle pens on the southeastern portion of the subject property.

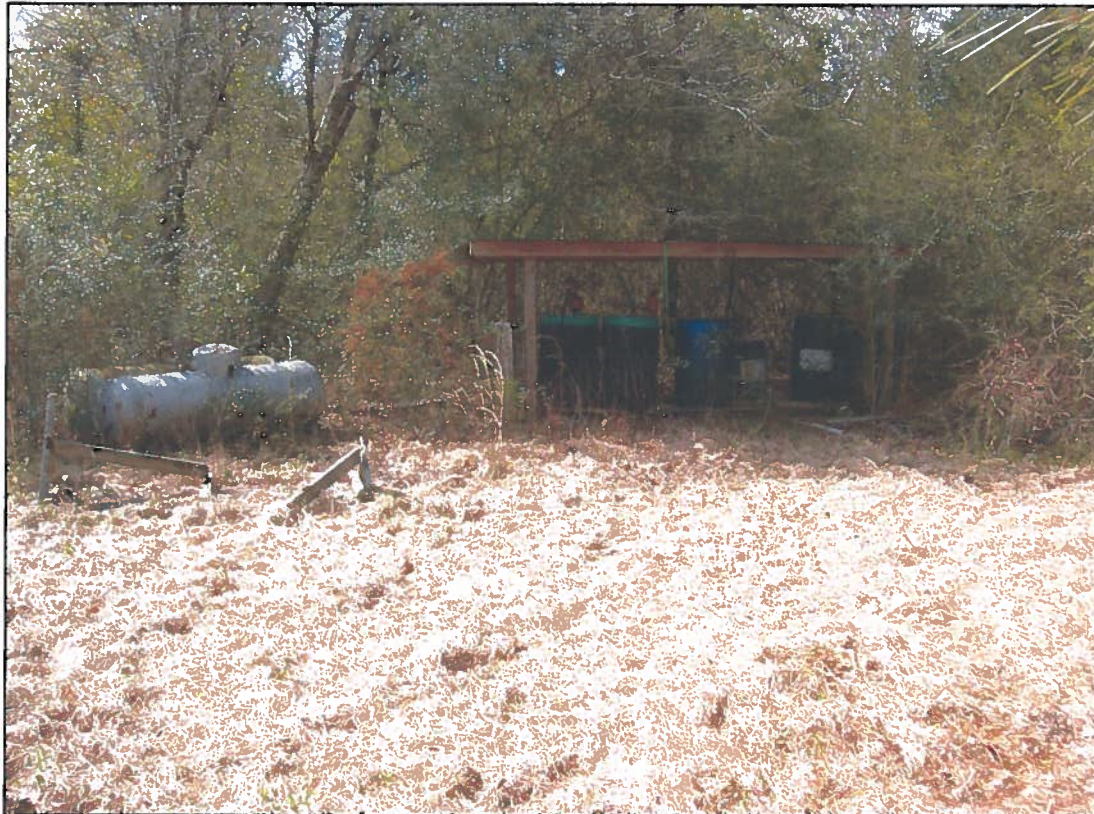
Photograph No. 11. View of covered drum storage located to the southwest of the barn.

- Area of soil staining beneath two adjacent drums near the sheds in the cattle pen area in the southeastern portion of the site (one sample);
- Beneath the stained pallets of the covered fuel drum storage area located to the southwest of the barn in the south-central portion of the site (one sample from beneath the most heavily stained area);
- Beneath the treated wood logs located along the southern property boundary between the residence and the cattle pen area (one to two samples);
- Beneath the debris pile located on the southern portion of the site, across the unpaved roadway along the southern boundary (up to three samples); and,
- In the interior portion of the barn (up to four samples).

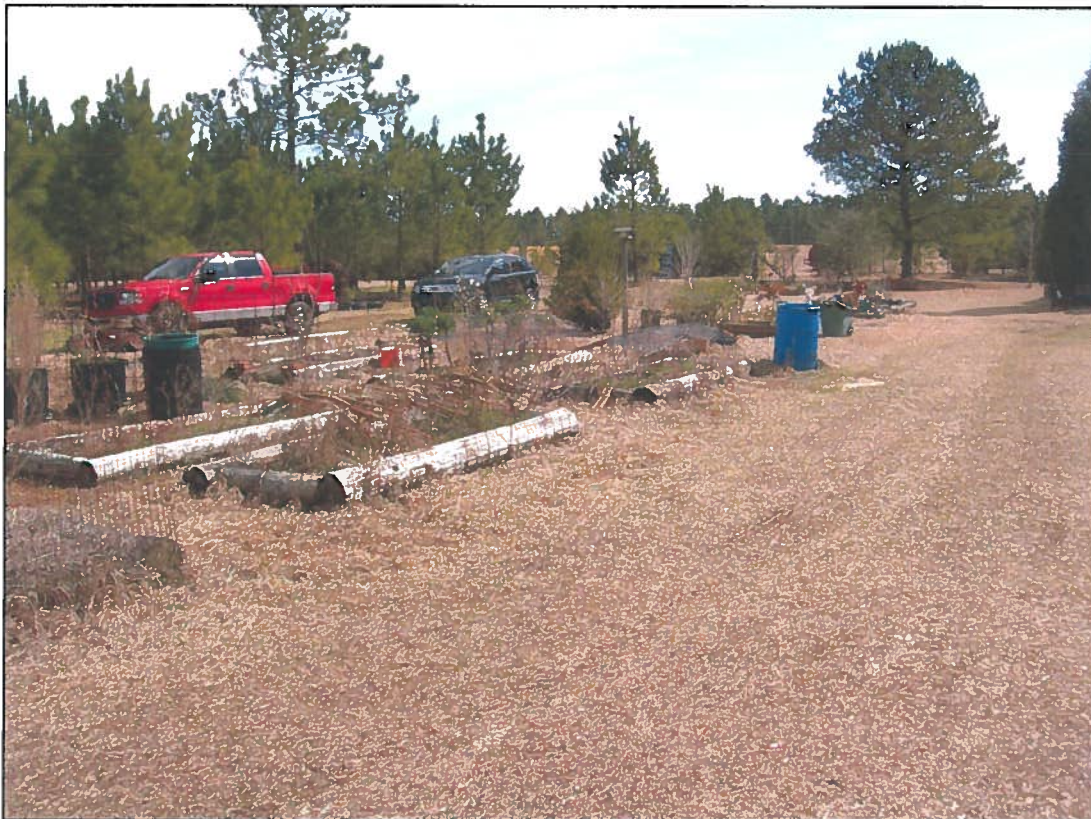
Photograph No. 12. View of garden to the north of the barn.

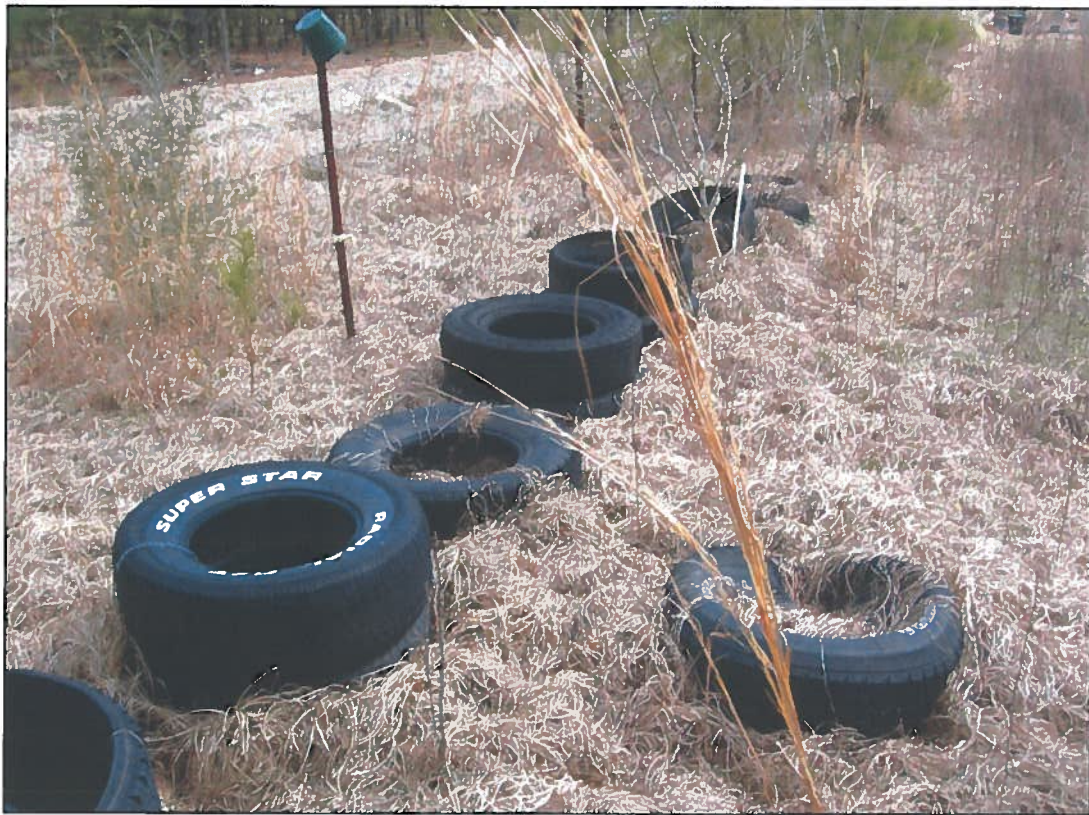
Photograph No. 13. View of tires used for plants to the west of the garden area.

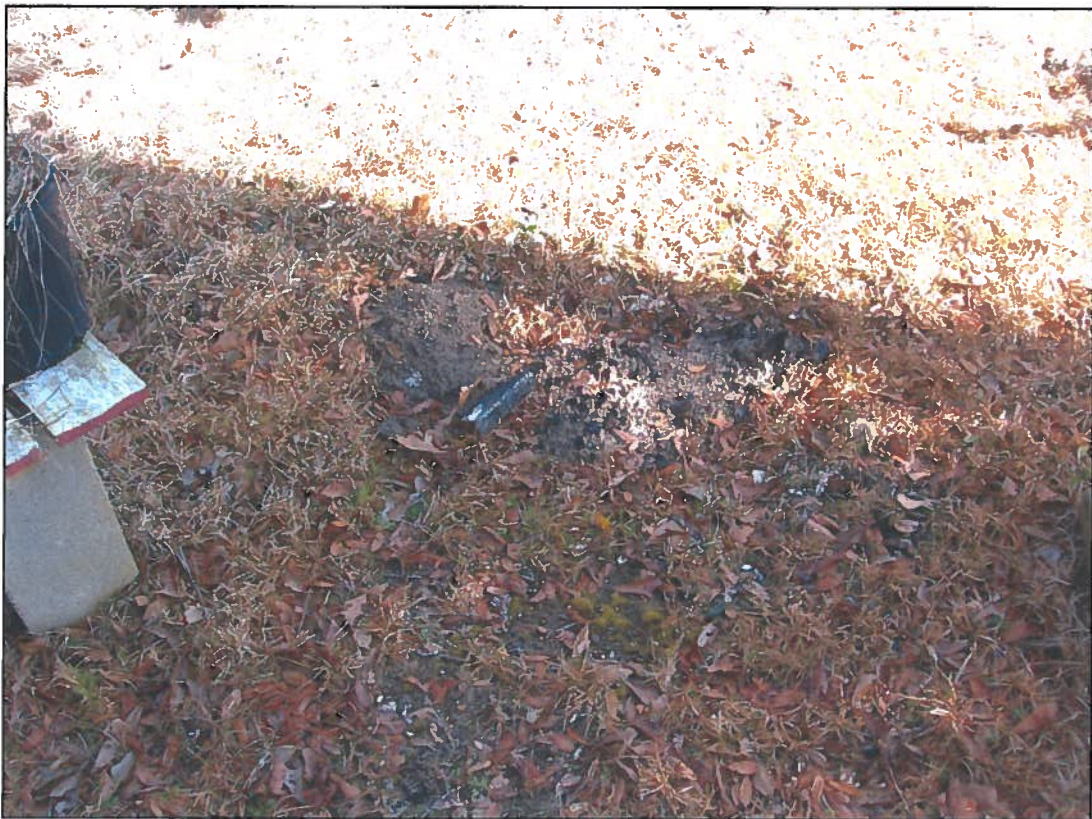
Photograph No. 14. View of a burn pile located near the onsite residence.

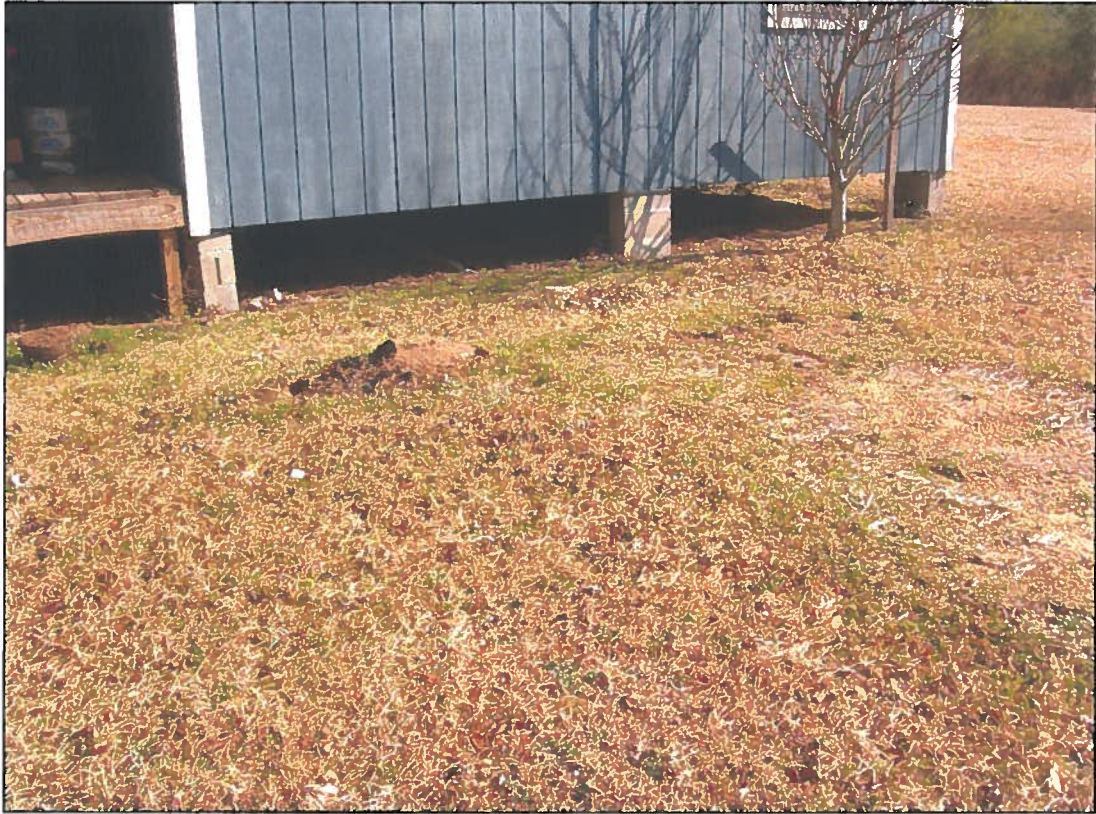
Photograph No. 15. View of a burn pile observed near the onsite residence.

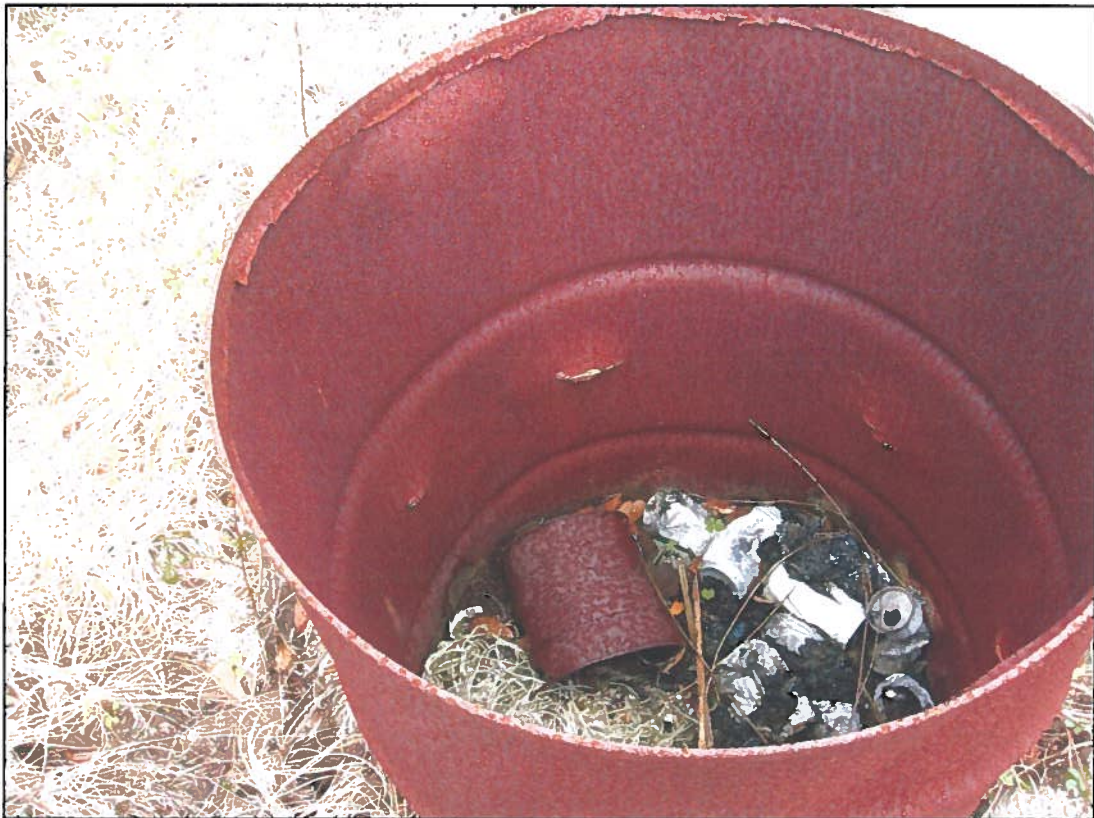
Photograph No. 16. View of a burn barrel observed near the sheds near the cattle pens.

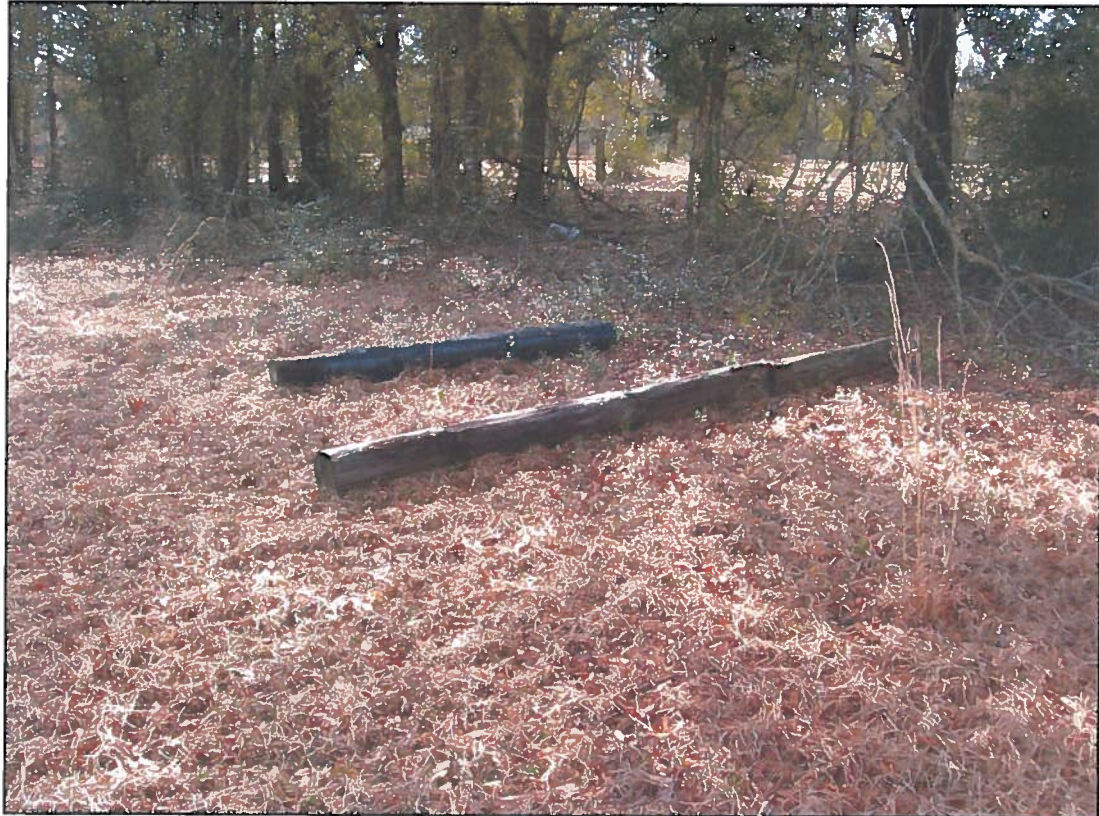
Photograph No. 17. View of treated wood observed near the southern boundary of the subject property.

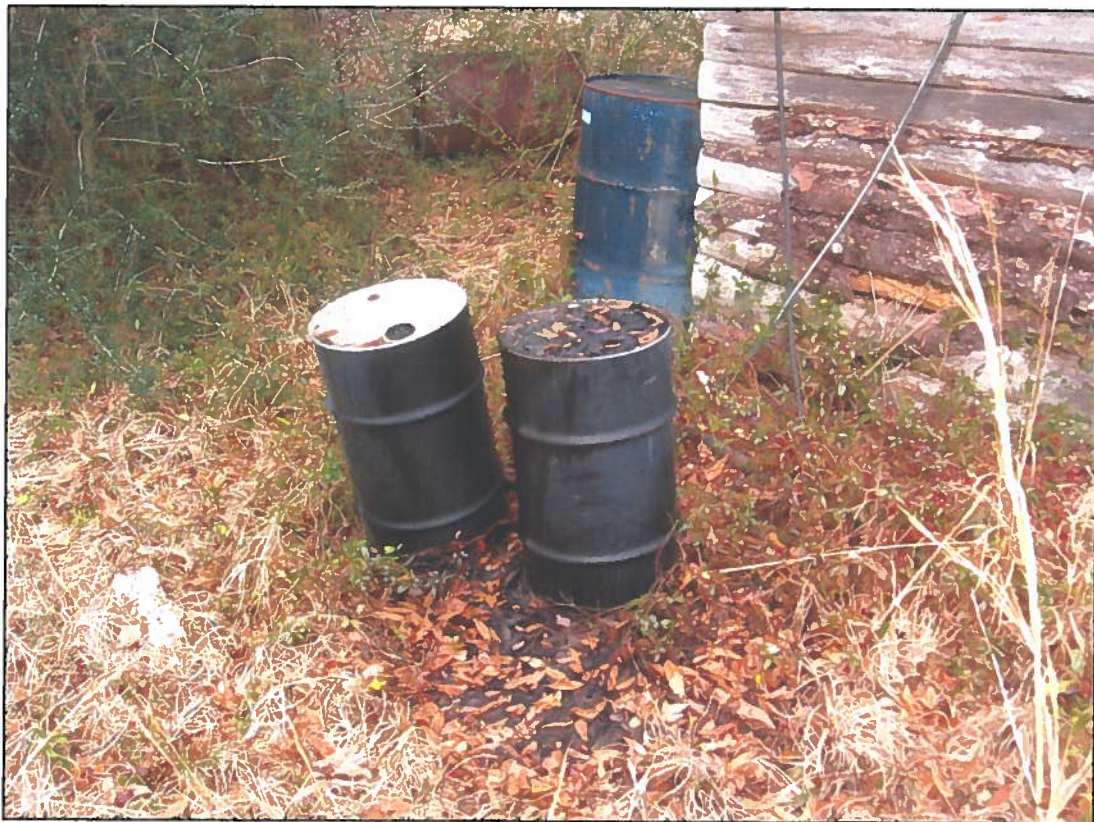
Photograph No. 18. View of stained soil observed beneath two drums located adjacent to one of the shed located near the cattle pens on the southeastern portion of the subject property.

At the completion of the removal of the solid waste, soil samples should be collected in the areas and at the depth most likely to detect impact as part of a phase II ESA. Based on the investigations to date, it is recommended that shallow (upper 6 to 12 inches) and deeper (approximately 2 feet below land surface) soil samples should be collected in the

The soil samples should be laboratory analyzed for volatile organic compounds by U.S. Environmental Protection Agency (EPA) method 8260, semi-volatile organic compounds by EPA method 8270, total petroleum hydrocarbons by the FL-PRO method, and for the Priority Pollutant metals (antimony, arsenic, beryllium, cadmium, chromium, copper, lead, mercury, nickel, selenium, silver, thallium, and zinc).

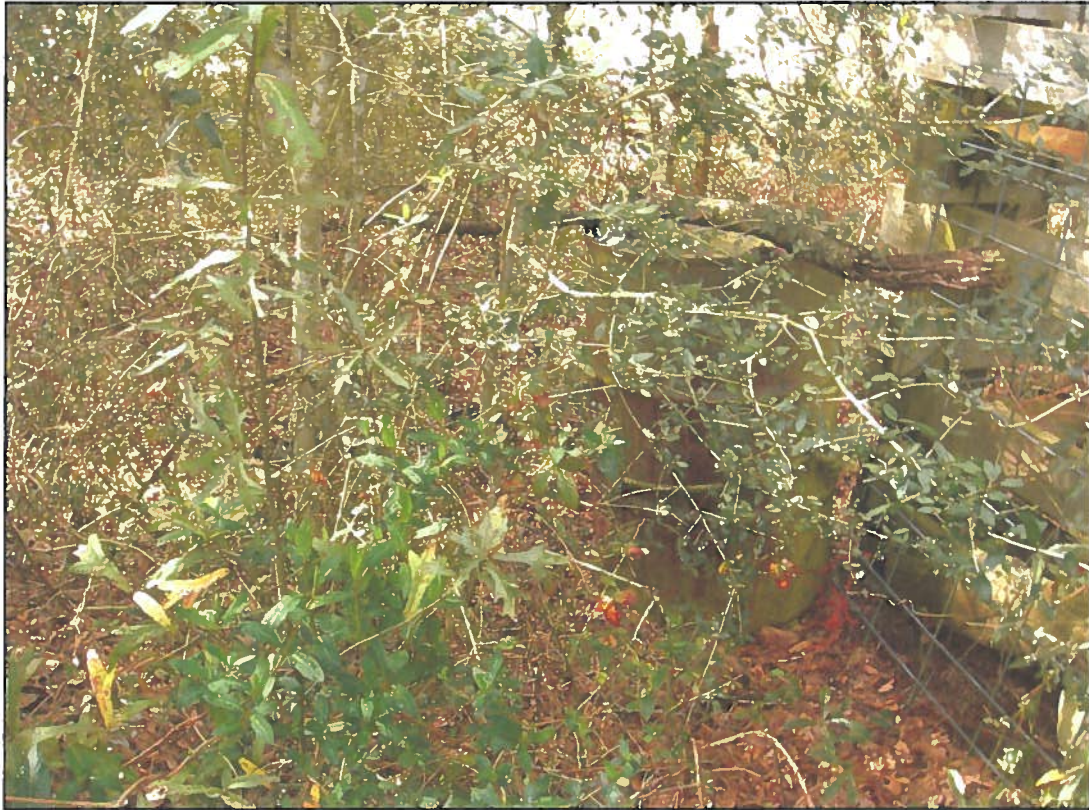
Photograph No. 19. View of drum observed near the sheds in the cattle pen area.

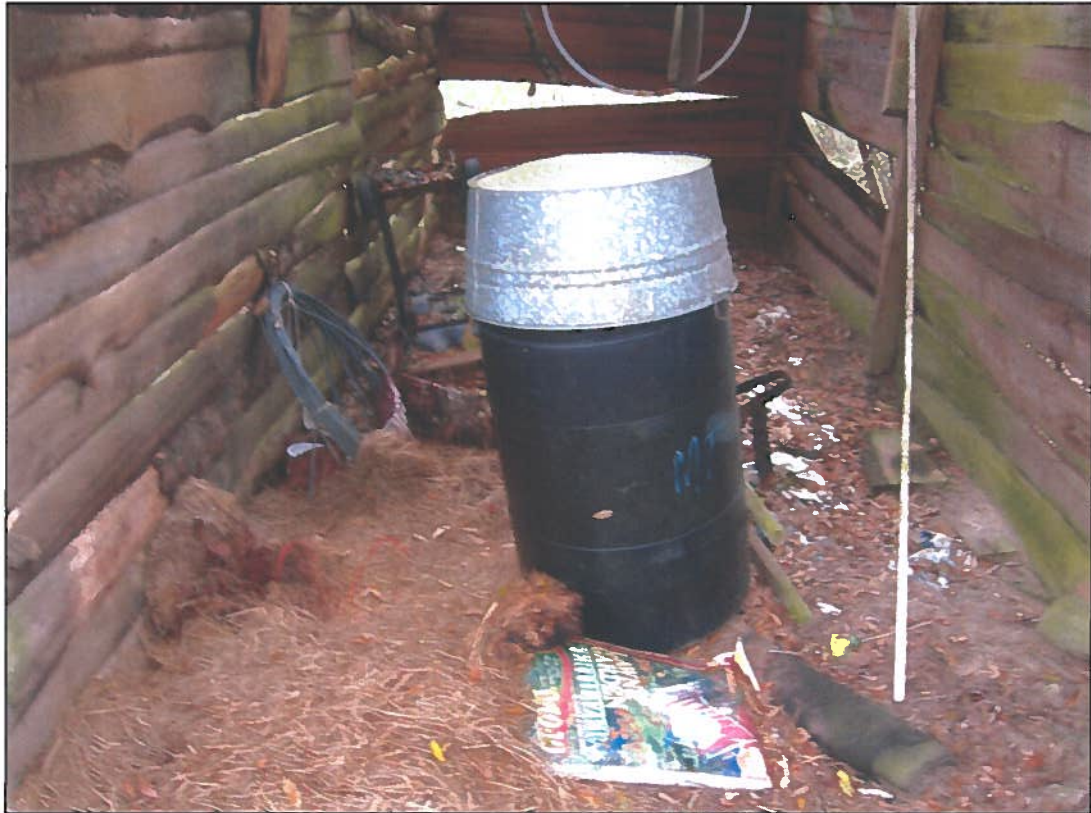
Photograph No. 20. View of drum and debris observed in the cattle pen area.

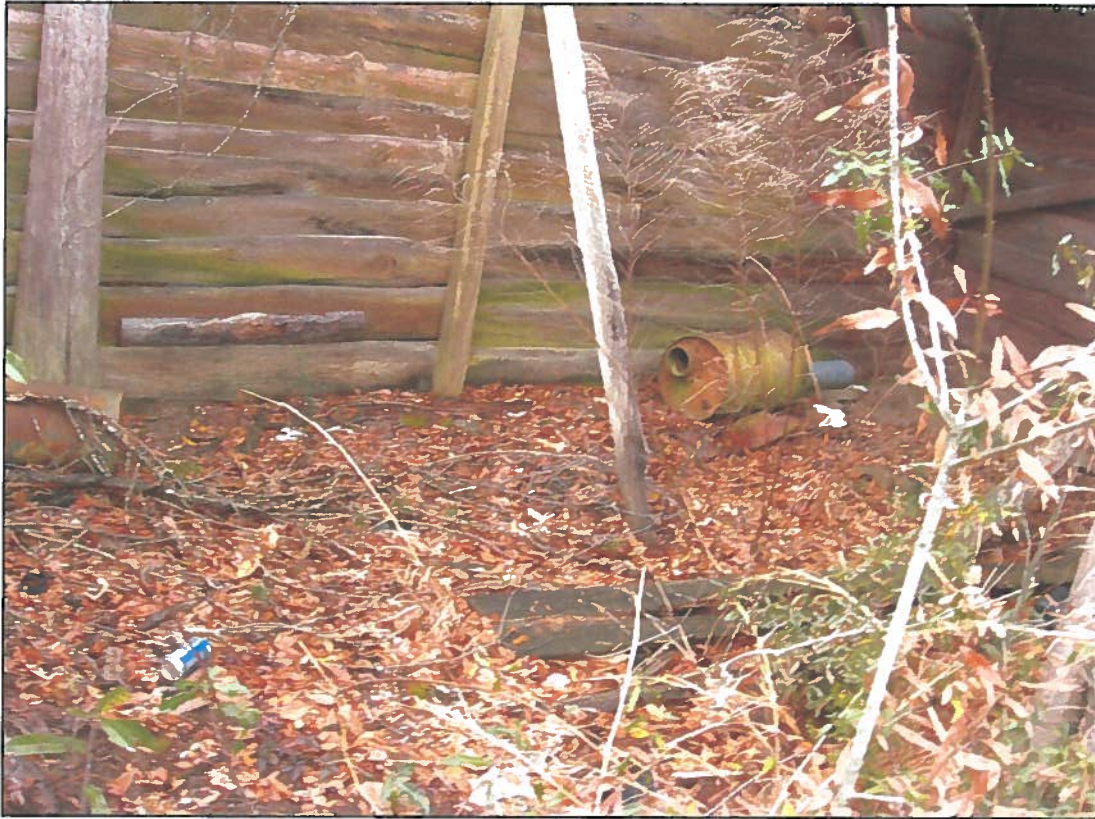
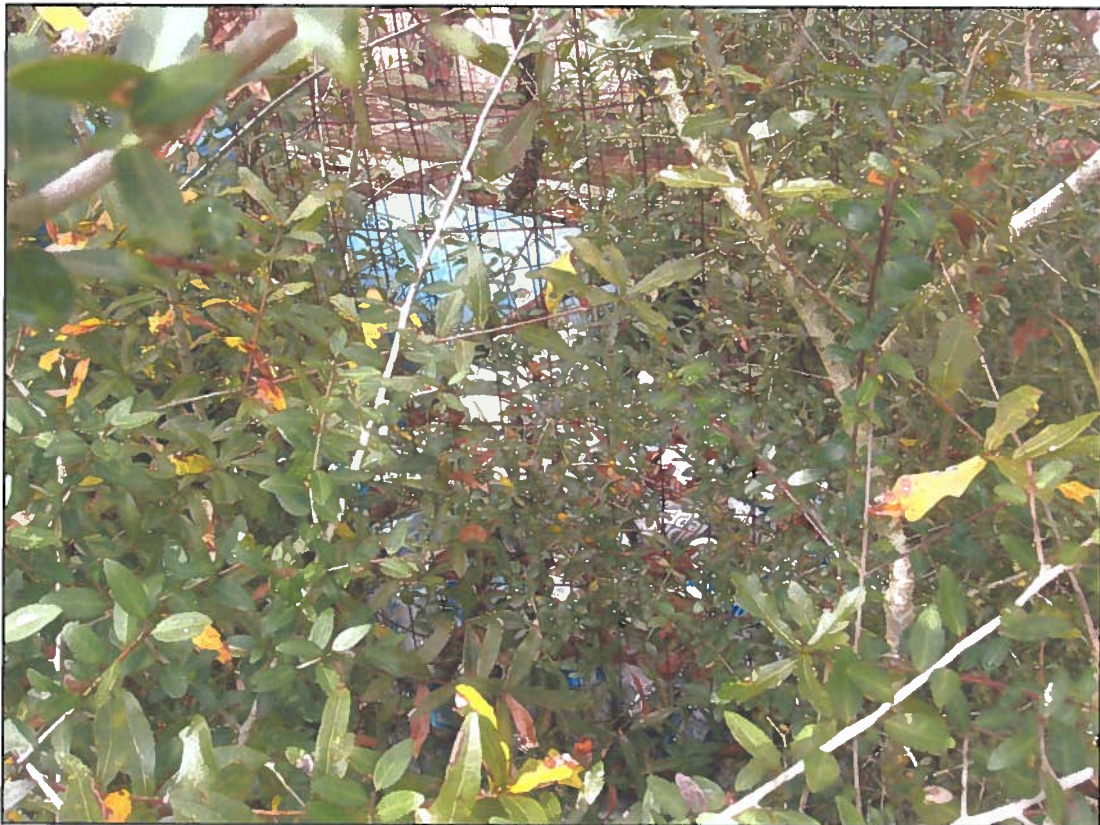
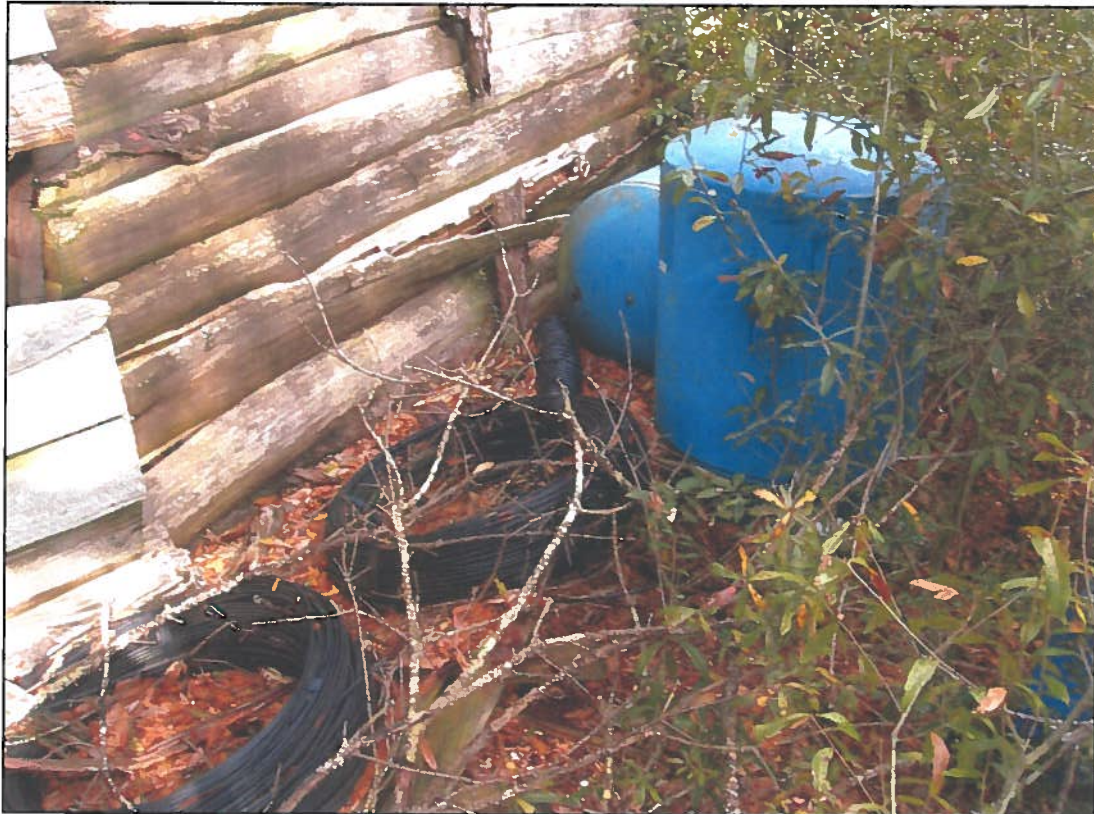
Photograph No. 21. View of items observed in the cattle pen area.

Photograph No. 22. View of items observed in the cattle pen area.

Photograph No. 23. View of items observed in the cattle pen area.
