Environmental Consulting & Technology, Inc.

June 30, 2011
090213-0100

**Re: Phase I Environmental Site Assessment (ESA) Summary
Celia Site
John Castleberry Parcel
1571 Cox Road
McDavid, Escambia County, Florida**

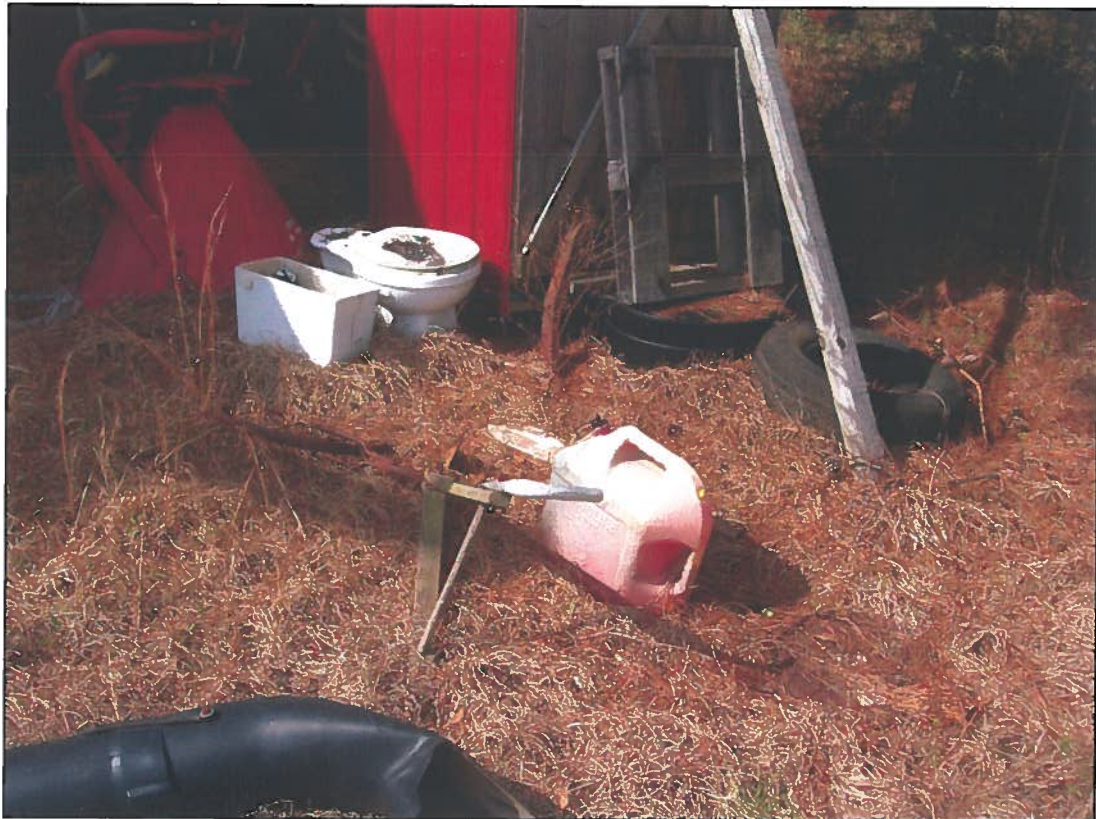
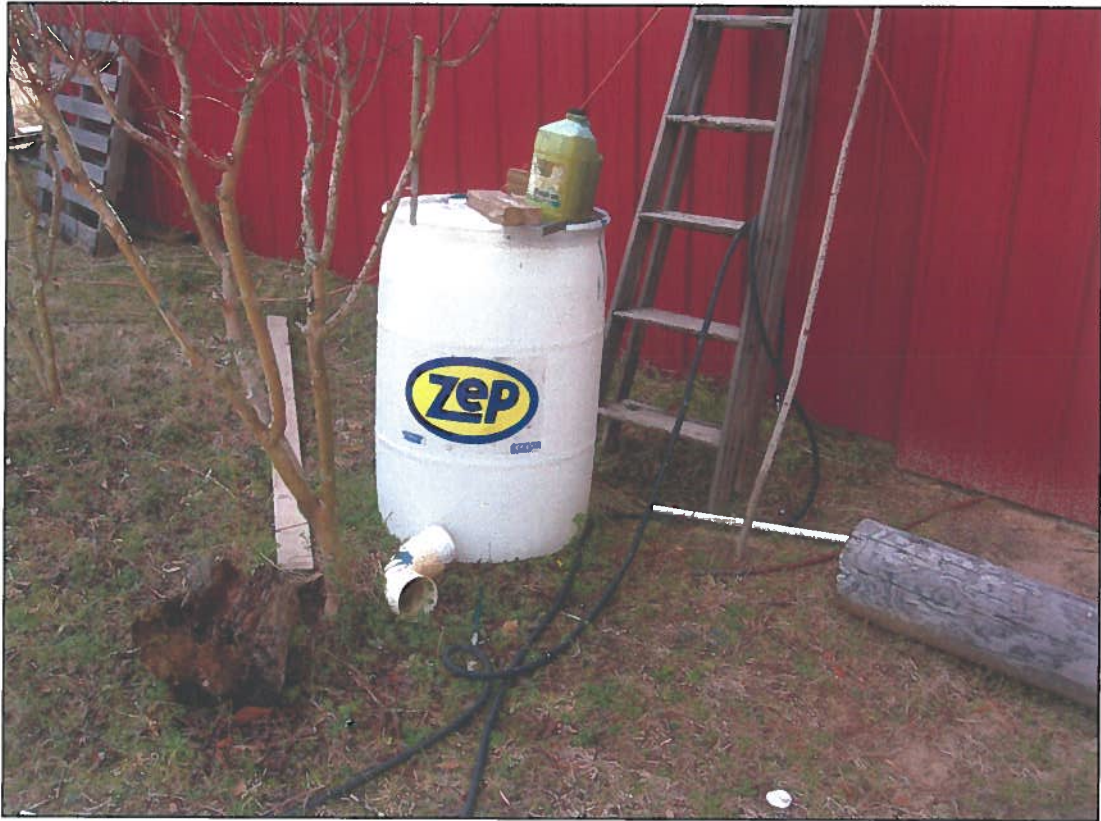
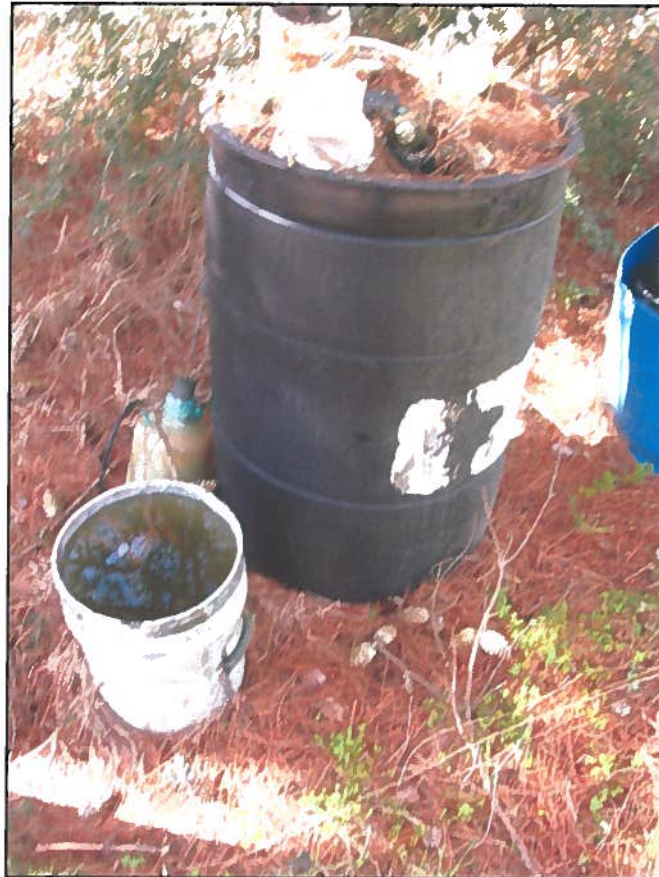
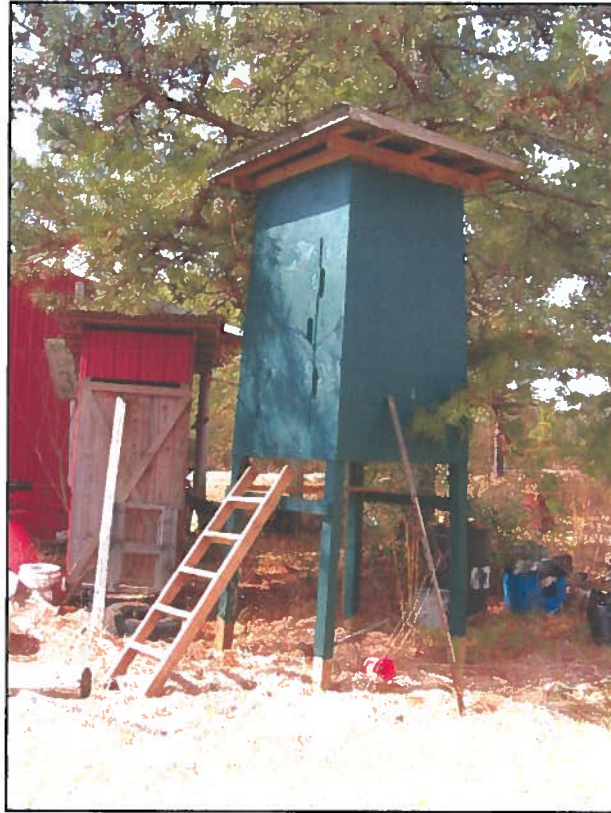
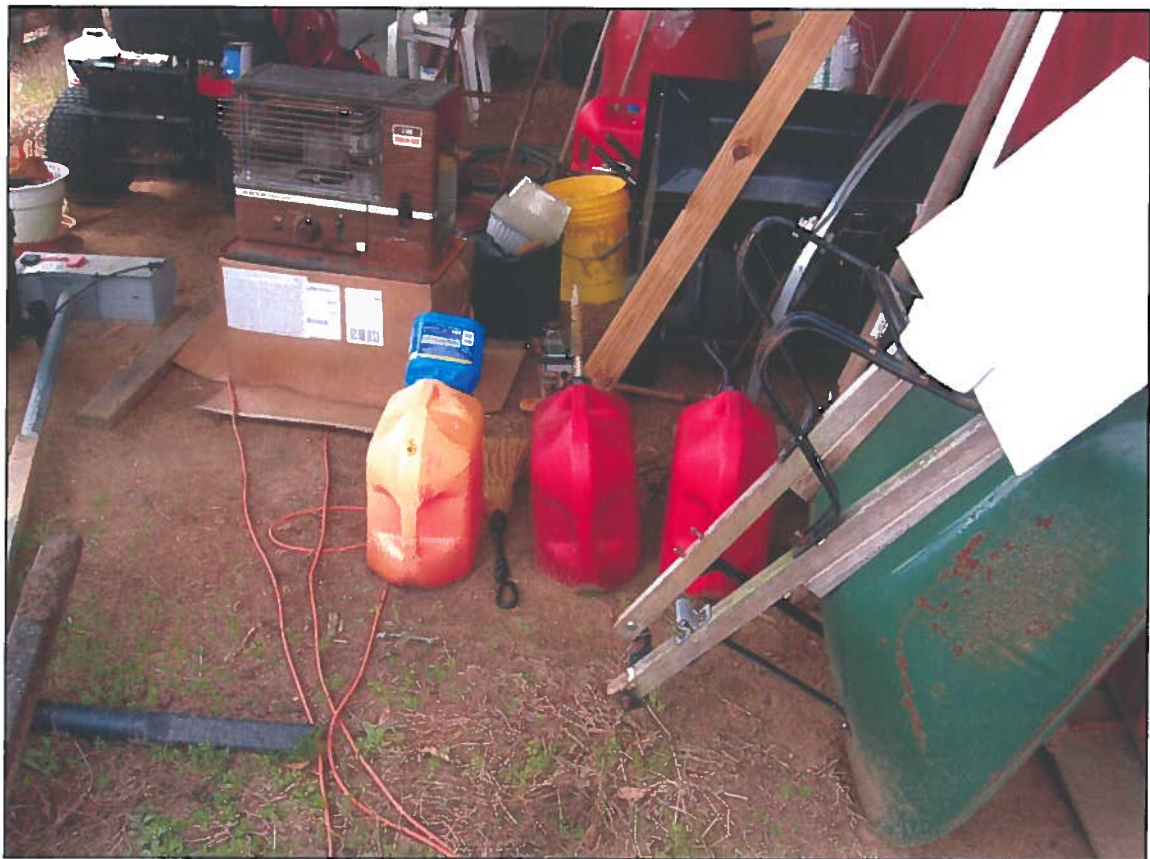
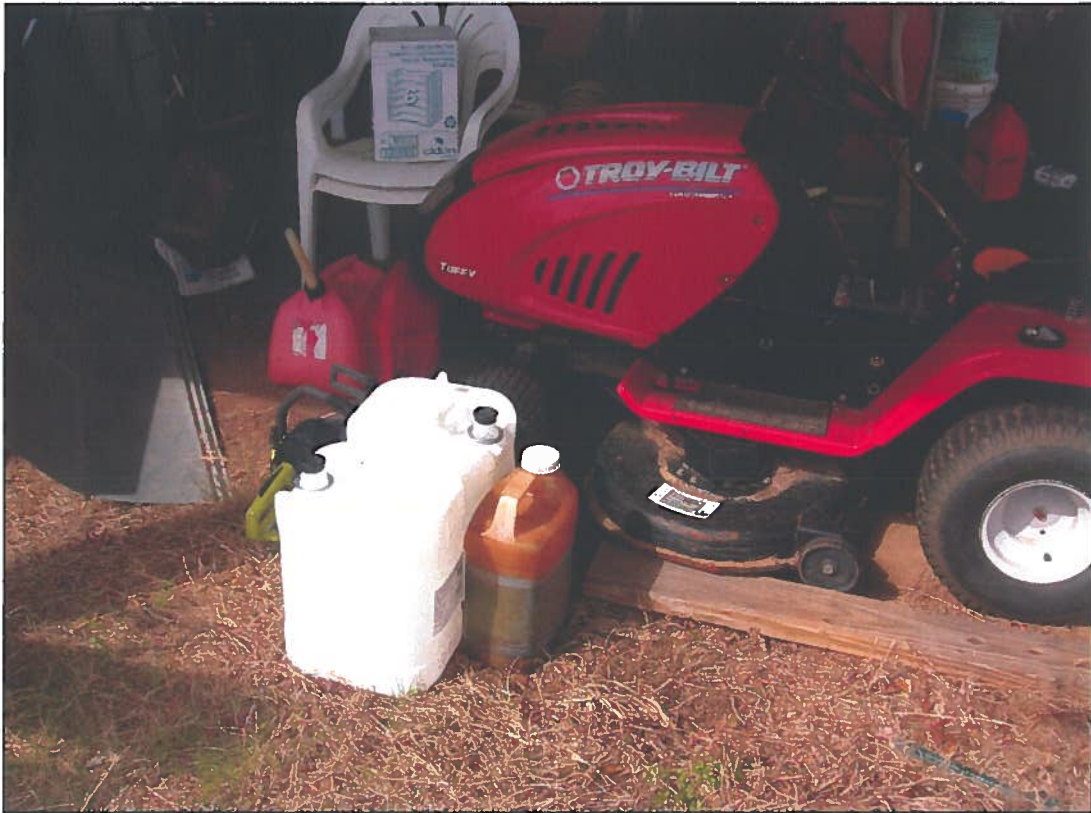
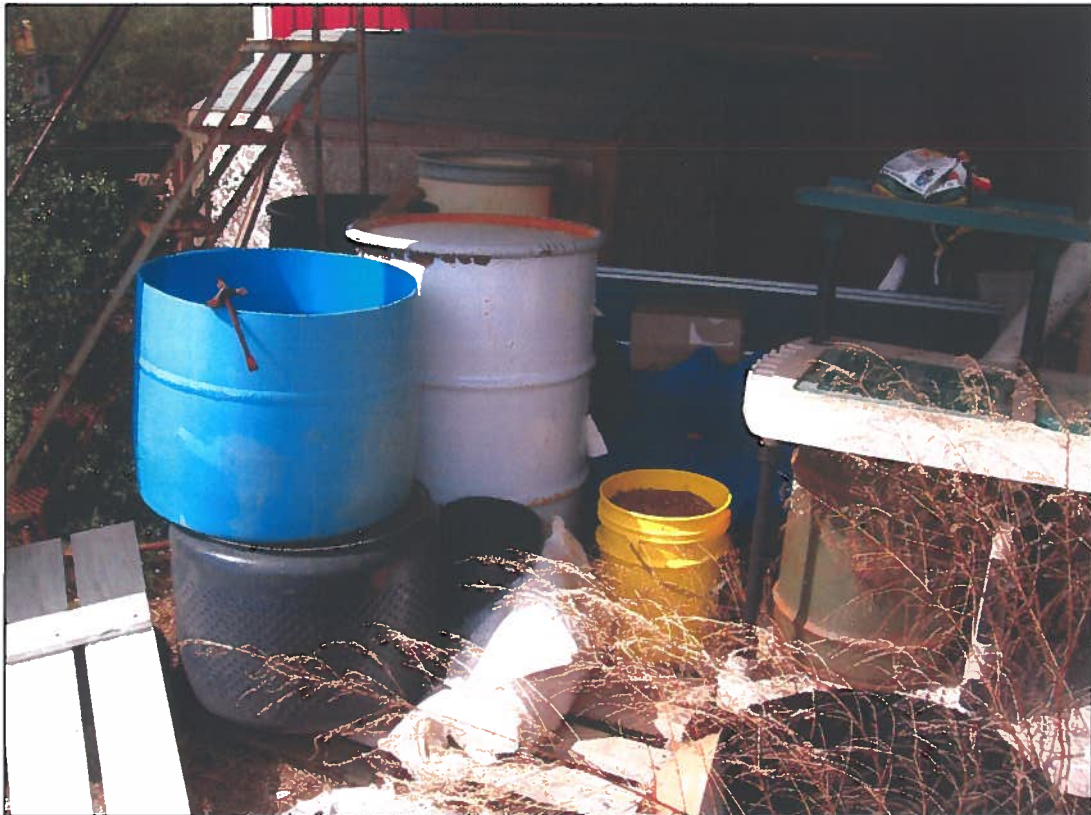
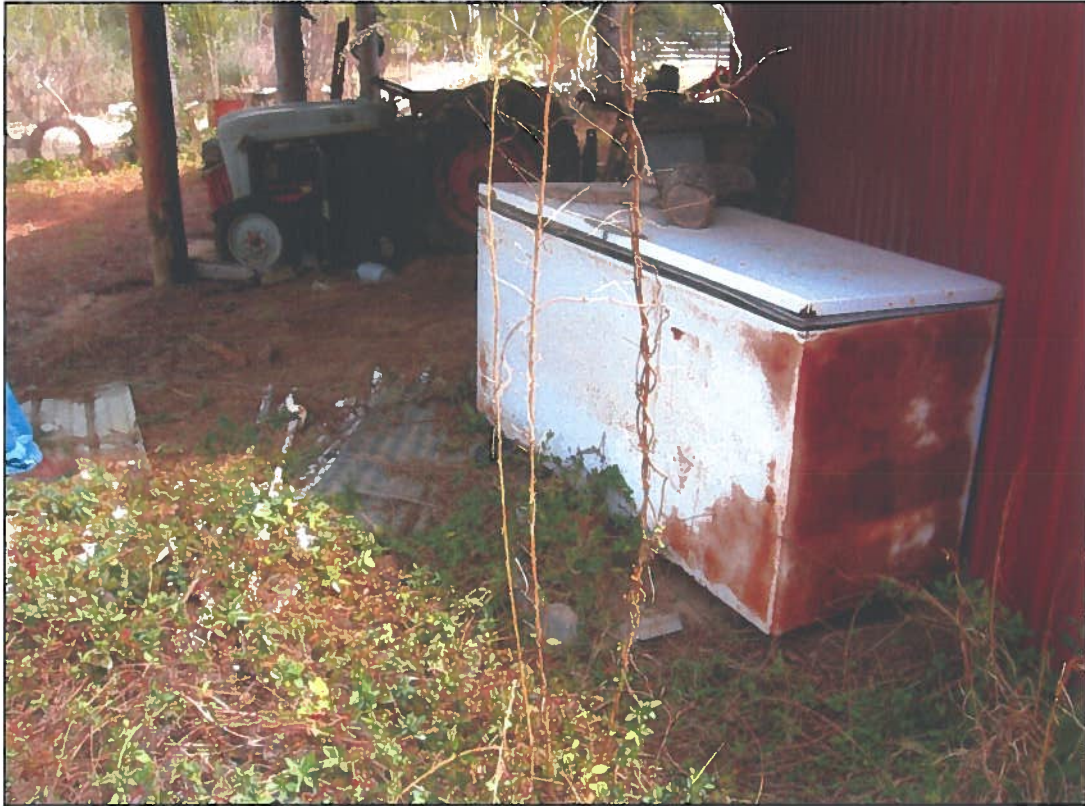
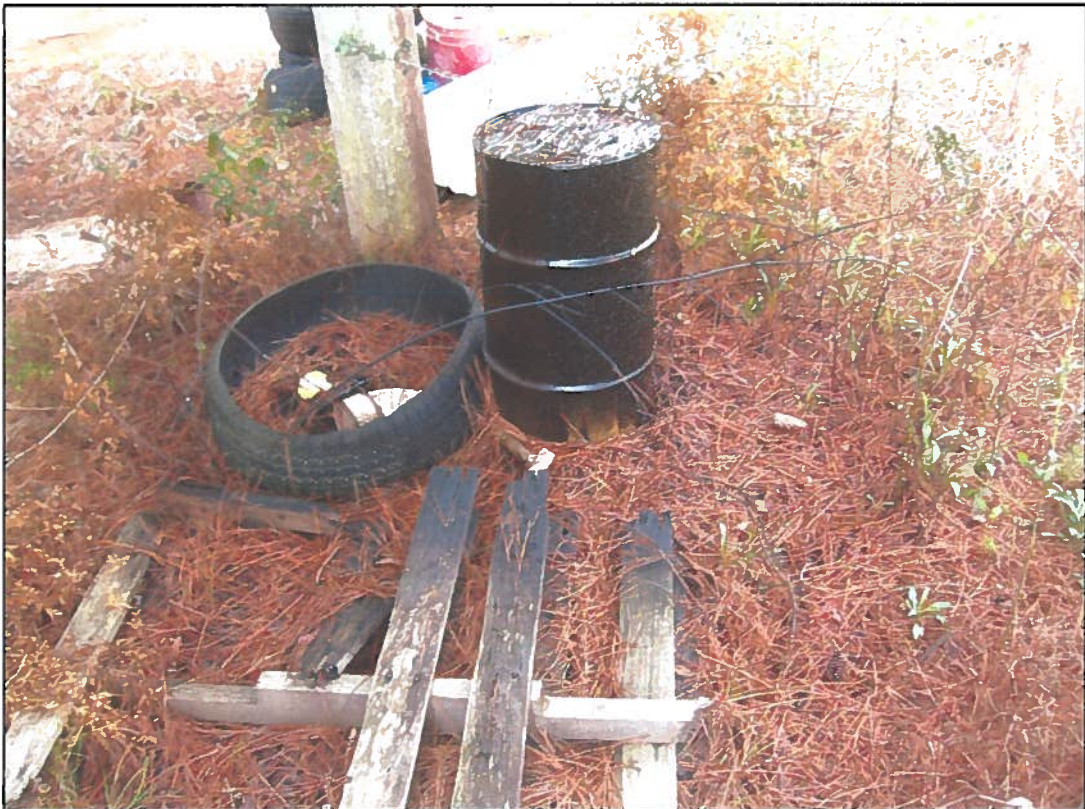
Photograph No. 24. View of items observed around the barn.

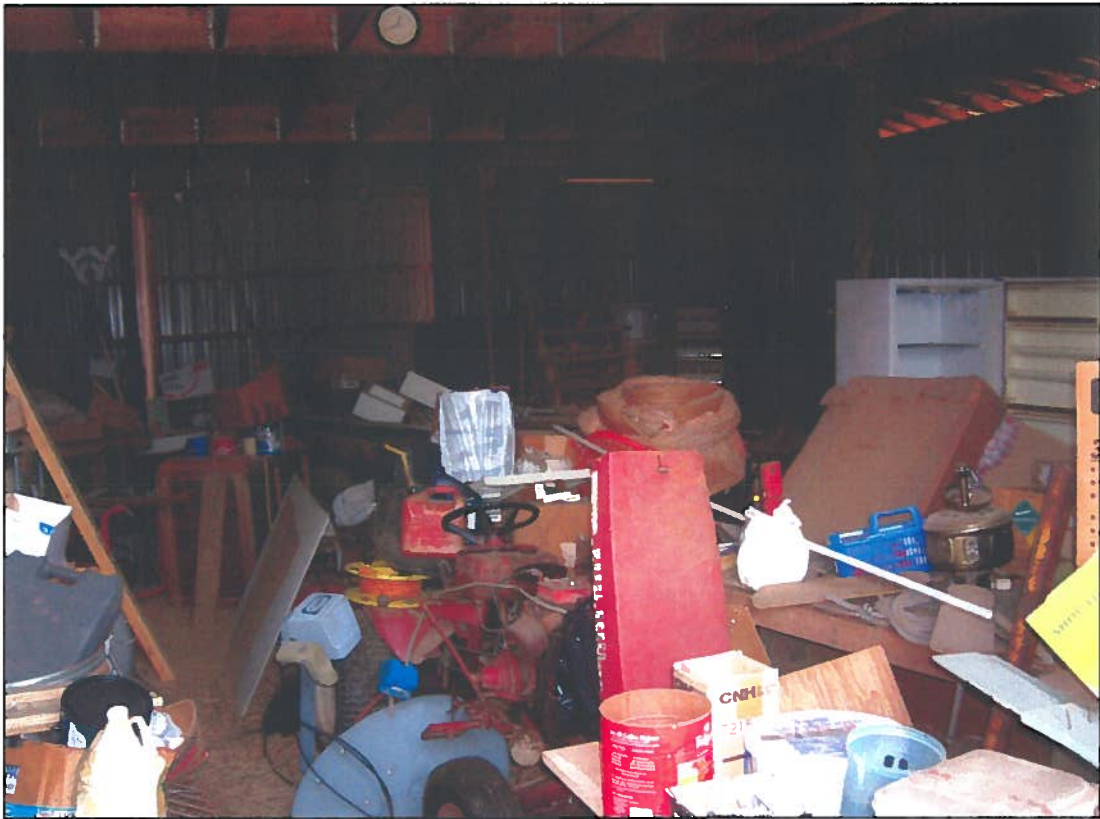
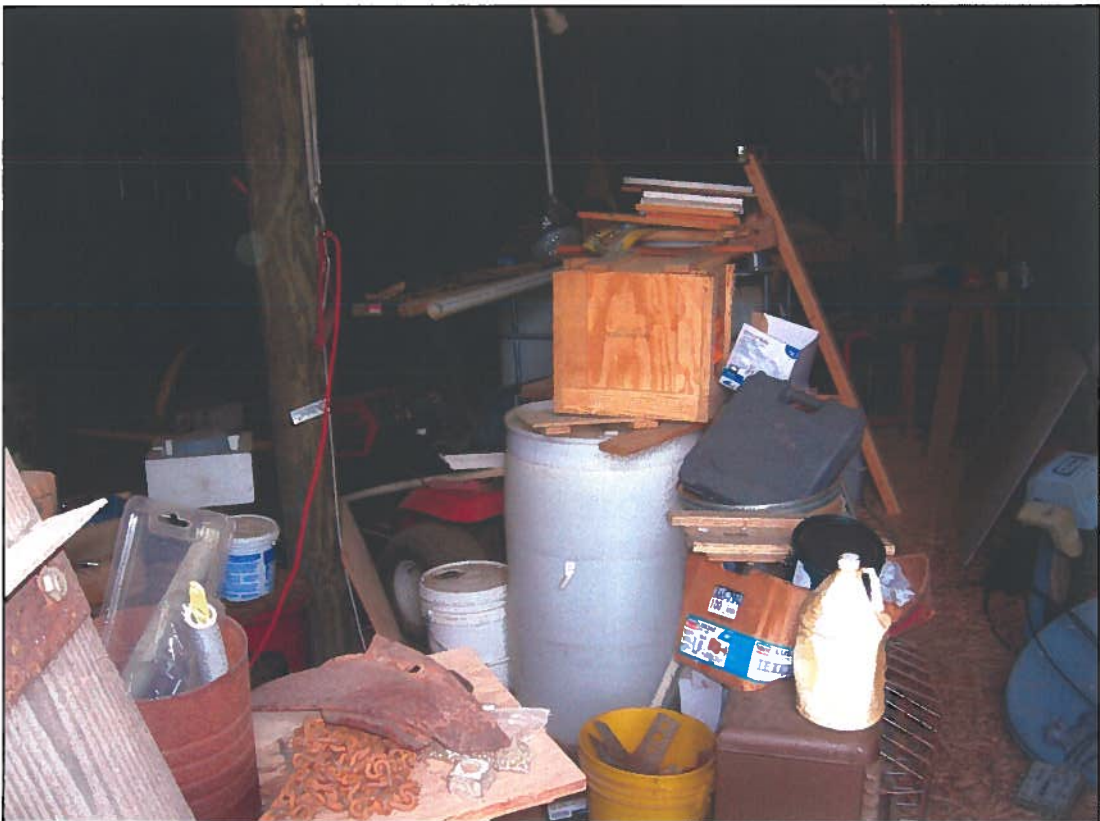
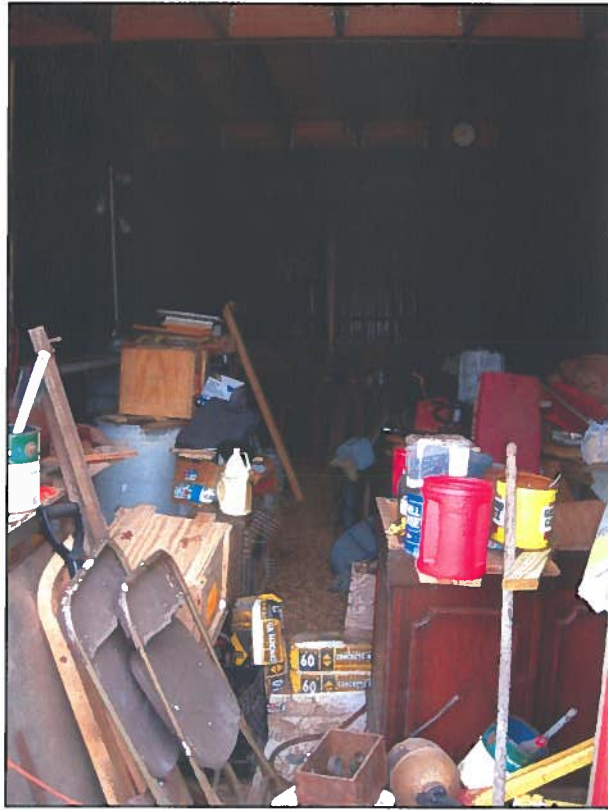
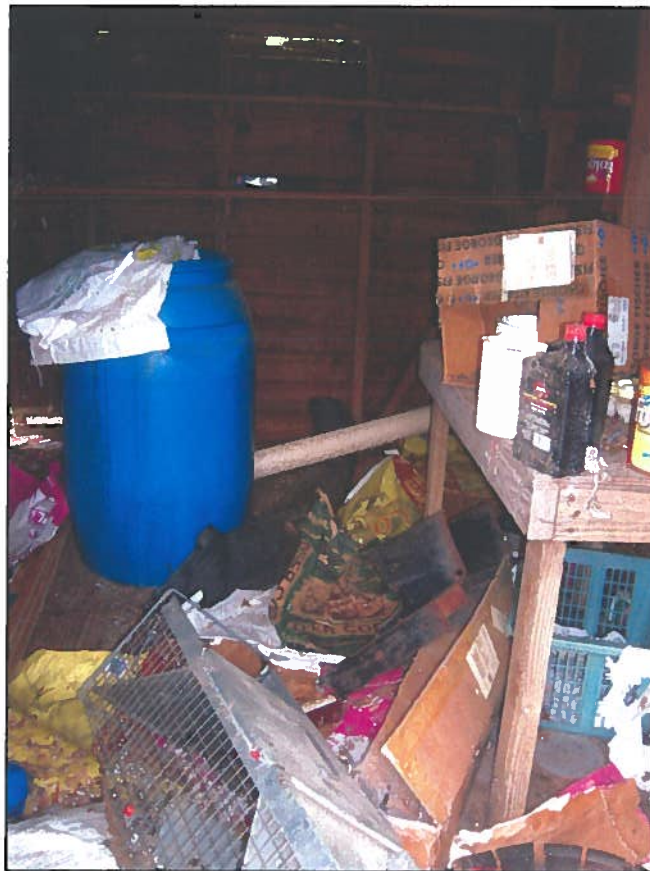
areas), consisting primarily of household items. The interior of the barn was inaccessible at the time of the site visit, due to the amount of stored materials. Drums, gasoline cans, and other miscellaneous materials were observed in the barn interior. A pole-mounted transformer (PMT) was observed near the barn in the south-central portion of the site. The PMT appeared relatively new and in good condition, with no evidence of leaks. Another PMT was observed along Cox Road, near the northeastern corner of the subject property. This PMT also appeared relatively new and in good condition, with no evidence of leaks. Although not observed at the time of the site visit, a pile of debris was previously noted in the southern portion of the subject property, which juts across the unpaved roadway along the southern property boundary (see Figure 2). The debris consisted primarily of household items.

Photograph No. 33. View of the barn interior.

- Area of soil staining beneath two adjacent drums near the sheds in the cattle pen area in the southeastern portion of the site (one sample);
- Beneath the stained pallets of the covered fuel drum storage area located to the southwest of the barn in the south-central portion of the site (one sample from beneath the most heavily stained area);
- Beneath the treated wood logs located along the southern property boundary between the residence and the cattle pen area (one to two samples);
- Beneath the debris pile located on the southern portion of the site, across the unpaved roadway along the southern boundary (up to three samples); and,
- In the interior portion of the barn (up to four samples).

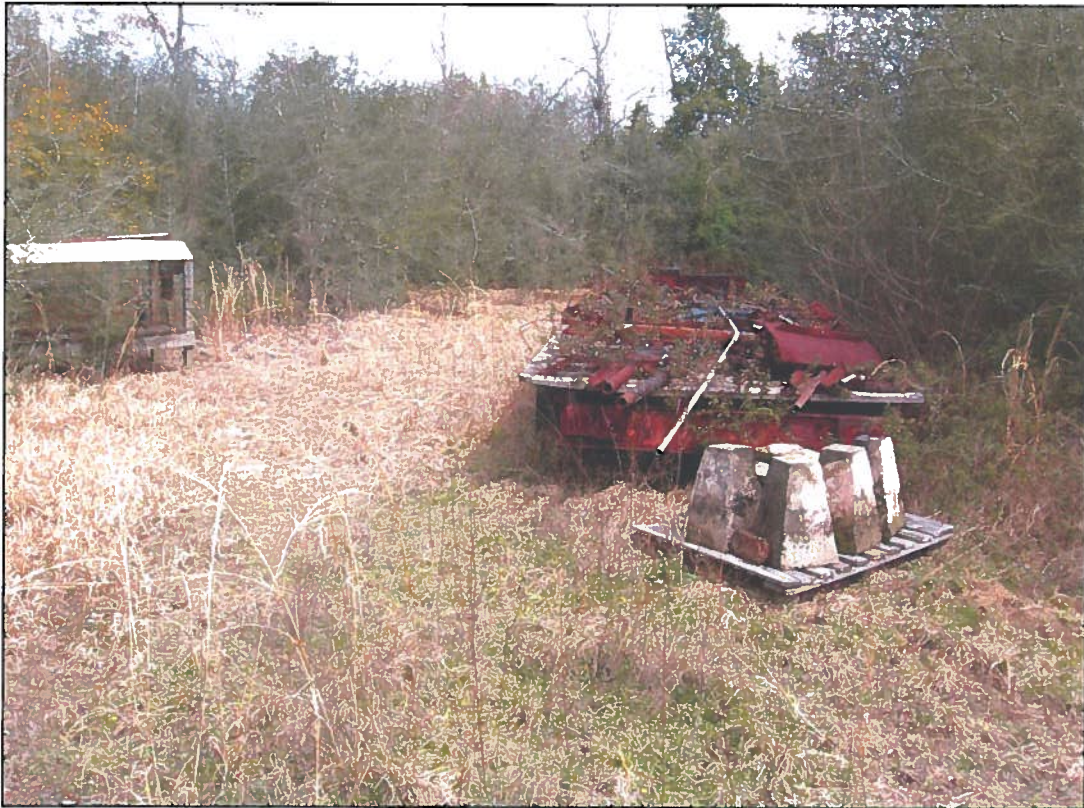
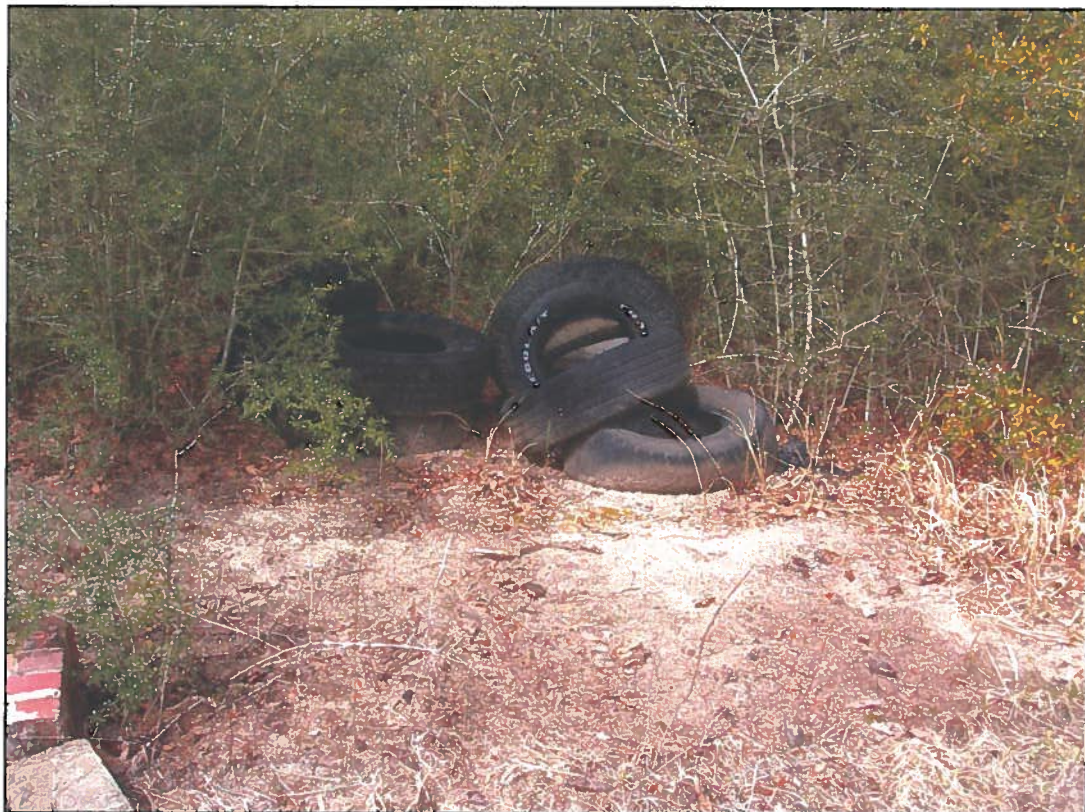
Photograph No. 37. View of items observed in the pig pen area.

Photograph No. 38. View of items observed in the pig pen area.
