BRR 4S L-0 Background

The Bartow Combined Cycle Steam Turbine 4s (COE mid-2009) last stage blade (L-0) issues started with a routine visual inspection that lead to a forced outage in 2012 after just 3 years of in service time. Several cracks and chips were found on the blade mid-span snubbers and tip z-notches of the turbine end row. The generator end was undamaged and turbine end L-0's were replaced. The OEM concluded in a root cause investigation the cause of the issue was last stage steam flow rates beyond their design limits forcing non synchronous blade vibrations and subsequent wear and fatigue of the mating blade contact surfaces. At that time, the OEM required a limit to the IP exhaust pressure to limit steam flow into the LP section to the original design limit thus restricting output. The unit continued to run at the original design conditions until a more rugged design upgrade was developed and made available.

# Bartow Steam Turbine RCA Review Addendum Presentation Nov 17<sup>th</sup> 2016

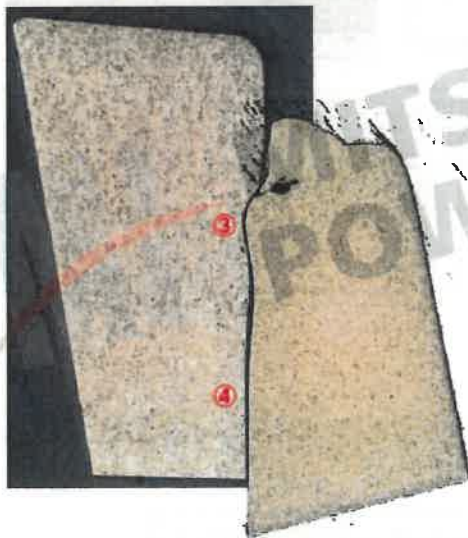
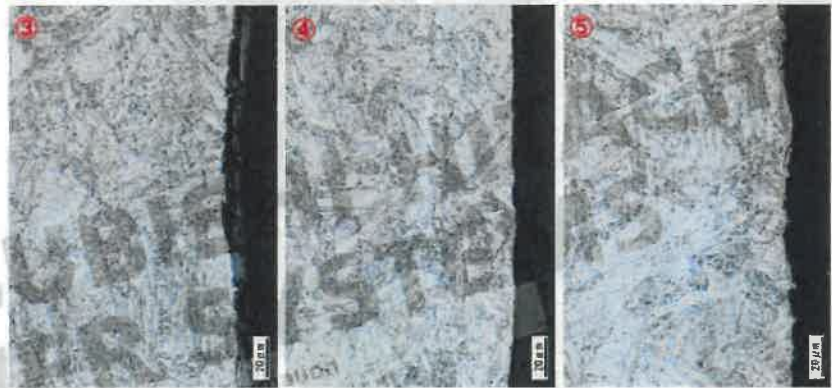
Microscopic observation was performed on the same sections in contact condition for each of outlet side of #43 blade and inlet side of #44 blade.

- ③: Oxide scale was found on black surface of local deformation area.
- ④: Dark brown surface of worn and thinned part is free of oxide scale and smoother than non-contact surface of ⑤.

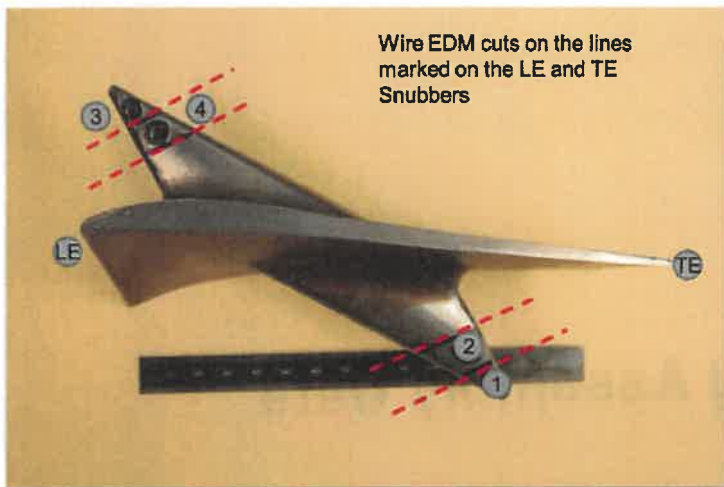
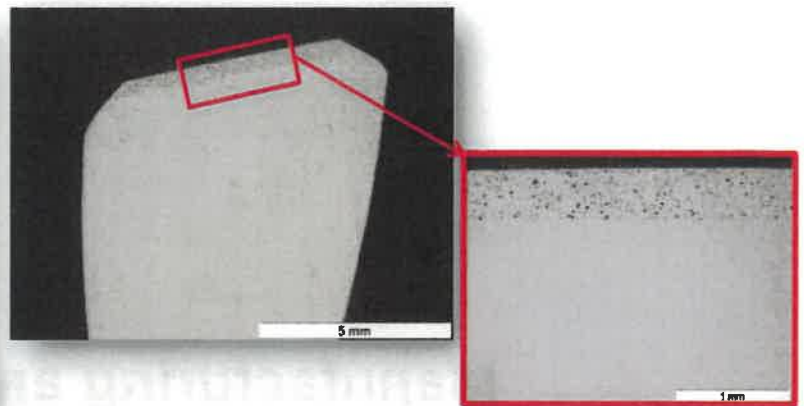
- The contact surface coating did not show any cracks, deformation or wear.
- Uniform thickness was measured on the areas of contact between the LE and TE snubbers.

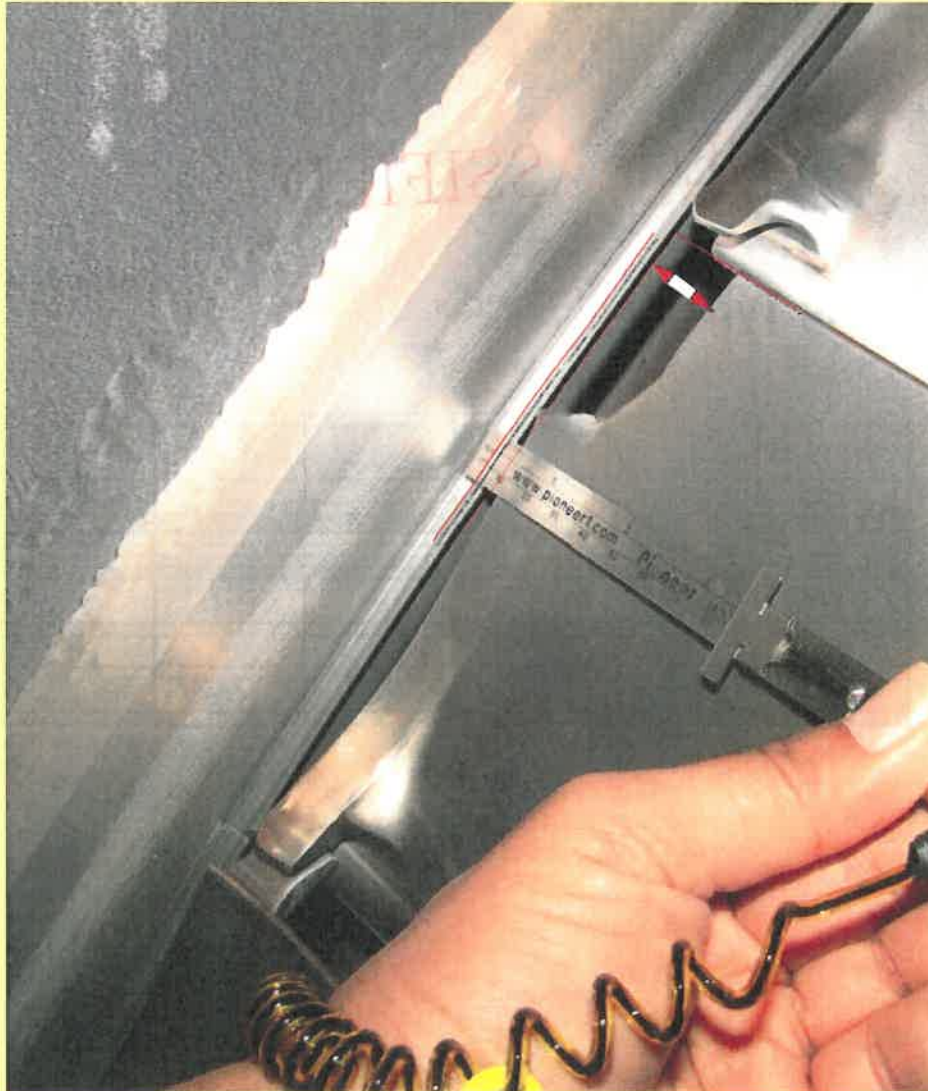
Oct 2016 photo of gen end #22. Three blades failed similar this GE # 13 and TE #2. Adequate mass loss to drive recorded Vibration step changes below.

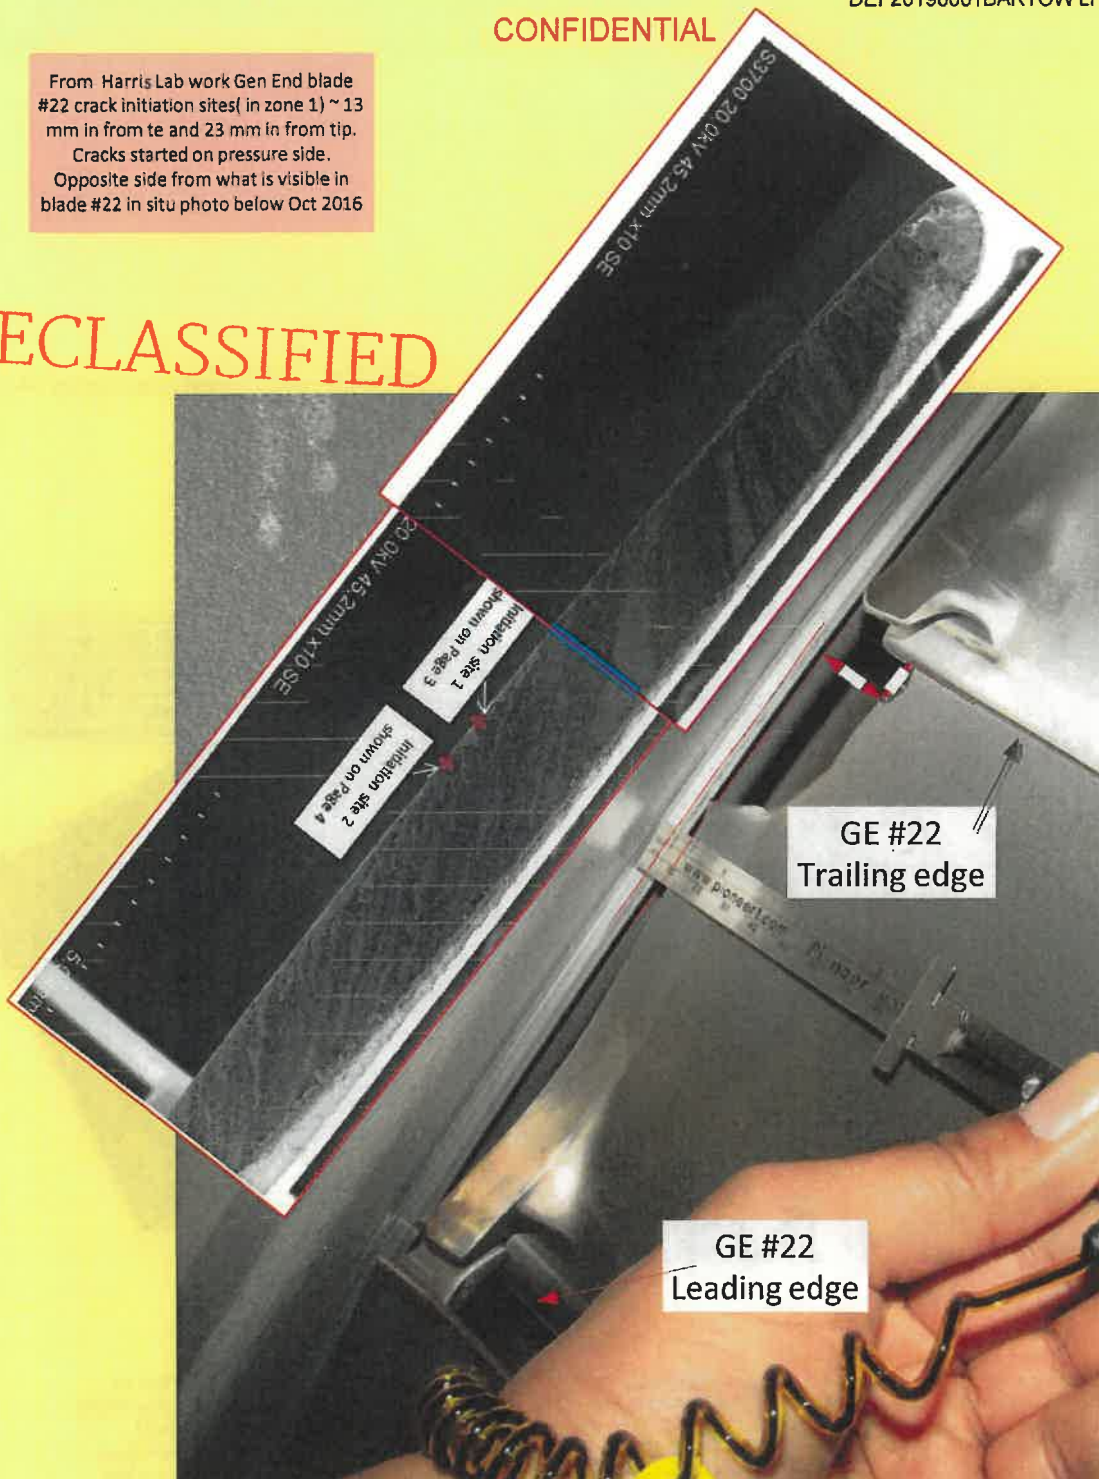
Harris lab work identifies crack as three zones. Initial zone 1 ( sem photo above) was high cycle fatigue that started at possibly more that one site ~ 13 mm from trailing edge and joined to grow to zone 2. It was suspected crack started at trailing edge and grew. NOT true started at 13 mm from edge, on the pressure side ( opposite side that's shown in photo) and trailing edge failed by ductile overload. Dental molds taken from other two failed blades TE #2, GE #13 show consistent failure mechanisms.

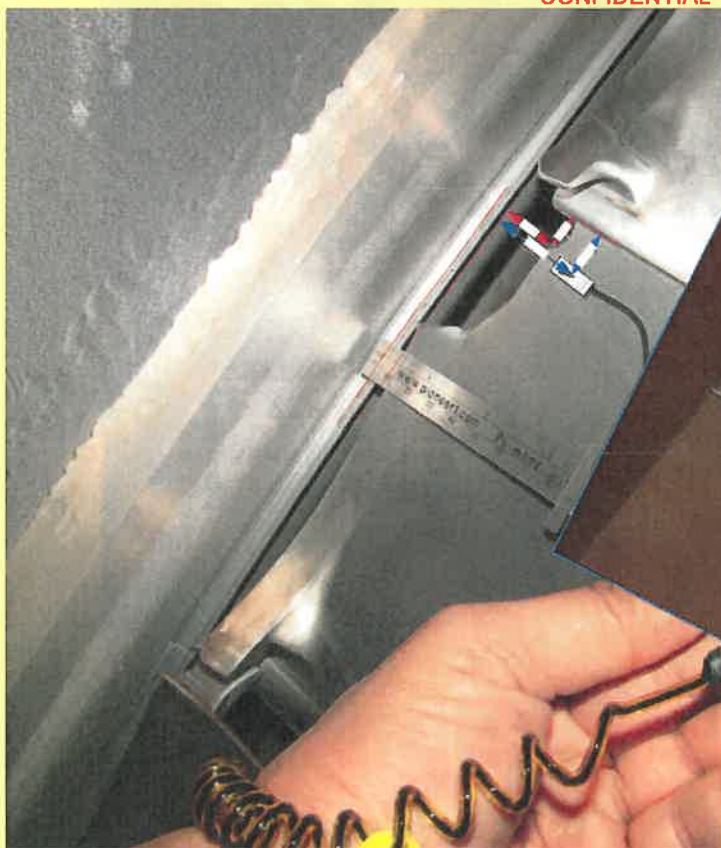
From period III photo of tip strain gage location ~ 18mm in from te and 32 mm in from tip. Gage was on suction side while high stress and crack initiation was on opposite side pressure side

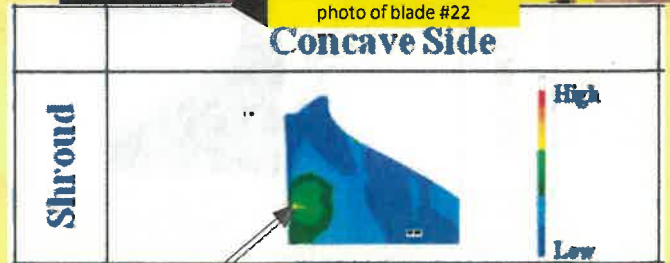
From MHI 2012 Period I RCA  
 presentation. Confirming  
 high static stress area where  
 Period IV cracks initiated.

Finite element analysis performed after 2012 failure showed the crack starting point area had stresses above yield and the design would need to be "yielded down". This is possible because full section of blades was not above yield. This was not a concern with earlier failures, because the air foil was not liberating just contact face wear on mid span snubber and z lock tip. Partial tip and snubber loss was possible. The 2016 work re confirmed the high stress area and an earlier presentation 2012 by MHI supports the pressure side of the blade tip below the latch has high stress. The crack started at nearly the same spot as the predicted high stress area.

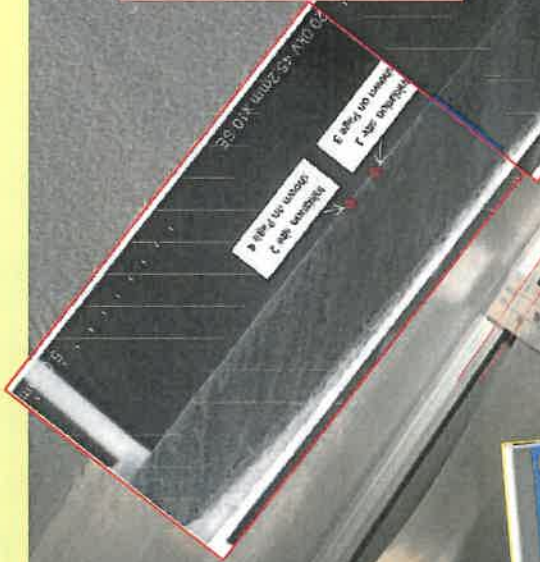
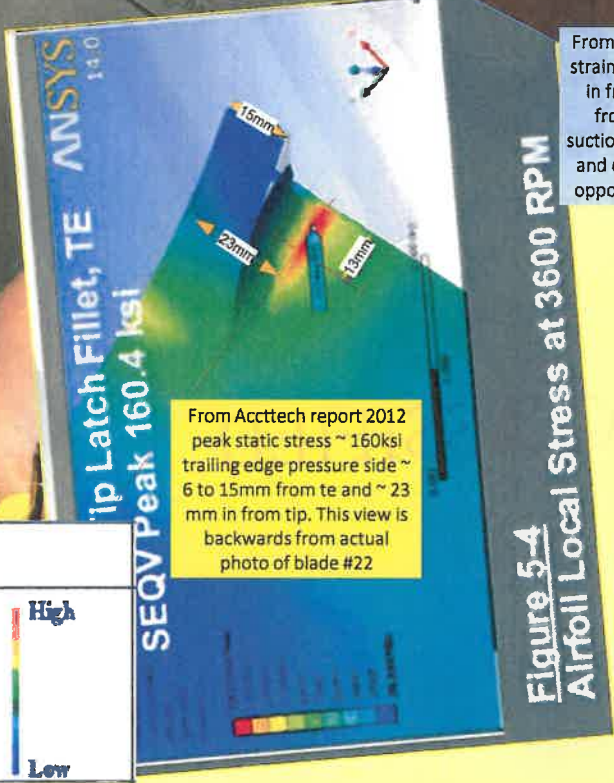
From Harris Lab work Gen End blade #22 crack initiation sites( in zone 1) ~ 13 mm in from te and 23 mm in from tip. Cracks started on pressure side. Opposite side from what is visible in blade #22 in situ photo below Oct 2016

From period III photo of tip strain gage location ~ 18mm in from te and 32 mm in from tip. Gage was on suction side while high stress and crack initiation was on opposite side pressure side

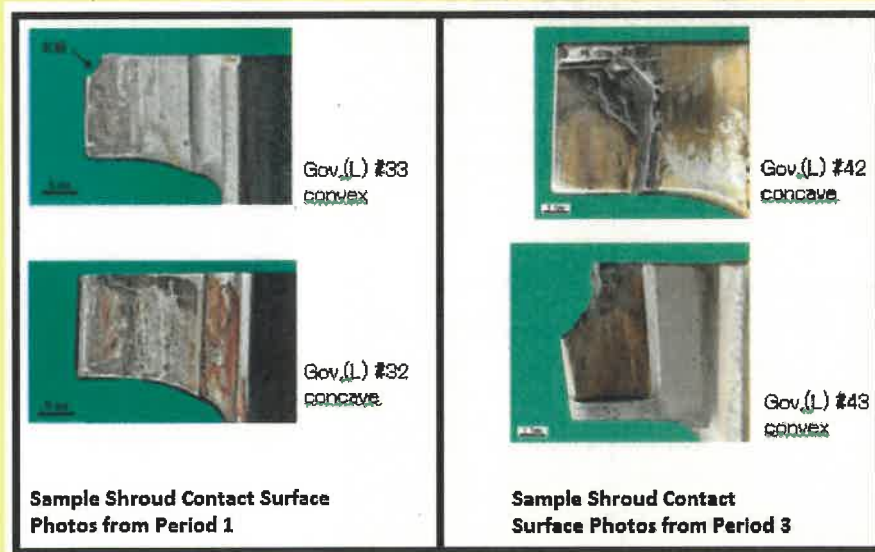
Figure 1 -- Comparative Photos of Shroud Contact Surface Wear for Periods 1 and 3

With the L-0s currently removed from the machine and with the pressure plate installed, MHPS Engineering has indicated that back-end loading is not currently an issue of concern at the current LP inlet operating limits. MHPS Engineering does not have enough technical data to support releasing Duke to operate the machine

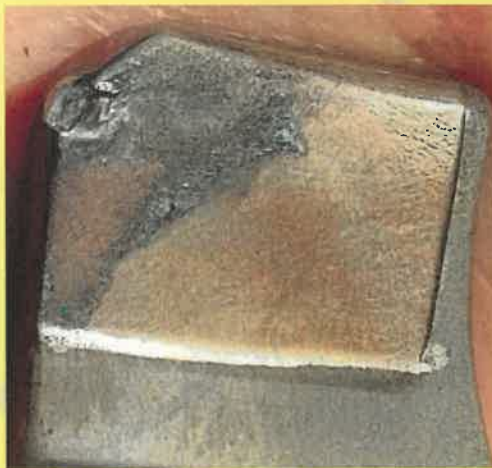
**Figure 4 -- Photo of an L-0 blade Z-Lock from Period 5 Showing Contact Surface Wear**

Period 5 did have its share of higher energy blends as detected by the blend energy method. However, in terms of operating hours in blend mode, Period 5 is not excessive in terms of percentage time blending. The total of 20 hours of blend time does not appear to justify the wear seen.

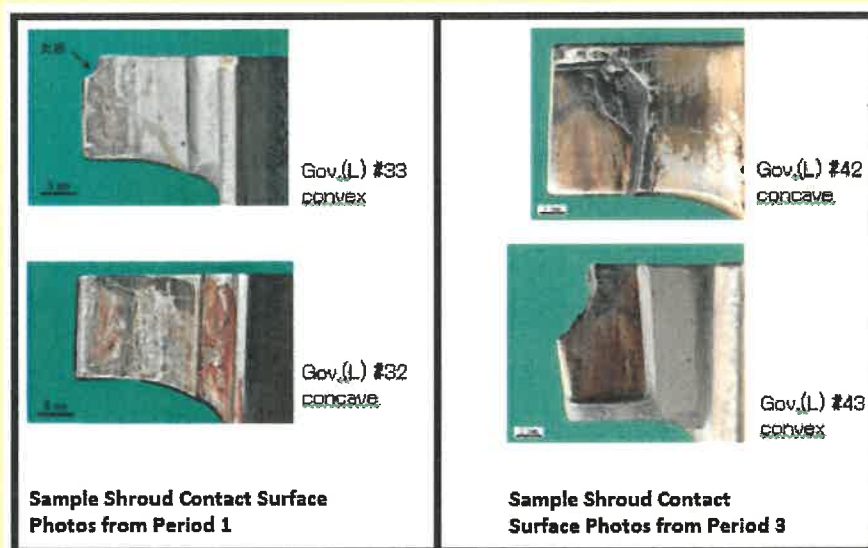
Figure 1 -- Comparative Photos of Shroud Contact Surface Wear for Periods 1 and 3

With the L-0s currently removed from the machine and with the pressure plate installed, MHPS Engineering has indicated that back-end loading is not currently an issue of concern at the current LP inlet operating limits. MHPS Engineering does not have enough technical data to support releasing Duke to operate the machine beyond the current LP inlet operating limits due to concerns for impacts to upstream blading – i.e. the L-1 blade sets.

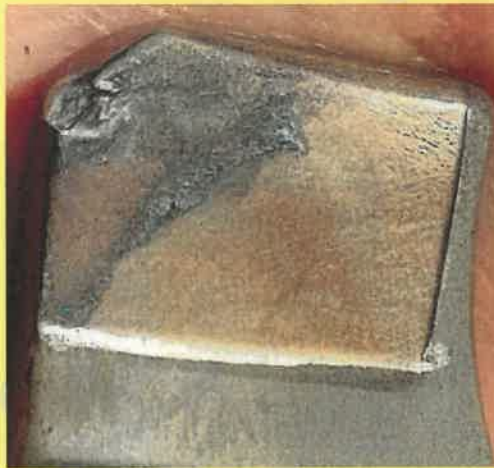
Figure 4 -- Photo of an L-0 blade Z-Lock from Period 5 Showing Contact Surface Wear

Period 5 did have high energy blends as detected by the blend energy method. However, in terms of operating hours in blend mode, Period 5 is not excessive in terms of percentage time blending as compare to time operated in Zone F1.

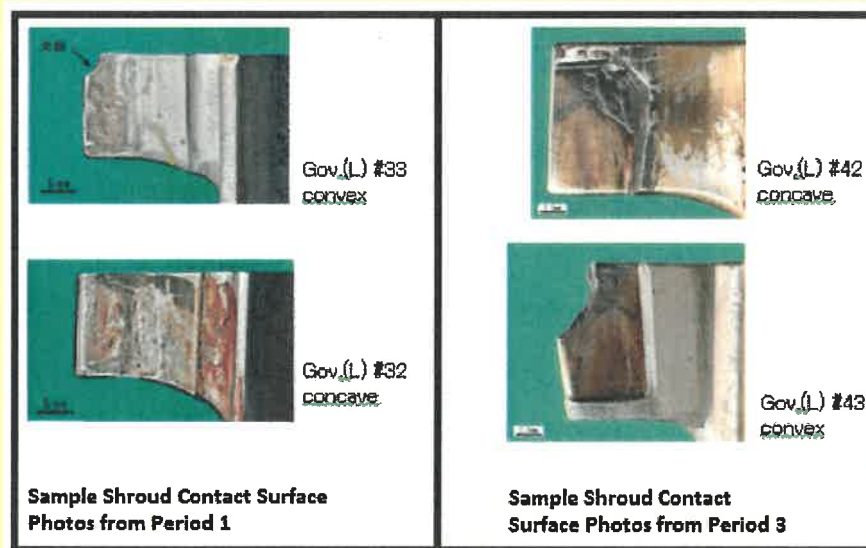
Figure 1 -- Comparative Photos of Shroud Contact Surface Wear for Periods 1 and 3

With the L-0s currently removed from the machine and with the pressure plate installed, MHPS Engineering has indicated that back-end loading is not currently an issue of concern at the current LP inlet operating limits. MHPS Engineering does not have enough technical data to support releasing Duke to operate the machine beyond the current LP inlet operating limits due to concerns for impacts to upstream blading – i.e. the L-1 blade sets.

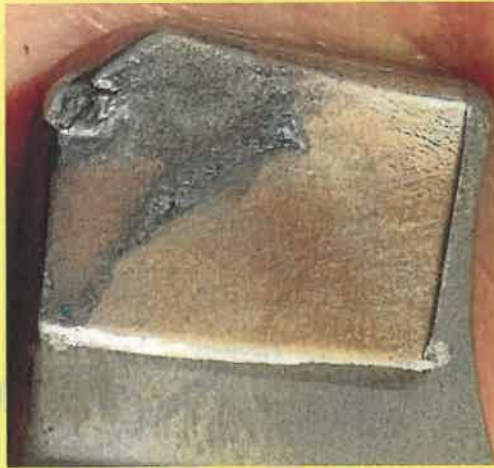
**Figure 4 -- Photo of an L-0 blade Z-Lock from Period 5 Showing Contact Surface Wear**

Period 5 did have its share of higher energy blends as detected by the blend energy method. However, in terms of operating hours in blend mode, Period 5 is not excessive in terms of percentage time blending. The total of 20 hours of blend time does not appear to justify the wear seen.

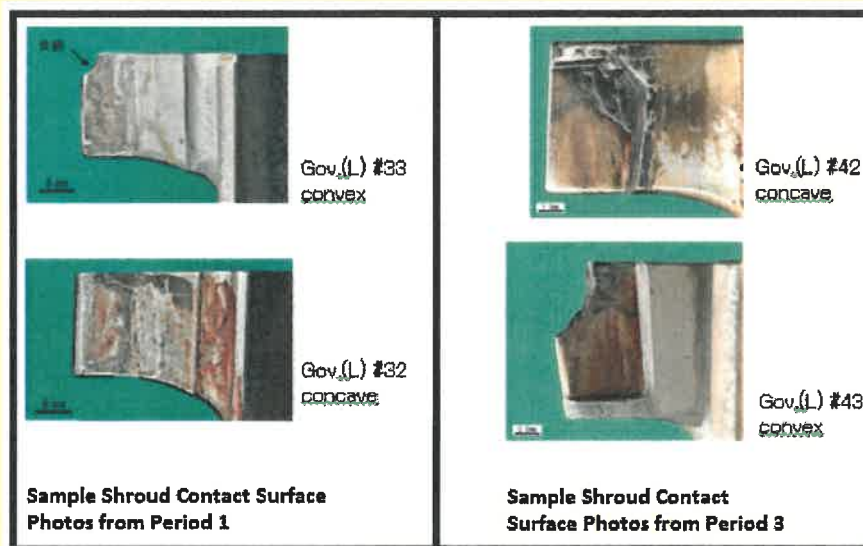
Figure 1 -- Comparative Photos of Shroud Contact Surface Wear for Periods 1 and 3

With the L-0s currently removed from the machine and with the pressure plate installed, MHPS Engineering has indicated that back-end loading is not currently an issue of concern at the current LP inlet operating limits. MHPS Engineering does not have enough technical data to support releasing Duke to operate the machine beyond the current LP inlet operating limits due to concerns for impacts to upstream blading – i.e. the L-1 blade sets.

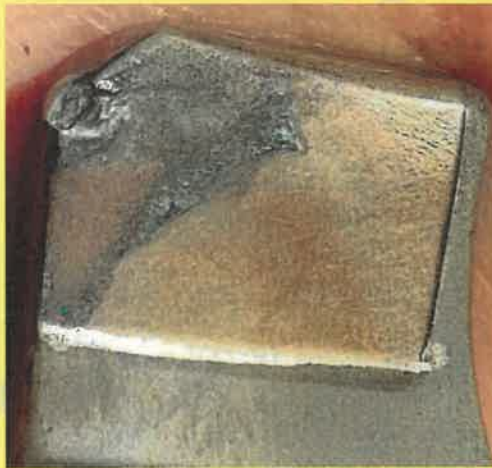
**Figure 4 -- Photo of an L-0 blade Z-Lock from Period 5 Showing Contact Surface Wear**

Period 5 did have high energy blends as detected by the blend energy method. However, in terms of operating hours in blend mode, Period 5 is not excessive in terms of percentage time blending as compared to operating hours in Zone F1.

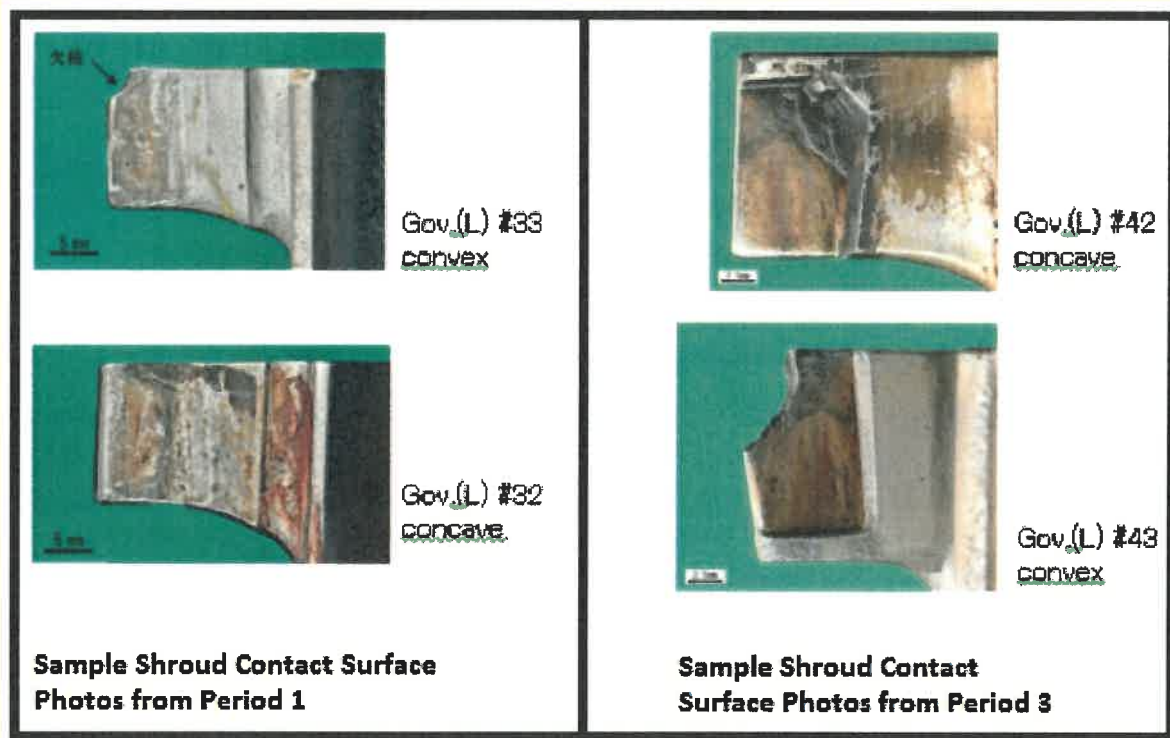
**Figure 1 -- Comparative Photos of Shroud Contact Surface Wear for Periods 1 and 3**

With the L-0s currently removed from the machine and with the pressure plate installed, MHPS Engineering has indicated that back-end loading is not currently an issue of concern at the current LP inlet operating limits. MHPS Engineering does not have enough technical data to support releasing Duke to operate the machine beyond the current LP inlet operating limits due to concerns for impacts to upstream blading – i.e. the L-1 blade sets.

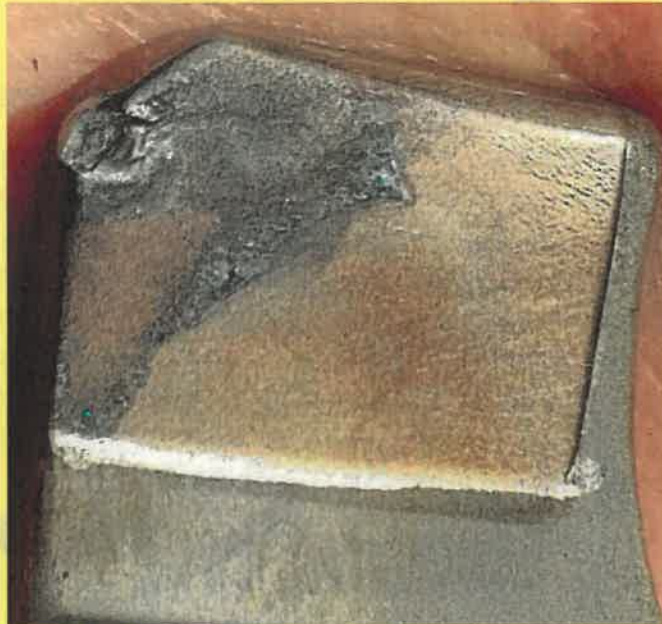
**Figure 4 -- Photo of an L-0 blade Z-Lock from Period 5 Showing Contact Surface Wear**

Period 5 did have high energy blends as detected by the blend energy method. However, in terms of operating hours in blend mode, Period 5 is not excessive in terms of percentage time blending as compared to operating hours in Zone F1.

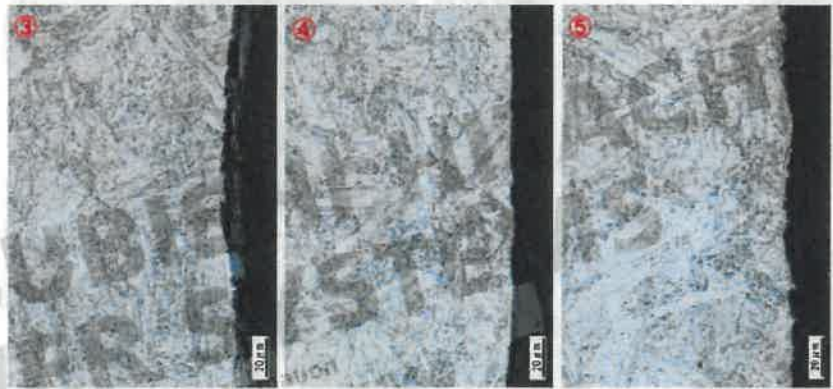
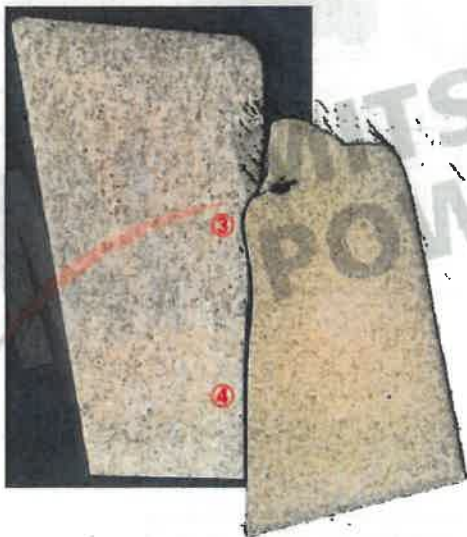
Microscopic observation was performed on the same sections in contact condition for each of outlet side of #43 blade and inlet side of #44 blade.

- ③: Oxide scale was found on black surface of local deformation area.
- ④: Dark brown surface of worn and thinned part is free of oxide scale and smoother than non-contact surface of ⑤.

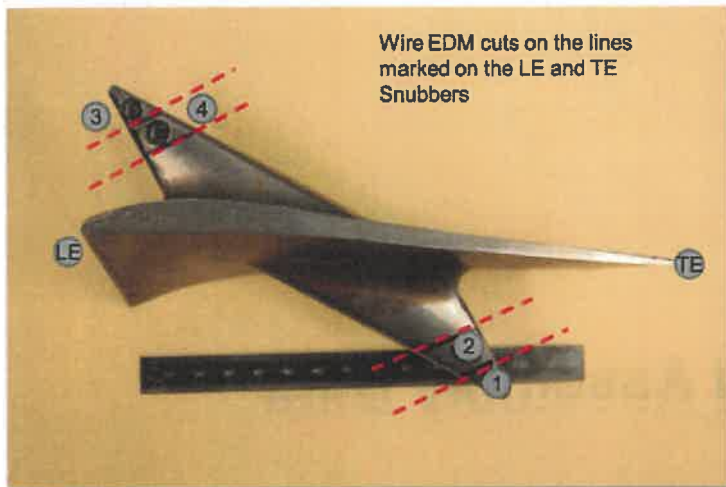
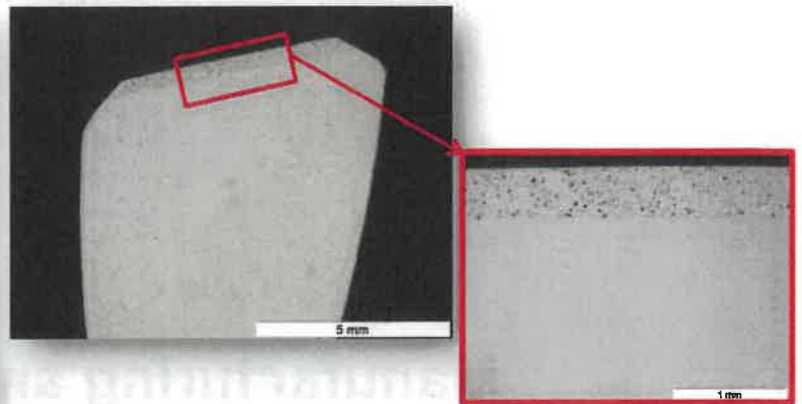
- The contact surface coating did not show any cracks, deformation or wear.
- Uniform thickness was measured on the areas of contact between the LE and TE snubbers.
