**BEFORE THE FLORIDA PUBLIC SERVICE COMMISSION**

| wastewater rates in Brevard, Citrus, Duval, | ) | DOCKET NO. 20250052-WS |

**DIRECT TESTIMONY OF**

**JACOB FREEMAN**

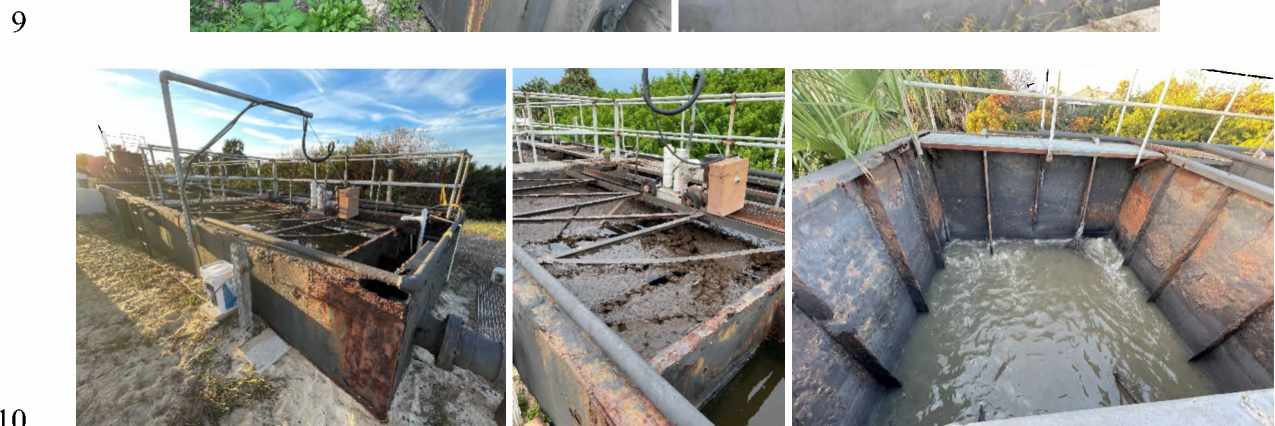
10  
11 *Examples of steel tanks and equipment deterioration at close and examples of the numerous*  
12 *poorly installed welded patches on the tanks.*

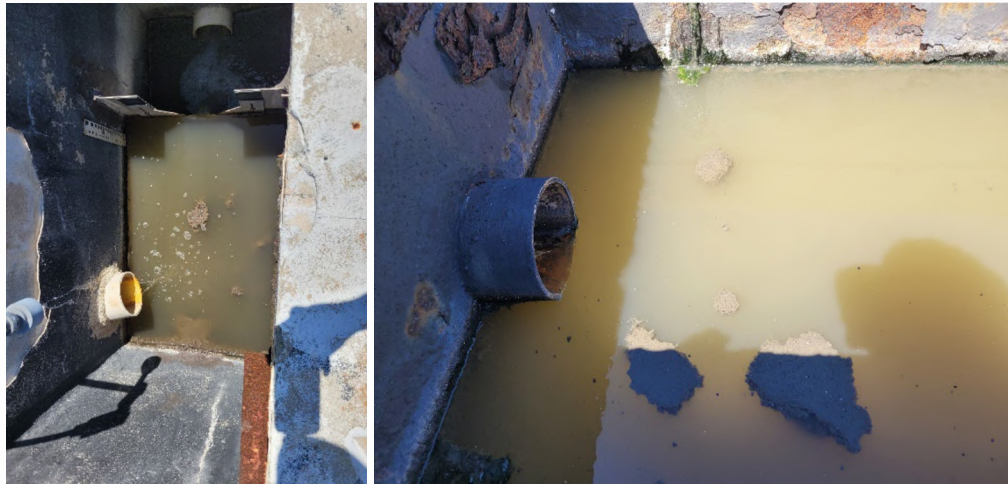
*Discolored effluent and floating sludge at discharge at acquisition, indicating poor treatment.*

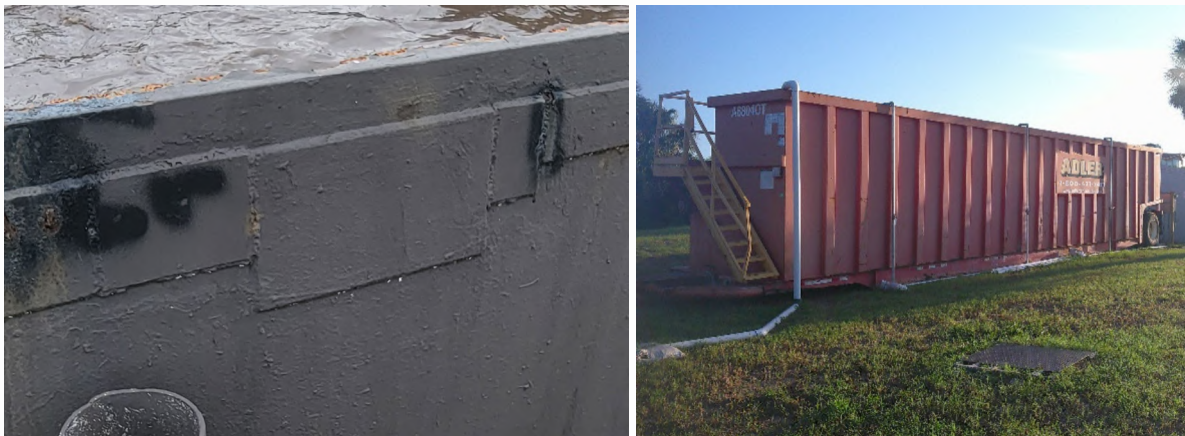
14  
15 *Example of patching leaks in steel tanks at North Peninsula (left) Temporary tank in place*  
16 *since concrete tank failure (right).*

10 Repairs to tanks have been made to patch leaks and a temporary tank has been  
11 installed following the failure of the concrete package plant used for flow equalization.  
12 This is the bare minimum required to prevent ongoing releases of untreated or partially  
13 treated wastewater on the site.

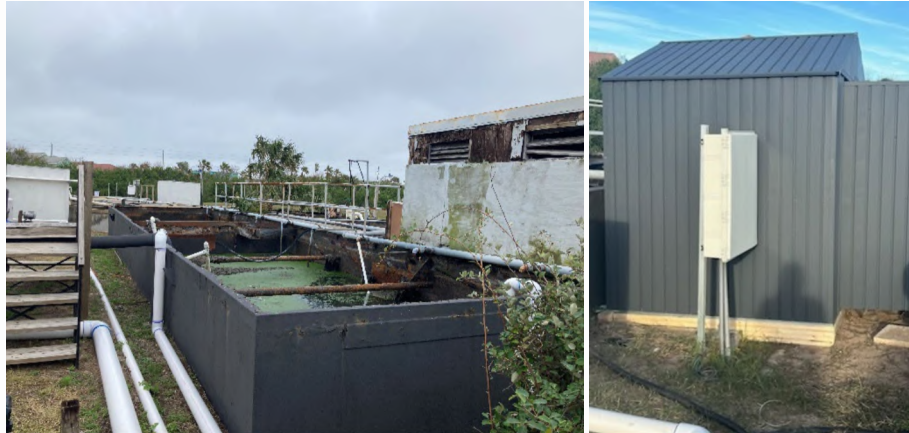
4  
5 *New temporary PVC aeration and sludge return lines throughout facility (left). Sound*  
6 *dampening shed installed around blowers (right).*

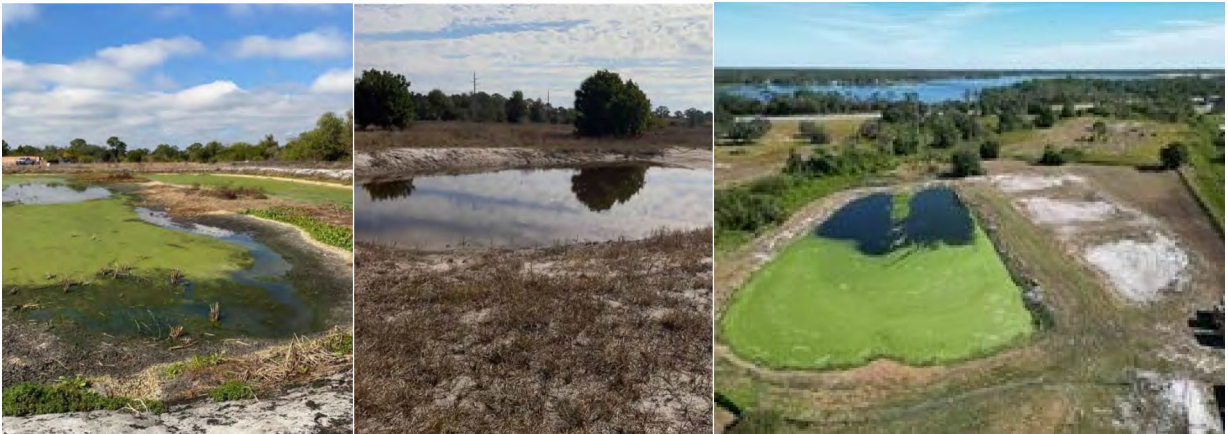
17  
18 *Rapid infiltration basin (left) and percolation ponds (center) before sludge and vegetation*  
19 *removal. Note percolation pond is holding water rather than draining both due to*

6 A. Various improvements have been made to date to the Sebring Ridge wastewater  
7 system. Both the percolation ponds and the rapid infiltration basin had issues that  
8 needed to be addressed to ensure adequate disposal of treated wastewater. Both these  
9 sets of assets had significant sludge accumulation resulting in vegetation growth.  
10 Furthermore, the elevation of the bottom of the percolation ponds meant that during  
11 rain events groundwater would rise to the point of accumulating in the percolation  
12 ponds, thereby preventing wastewater from percolating into the ground. To address  
13 these issues, sludge and nuisance vegetation has been removed and a maintenance  
14 schedule implemented to regularly service the ponds. In addition, a layer of sand was  
15 added to raise the elevation of the bottom of the percolation ponds to prevent the  
16 previously described groundwater issues.

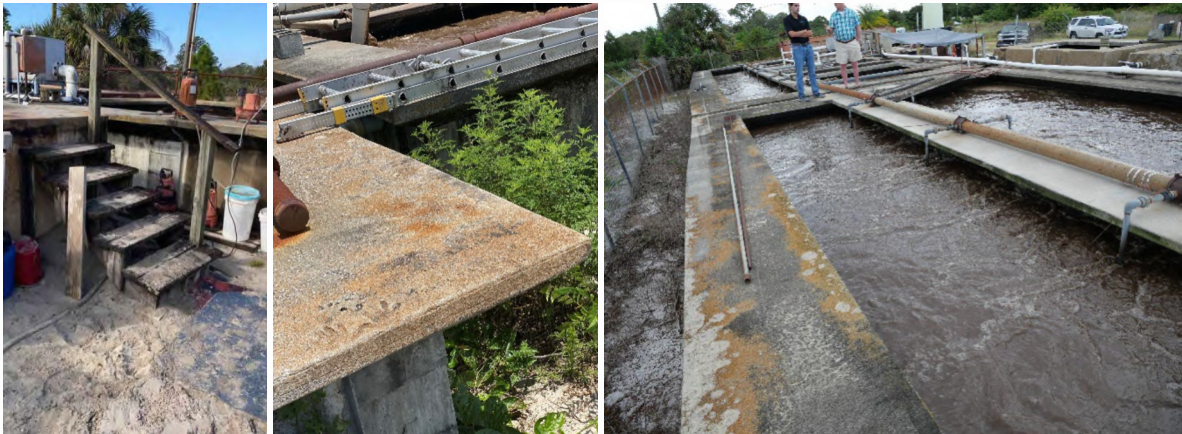
*Examples of inadequate safety features for operations access. Rotting wooden stairs with missing handrail on one side (left), aluminum ladder resting across tanks for access to air header (center), no leading edge protection or grating over open basins throughout plant (right).*

At acquisition the existing handrails, catwalks, and stairs were in poor condition and some areas lacked access with any operator safety features. CSWR Florida has begun to replace damaged safety features and install new ones and will continue to do so as improvement projects proceed.

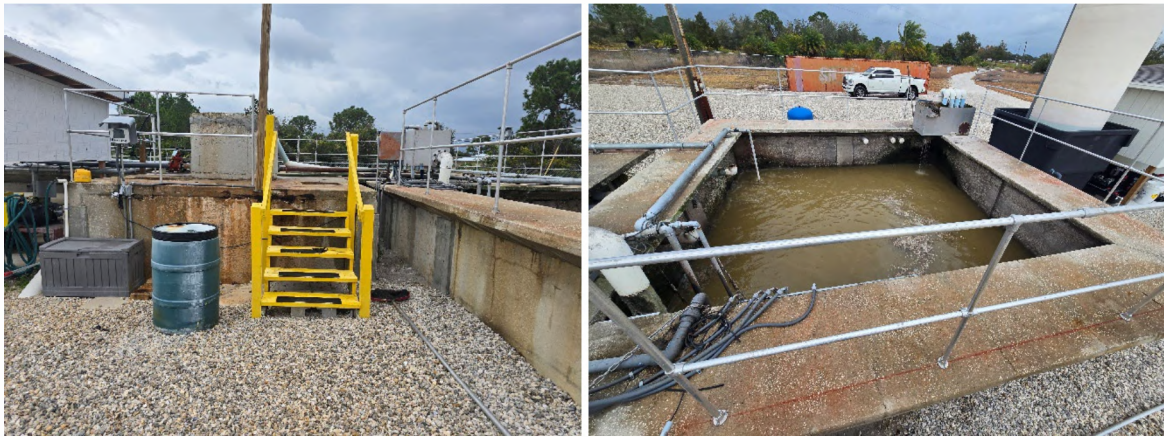
*New access stairs with handrails, high friction tread plates, high visibility coating (left) and new fall protection rails around the exterior of the facility to prevent falls from the plant (right).*

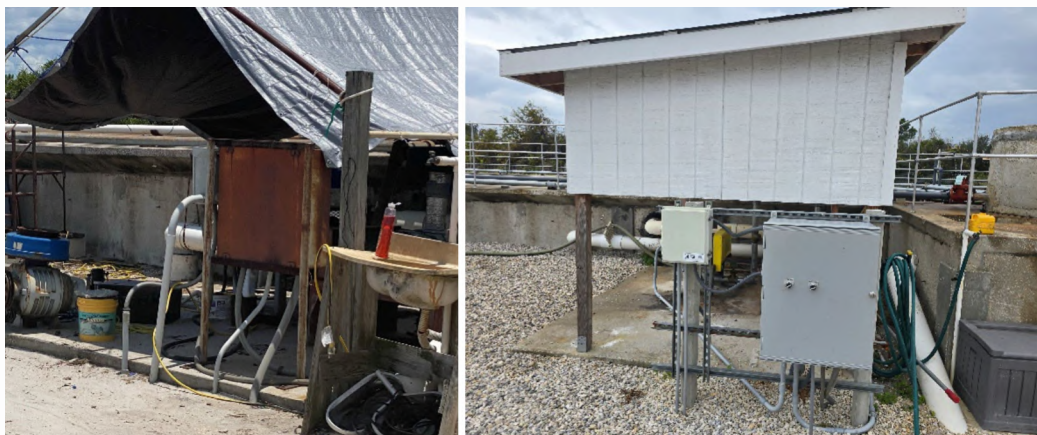
*Blower control panel and shade structure before (left) and after (right) improvements, note general cleanup of area from trash and debris as well.*

Although more improvements are required, some improvements also have been made to the power and control systems at the treatment plant to replace damaged equipment found throughout the facility. This included replacing the heavily deteriorated power and control panel for the blower system. Also, a proper shade structure has been installed over the blowers. Previously the blowers were protected from sunlight and rain with a tarp secured to scrap piping with rope and bungee cords. A proper structure has now been installed and the area cleaned up from trash and debris.

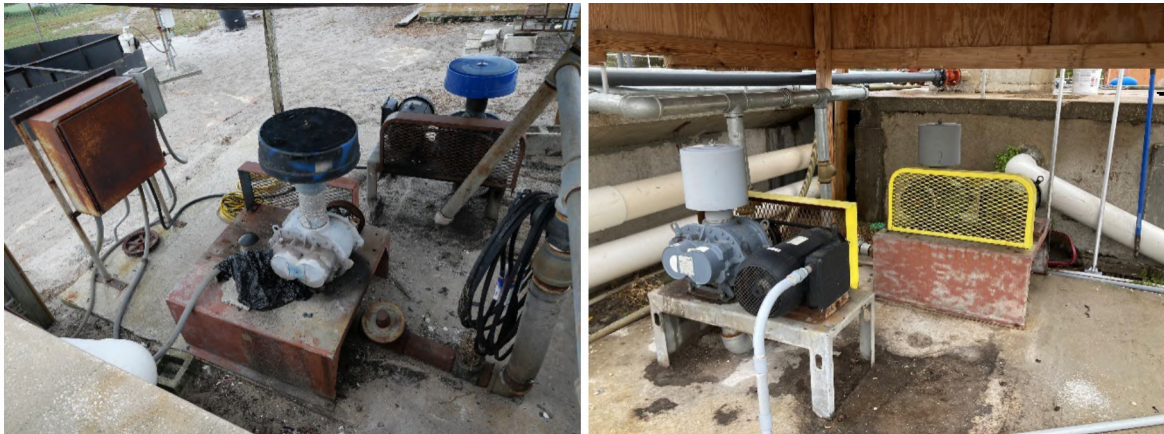
1 on the second blower. In addition, the blower housings were in poor condition, the  
2 functioning blower motor was in poor condition, belts were missing for the out of  
3 service blower, and both blower housings were deteriorating. Both blower motors and  
4 blowers have been replaced, including rewiring both units to the new blower controller.  
5 A belt housing has been installed along with new blower mufflers. Air leaks have been  
6 identified, and some aeration piping repairs have also been implemented.

8 *Blowers before (left) and after (right) improvements.*

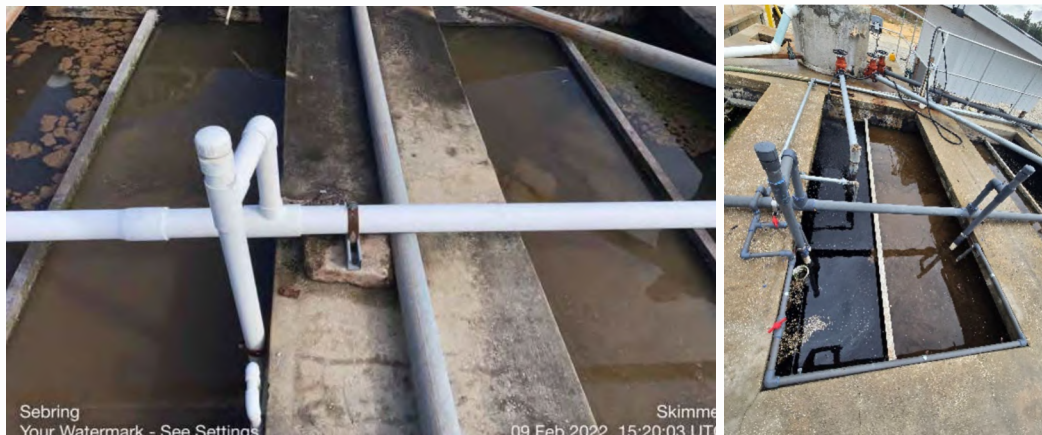
9 At acquisition, the clarifier sludge returns and skimmers were not properly  
10 functioning, and significant suspended solids in the clarifiers were noted in FDEP's  
11 previous enforcement action. To improve the function of the clarifiers, new sludge  
12 returns, sludge air lifts, and skimmers have been installed.

14 *Old skimmer and air lifts (left) and newly installed air lifts and sludge returns (right), note*

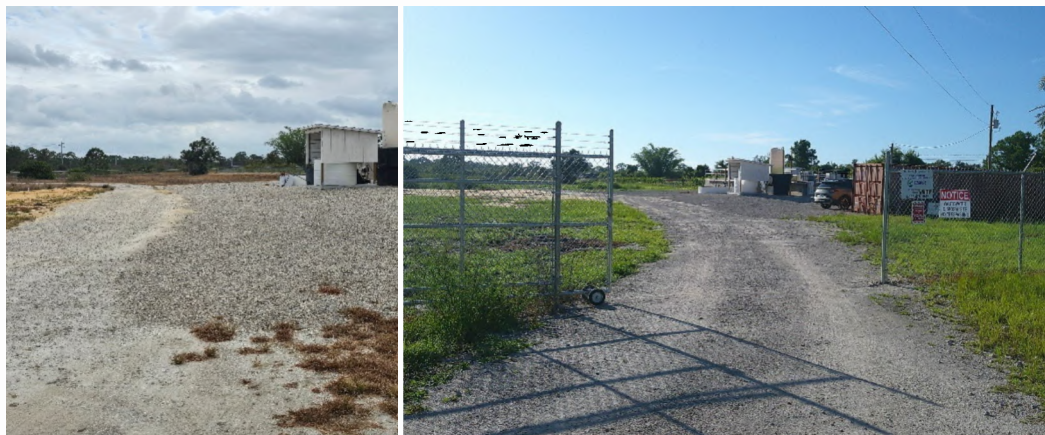
9  
10 *Site and road conditions following improvement.*

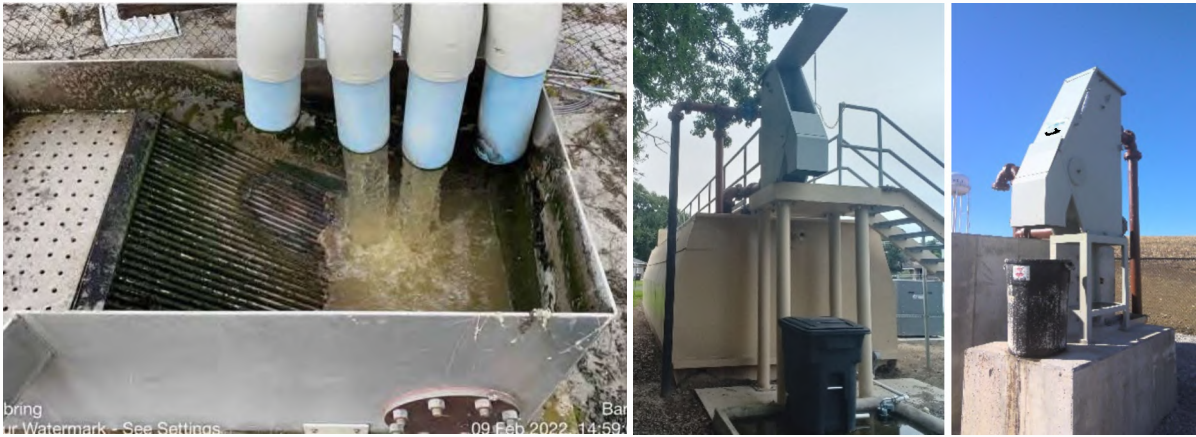
*Existing bar screen (left), examples of Hydrosieve with automatic trash collection beneath at two CSWR affiliated facilities (center and right).*

23          automatically capture solids and drop them into a dumpster. This eliminates the  
24          process of manual raking of a bar screen and prevents the screen from being filled and  
25          overwhelmed, allowing solids into the facility.

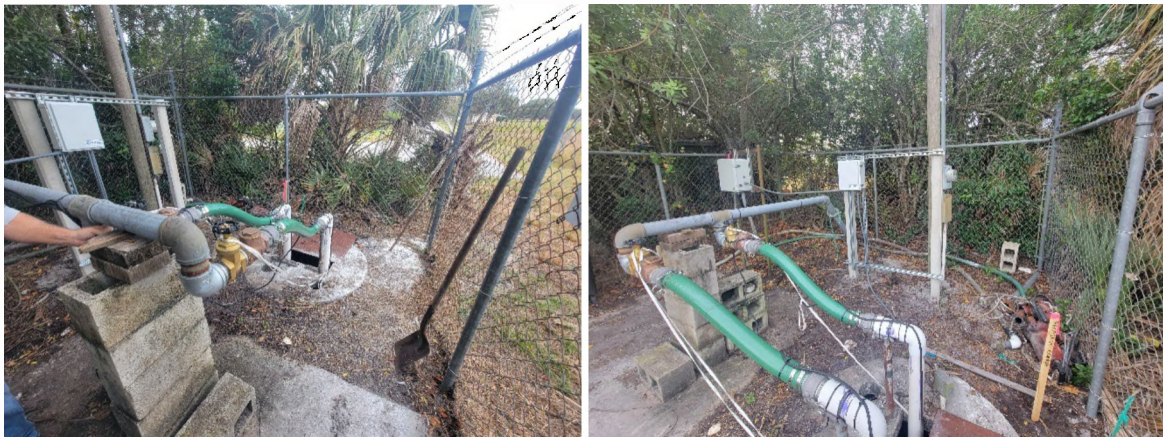
aging and in need of replacement, including control panels, manhole covers, pumps, and piping. Much of the discharge piping has been repeatedly repaired and is no longer properly supported (e.g., raised on piles of cinder blocks with wood shims) and often consists of improper piping materials including flex hoses and PVC pipes. The lift stations also do not include rail systems to aid in pump maintenance. None of the systems currently include emergency bypass piping, which allows a mobile pump to be connected to the lift station for operation during pump malfunctions or during power outages. All three stations will be overhauled with new pumps, control systems, rails, and piping to ensure proper function. Emergency bypass piping will also be installed during the piping overhaul. In addition, none of the lift stations currently include the means necessary to connect an emergency generator. This would typically be an emergency quick connect and manual transfer switch allowing a mobile generator to be connected to provide power to the lift station during a power outage. This equipment will be installed to improve the system's resiliency.

*Example of lift station piping and condition currently.*

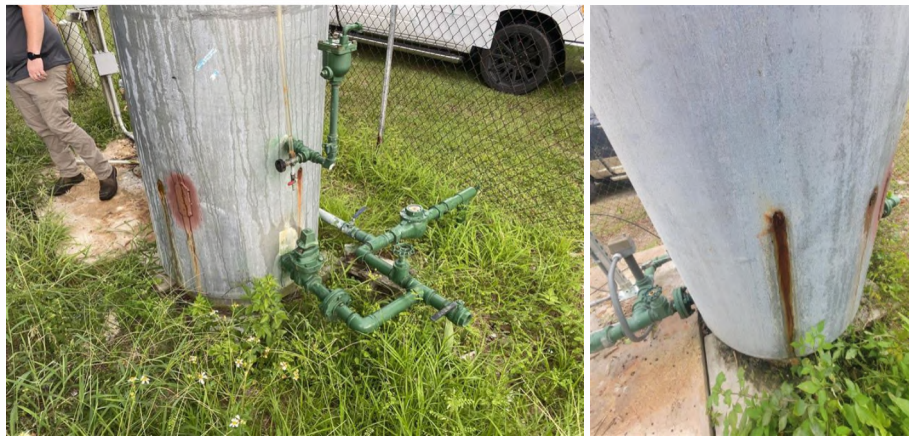
8  
9 *Hydro-pneumatic tank at Oakcrest Villas showing pinhole leaks and rust prior to catastrophic*  
10 *failure.*

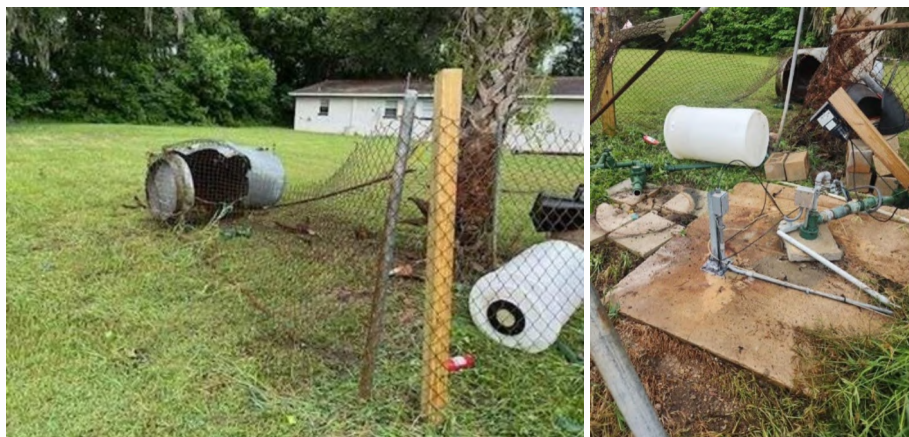
11  
12 *Oakcrest Villas hydro-pneumatic tank explosion. Failed tank with damaged fencing (left) and*  
13 *damage to other water assets (right).*

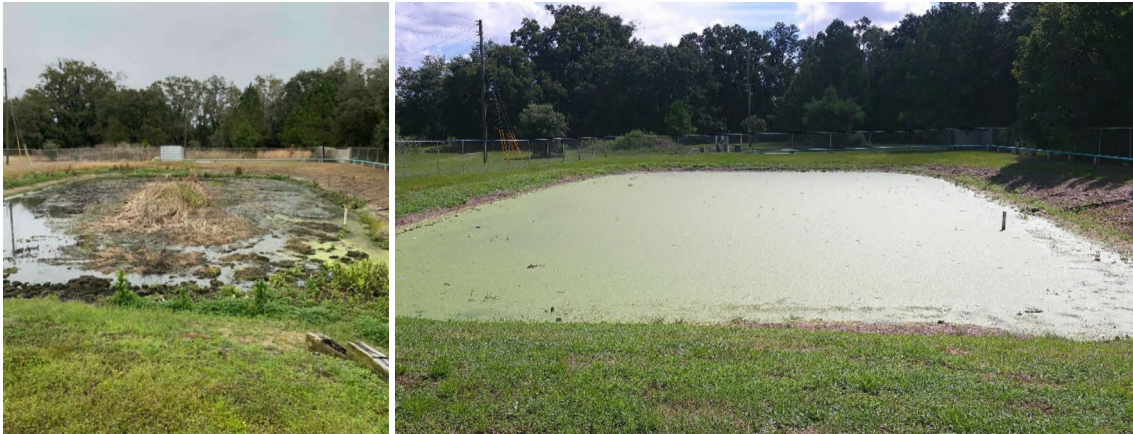
1 properly maintain the holding pond for treated wastewater, allowing significant sludge  
2 accumulation and vegetation growth in the holding pond. As required by the current  
3 Consent Order, CSWR Florida immediately cleaned the holding pond and has  
4 maintained it since taking acquisition.

5  
6 *Condition of holding pond before (left) and after (right) improvements by CSWR Florida.*

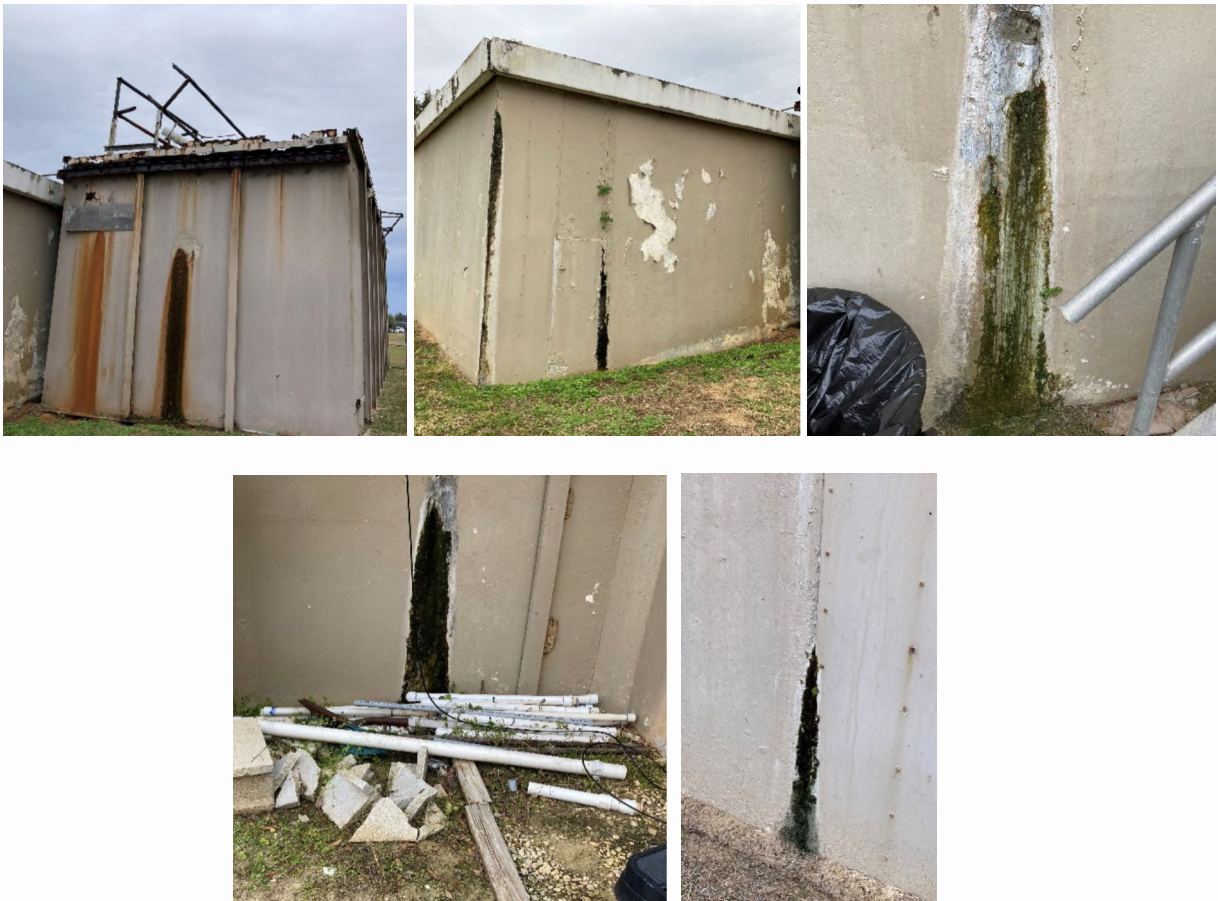
10  
11 *Examples of leaks on the steel (top left) and concrete (all other photos) tanks with ongoing*  
12 *leaks evident by ineffective patching and significant growth of algae and rust accumulation*  
13 *below leaks.*

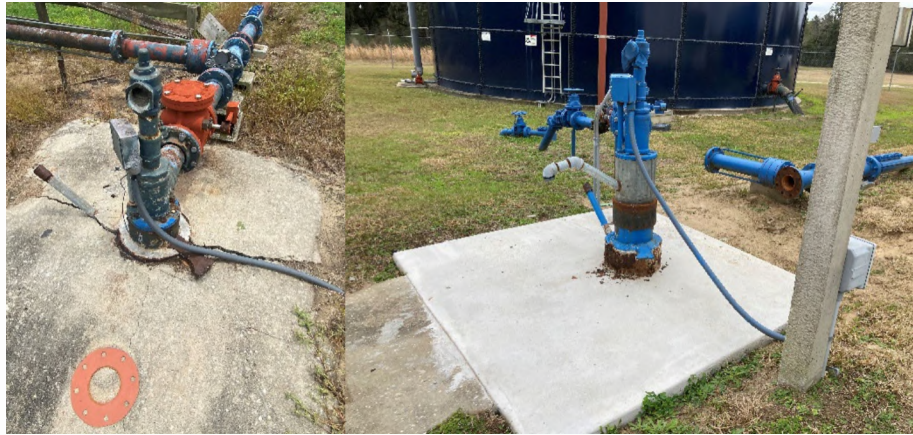
3  
4 *Well pad for well 2 before (left) and after (right) replacement. Well piping has also been*  
5 *replaced and well casing will be rehabilitated with future well reworking.*

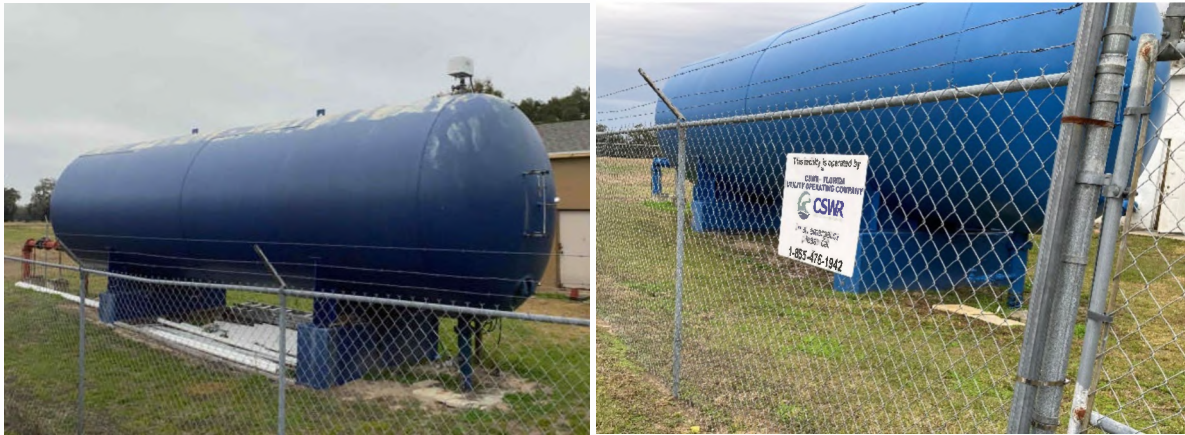
3  
4 *Hydro-pneumatic tank before (left) and after (right) recoating.*

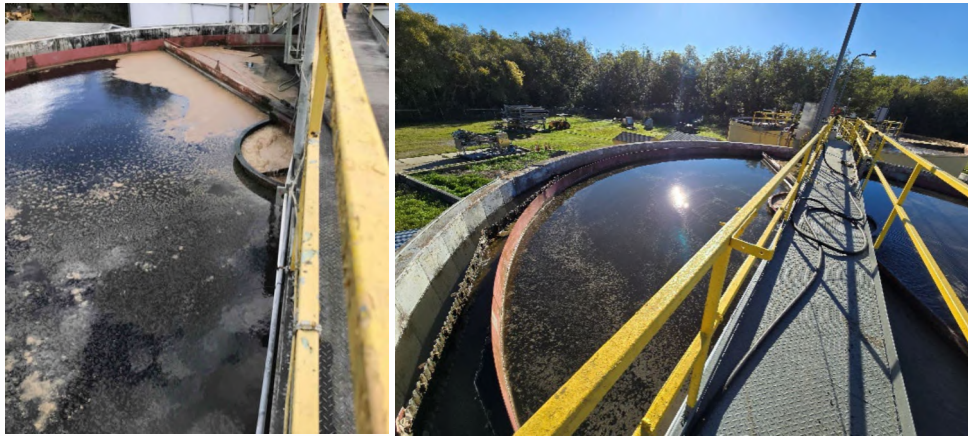
8  
9 *Clarifier with excessive floating solids before repair (left) and clear following repair (right).*

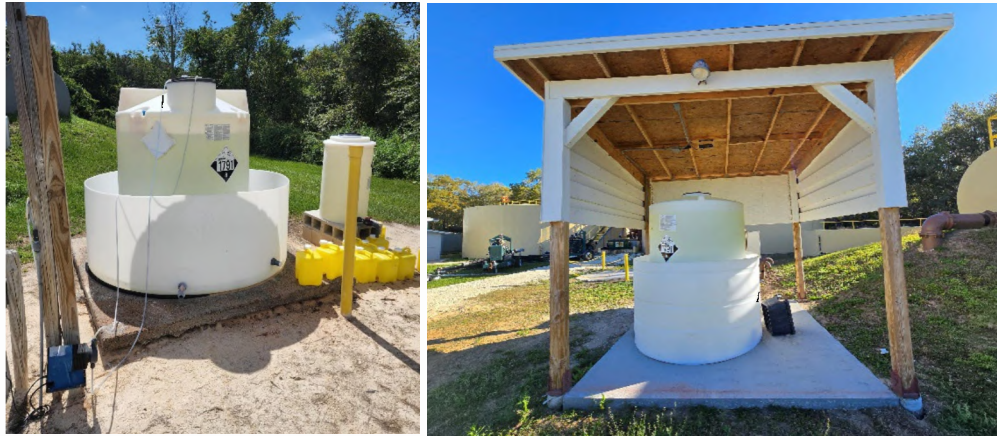
5  
6 *Chemical storage before (left) and after (right) improvement.*

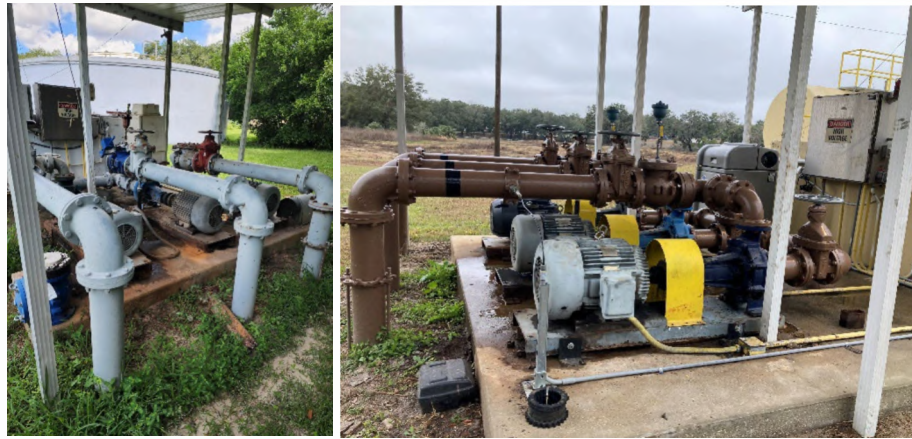
*Examples of before (left) and after (right) recoated piping and equipment (effluent pumps and piping)*

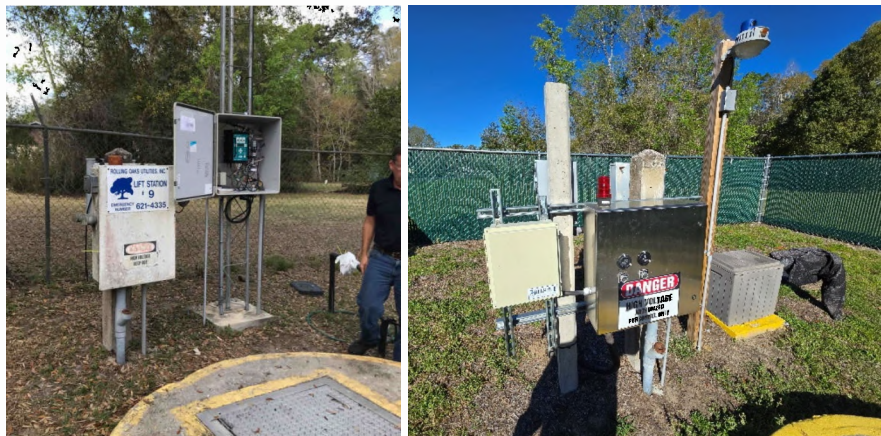
*Example of before (left) and after (right) control panel replacement at Lift Station #9. Note remote monitoring unit to the left of the new panel installed as well to be discussed below.*

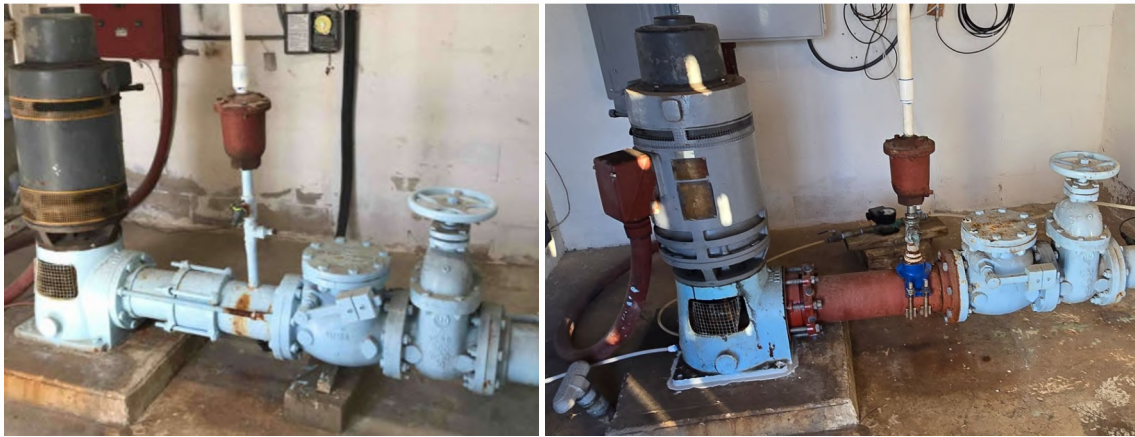
1  
2 *Well 6 before (left) and after (right) rehab work. Motor and pump serviced, leaking section*  
3 *cf pipe replaced.*

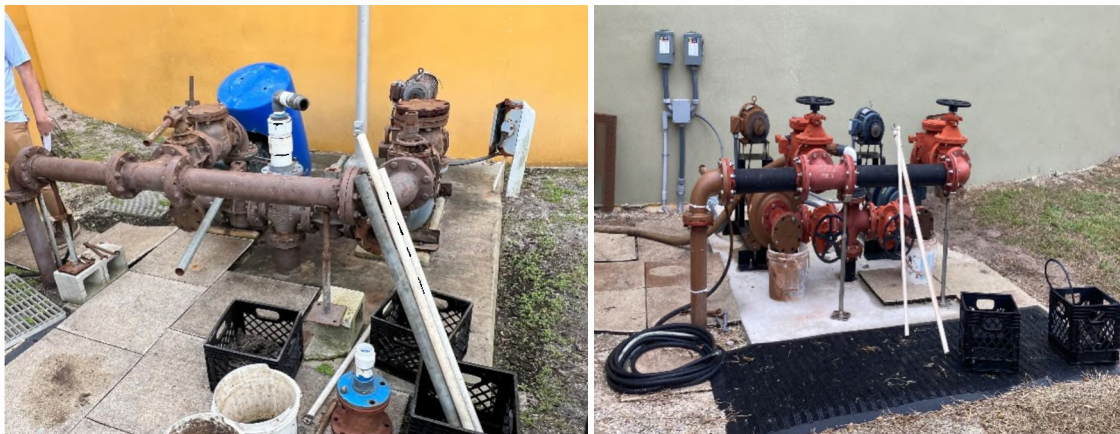
15  
16 *RAS/WAS pumping system before (left) and after(right) improvements, note both pumps in*  
17 *service, piping improvements, valve replacements, and new power supply.*

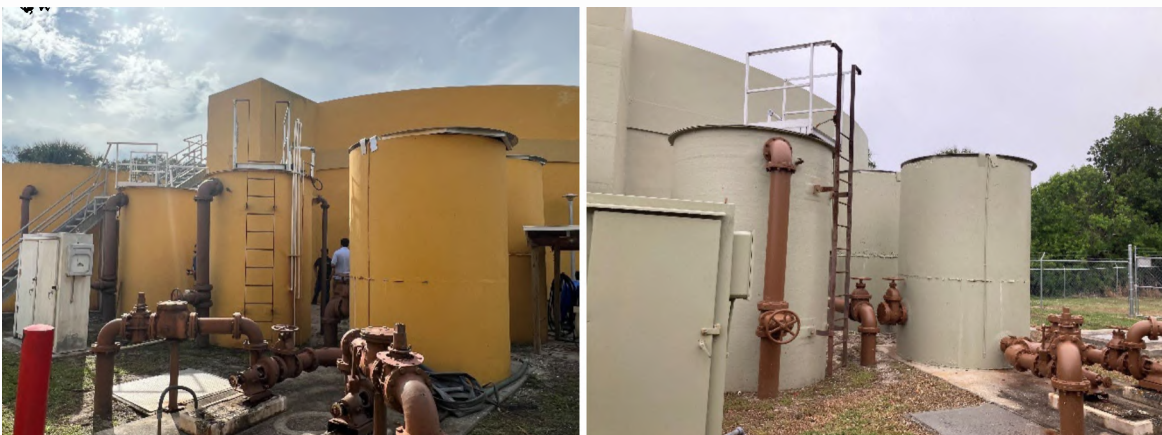
13  
14 *Treatment tanks, piping, and equipment before (left) and after (right) recoating.*

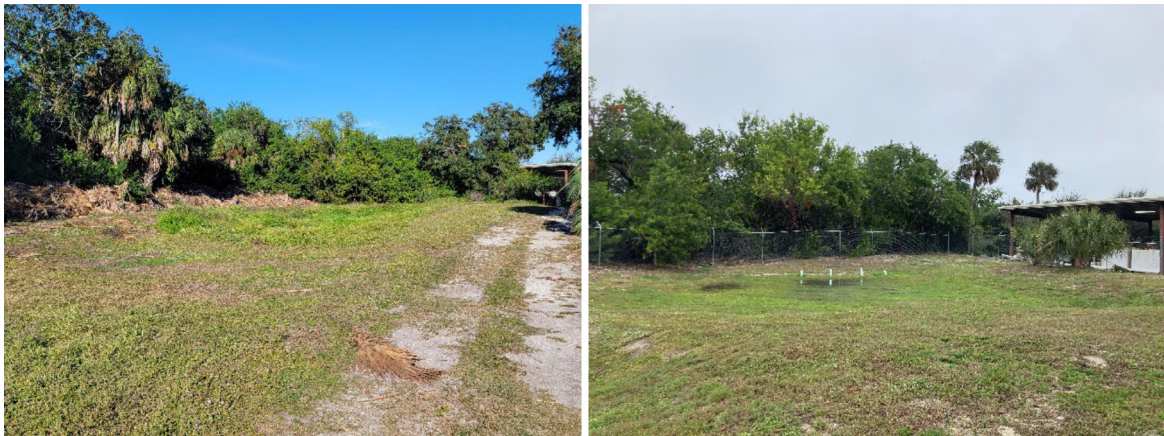
5  
6 *Fencing around drain field completely covered in overgrowth and vegetation overgrowing in*  
7 *drain basin (left). Fence line cleared and vegetation controlled in drain basin (right).*

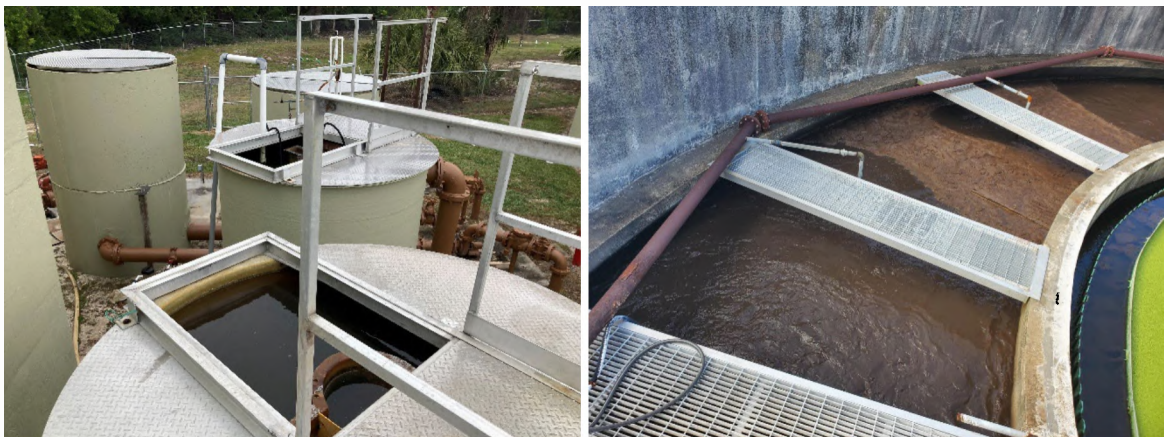
12  
13 *Leading edges without edge protection handrails/chains or grating over open basins (left).*  
14 *Aeration basin grating is not secured to structure and lacks handrails (right).*

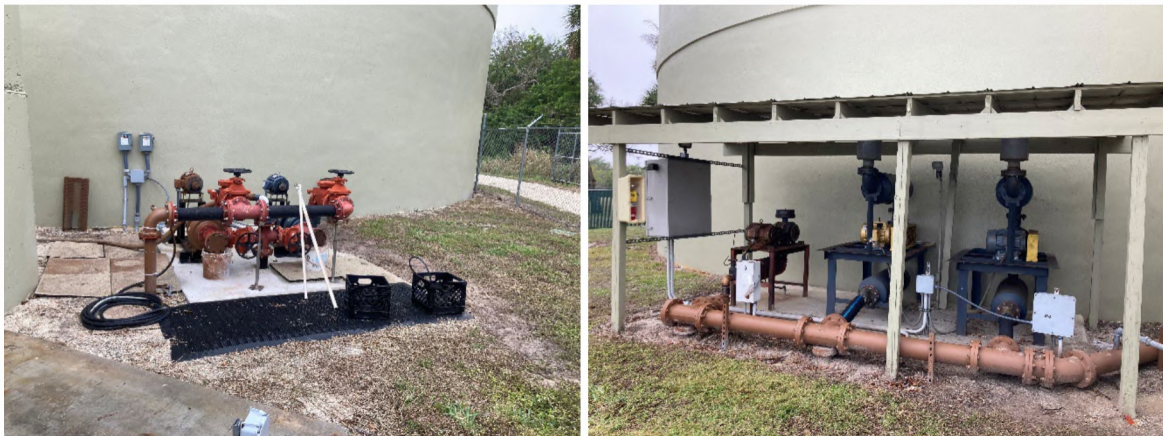
7  
8           *No shade structure currently installed over RAS/WAS pumping equipment (left), and new*  
9           *shade structure installed over facility blowers as example (right)*

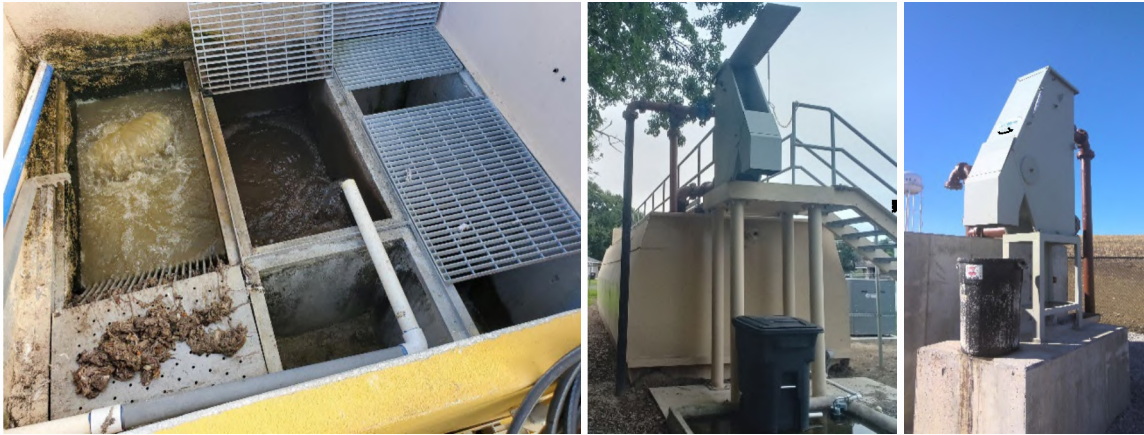
3  
4 *Existing bar screen backing up due to impacted solids in photo (left), examples of Hydrosieve*  
5 *with automatic trash collection beneath at two CSWR affiliated facilities (center and right).*

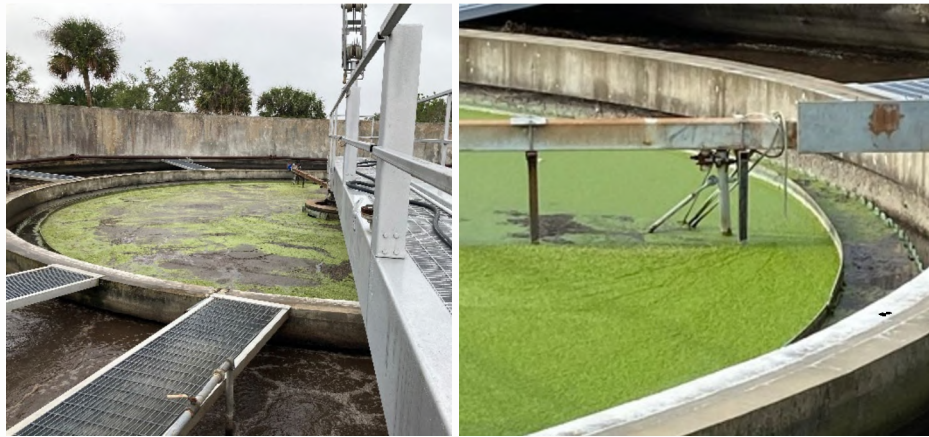
*Examples of accumulation of duckweed growth in clarifier (left and right) including duckweed passing over the trough (right).*

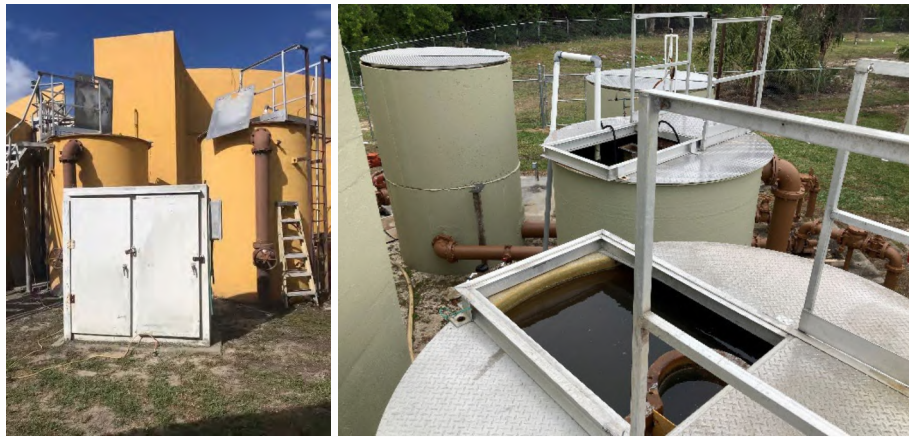
*Sand filter tanks which have been out of service for an extended period and need to be properly decommissioned or repurposed.*

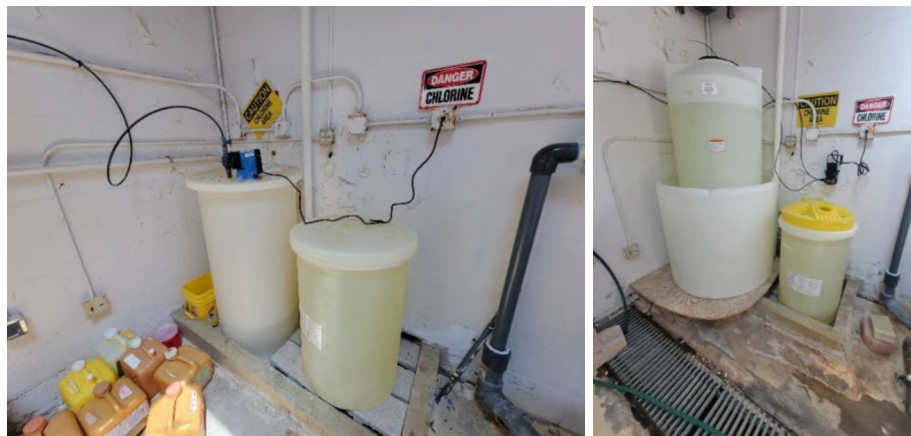
12  
13 *Chemical containment before (left) and after improvement (right). Note bleaching and dried*  
14 *chemicals all over ground previously due to inadequately sized spill berm and lack of*  
15 *cleanup.*

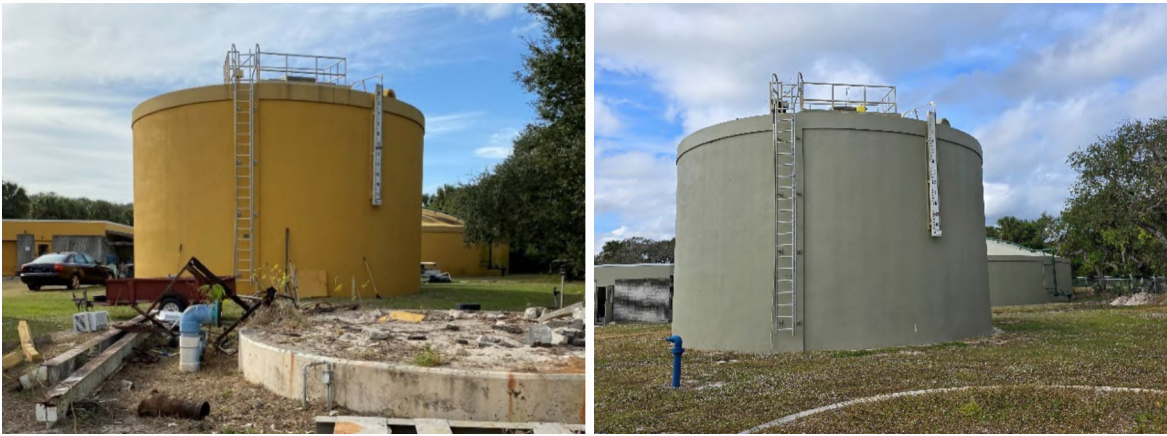
8  
9 *Ground Storage tank before (left) and after (right) before and after inspection and recoating,*  
10 *note trash and debris removed from tank area as well.*

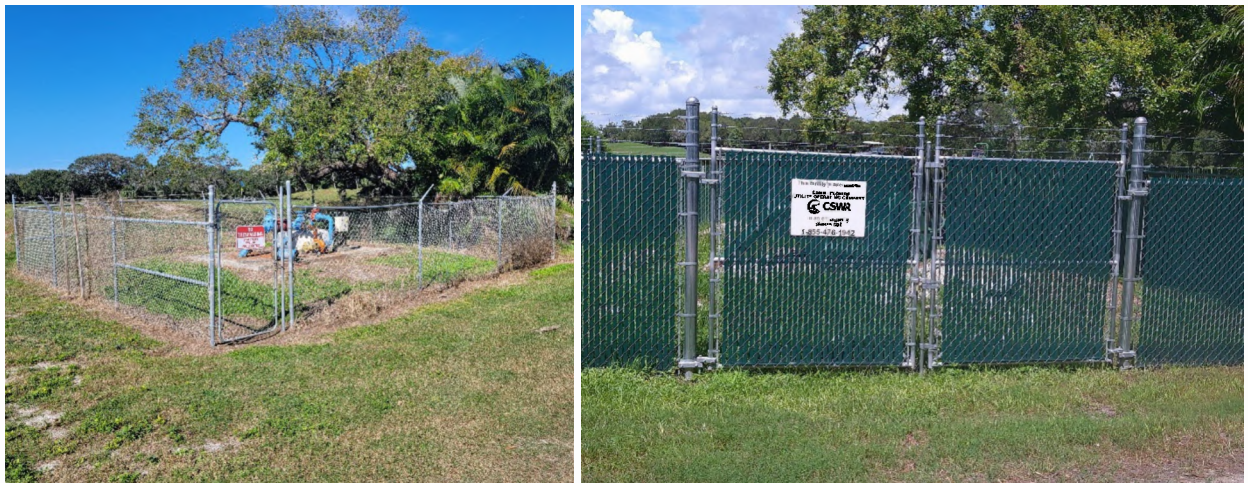
7  
8 *Damaged fencing (left) replaced with new fencing (right)*

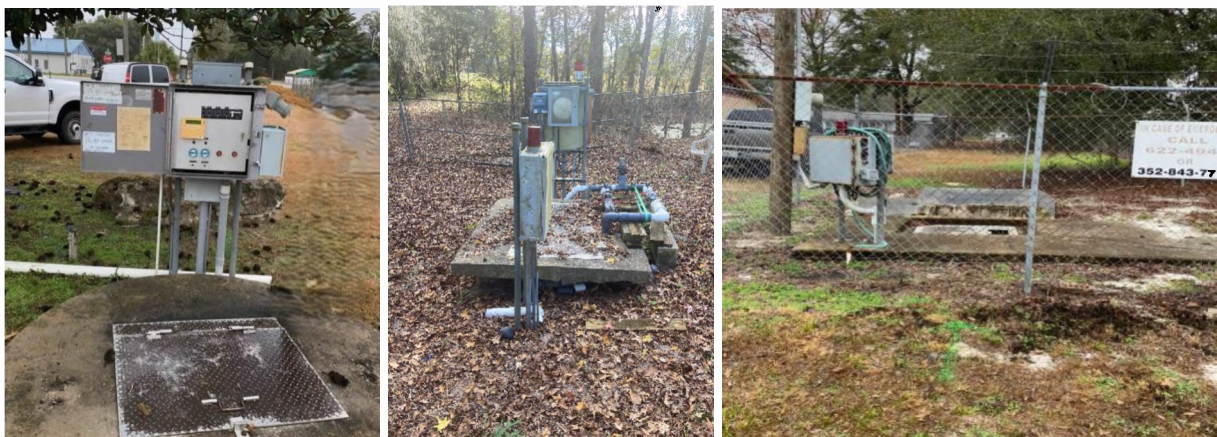
*Examples of older Tradewinds collection system lift stations. Some lift stations lacked fencing, remote monitoring, and had rusting or degraded assets.*

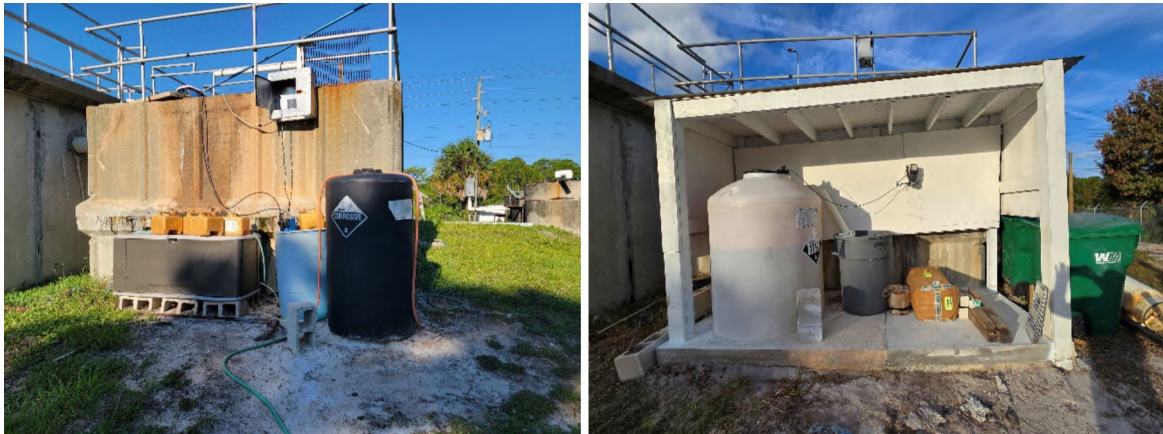
7  
8 *Chemical storage before (left) and after (right) improvement. Note dead grass and chemical*  
9 *storage around old tank indicating chemical spills and disorganized arrangement.*

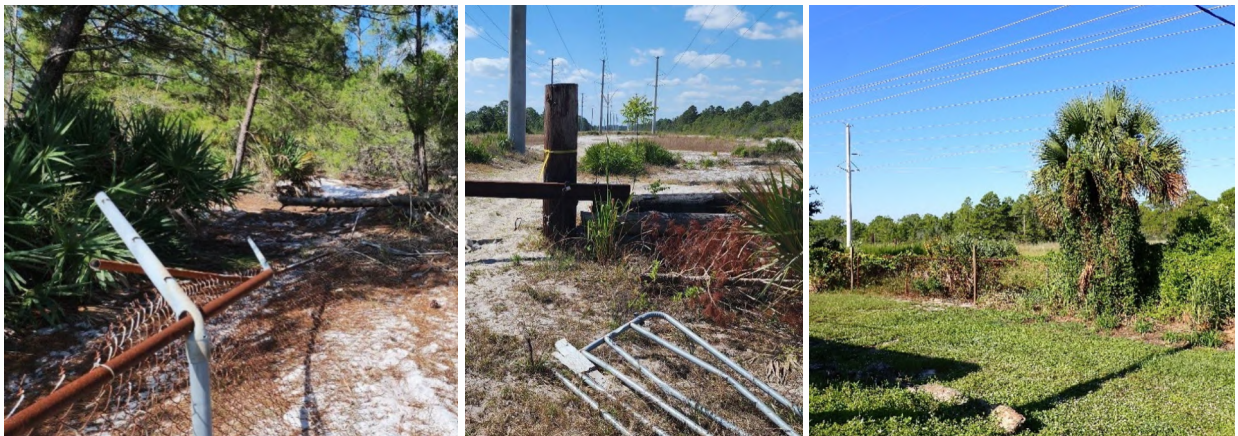
7  
8 *Examples of damaged fencing and gates at the Sun Lake Estates Facility at acquisition.*

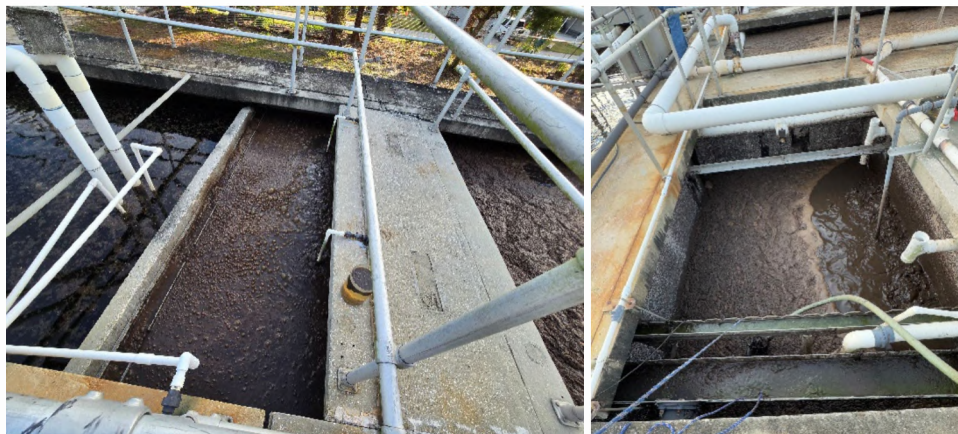
13  
14 *PVC aeration piping throughout facility to be replaced with proper materials.*

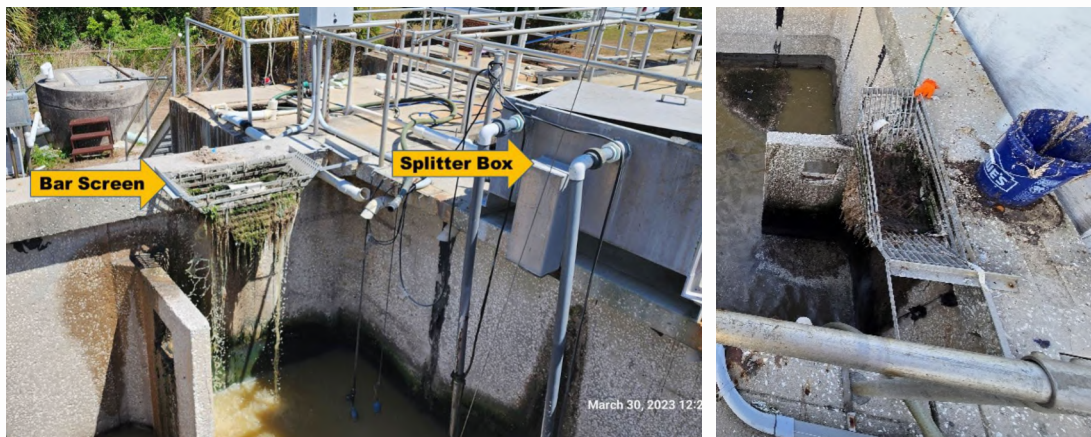
10  
11 *Current configuration of splitter box and bar screen (left) and photo of bar screen filling*  
12 *with solids, note bar screen is not easily accessible by the protected walkways and hangs*  
13 *over the influent basin and frequently overfills with solids.*

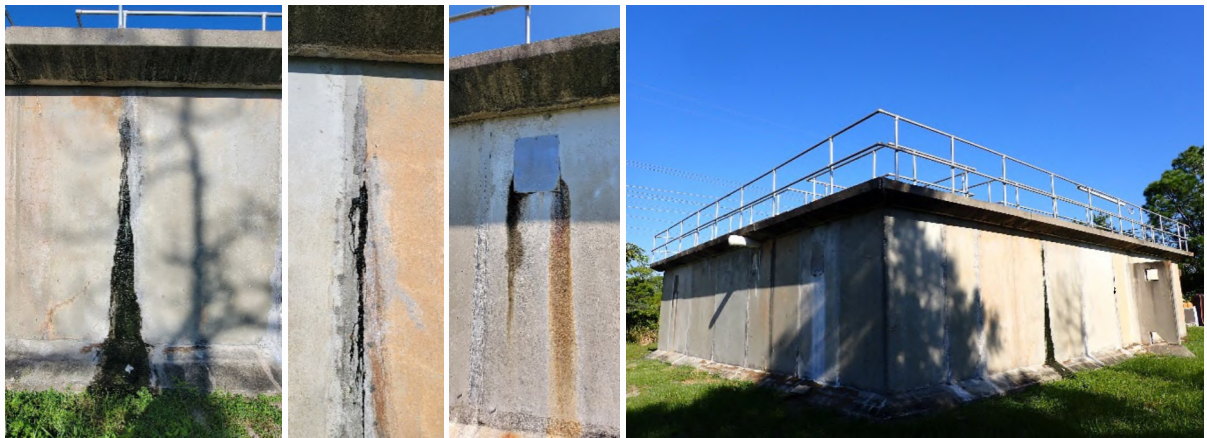
10                  *Examples of leaks throughout tanks, and context for leaks along the outside of most tanks.*
