**BEFORE THE FLORIDA PUBLIC SERVICE COMMISSION**

| wastewater rates in Brevard, Citrus, Duval, | ) | DOCKET NO. 20250052-WS |

**DIRECT TESTIMONY OF**

**JACOB FREEMAN**

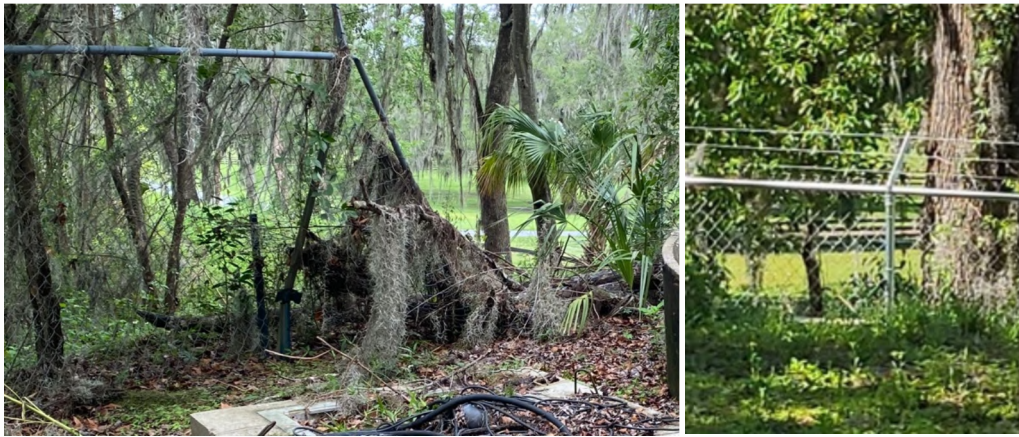
*Example of fencing damage at the main lift station site (left) and new fencing (right)*

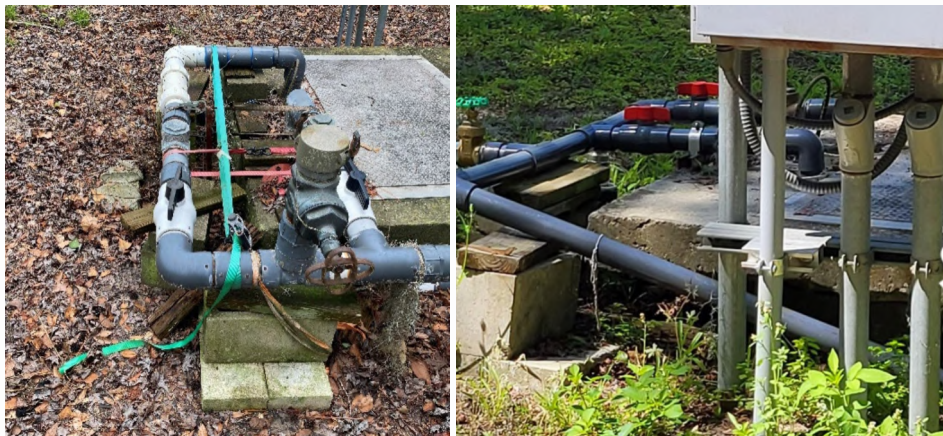
*Improper repairs to discharge piping at main lift station with PVC and ratchet straps (left) and new discharge piping (right)*

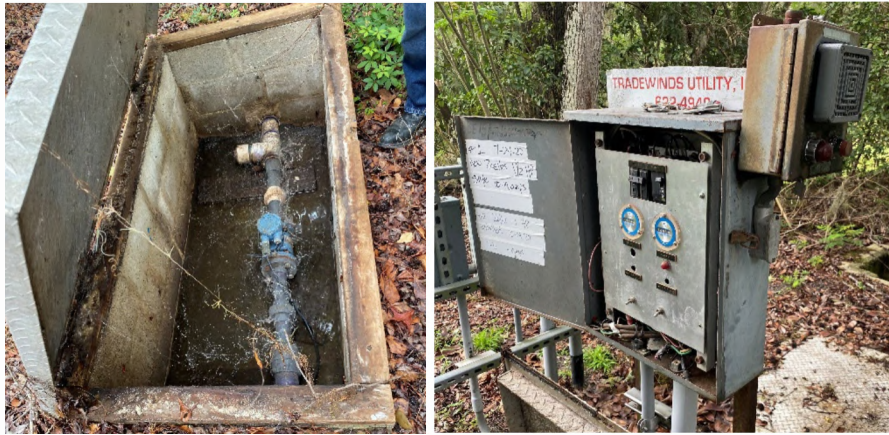
*Valve box cover allowing water infiltration (left) and poor condition power and control panels (right) at main lift station.*
