Title: Siemens Stator Ground Fault Report

## **ROOT CAUSE ANALYSIS – STATOR GROUND FAULT – ST. LUCIE NUCLEAR PLANT UNIT 1 GENERATOR**

**Michael Garmon  
Generator Service Engineering  
PG PR R&D GN GNS TIAM  
Orlando, FL.**

**August 23, 2019**

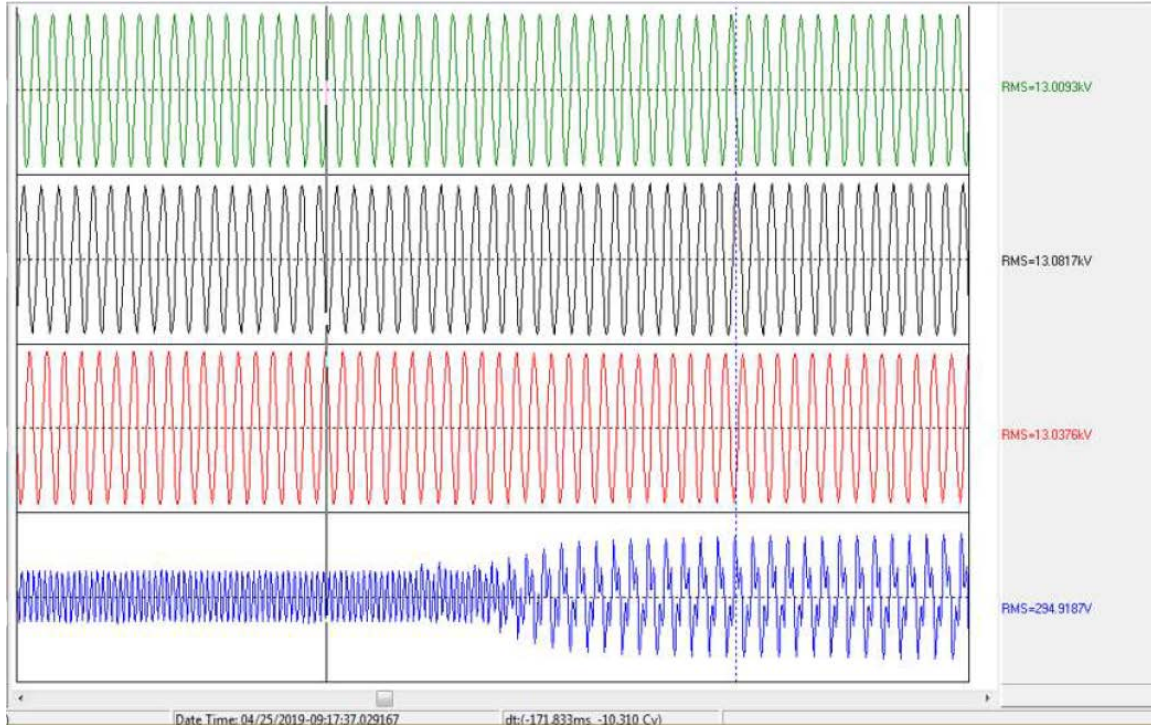
**Figure 3. Reported Phase Voltages at the Time of Fault**

Figure 3 and Table 1 show the three phase voltages as measured at the generator terminals from phase to ground. The relay that reportedly tripped, 64G, is a voltage signal from an open delta PT circuit. Relay 59N, Neutral Overvoltage, did not trip.

Phase	Voltage Prior to Fault	Increase over Nominal Voltage (12.7017kV)	Voltage After Fault	Voltage Change
A	13.0093kV	2.42%	12.9065kV	-0.1028kV
B	13.0810kV	2.99%	13.4914kV	0.4104kV
C	13.0376kV	2.64%	12.7334kV	-0.3042kV
Neutral	294.9187V	-	525.7836V	230.8649V

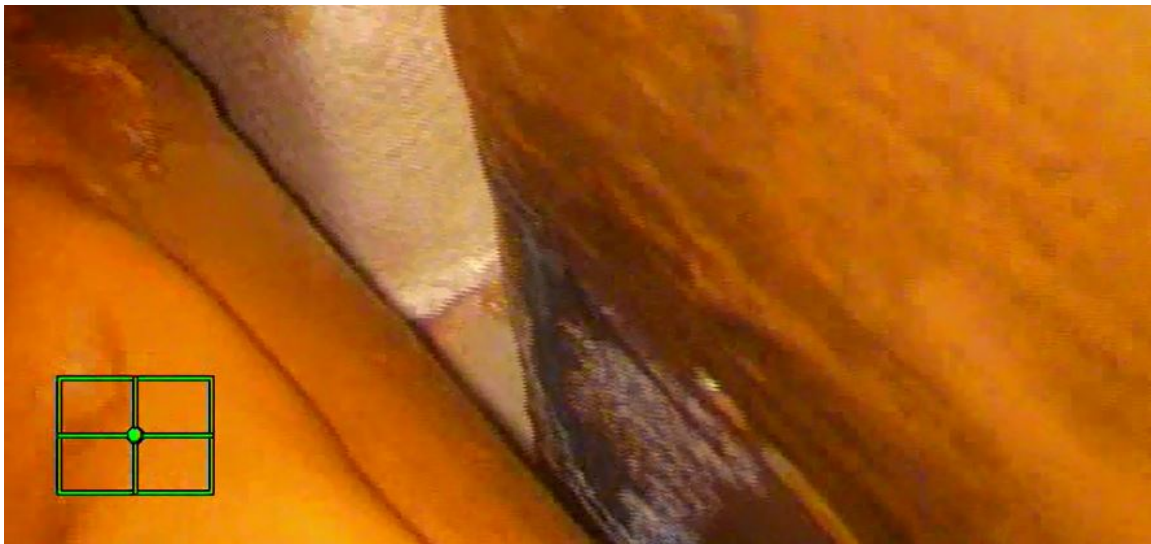
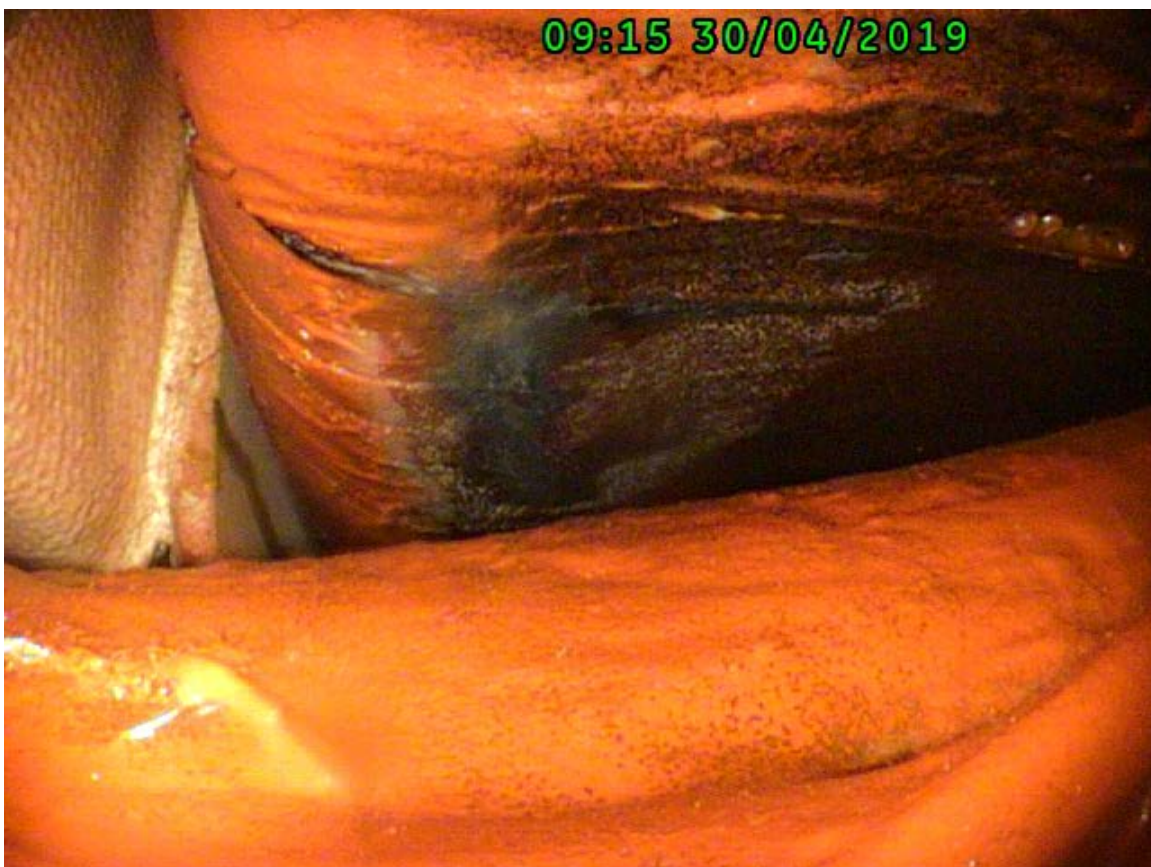
The lead box crawl-through did not show any signs of a stator ground. Borescope pictures of the stator bars in the area of the core end plates and finger plates showed a discolored area on the turbine end of bottom bar 17, shown in Figure 5. The discoloration was observed on the straight part of the bar as it exits the stator core slot, near the core finger plate. There were no other significant findings during the crawl through inspection.

**Figure 5. Discoloration on Bottom Bar 17**

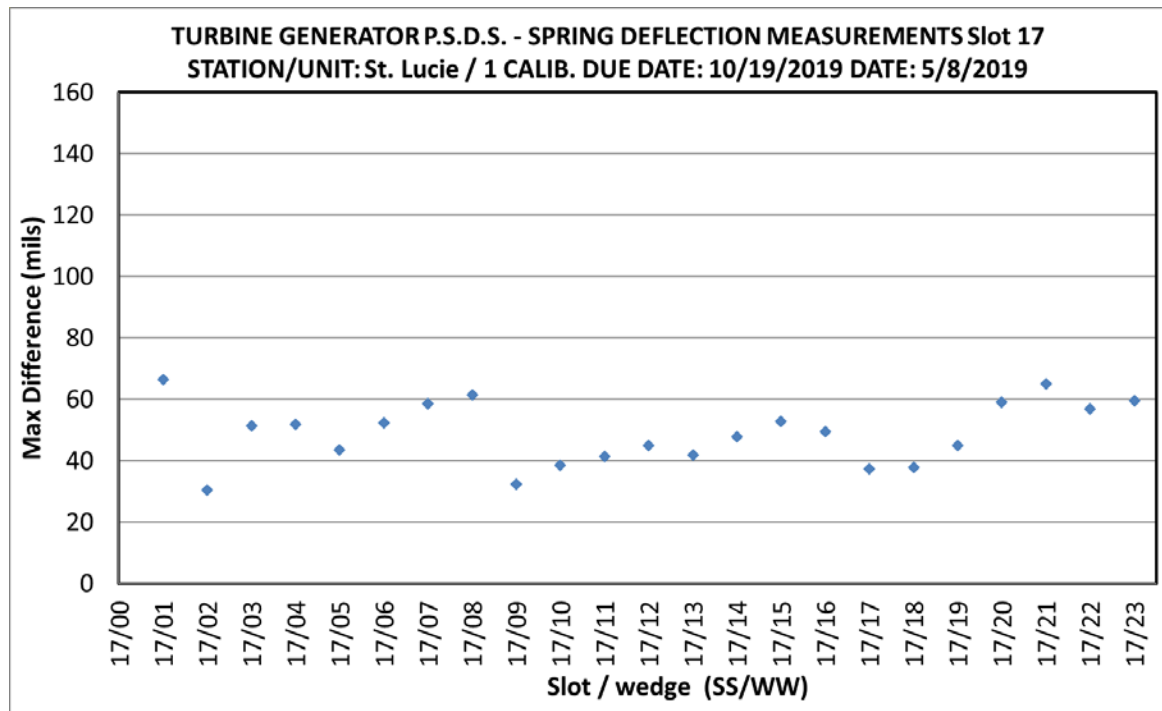
**Figure 6. PSDS Deflection Measurements – Slot 17**

The average deflection measurement for slot 17 is .049in. This indicates that the spring relaxed from installation, where the average was reported to be .032in, but this is within Siemens' experience for a generator after a period of operation.

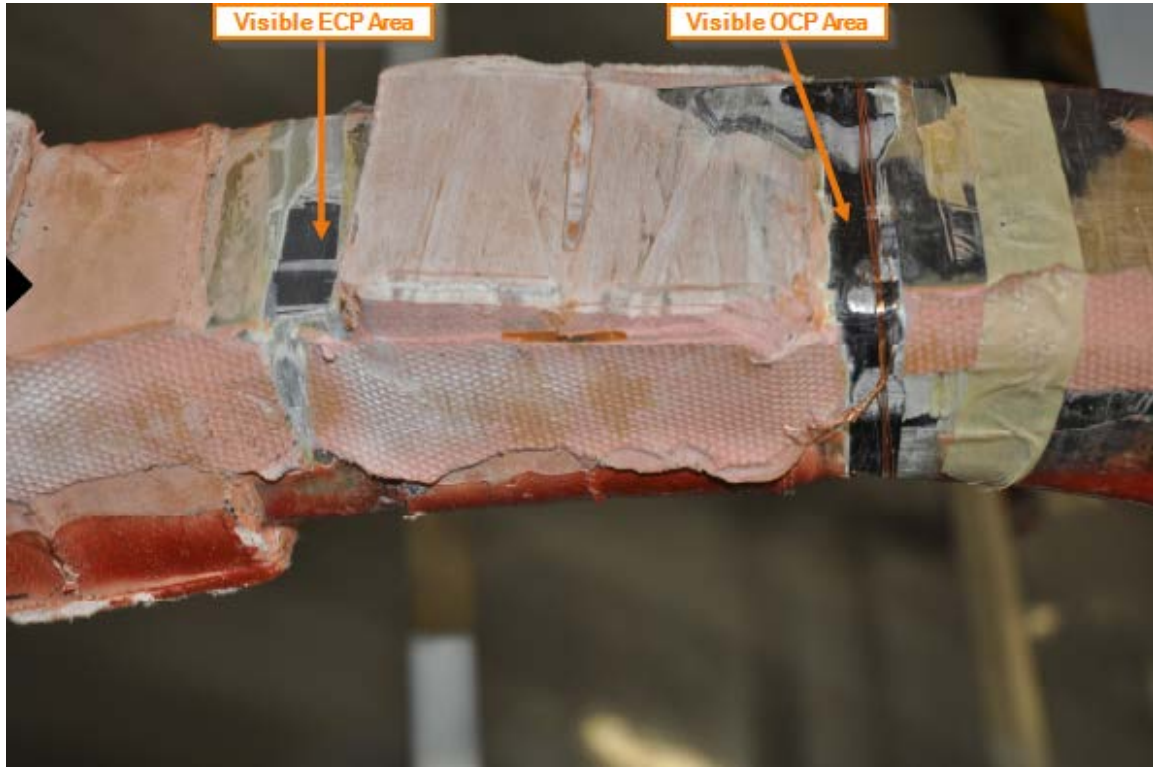
Detailed analysis was performed on the faulted bar, which identified electrical tracking along the outer corona protection (OCP) at the area of discoloration originally observed at site. Following the tracking in the outboard direction, the fault location was assessed as underneath a spacer block and its associated banding. The banding above the fault was found intact.

**Figure 7. Spacer Block and Banding Above Assessed Fault Location**

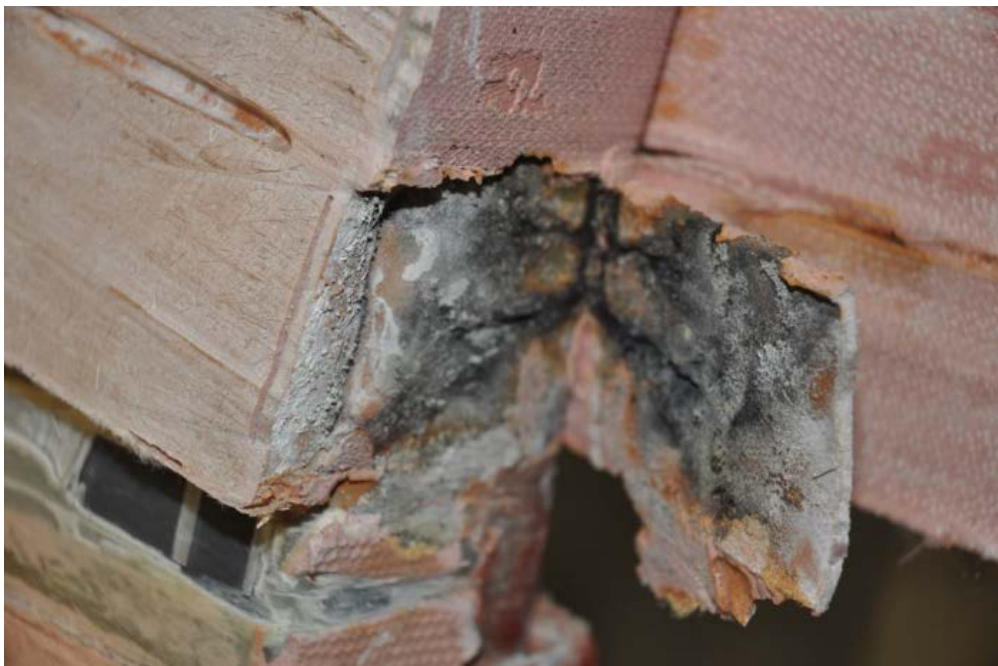
**Figure 8. Spacer Banding Partially Removed, Showing the Assessed Fault Location**

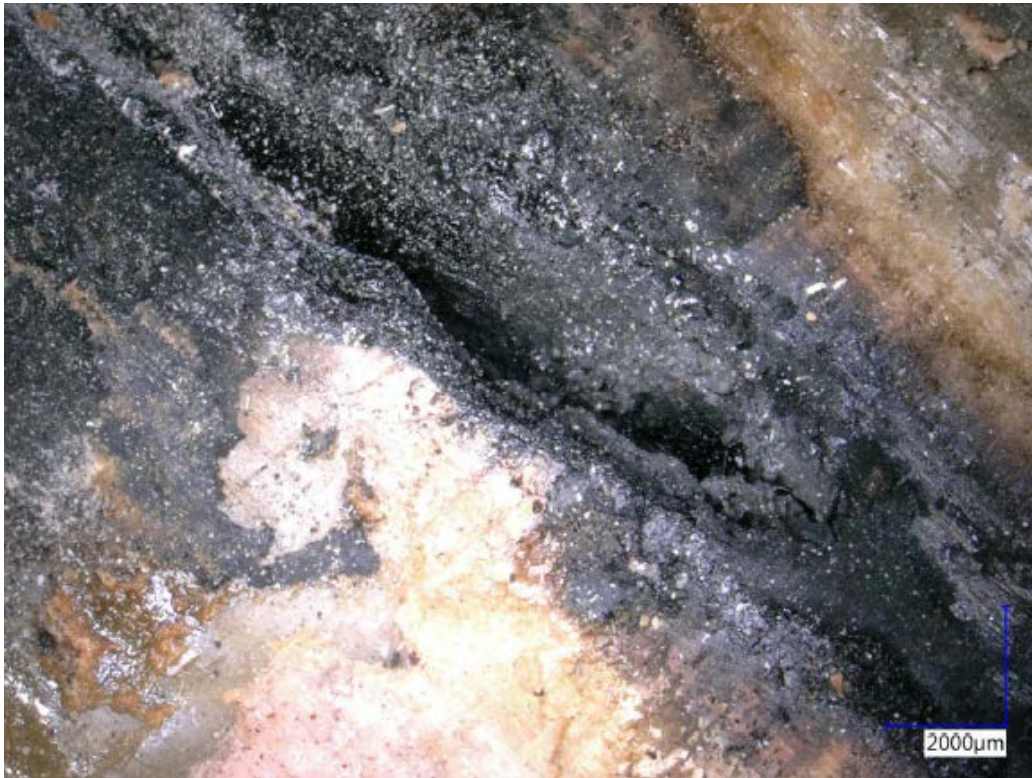
**Figure 9. Assessed Fault Location, Microscope View**

The fault had the appearance of a linear, V-shaped indication. This was confirmed by a CT scan of a section of the faulted bar.

One significant finding that guided the fault tree analysis was the shape of the ground fault. Visual and CT inspections showed a linear, V-shaped indication (see Figure 9 and Figure 10). Considering this finding and the insulation testing, which showed properties within typical ranges, the root cause team concluded that the most likely cause was an external event, i.e. not related to bar design or insulation material properties.

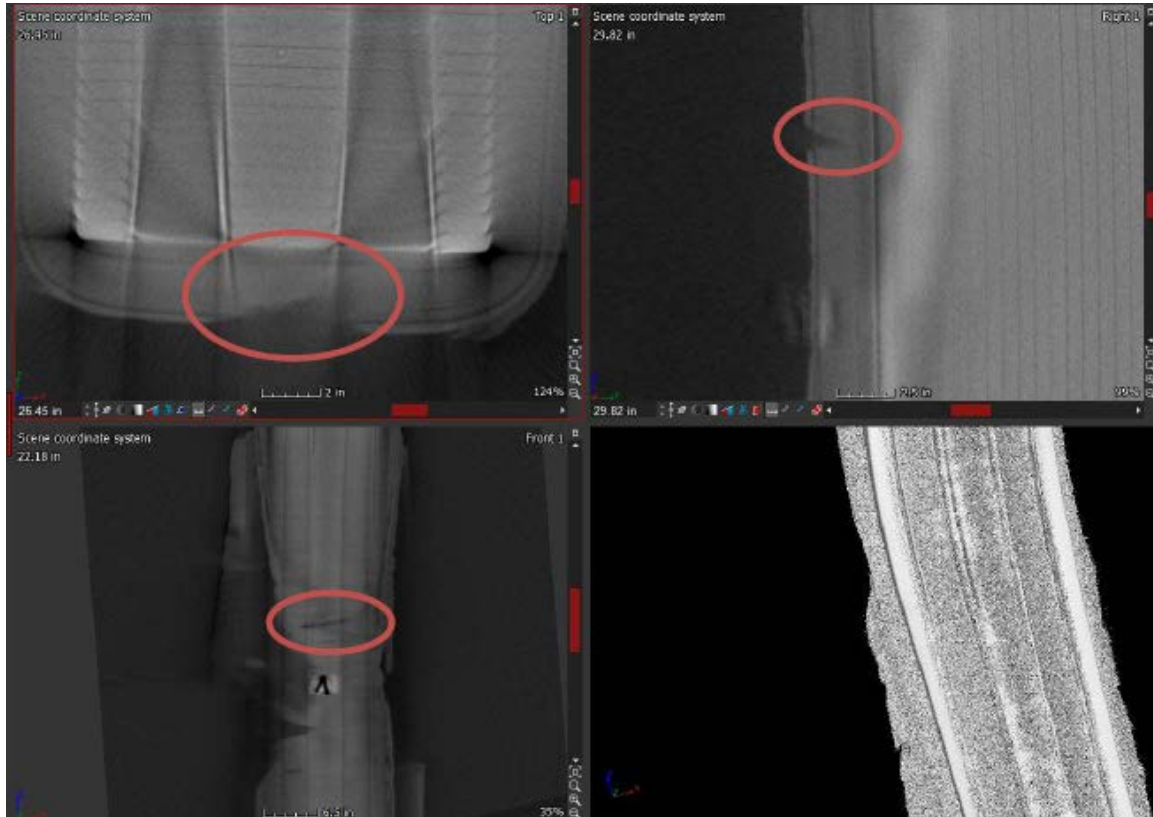
**Figure 10. CT Image of the Assessed Fault Location**

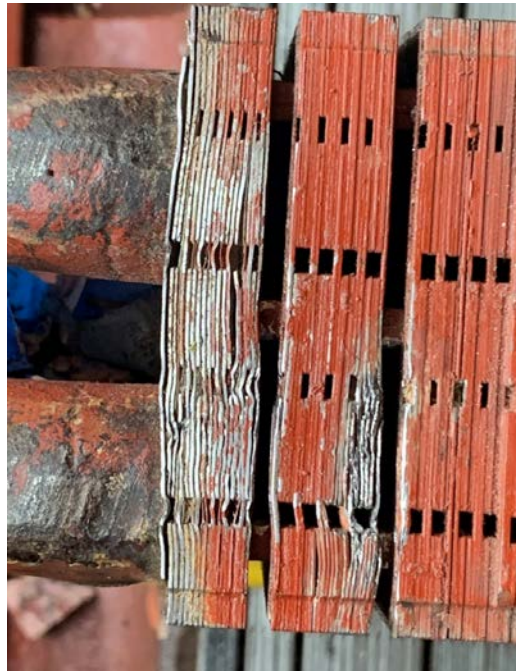
- **Conclusion:** Not a potential cause or contributor
- **Observations:**
  - Deformed laminations were noted in the step iron.

**Figure 14. Deformed Laminations**

- Any deformed laminations found were attributed to winding removal activities.
- Visual inspection before and after removal of slot 17 stator bars showed no evidence of greasing or dusting in the area of the slot.
- The fault location was identified outside of the slot during materials testing.
- SMCAS after fault did not show any systemic indications
- The core tightness check prior to installing the new winding showed the through bolts and building bolts were sufficiently tensioned.
