DESCRIPTION: Late filed deposition Exhibit No. 4

DOCUMENTS: Panel deposition of Jeffrey Swartz, Anthony Salvarezza and C. Wayne Toms, August 30, 2019.

BRR 4S L-O Background

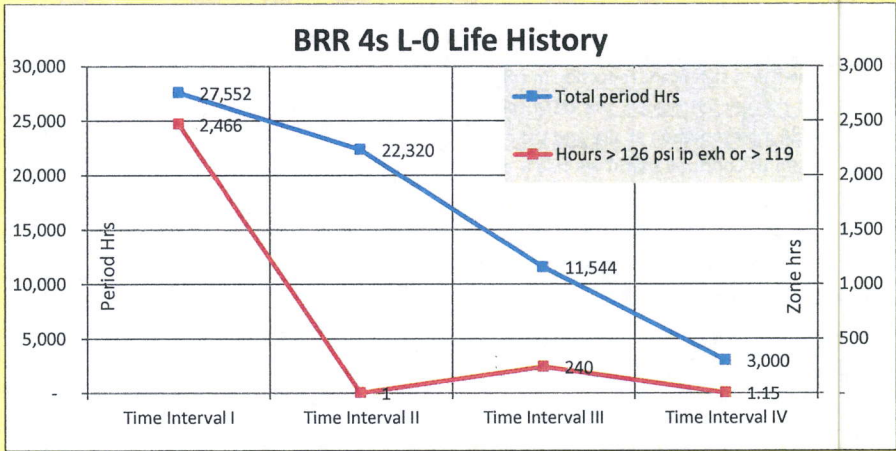
The expected blade life predictions of the latest blade configuration compared to the actual field experience is the driver for the study in attachment A of steam turbine output and operating pressures versus time. There is one particular fact and clear apparent path forward that can be seen in this data. The Table below from the attachment presents the fact that the more we modified the blades, the shorter the time before contact surface failure despite the fact we have continued operate the unit with lower steam flows that fall mostly within the OEM limits for the original design.

Inspection of the data reveal that the original design in time intervals 1 and 2 only had the mid-span snubber failure of the original turbine end (TE) blades – and the 1st time interval nearly 2500 hours of operation was above the OEM limit. In time interval 2, no failures occurred and there was only 1 hours of operation slightly above the limit. This means that the generator end (GE) blades ran nearly 50,000 hours with no failures.

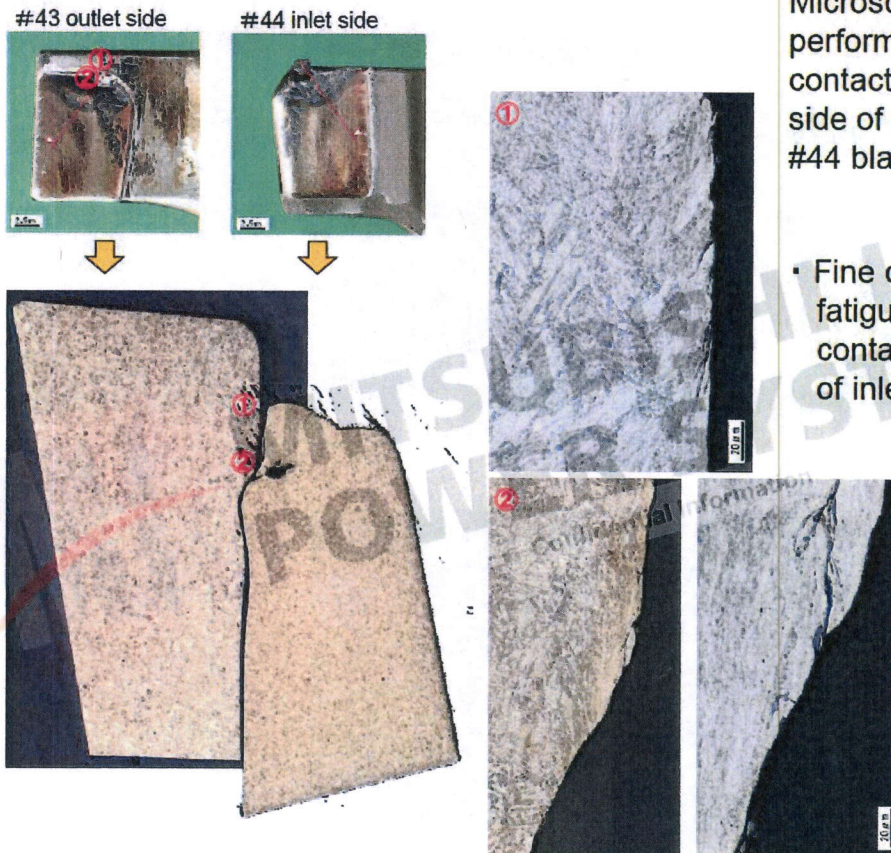
Microscopic observation was performed on the same sections in contact condition for each of outlet side of #43 blade and inlet side of #44 blade.

- Fine cracks, caused by fretting fatigue, are found near the end of contact part with local deformation of inlet side of #44 blade.

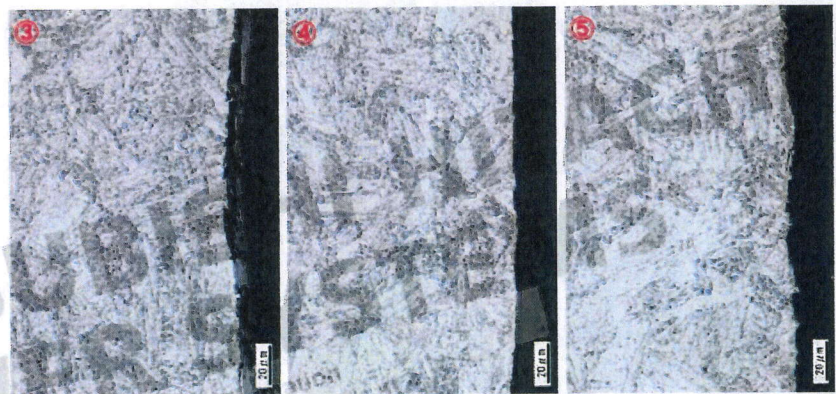
- ③: Oxide scale was found on black surface of local deformation area.
- ④: Dark brown surface of worn and thinned part is free of oxide scale and smoother than non-contact surface of ⑤.

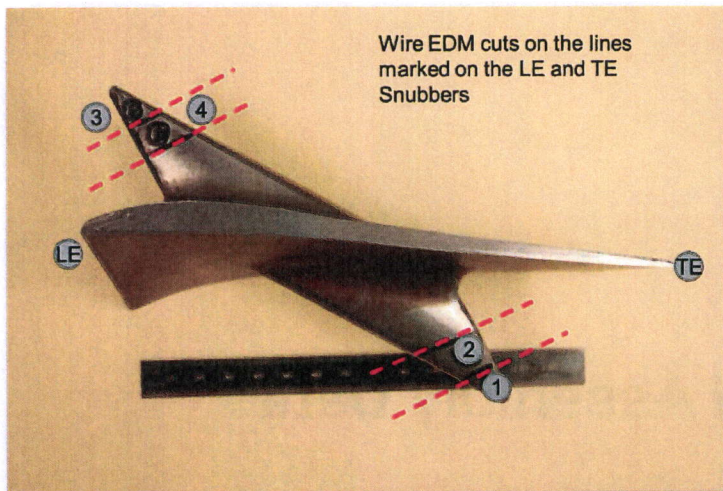
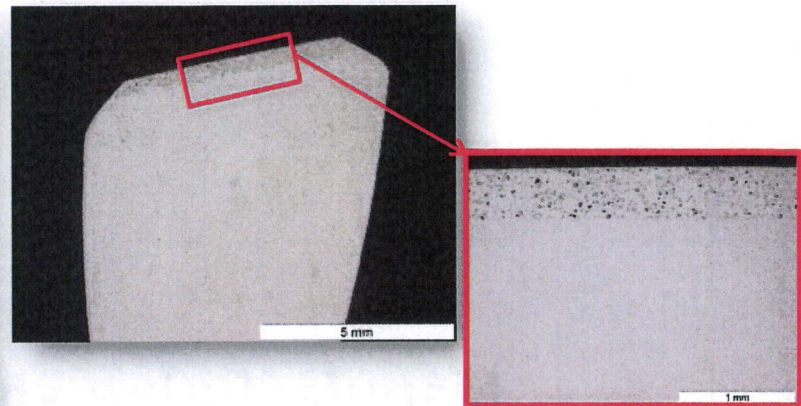
- The contact surface coating did not show any cracks, deformation or wear.
- Uniform thickness was measured on the areas of contact between the LE and TE snubbers.

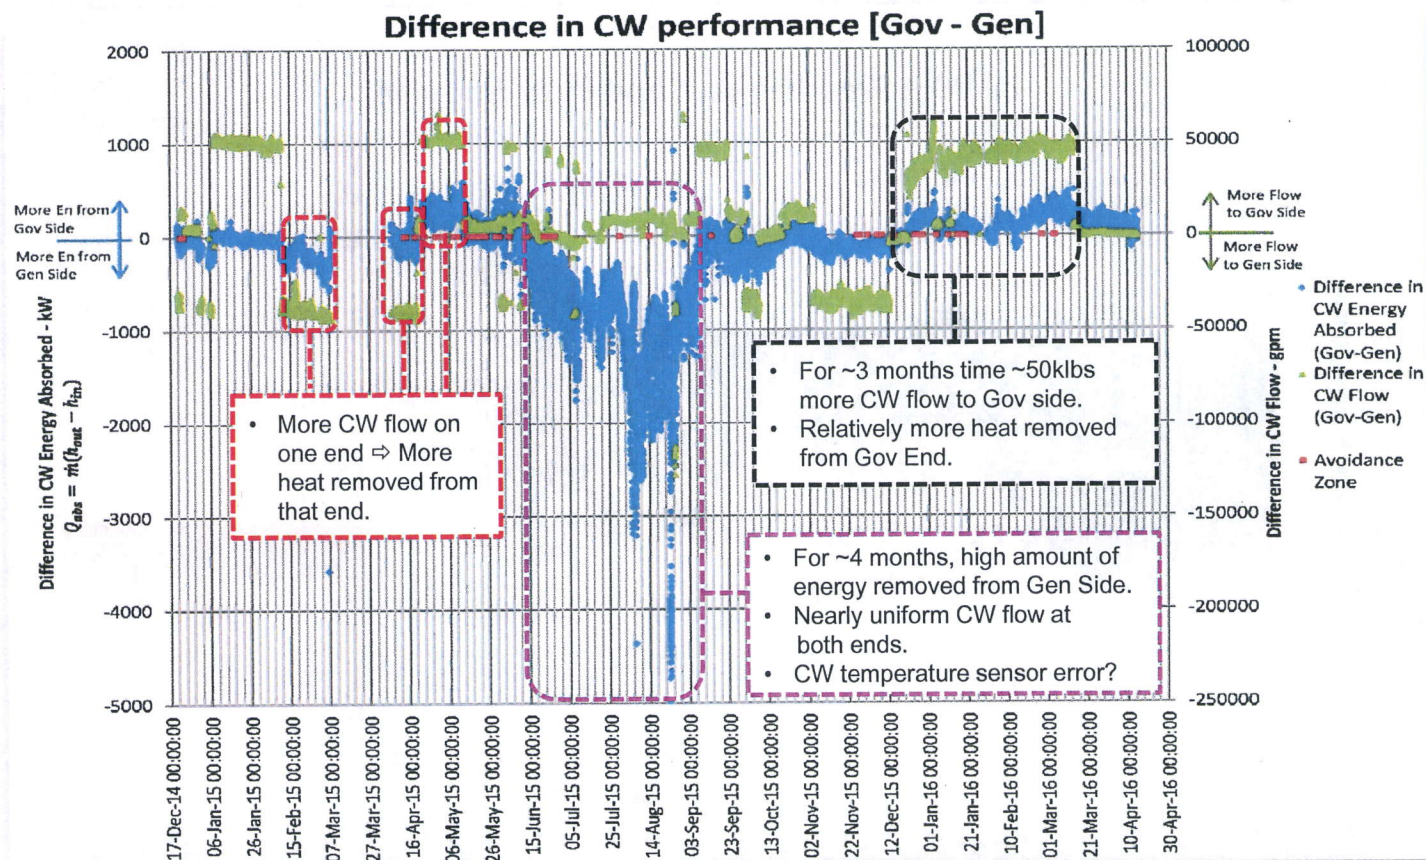
Asymmetric circulating water flow may explain difference in water erosion observed
Not enough data to draw any conclusion on blade shroud damage

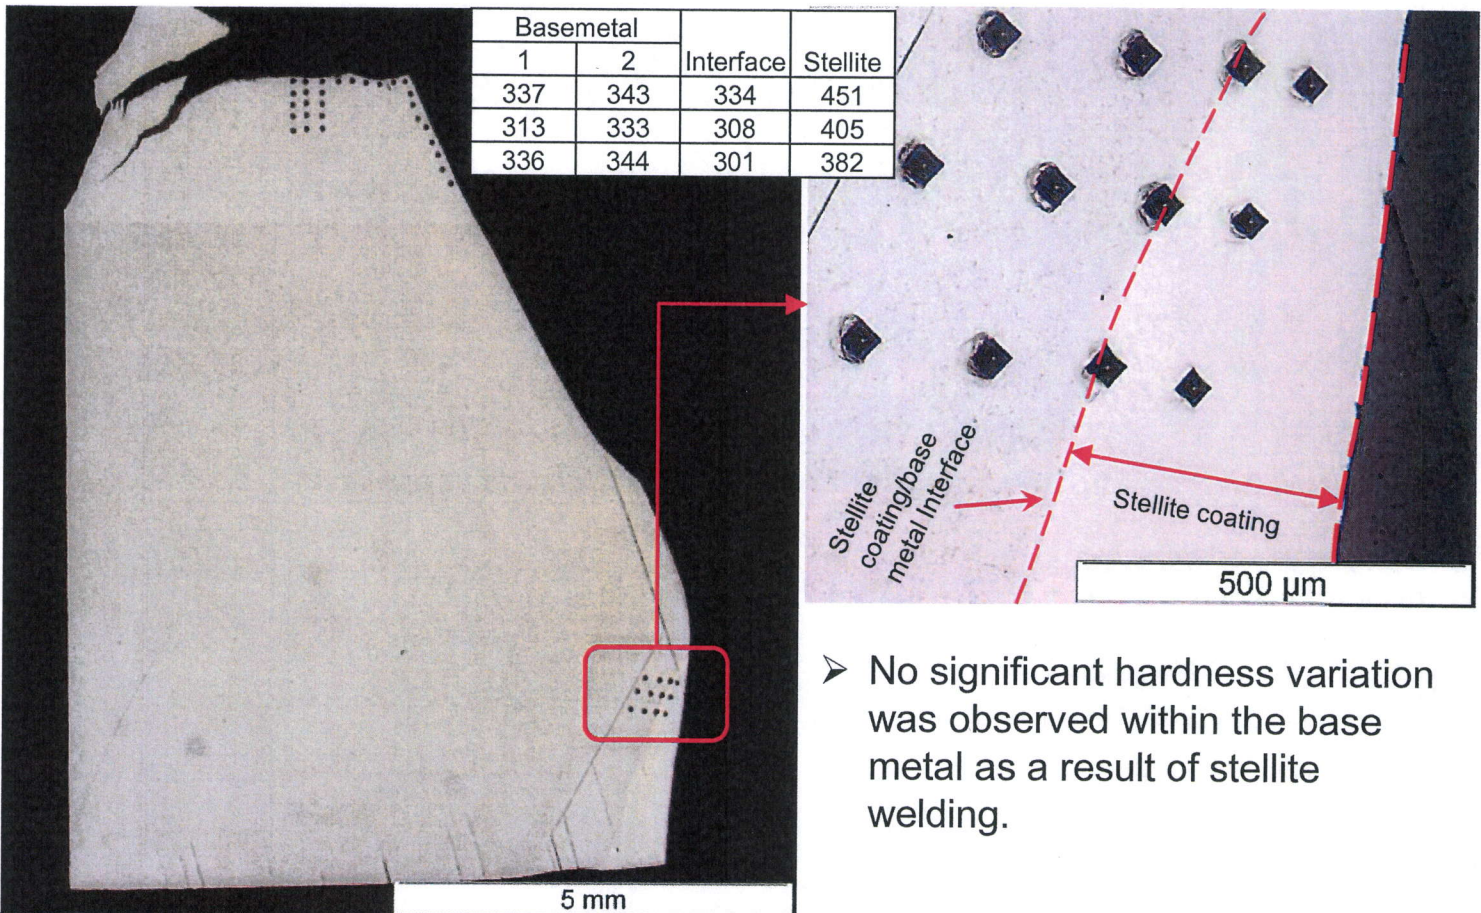
2- Hardness Variation basemetal, Interface and Stellite Coating

- No significant hardness variation was observed within the base metal as a result of stellite welding.

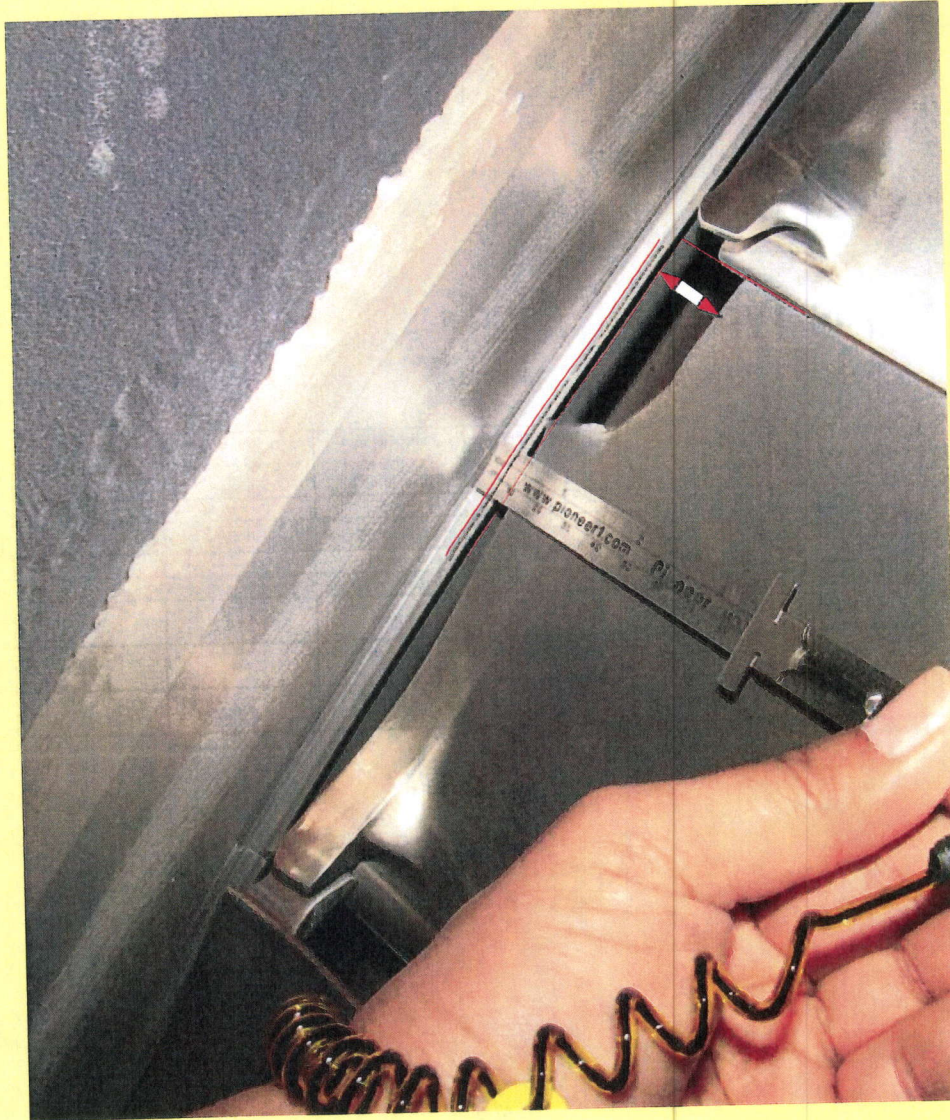
Oct 2016 photo of gen end #22. Three blades failed similar this GE # 13 and TE #2. Adequate mass loss to drive recorded Vibration step changes below.

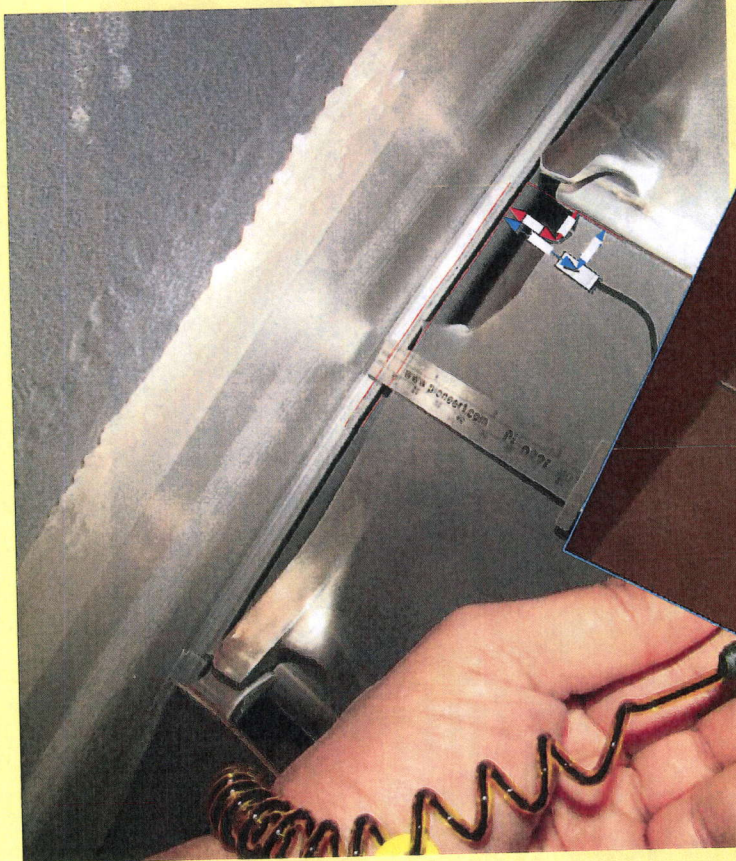
From period III photo of tip strain gage location ~ 18mm in from te and 32 mm in from tip. Gage was on suction side while high stress and crack initiation was on opposite side pressure side

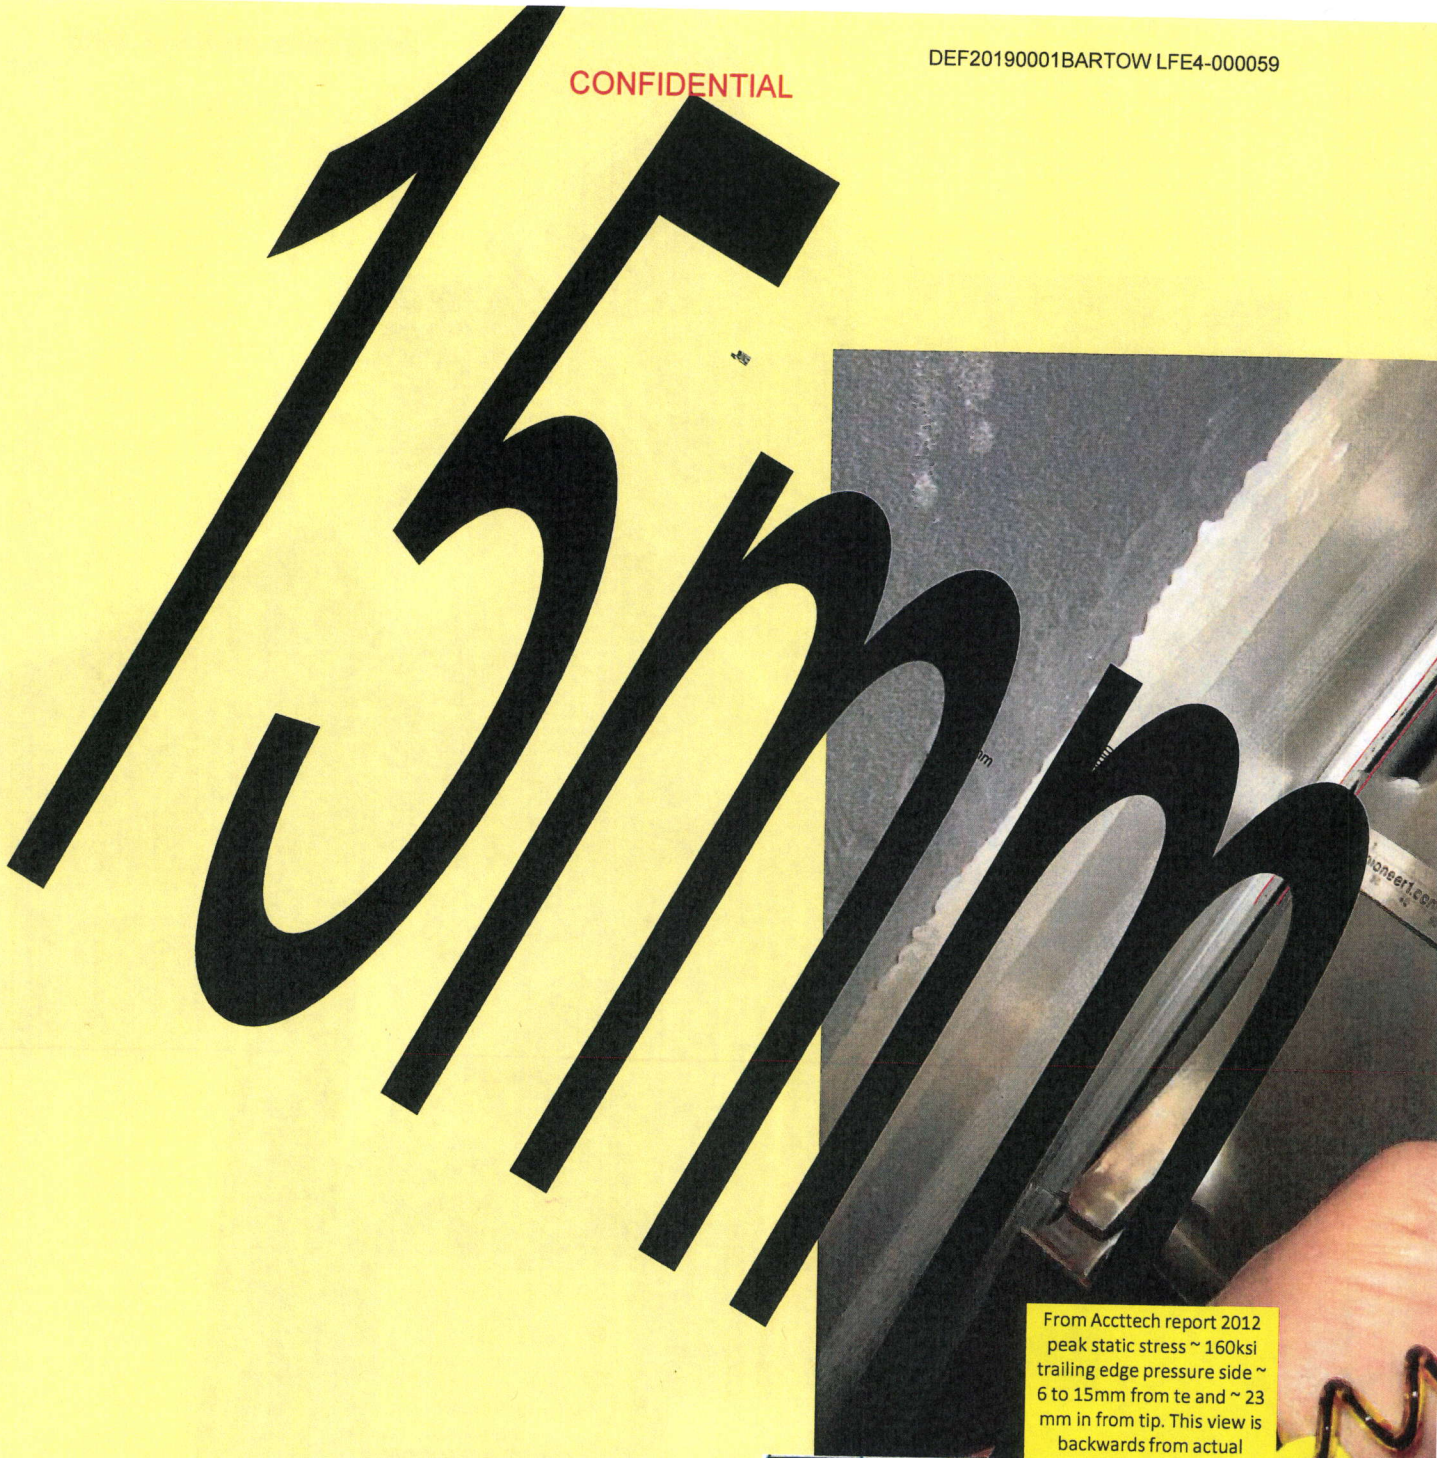
From Acctech report 2012
peak static stress ~ 160ksi
trailing edge pressure side ~
6 to 15mm from te and ~ 23
mm in from tip. This view is
backwards from actual
photo of blade #22

From MHI 2012 Period I RCA
presentation. Confirming
high static stress area where
Period IV cracks initiated.

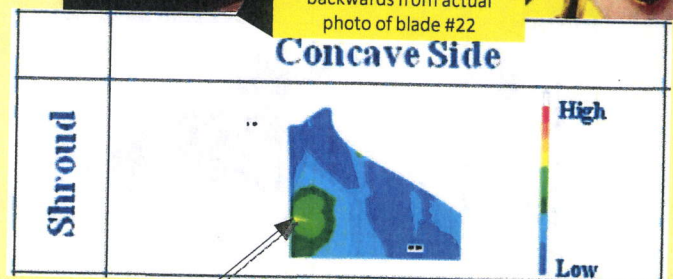
Finite element analysis performed after 2012 failure showed the crack starting point area had stresses above yield and the design would need to be "yielded down". This is possible because full section of blades was not above yield. This was not a concern with earlier failures, because the air foil was not liberating just contact face wear on mid span snubber and z lock tip. Partial tip and snubber loss was possible. The 2016 work re confirmed the high stress area and an earlier presentation 2012 by MHI supports the pressure side of the blade tip below the latch has high stress. The crack started at nearly the same spot as the predicted high stress area.

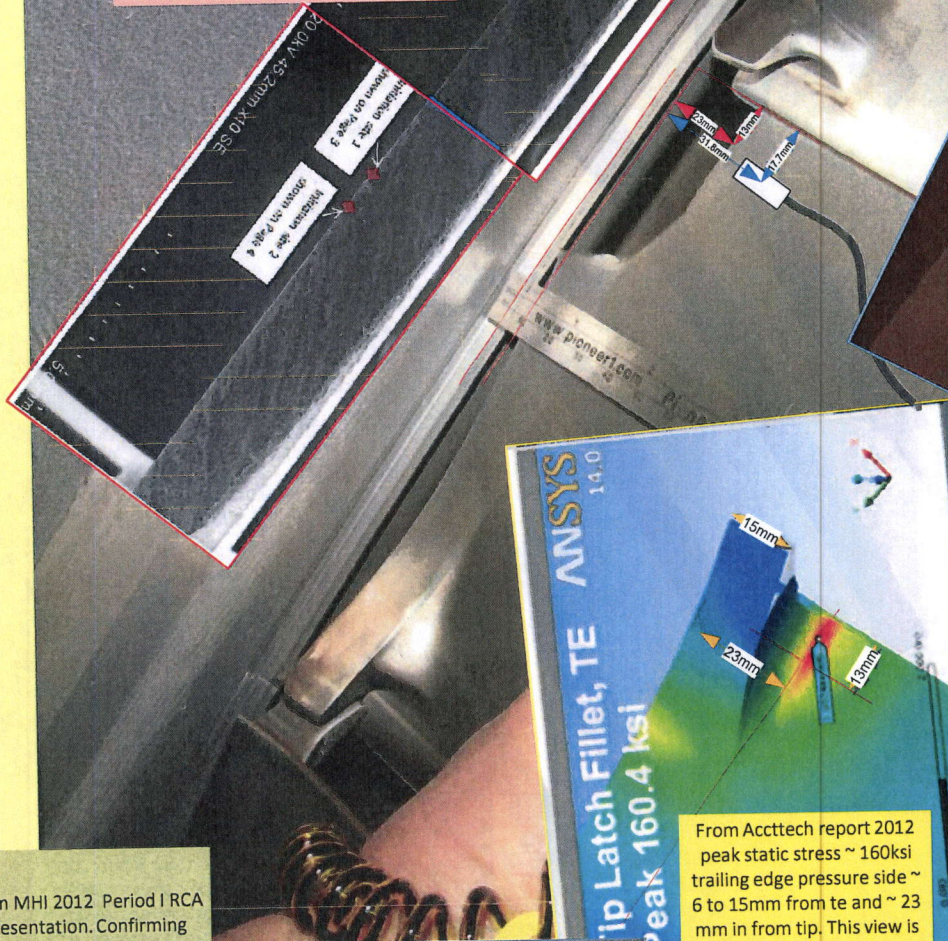
From Harris Lab work Gen End blade #22 crack initiation sites(in zone 1) ~ 13 mm in from te and 23 mm in from tip. Cracks started on pressure side. Opposite side from what is visible in blade #22 in situ photo below Oct 2016

From period III photo of tip strain gage location ~ 18mm in from te and 32 mm in from tip. Gage was on suction side while high stress and crack initiation was on opposite side pressure side

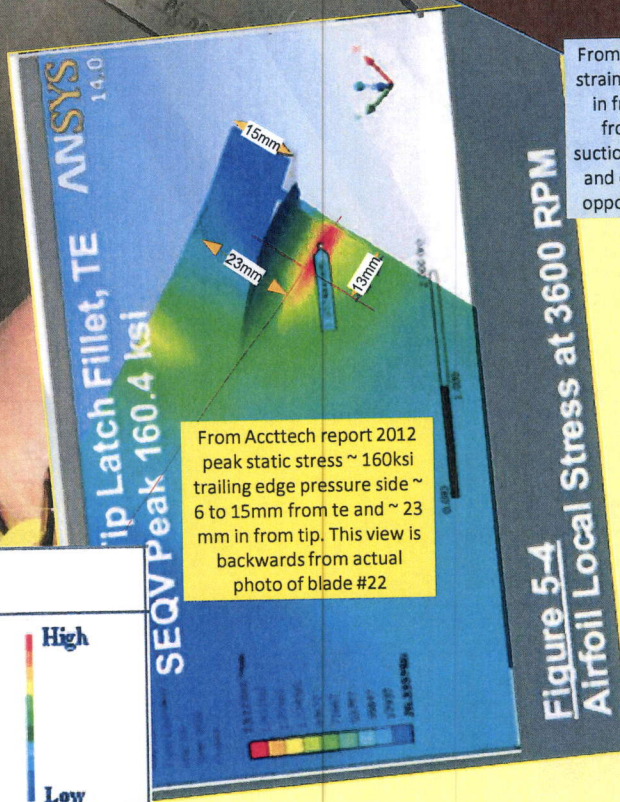
From Acctech report 2012 peak static stress ~ 160ksi trailing edge pressure side ~ 6 to 15mm from te and ~ 23 mm in from tip. This view is backwards from actual photo of blade #22

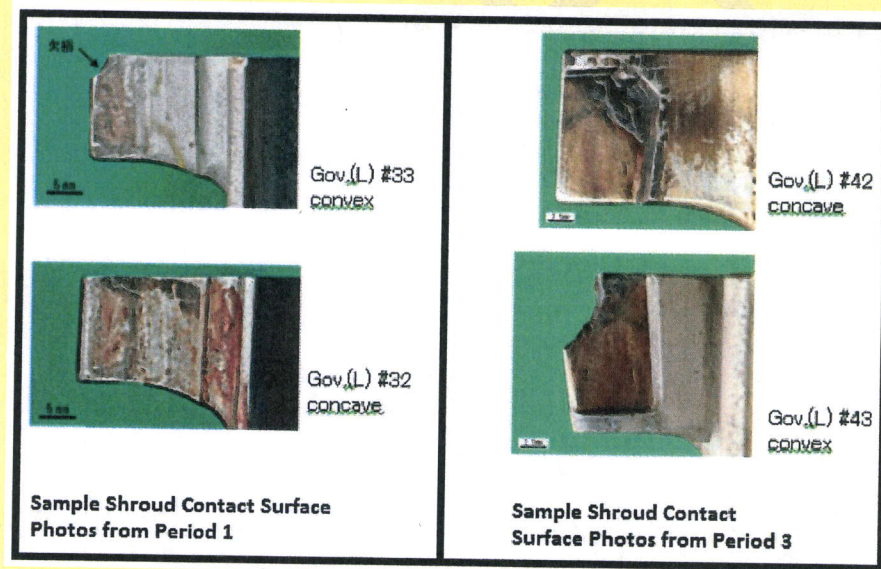
Figure 1 -- Comparative Photos of Shroud Contact Surface Wear for Periods 1 and 3

With the L-0s currently removed from the machine and with the pressure plate installed, MHPS Engineering has indicated that back-end loading is not currently an issue of concern at the current LP inlet operating limits. MHPS Engineering does not have enough technical data to support releasing Duke to operate the machine

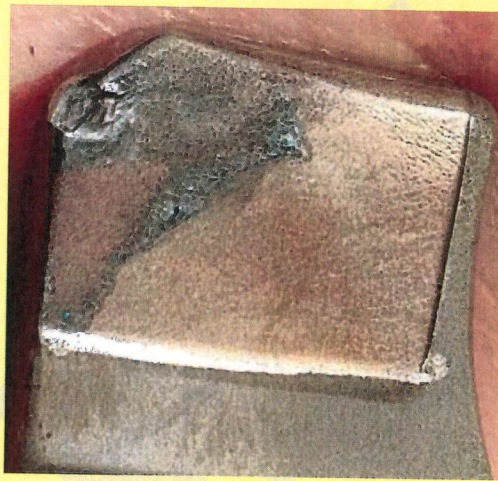
Figure 4 -- Photo of an L-O blade Z-Lock from Period 5 Showing Contact Surface Wear

Period 5 did have its share of higher energy blends as detected by the blend energy method. However, in terms of operating hours in blend mode, Period 5 is not excessive in terms of percentage time blending. The total of 20 hours of blend time does not appear to justify the wear seen.

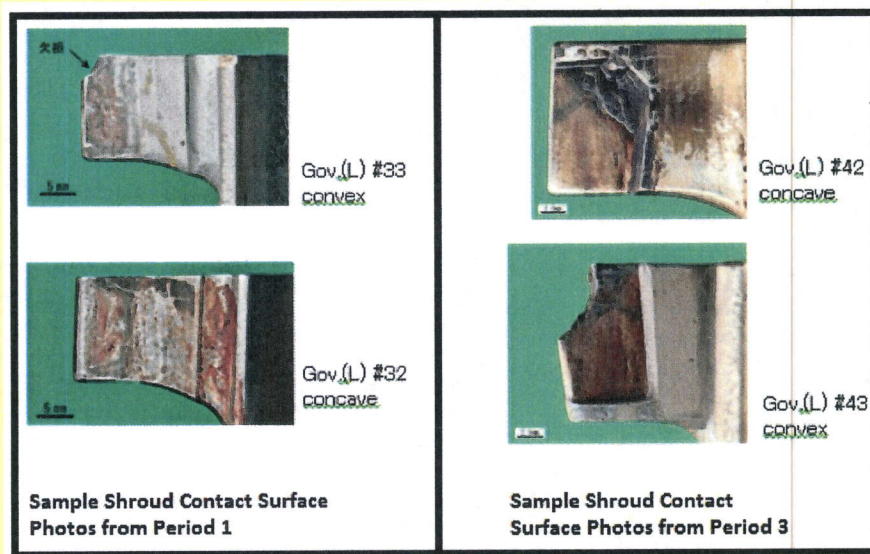
Figure 1 -- Comparative Photos of Shroud Contact Surface Wear for Periods 1 and 3

With the L-0s currently removed from the machine and with the pressure plate installed, MHPS Engineering has indicated that back-end loading is not currently an issue of concern at the current LP inlet operating limits. MHPS Engineering does not have enough technical data to support releasing Duke to operate the machine beyond the current LP inlet operating limits due to concerns for impacts to upstream blading – i.e. the L-1 blade sets.

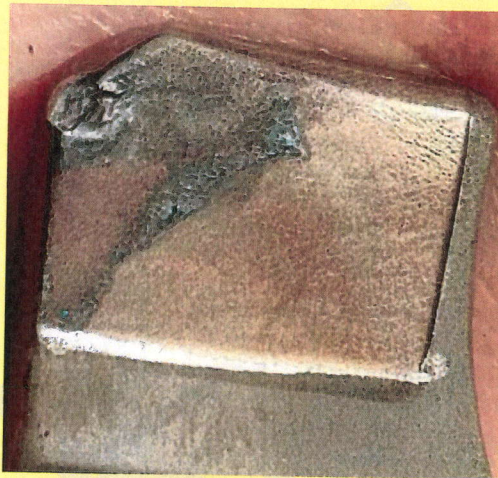
Figure 4 -- Photo of an L-0 blade Z-Lock from Period 5 Showing Contact Surface Wear

Period 5 did have high energy blends as detected by the blend energy method. However, in terms of operating hours in blend mode, Period 5 is not excessive in terms of percentage time blending as compare to time operated in Zone F1.

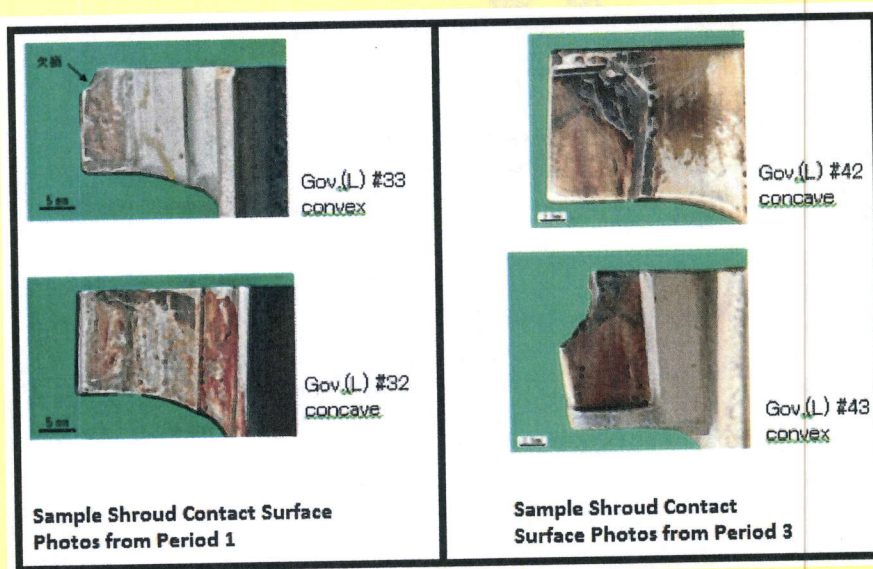
Figure 1 -- Comparative Photos of Shroud Contact Surface Wear for Periods 1 and 3

With the L-0s currently removed from the machine and with the pressure plate installed, MHPS Engineering has indicated that back-end loading is not currently an issue of concern at the current LP inlet operating limits. MHPS Engineering does not have enough technical data to support releasing Duke to operate the machine beyond the current LP inlet operating limits due to concerns for impacts to upstream blading – i.e. the L-1 blade sets.

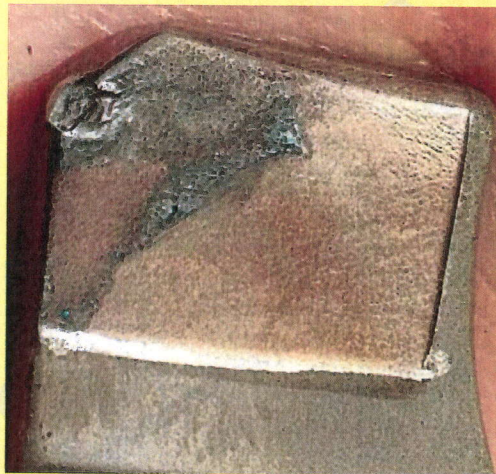
Figure 4 -- Photo of an L-0 blade Z-Lock from Period 5 Showing Contact Surface Wear

Period 5 did have its share of higher energy blends as detected by the blend energy method. However, in terms of operating hours in blend mode, Period 5 is not excessive in terms of percentage time blending. The total of 20 hours of blend time does not appear to justify the wear seen.

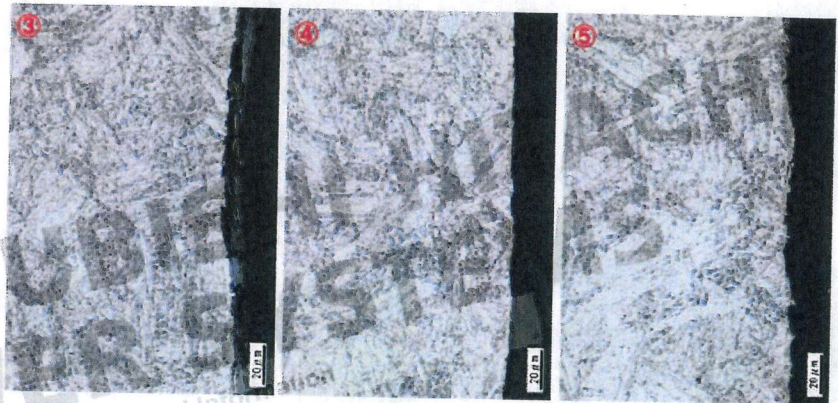
- ③: Oxide scale was found on black surface of local deformation area.
- ④: Dark brown surface of worn and thinned part is free of oxide scale and smoother than non-contact surface of ⑤.

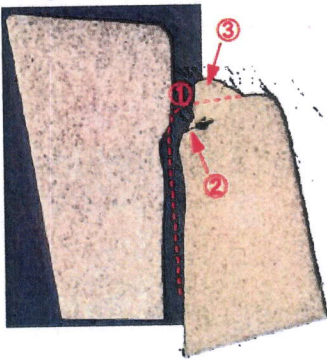
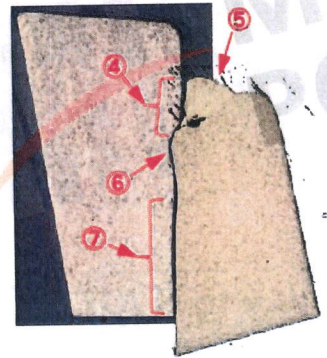
① Partial local contact at the top and tip of blade

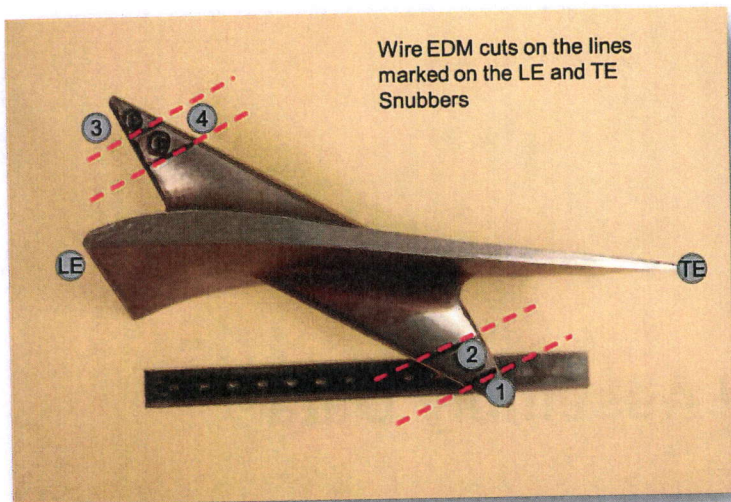
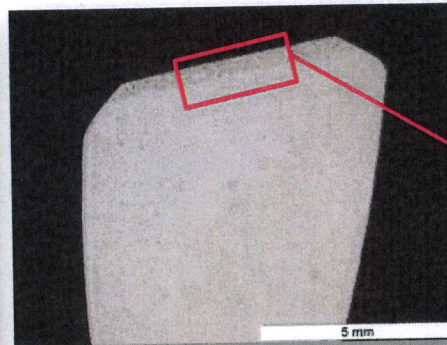
- The contact surface coating did not show any cracks, deformation or wear.
- Uniform thickness was measured on the areas of contact between the LE and TE snubbers.

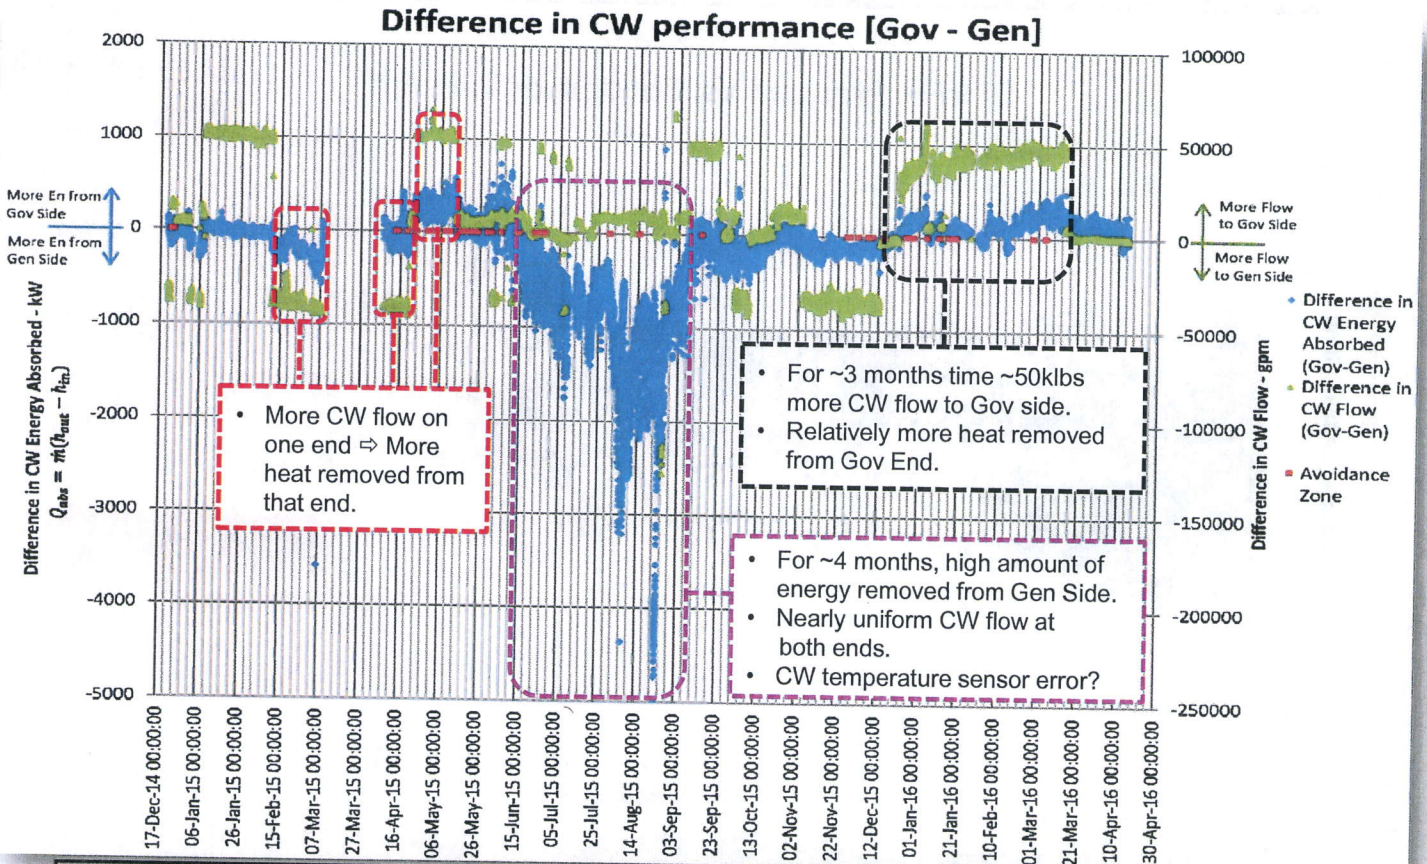
Asymmetric circulating water flow may explain difference in water erosion observed
Not enough data to draw any conclusion on blade shroud damage

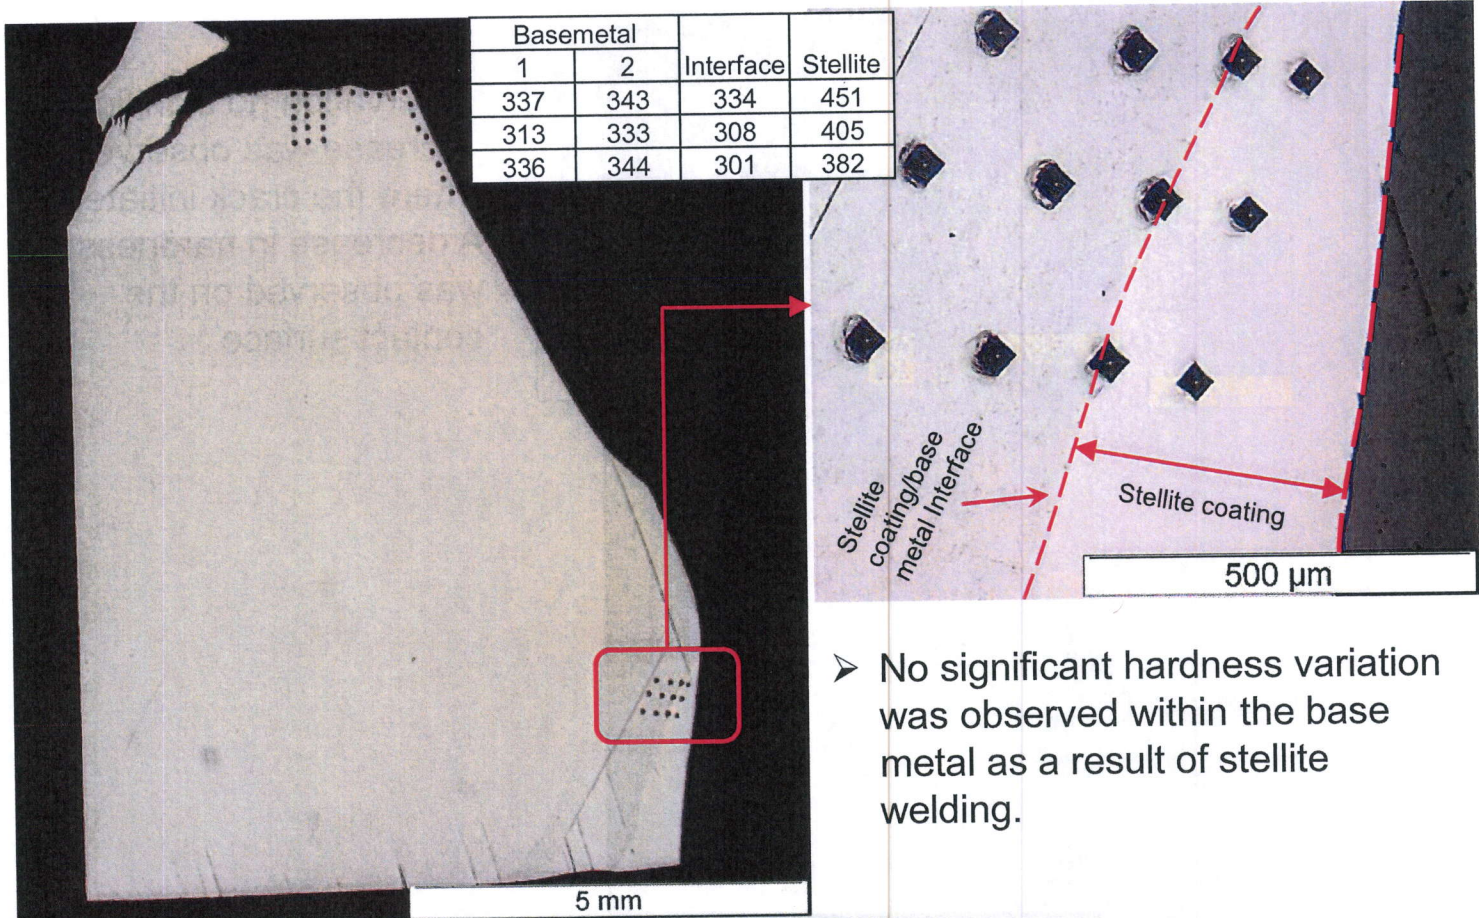
- No significant hardness variation was observed within the base metal as a result of stellite welding.
