Exhibit No.	Witness	I.D. # As Filed	Exhibit Description
70	Richard A. Polich, P.E.	RAP-3	Bartow Combined Cycle Thermal Cycle. CONFIDENTIAL DN. 09202-2019, X-REF. 08773-2019
73	Richard A. Polich, P.E.	RAP-6	Bartow ST #1 LO Blade Upgrade To Achieve 450 MW, Dated September 18, 2013. CONFIDENTIAL DN. 09202-2019, X-REF. 08773-2019
74	Richard A. Polich, P.E.	RAP-7	Bartow RCA Review, Dated March 15, 2017. CONFIDENTIAL DN. 09202-2019, X-REF. 08773-2019
75	Richard A. Polich, P.E.	RAP-8	Update On 40'' Last Stage Blade, Dated 2015. CONFIDENTIAL DN. 09202-2019, X-REF. 08773-2019
80	Jeffrey Swartz	JS-2	Bartow Plant Root Cause Analysis. CONFIDENTIAL DN. 09061-2019
81	Jeffrey Swartz	JS-3	Bartow ST 40'' Blade Test. CONFIDENTIAL DN. 09061-2019
82	Jeffrey Swartz	JS-4	Bartow RCA Summary. CONFIDENTIAL DN. 09061-2019

Bartow ST#1 – L0 Blade Upgrade to Achieve 450MW

**Mitsubishi Power Systems
Americas, Inc.**

September 18th, 2013

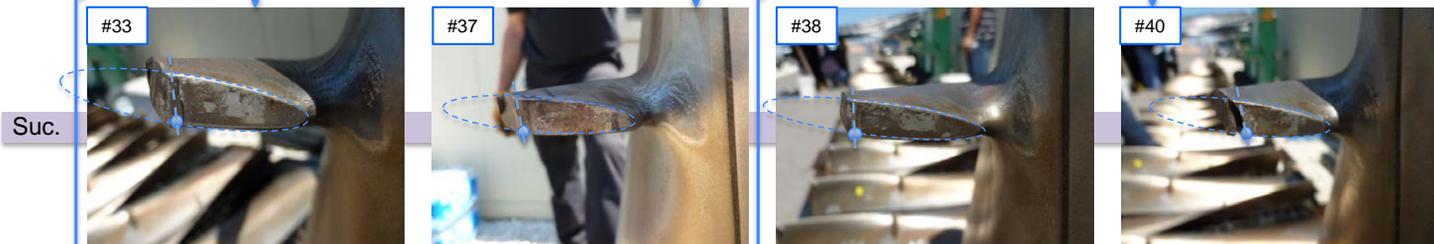
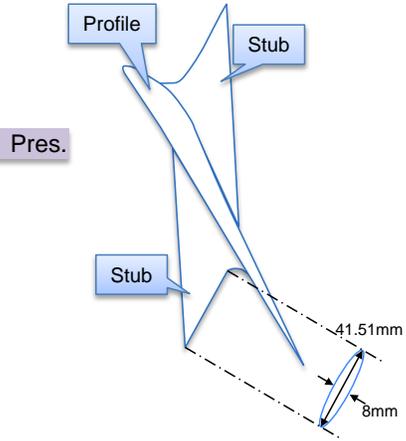
Failure Blades at Site (Stub)

- Mitsubishi recommended that the Duke ST operate at or below 420MW to ensure proper loading on the LP turbine and L-0 blades
- Mitsubishi evaluated modification of L-0 blades to increase output from 420MW up to 450MW
- X-ray and mold tests were conducted by customer on the governor end L-0 blades in March 2013. Customer analysis indicates fretting wear on the contact surface of mid span stub.

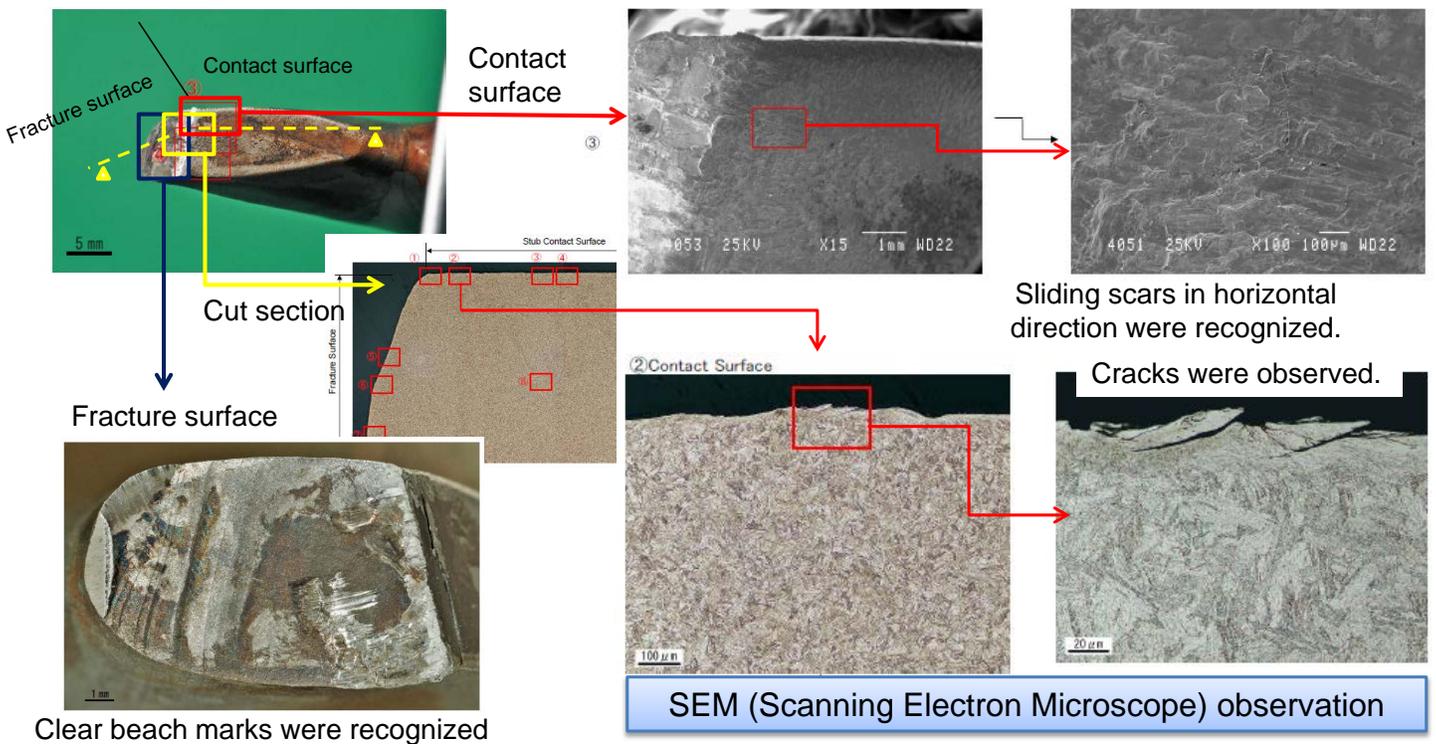
Metallurgical Analysis

Clear beach marks were recognized

SEM (Scanning Electron Microscope) observation

Fretting crack was generated on the contact surface. The crack was propagated by high cycle fatigue.

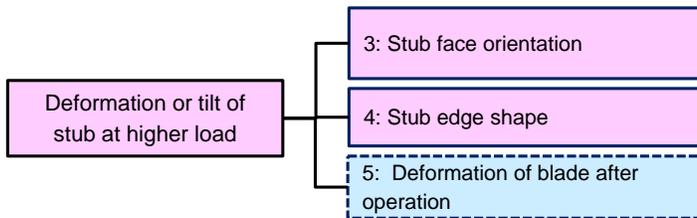
Local pressure increases with tilted contact surface.

- If stub surface is tilted in horizontal or vertical direction, high local stress on the stub is observed.
- Crowning is applied to the edge of stub contact to avoid the high local stress.

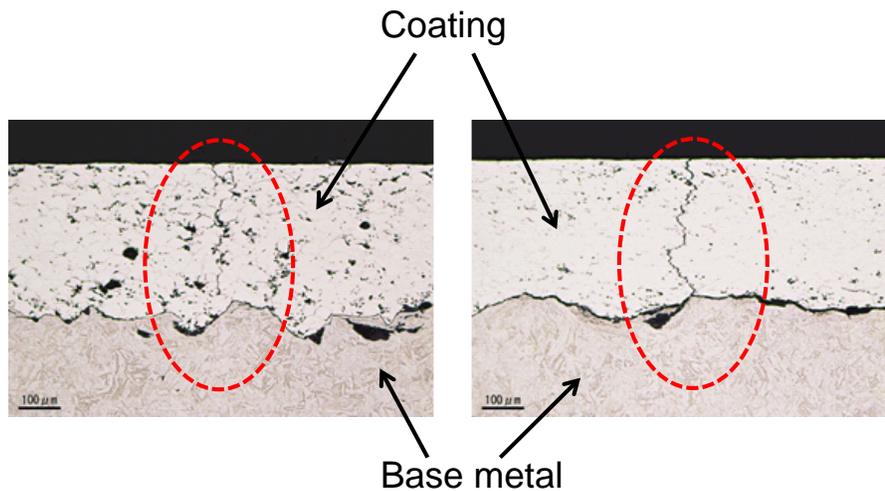
Bending Test Result

It is confirmed by the bending test that any crack that initiates in the coating will not propagate into base material.

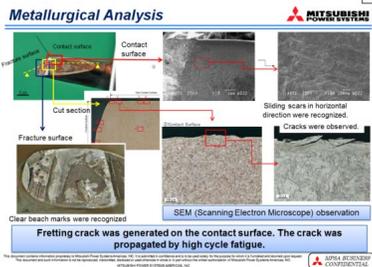
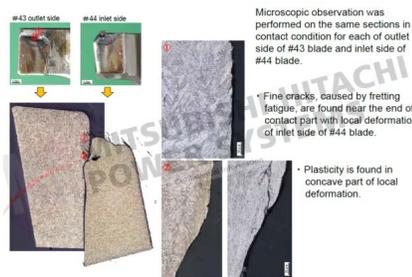
Period 3 Shroud Heavy Wear
Presented 5/26/16 and 11/9/16

→ Shroud wear is obvious after the Period III. Blade vibration might increase.

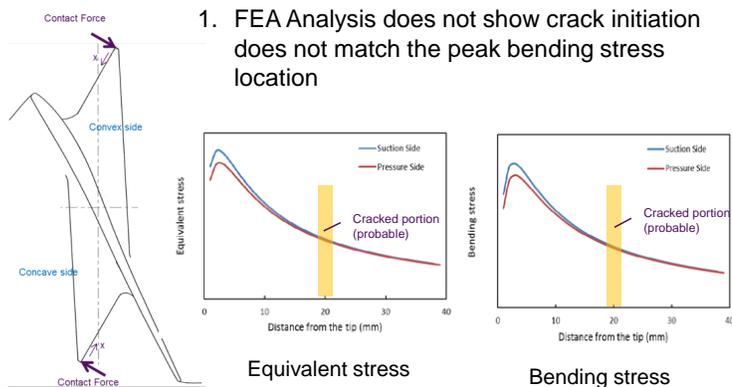
Failed stub #54 Blade.
 Crack initiated at close the mid span of contact surface.

Duke raised concern that the crack initiation may be from bending stresses induced from tip contacting on the mid span snubber. Analysis was conducted to confirm that snubber cracking did not occur at the location of maximum bending stress associated with tip loading.

Fretting Fatigue Crack Initiation is to be confirmed through SEM review of fracture surfaces.

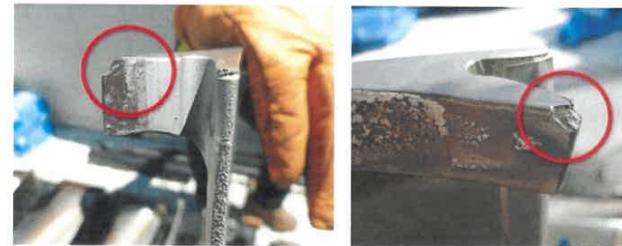
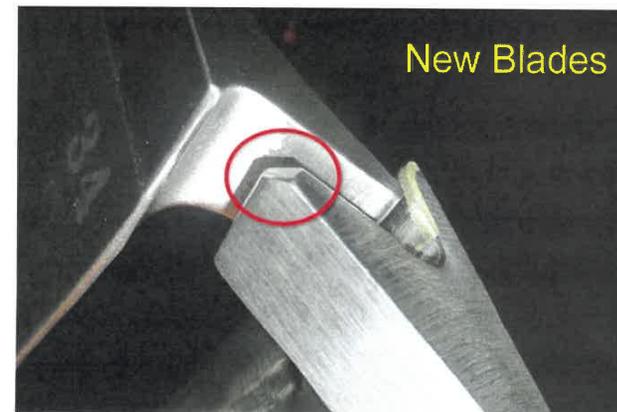
Update on Tip Chipping Experience

- On few of the units, blade shroud leading edge chipping have been observed.
- Evaluation of chipping shows no impact on structural integrity or performance of the blade.
- As a countermeasure, a chamfer is applied to reduce stress concentration caused by blade twist and contact pressure.
- This has only been applied on one unit after chipping was observed.

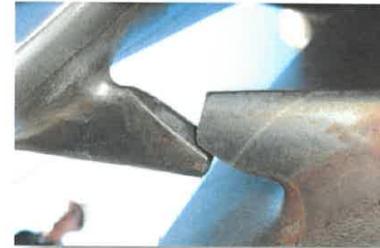
Damaged Stub

- In last year MSTUG meeting, we informed about mid-span damage on one unit.
- The cause of the damage was concluded as overloading the unit. The unit was designed for 420MW but it was operated at 450MW.
- The loading on the last stage blade for 450MW operation was well outside the Mitsubishi experience range.
- Enhanced blade with special coating at the mid span along with improved stub geometry provided to customer for high loading operation.

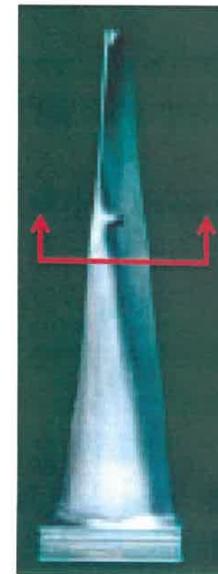
Damage Plane

- An incidence of a blade damage occurred on PowerSouth's Vann unit.
- First incidence of such kind in the 15 years operational history of the 40" L0 blades.
- This incident is not related with erosion issue observed on few units.
- One blade was found broken off just below the Stellite shield on the leading edge.
- Mitsubishi along with PowerSouth team launched a RCA to understand the root cause.
- More details will be shared in the Vann unit presentation.

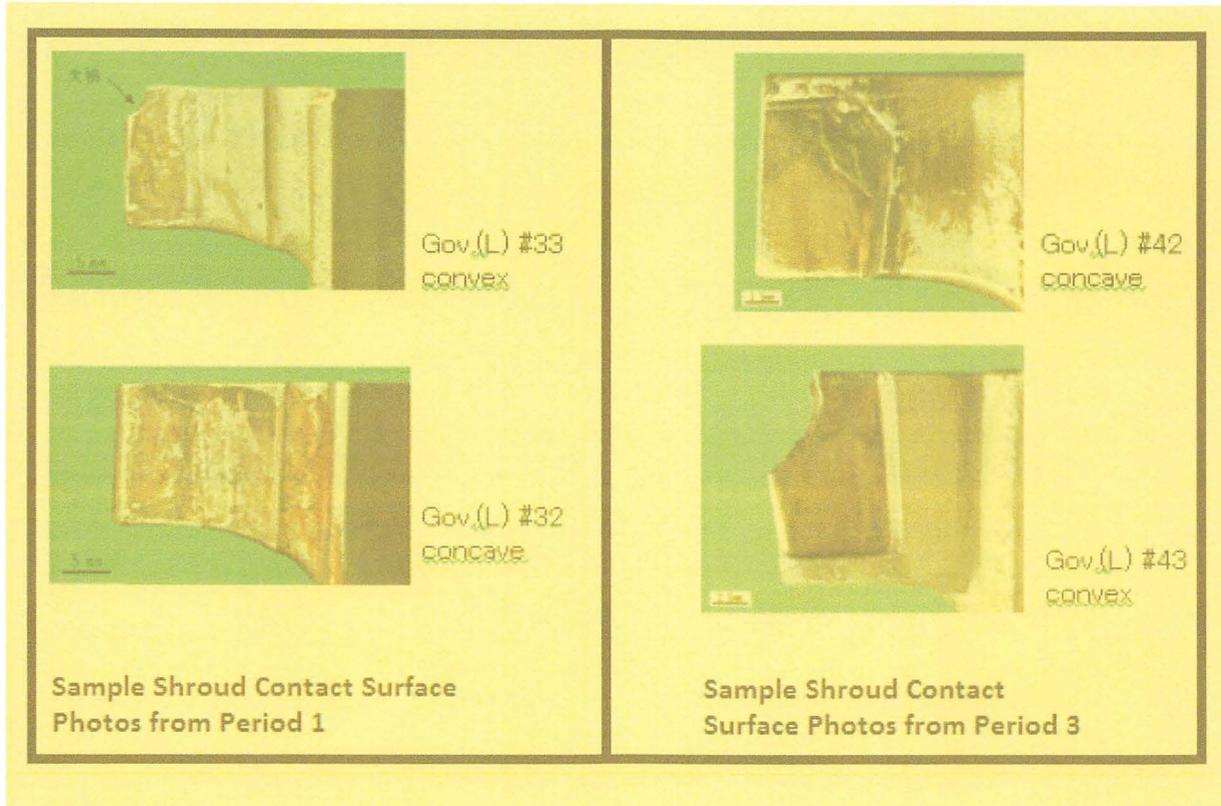
Figure 1 –Photos of Shroud Contact Surface Wear for Periods 1 and 3

Based on comparative run times and damage, it is difficult to conclude that the L-0 blade damage in each Period or any particular Period is due to unit operation in the avoidance zone.⁶

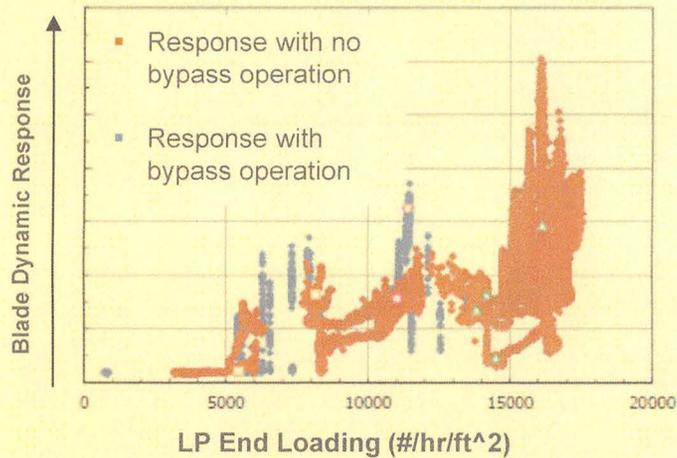
Blade Response vs LP End Loading

- Outside of the originally developed design space, blade response becomes sensitive to operating conditions.
 Example : At 16,500 #/hr/ft² there is a 10X change in blade response based on condenser pressure

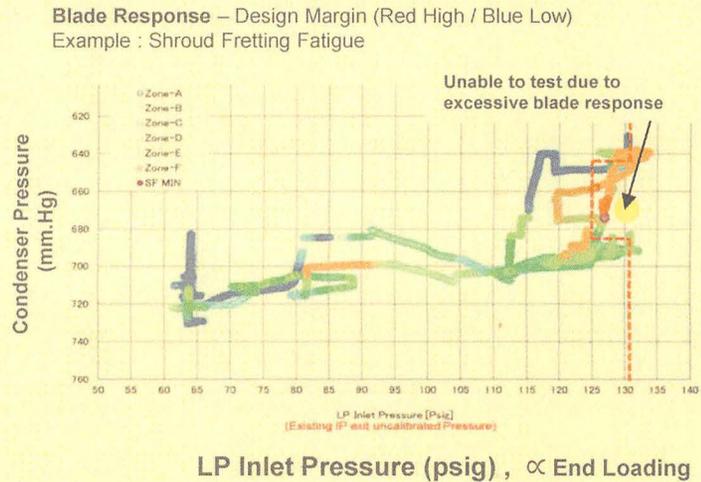
Blade Response vs Pressure and Condenser Pressure

- The avoidance zone established in 2015 was developed to prevent operation in the region which measured high blade response.

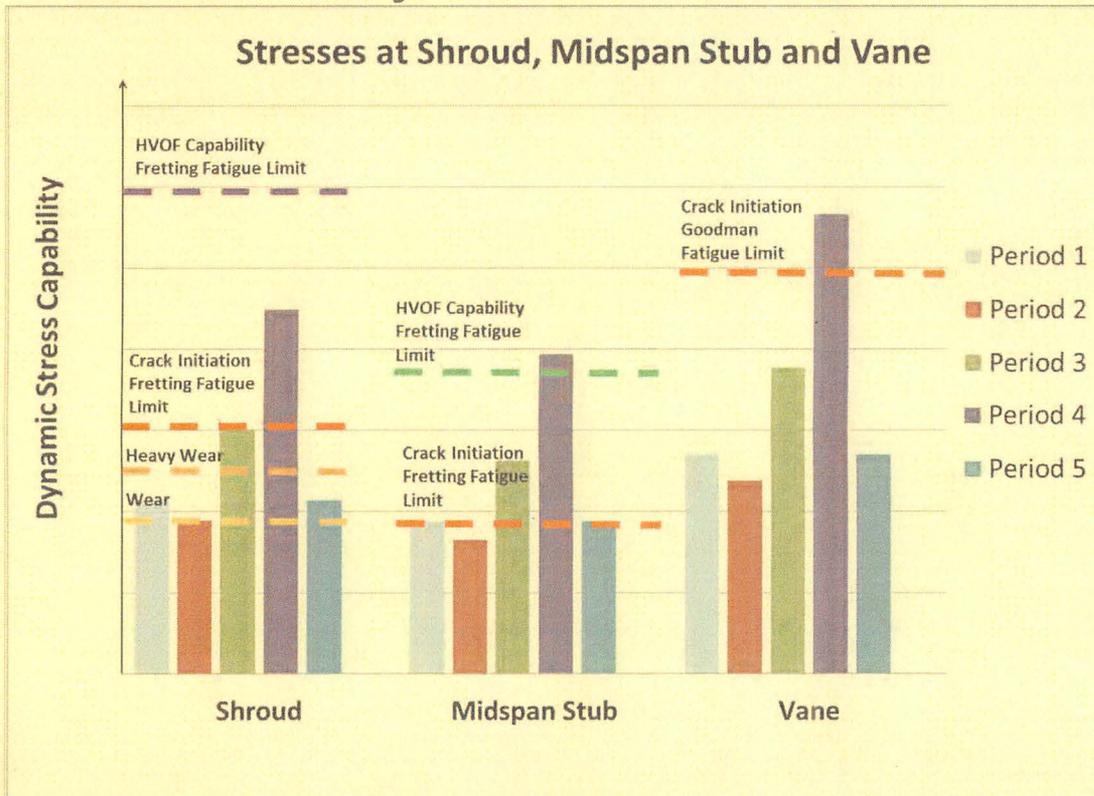
Stress Summary – Period 1 thru 5

- **Period 1 – Mid Span Stub Cracking**
 High LP Loading but increased mechanical damping from Type 1 blade over baseline telemetry test
- **Period 2 – No Major Damage**
 Reduced LP Loading over Period 1, reduced bypass operation loading over period 5, light wear observed on shroud
- **Period 3 – Shroud Cracking**
 High LP Loading identified in Telemetry Test. Mid Span Stub protected by HVOF
- **Period 4 – Vane Cracking**
 Reduced Loading. Application of HVOF reduces mechanical damping increasing amplitude of response. With HVOF protecting Shroud and Stub, the limiting location becomes the Vane
- **Period 5 – Mid Span Stub Cracking**
 Reduced Loading with longer periods of bypass operation at High Mach Number over Period 2. No HVOF Protection
