# REPORT OF PHASE I ENVIRONMENTAL SITE ASSESSMENT U.S. HIGHWAY 301 SITE DUVAL COUNTY AND BAKER COUNTY, FLORIDA E&A PROJECT NO. 05JX-7195

MHK of Volusia County, Inc. 2379 Beville Road Daytona Beach, Florida 32119

Ellis & Associates, Inc. 7064 Davis Creek Road Jacksonville, Florida 32256

December 2, 2005

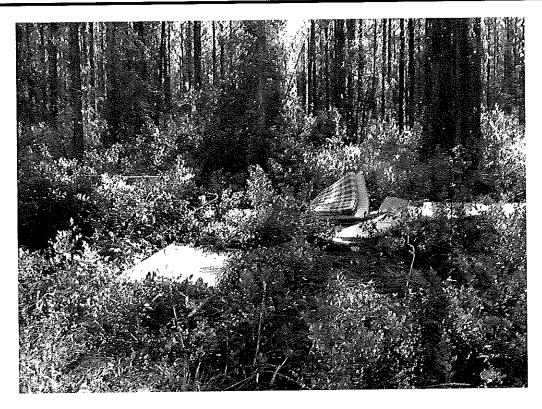
Indications of solid waste disposal were evident during our site visit. Minor amounts of unregulated dumping were observed around the boundaries of the property. As is typical with undeveloped wooded land, small amounts of bottles, cans, and paper trash was observed near the property boundaries. Mattresses, household appliances, and sheet metal were also observed. No signs staining or stressed vegetation was observed in the areas of dumped trash.

Photograph 3 – View to the east showing a trash pile observed on the southwestern portion of the property.

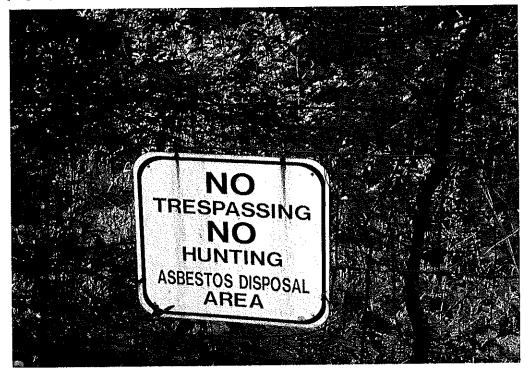
E&A's opinion that the Trail Ridge Landfill is a recognized environmental condition and a low to moderate threat to the property based on its operation as a landfill.

Photograph 10- View to the north showing a warning sign posted on the boundary of the Trail Ridge Landfill outparcel.

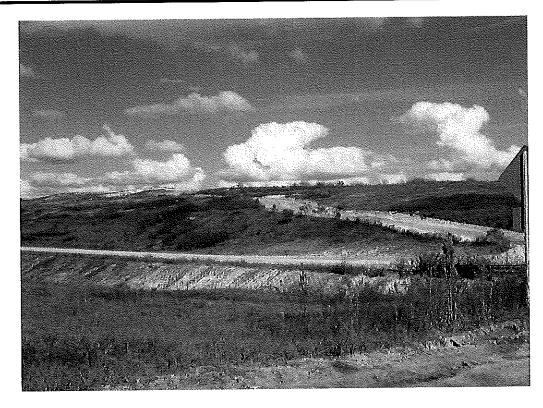
Photograph 11 - View to the northeast showing the Trail Ridge Landfill.

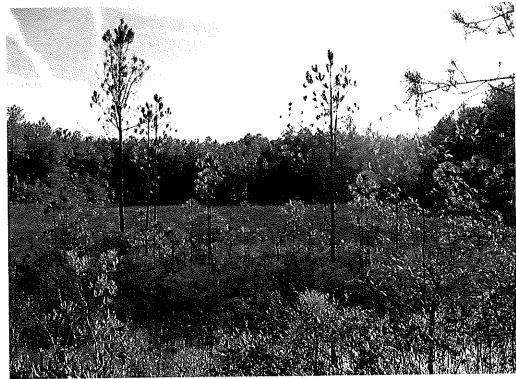
- Ponds Several low areas were observed on the eastern portion of the property. A review of aerial photographs showed these areas as ponds or areas of standing water. Based on the visual observation, the low areas appeared marshy with standing water. Based on the shaped of these areas, they appear to have been man-made. Based on historical aerial photograph review, the areas of standing water were borrow pits which were likely associated with the nearby road construction.

Photograph 14 – View to the northeast showing a low area of standing water on the eastern portion of the property.

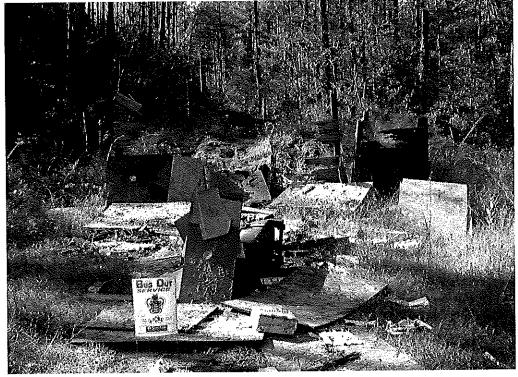
A small shooting range was observed on the central portion of the property. A dirt berm approximately 10 feet long by 5 feet wide by 4 feet high served as the backstop for the shooting range. Shooting ranges receive bullets that are largely comprised of lead. In E&A's opinion, the presence of a shooting range on the property is a recognized environmental condition and a moderate threat to the property.

Photograph 16 - View to the west showing the shooting range observed on the central portion of the property.

Based on these findings, in E&A's opinion, if a higher degree of confidence is required to discount the conditions revealed by this investigation, then additional assessment would be warranted.

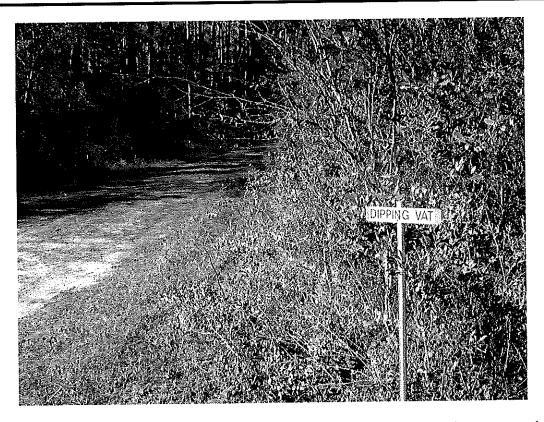
- Potential Cattle Dipping Vat During the site visit, a road sign was observed indicating one of the on-site trail roads was known as Dipping Vat Road. The Florida Department of Environmental Protection's (FDEP's) list of known cattle dipping vats in Duval County has a listing for "Fiftone" and "Maxville" dipping vats. No dipping vat structure was observed on the property. Members of the property's

hunt club were questioned regarding the road name and stated that they thought a dipping vat was formerly located in the area of Dipping Vat Road but were not aware of the exact location. A review of aerial photographs back to 1943 did not appear to show any large scale cattle usage on the property. Based on the information obtained, it is E&A's opinion that the potential presence of a cattle dipping vat on the property is a recognized environmental condition and a moderate to high potential threat to the property.

Photograph 17 – View to the west showing the sign indicating a trail road on the east-central portion of the property as "Dipping Vat" Road.

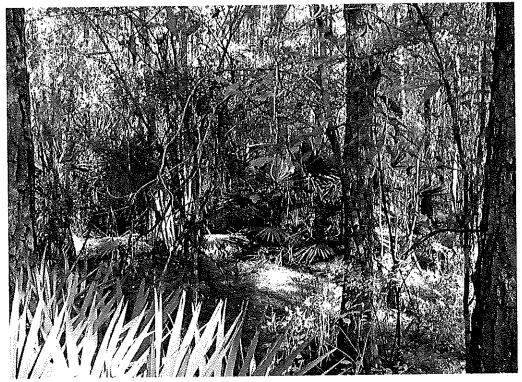
Photograph 18 – View to the north showing a disturbed area along Dipping Vat Road that potentially may be the former location of a cattle dipping vat.

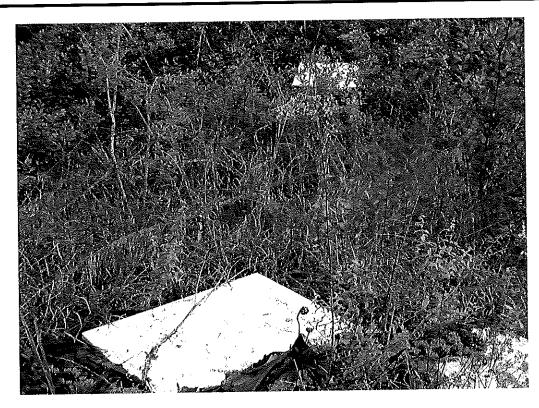
- Trash Dumps Minor amounts of unregulated dumping were observed around the boundaries of the property. As is typical with undeveloped wooded land, small amounts of bottles, cans, and paper trash was observed near the property boundaries. Mattresses, household appliances, and sheet metal were also observed. No signs staining or stressed vegetation was observed in the areas of dumped trash.

Photograph 19 - View to the west showing a trash pile observed along the easement road on the northeastern portion of the property.

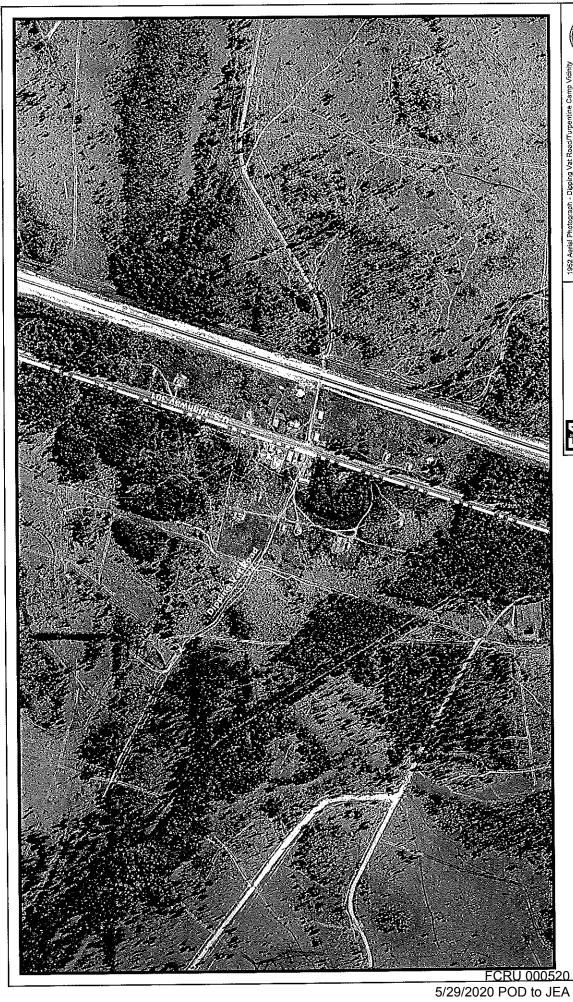
1952 Aerial Photograph Dipping Vat Road and Turpentine Camp Vicinity

- Turpentine Camp A review of historical aerial photographs indicated the presence of several small structures on the east-central portion of the property near U.S. Highway 301 in the 1940s and 1950s. Interviews with members of the on-site hunt club indicated that this was the former location of a turpentine camp. It is not known if turpentine was merely collected from the property or if distillation activities were also associated with the former camp. It is E&A's opinion that the former turpentine camp is a recognized environmental condition and a low to moderate potential threat to the property.
