**TECO's Responses to Staff's Second Set  
of Interrogatories, No. 2.**

**TAMPA ELECTRIC COMPANY  
DOCKET NO. 20220001-EI  
STAFF'S SECOND SET OF  
INTERROGATORIES  
INTERROGATORY NO. 2  
BATES PAGE(S): 1 - 4  
FILED: SEPTEMBER 27, 2022**

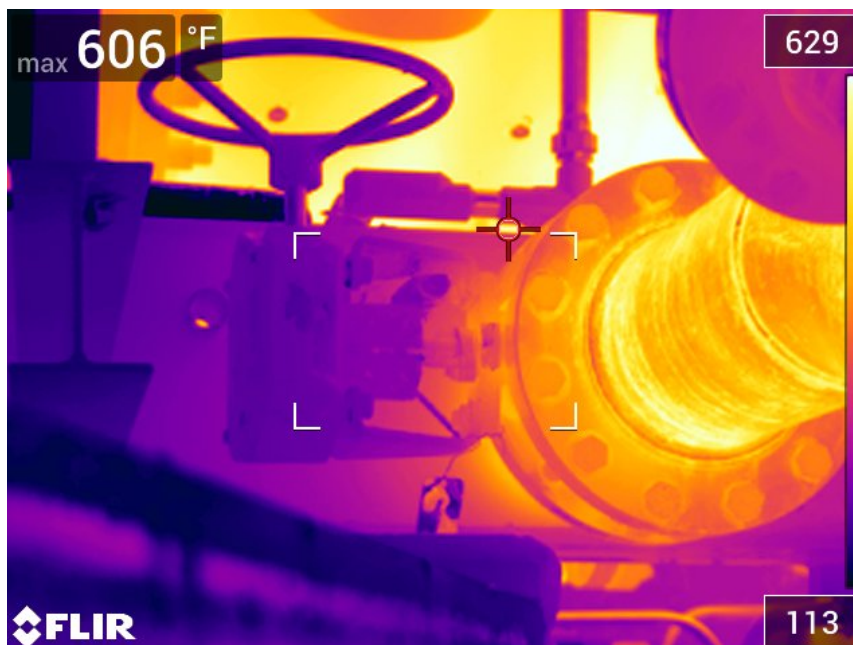
- e. Explain why the labeling of valve WW-23 was burned off from the heat in compartment.
  - f. Explain why the color deviated from the labelling associated with normal water wash practice for valve WW-23.

- d. Yes, Tampa Electric followed its internal maintenance schedule as overhauls were performed based on the monitoring above. Additionally, please see Tampa Electric's response to Interrogatory 2 (c), above.
- e. The heat in the compartment, an enclosed area below the turbine, reach 600 degrees Fahrenheit. Since valve WW-23 is in the vicinity of the combustion turbine casing, the labeling was burned off. The picture below displays the location of the valve and the temperature around it.

- f. A portion of the valve was not fully painted. The valve was painted for full visibility from the most common entry point to the compartment. When personnel enter the compartment from an unusual and more difficult access point, the water wash labelling was not apparent. Hard permanent field tagging is being implemented to ensure visibility regardless of the entry point into the compartment.
