FPL's Response to OPC's First
Production of Documents Nos. 4-5

Power Delivery Performance

Hurricane Irma

Report Date: April 19, 2018

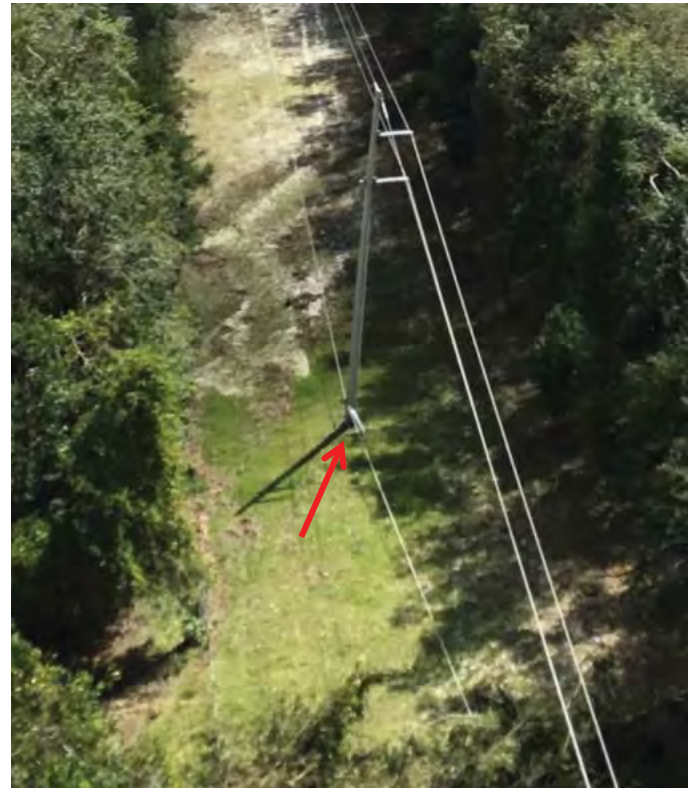
Structure 55R13A – Broken insulator

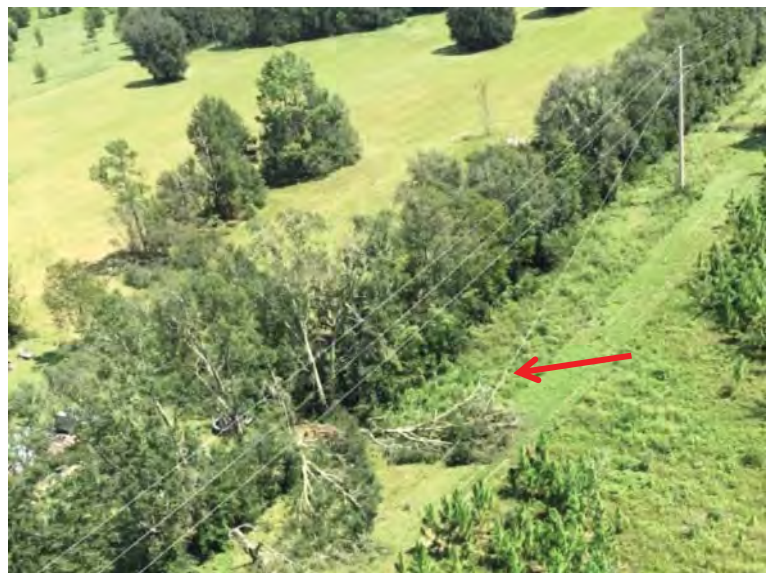
Structure 112R1 - Wire down due to vegetation

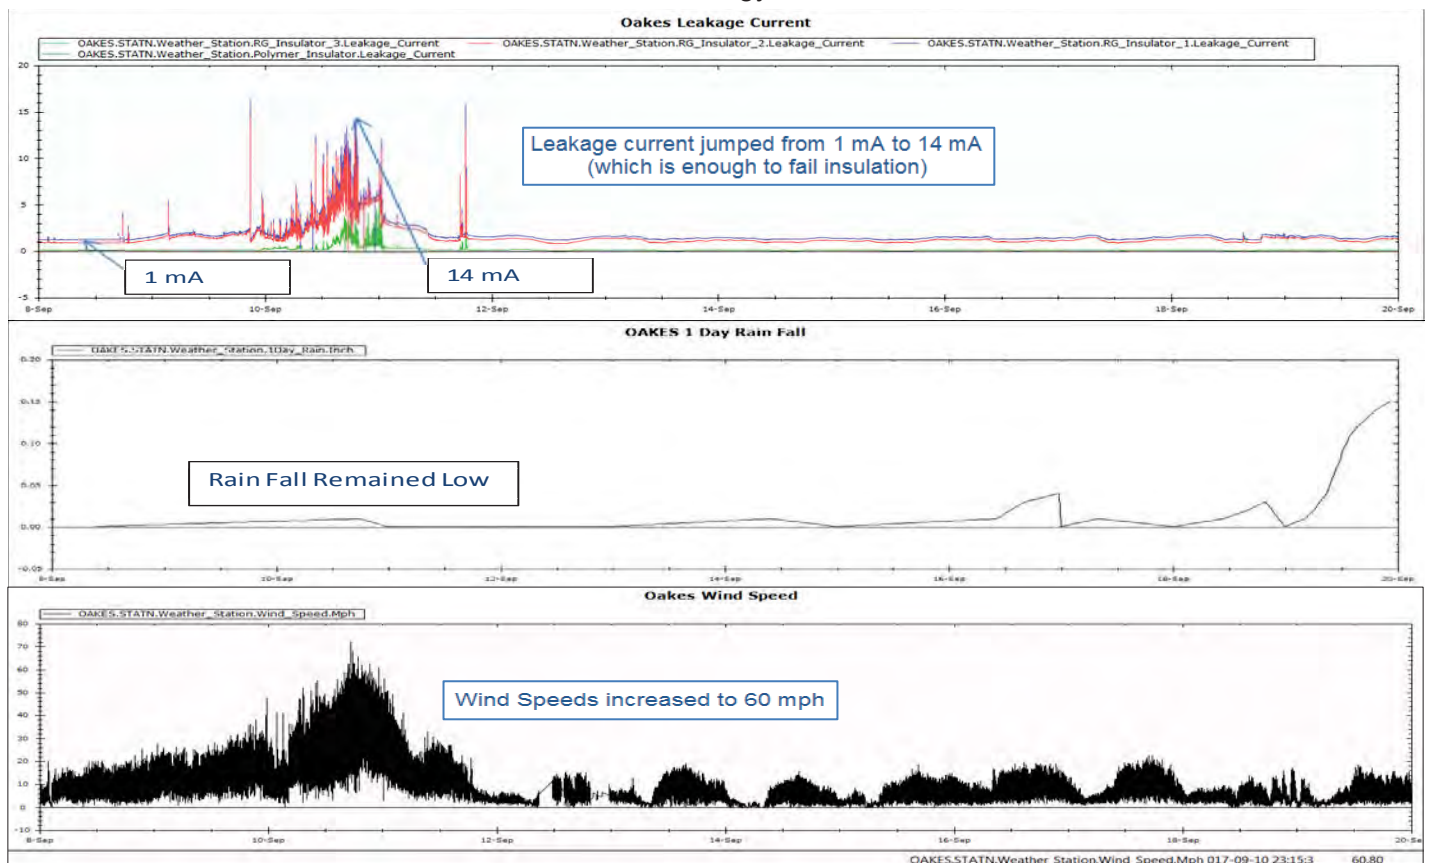
Above shows high winds and little or no rainfall caused contamination and increased leakage current to damaging levels.

Data from the remote contamination monitor shows the pre-storm leakage current and the increase in leakage current as the storm winds blow salt contaminants onto the test insulators. The vertically mounted RG insulators measured 1.2 mA of leakage current pre-storm with the highest level of 31.2 mA achieved prior to the monitor being de-energized. The horizontally mounted polymer insulator had a similar increase signature starting at 0.18 mA and reached a maximum high of 25.2 mA. This data confirmed that the insulation system was clean pre-storm and the buildup was seen as the storm moved across the stations. The test insulators were de-energized and stopped supplying data when the Hutchinson Island #2 line was de-energized.

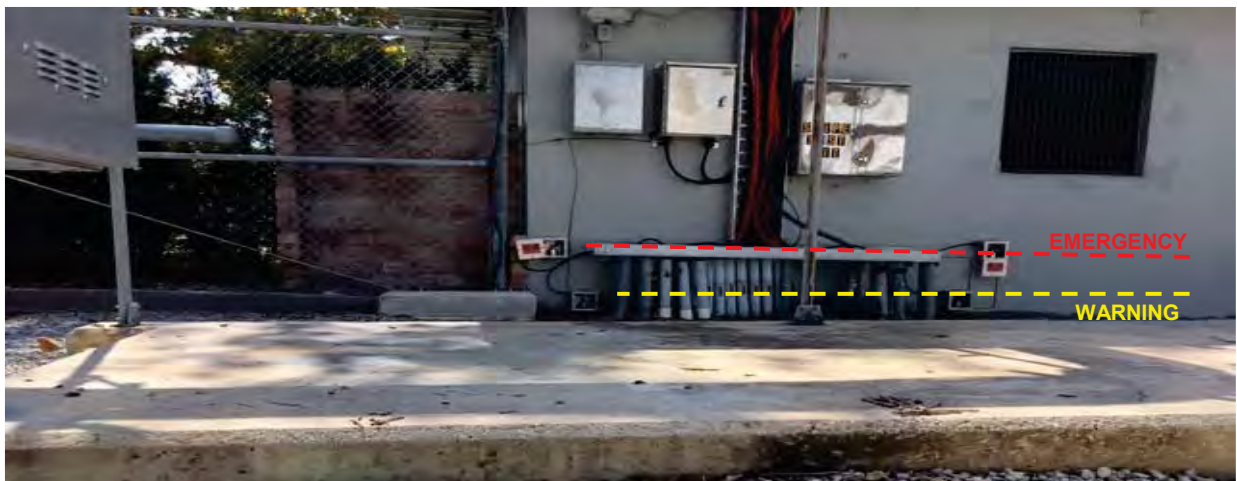
Date Time EST ^	Station	Event	Src
09/11/2017 06:57:28	South_Daytona	Statn Flood_Monitor Warn Normal	T
09/11/2017 02:27:42	South_Daytona	Statn Flood_Monitor Emrg Alarm	T
09/11/2017 01:22:02	South_Daytona	Statn Flood_Monitor Warn Alarm	T
09/11/2017 01:21:51	South_Daytona	Statn Flood_Monitor Warn Normal	T
09/11/2017 01:21:26	South_Daytona	Statn Flood_Monitor Warn Alarm	T

South Daytona Substation and Flood Warning Monitors

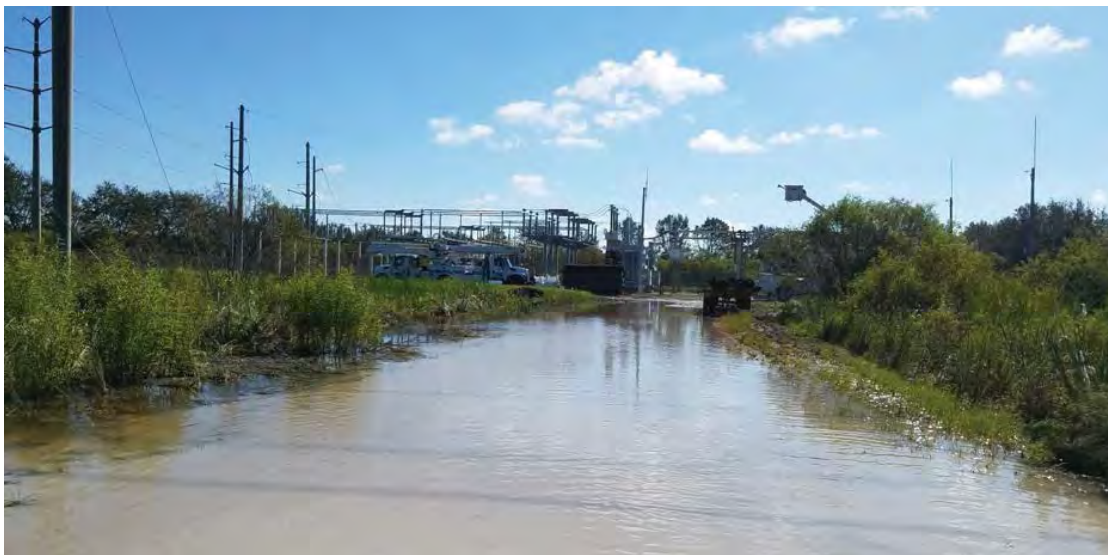
Corkscrew Access Drive

Corkscrew Substation Rain Event Flooding

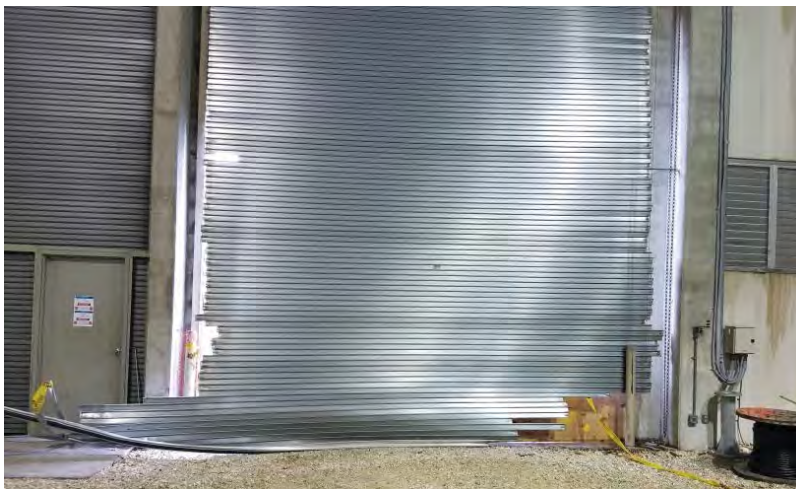
Watkins Substation – Overhead Door

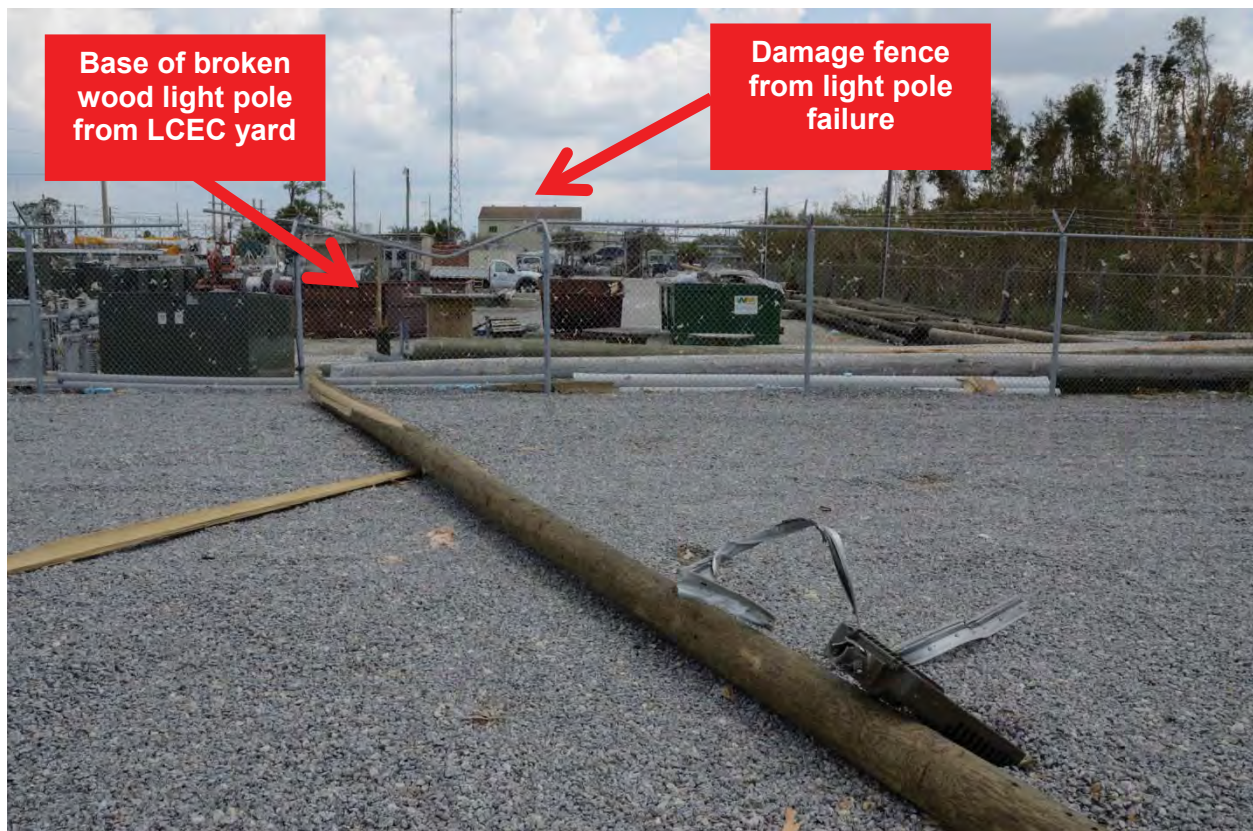
Large debris found in substation (part of shed and wood light pole from LCEC yard).

Switch jumper was damaged/disconnected due to debris from LCEC.

Station and fence performed well even with the large debris impact. Station and fence were designed to FPL current design criteria.

Belle Meade Substation (Looking East) adjacent to LCEC yard (Lee County Electric Coop)

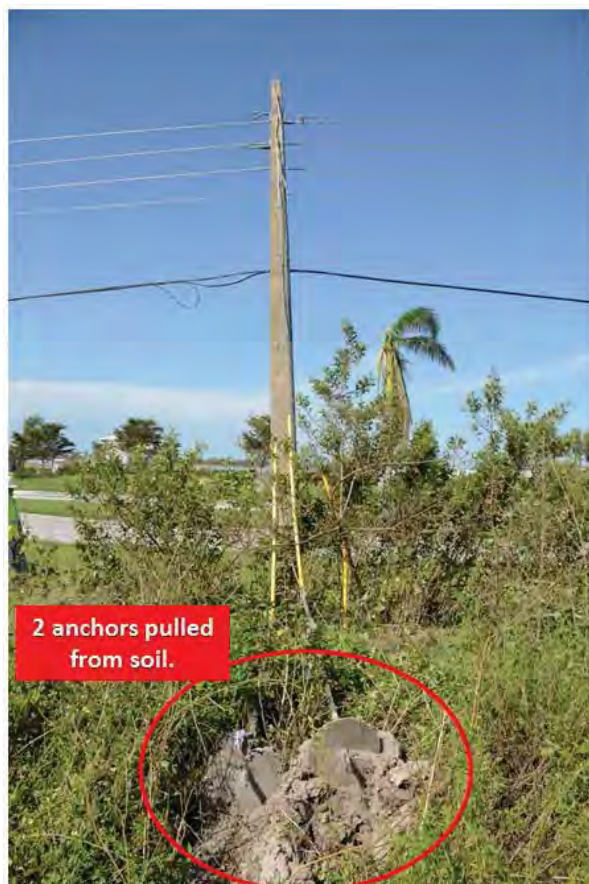
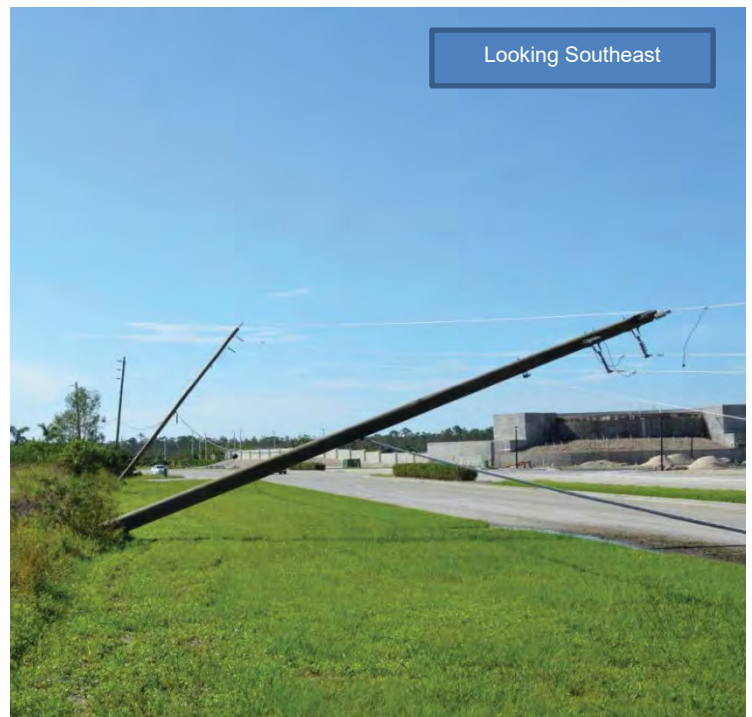
The anchors on the structure at the northern end of the failure pulled out of the soil. The anchors were set in a berm with a small pond behind. No extensions were utilized on the anchors. The shallow installation depth into a berm would significantly reduce the holding capacity of the anchor particularly in saturation soil.

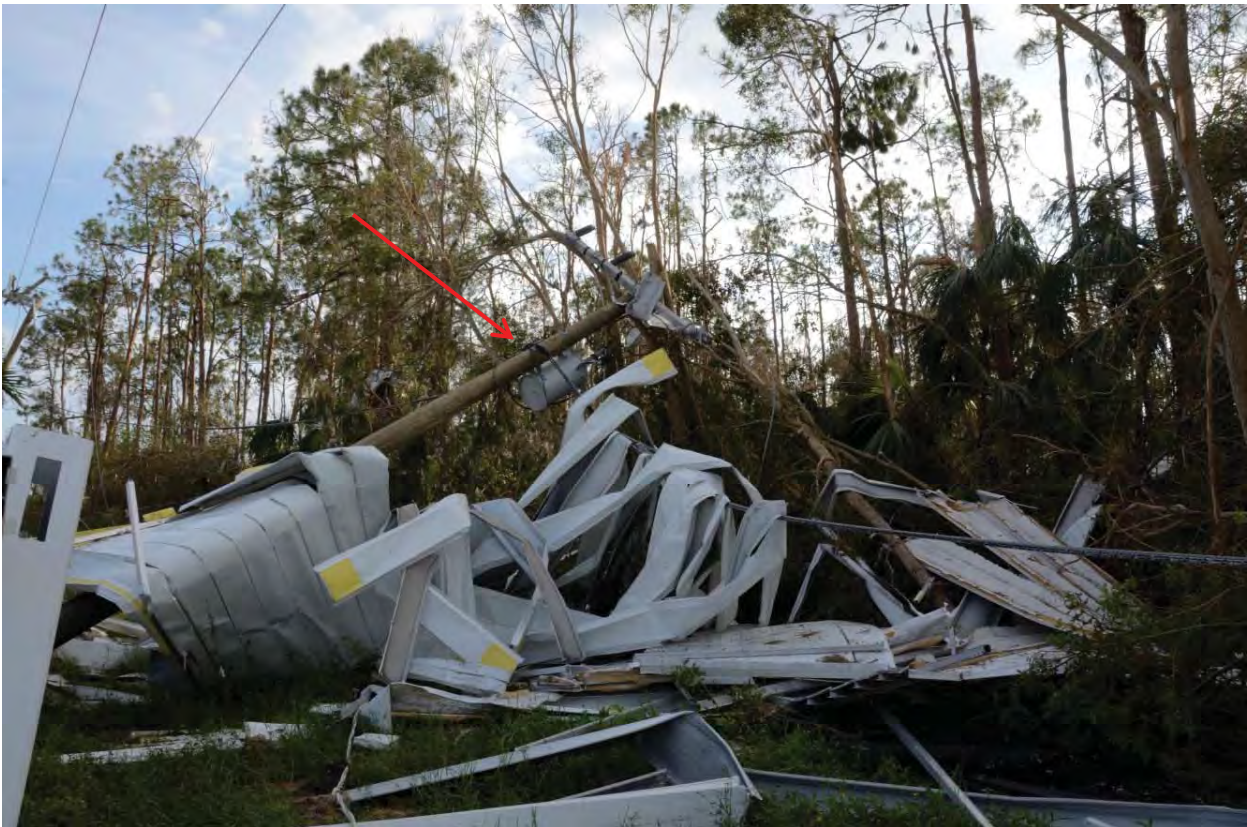
Pole down with transformer in West area due to trailer park debris

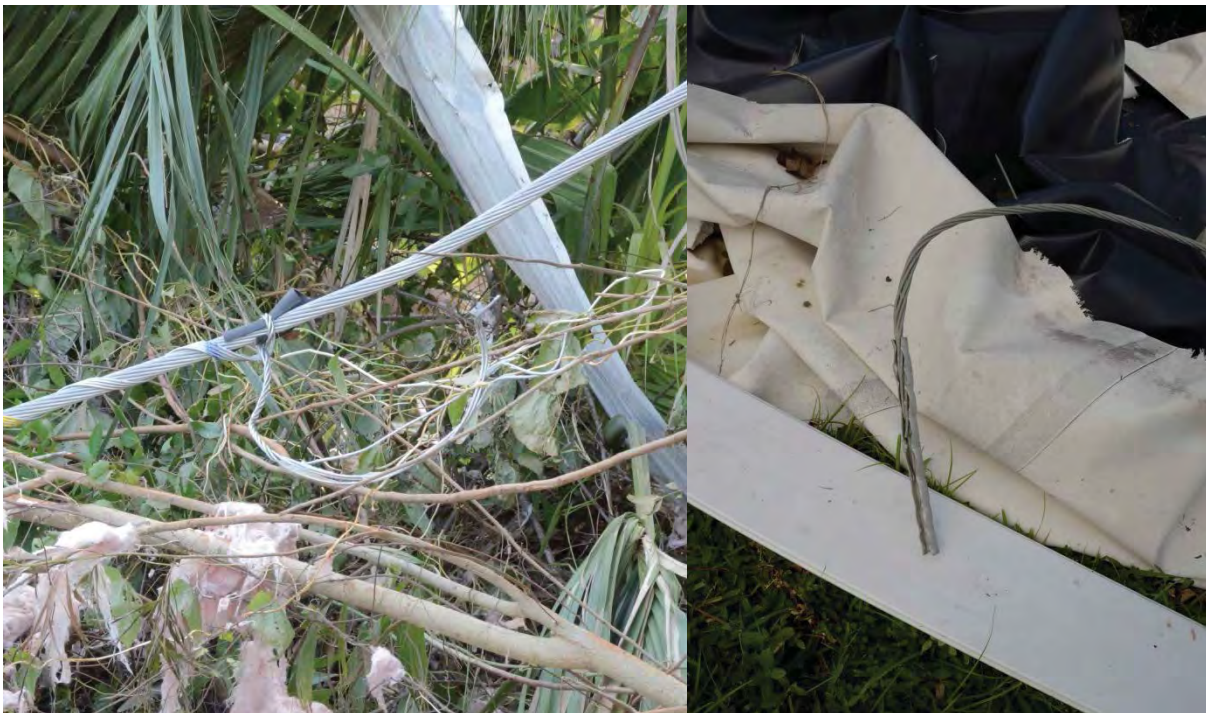
Insulator tie and failed splice. Below: ALS out of support and on ground

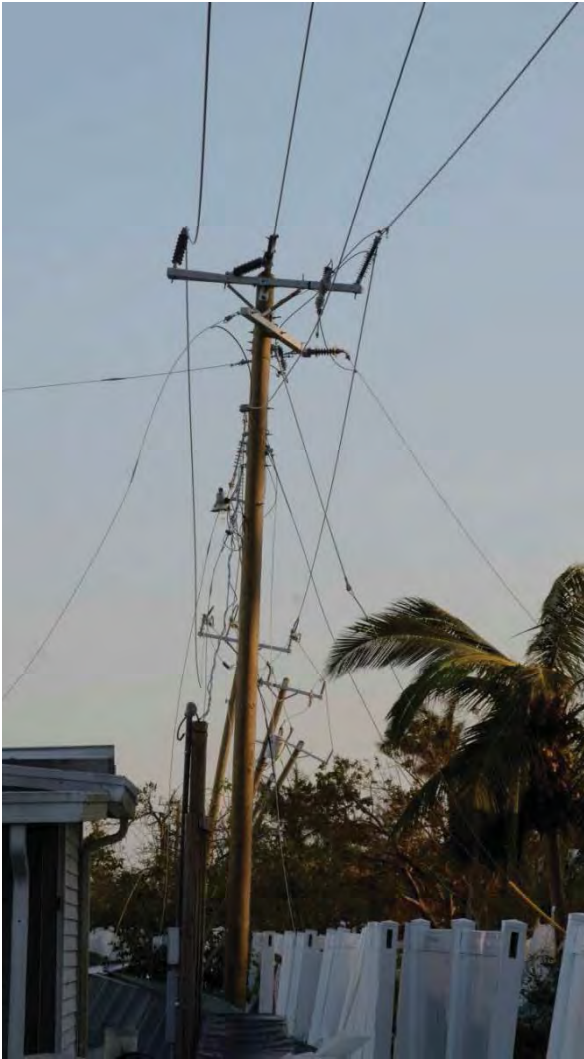
View of leaning poles

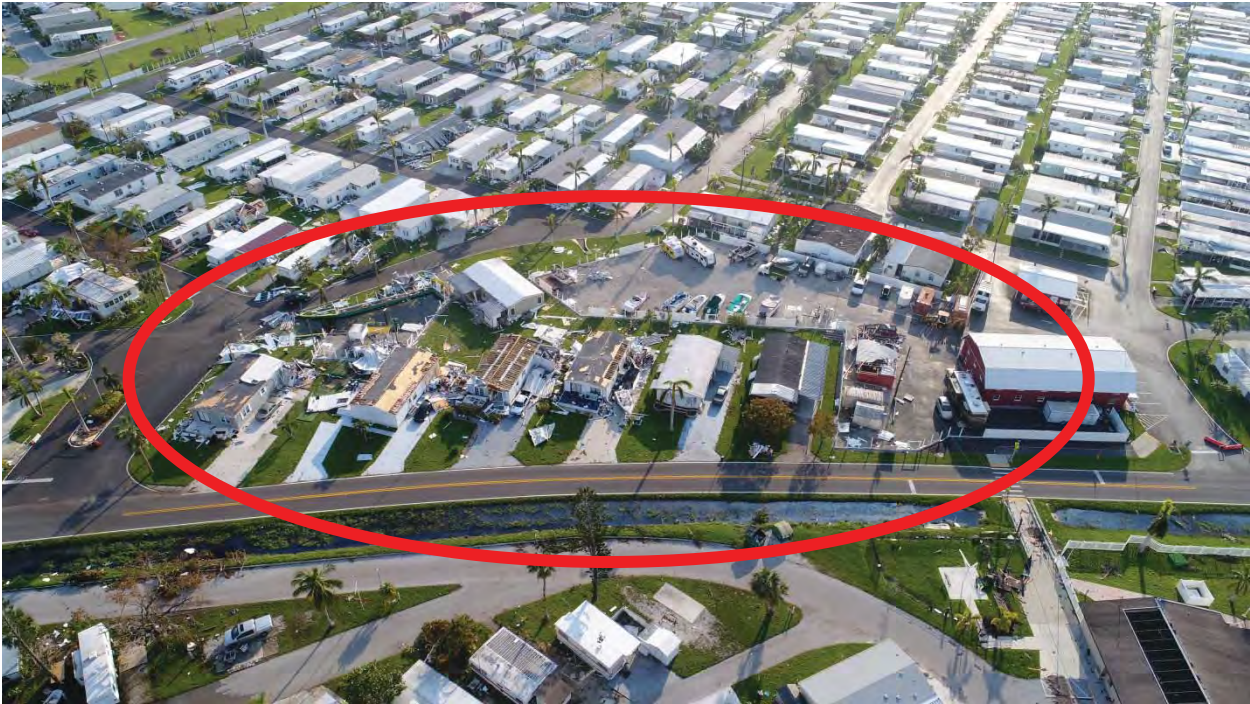
Area of concentrated damage, looking west.

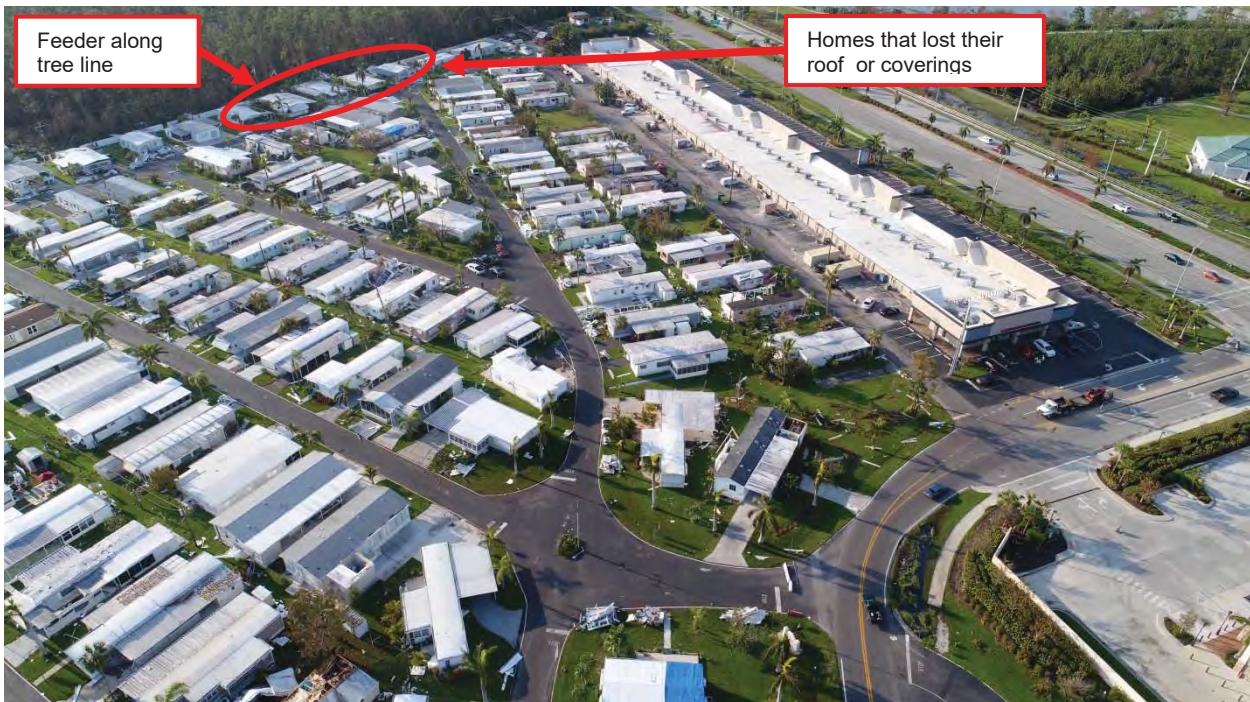
Looking northwest through the trailer park toward the feeder

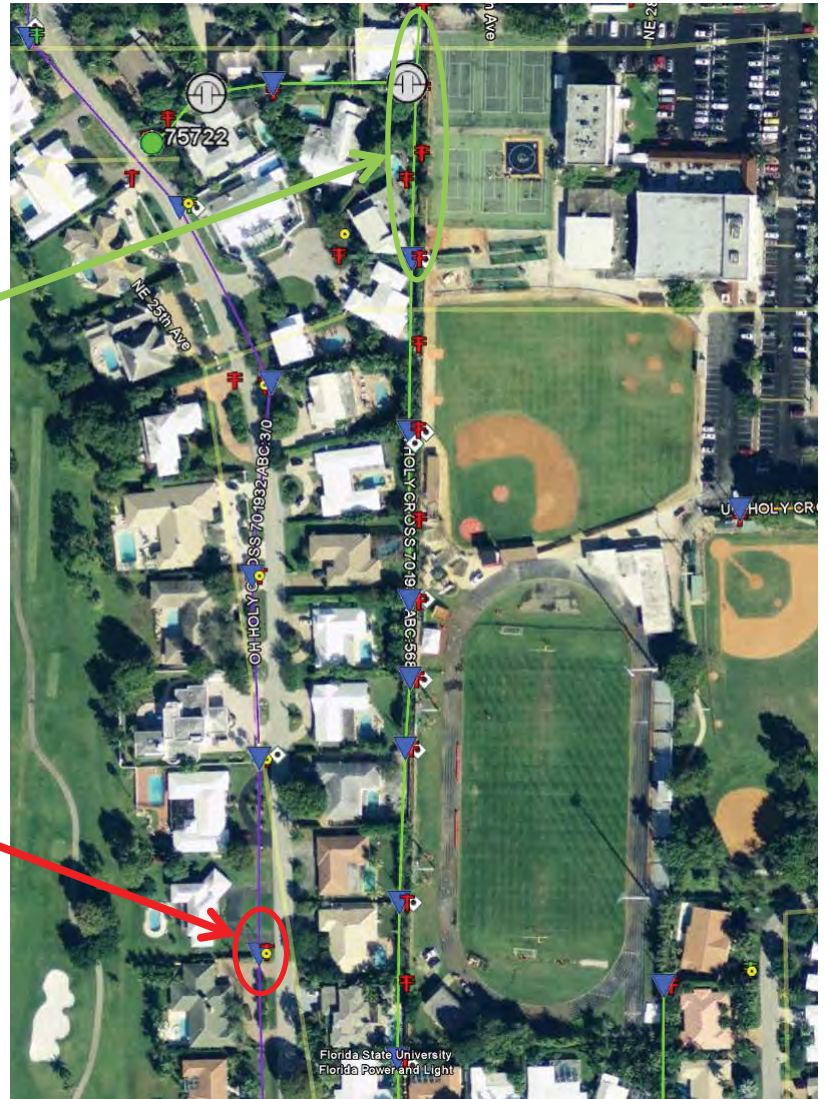
- Slightly leaning in rear of due to wind

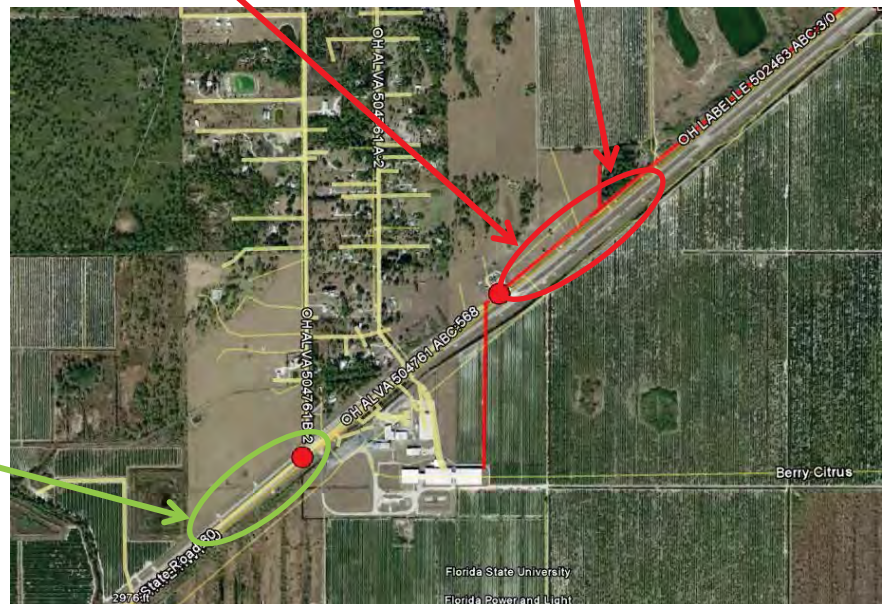
- Section of wood hardened poles that were unaffected by the storm. These poles were not leaning and showed no signs of any damage.

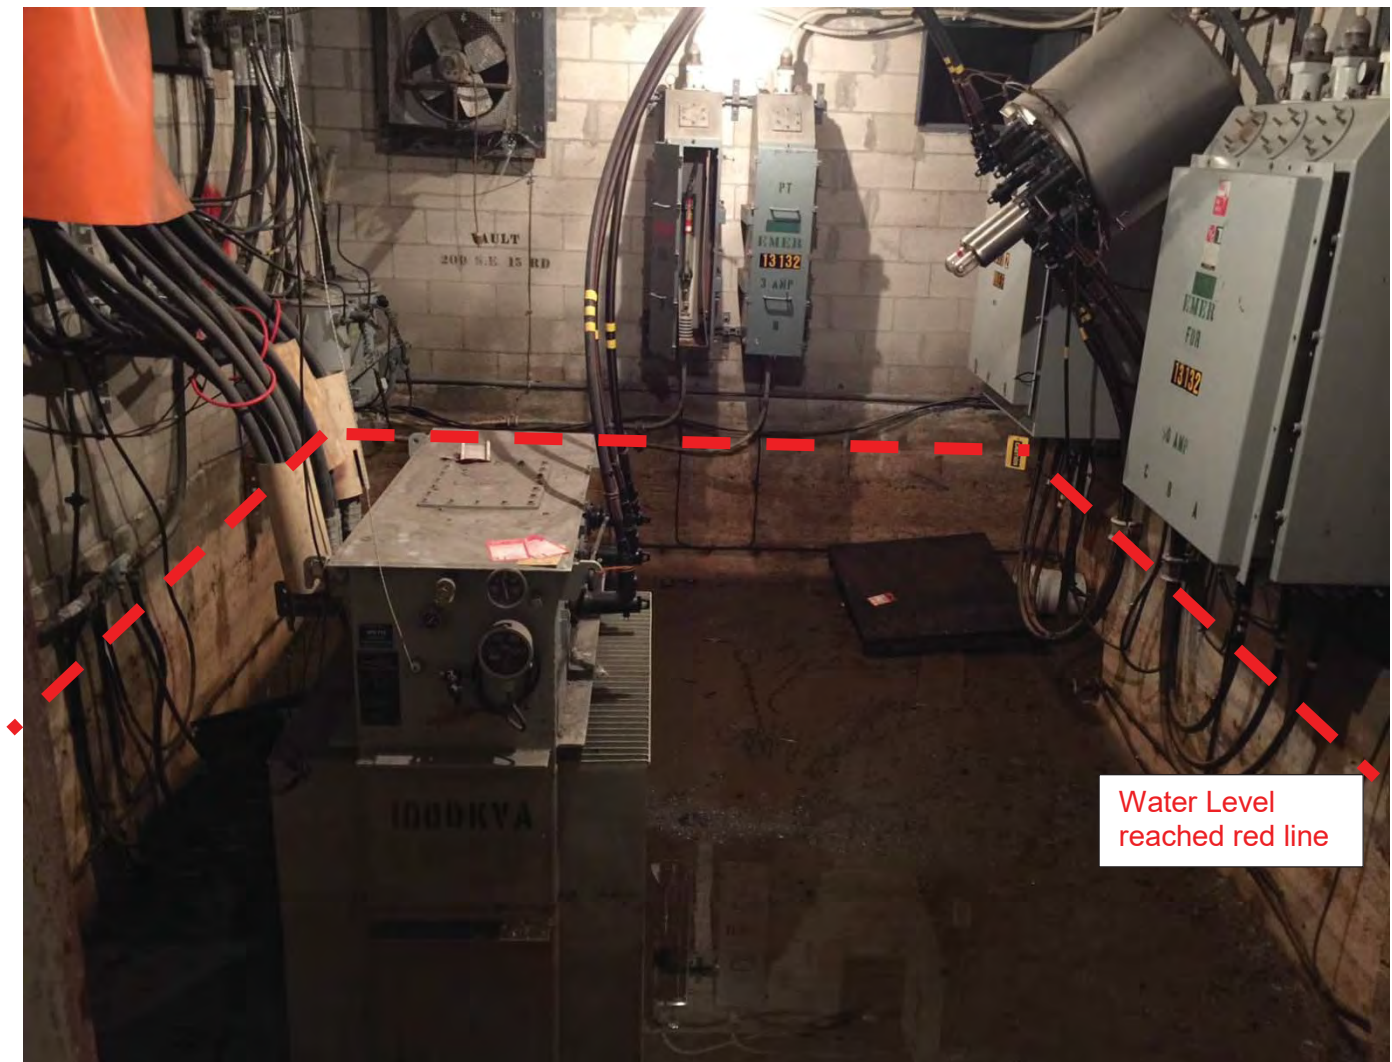
Below is one of the vaults after the water was pumped out (200 SE 15th Road, 8VC13102.) It is the vault for Brickell Harbour, which is a subgrade vault. The water level (noted by the red line) never reached the spades of the transformer nor the bottom of the fuse cabinets, so it remained in service. Actually, none of the flooded network vaults lost power because of Hurricane Irma.

Subgrade Vault for Brickell Harbour

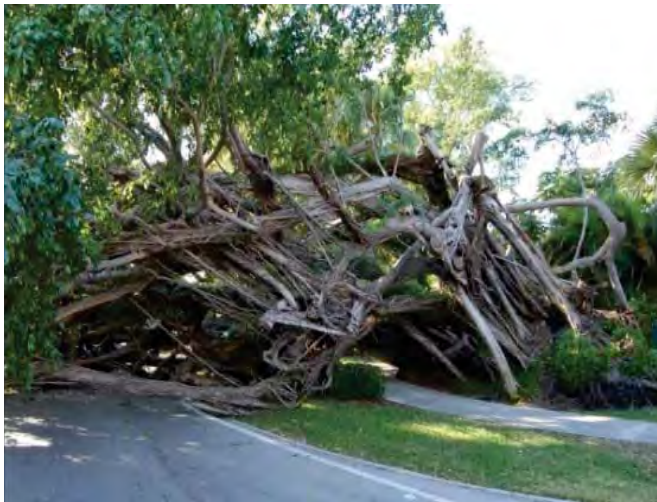
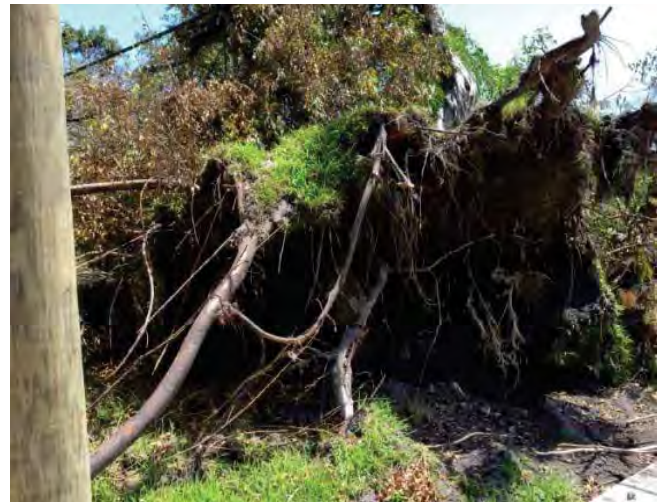
Pictures above:
Large, mature ficus trees topple over due to massive tree canopy with shallow root systems

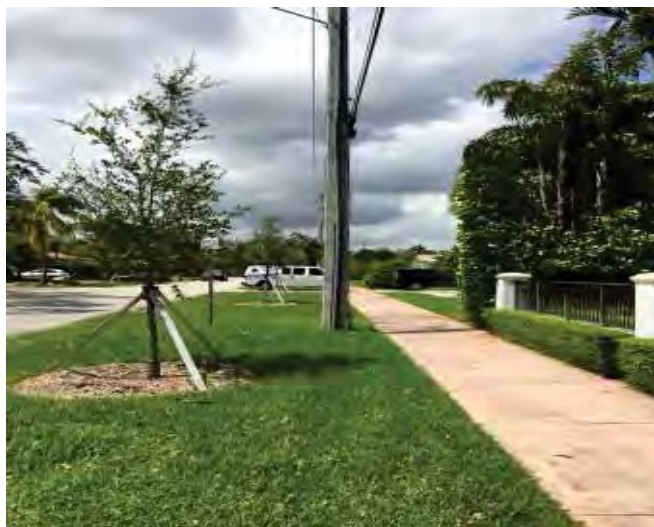
Pictures to the right:
Young canopy trees (i.e. oak) and palms planted in the wrong place and will impact facilities in the future

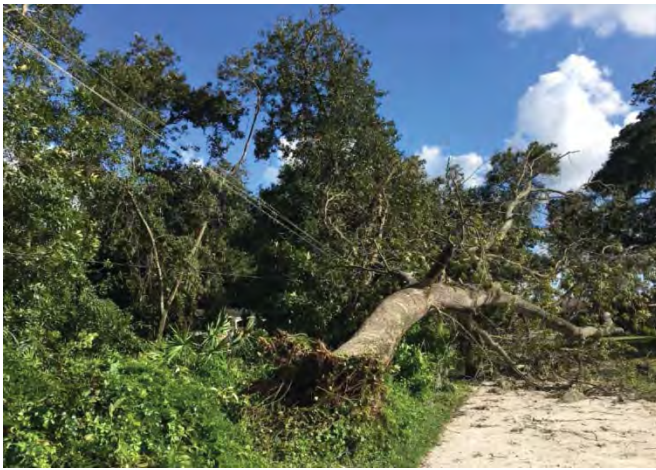
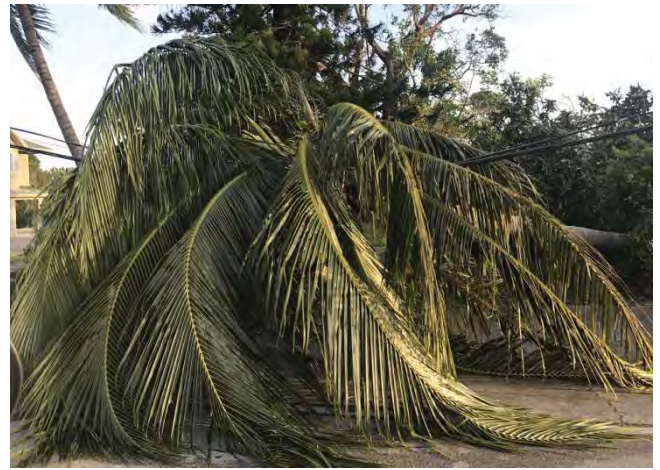
Large trees and palms topple over onto from outside the utility trim zone

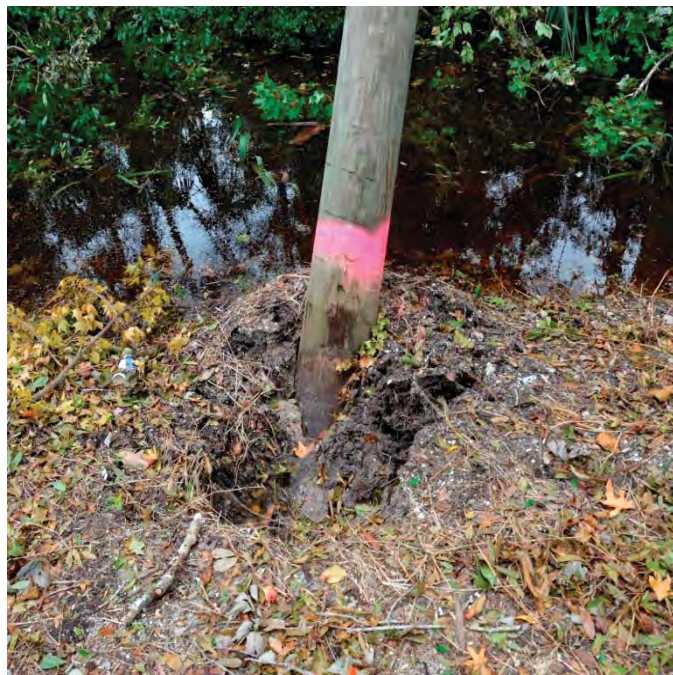
The poles that were leaning the most had soft soil foundations. The rain from Hurricane Matthew saturated the soils so that the foundations failed before the poles did when the trees came down and broke the wire.

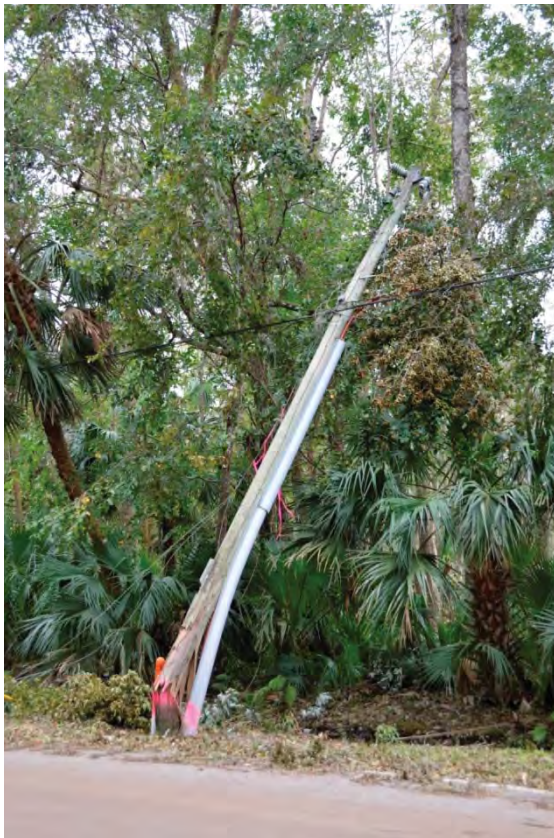
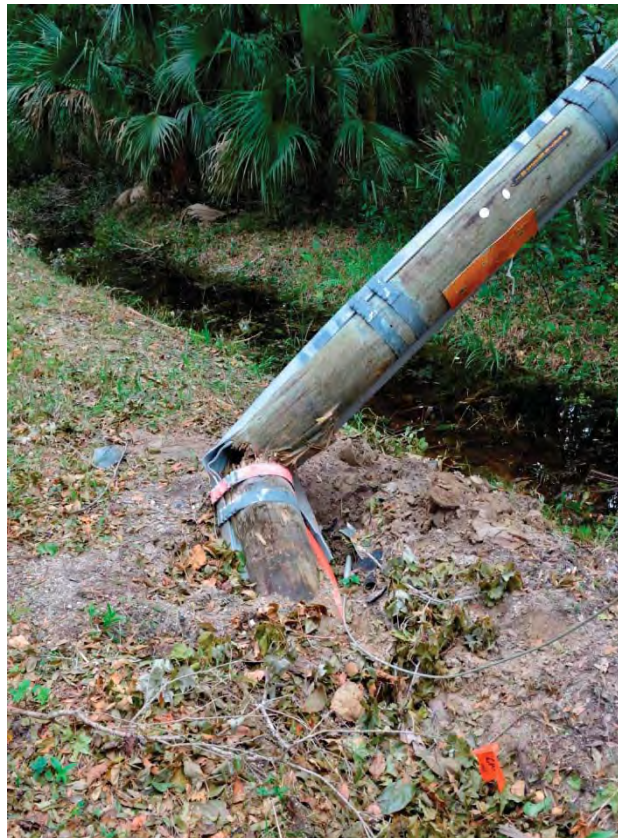
The poles that failed had varying factors that caused the failure. All failed at or just above ground line. The root cause of the pole failures were the tree failures.

Overall, the structures performed well given the loading placed on them by the tree failures.

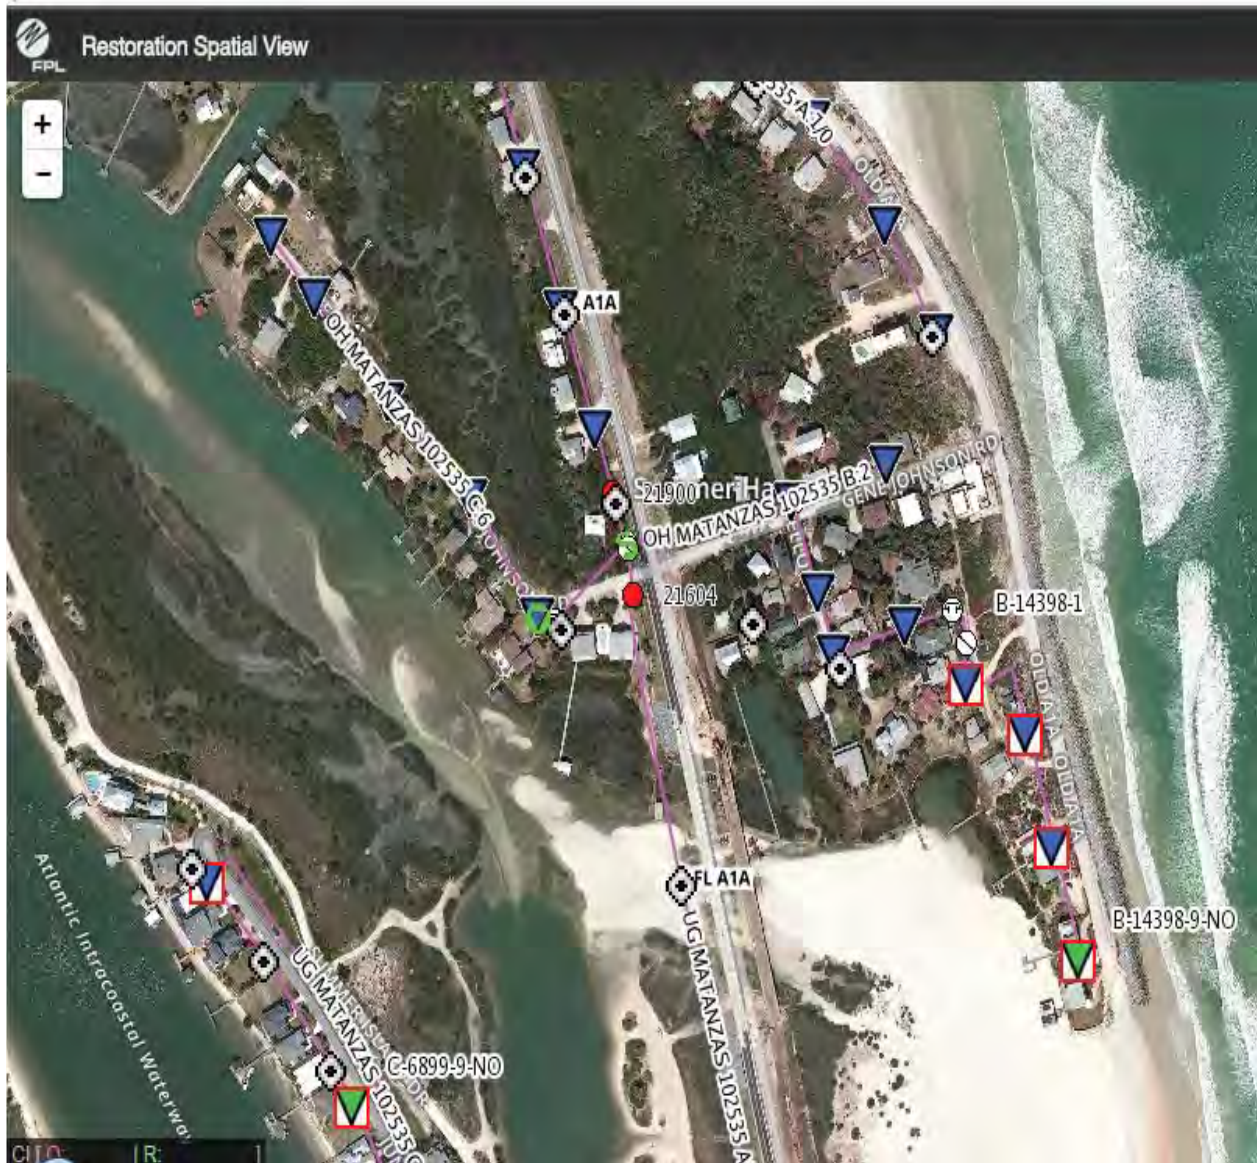
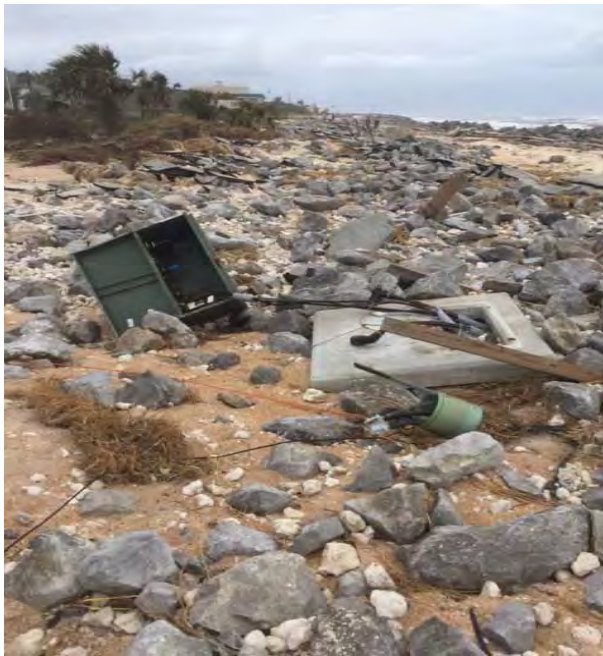
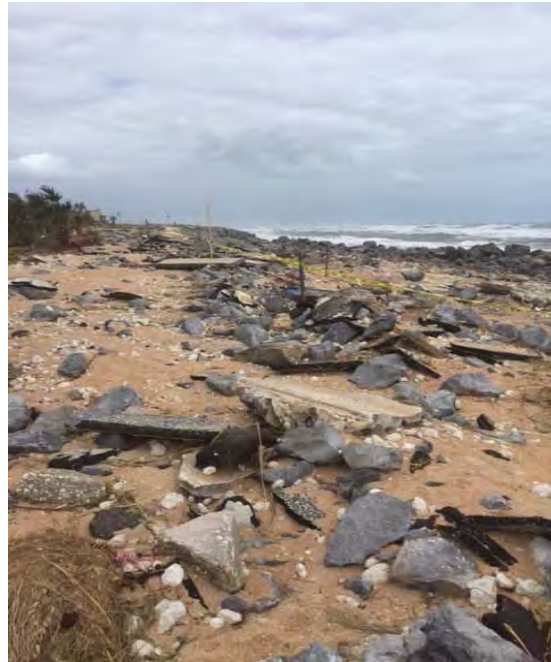
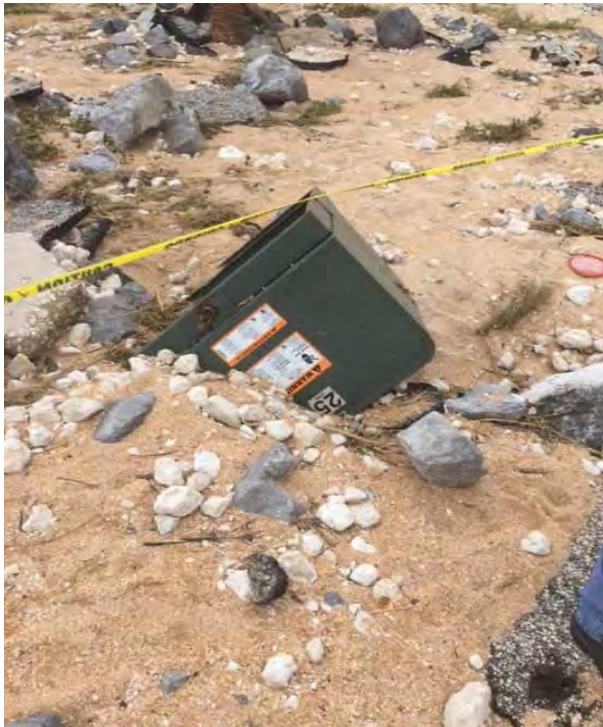
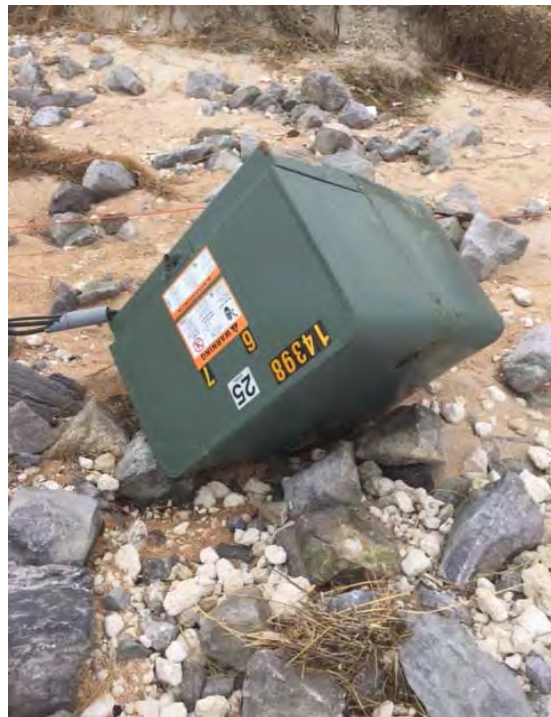
Matanzas Inlet is located just south of St. Augustine. The pad mounted equipment experienced severe effects of waves and scouring which resulted in the catastrophic failures of the equipment shown below. This type of failure can lead to extended restoration times.

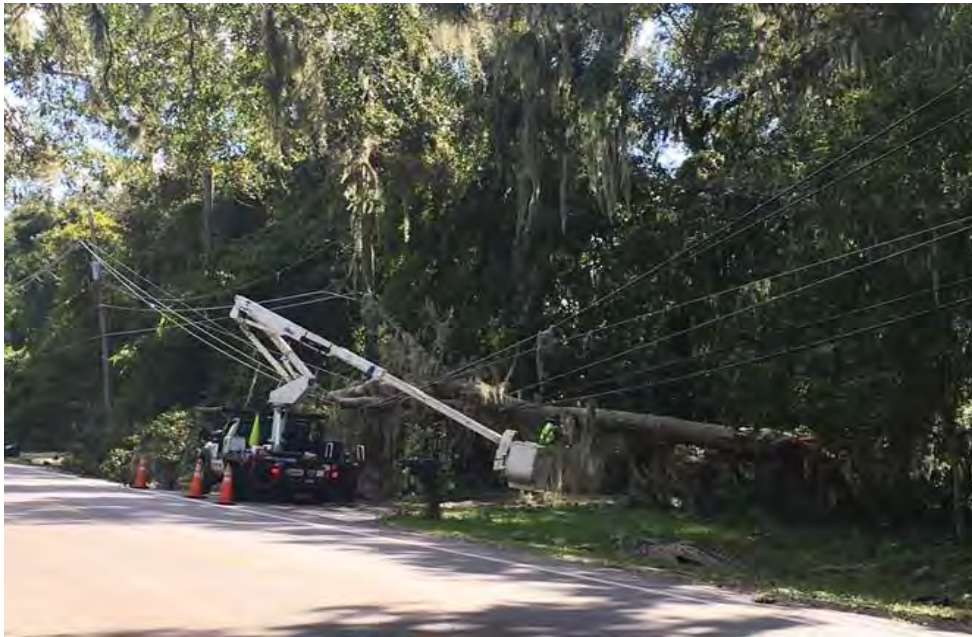
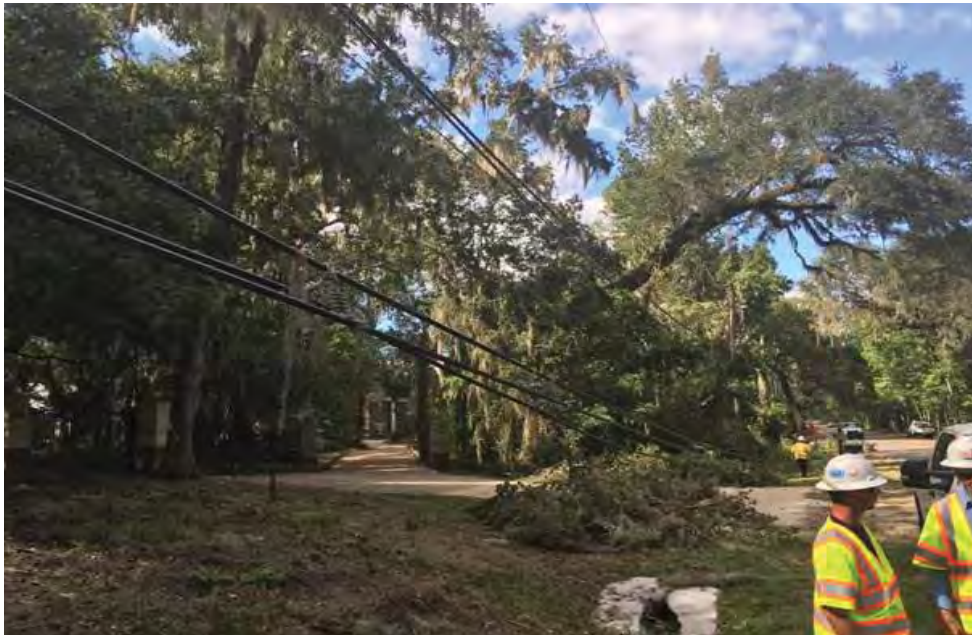
Riverton 5761 experienced heavy winds and related tree damage. There were 4 areas each with multiple spans of Hendrix cable down or broken, 4 damaged/down poles (veg related), 20+ locations of vegetation and ~5 locations of broken Hendrix brackets/spacers. 12 line crews were engaged (around 50 line personnel from three different companies) and a sufficient amount of vegetation crews. This case is on SR 13 - scenic road along the St. John's River
