**Before the
Florida Public Service Commission
Docket No. 970261-EI**

**PRELIMINARY
CRYSTAL RIVER UNIT 3 OUTAGE REVIEW**

**Direct Testimony of
WILLIAM K. JACOBS, JR., Ph.D.**

**On Behalf of
THE FLORIDA OFFICE OF PUBLIC COUNSEL**

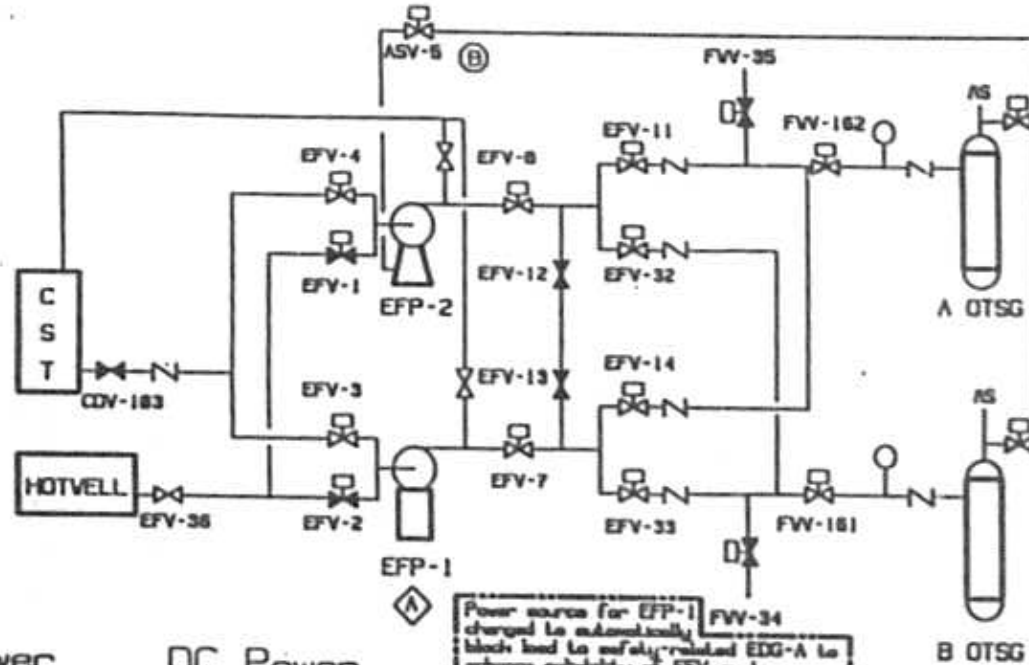
Configuration #2 - EFP-1 Auto Connected to EDG-A (July 1980)

Power source for EFP-1
 changed to automatically
 block load to safety-related EDG-A to
 enhance reliability of EFM system
 (VAR79-11-82)

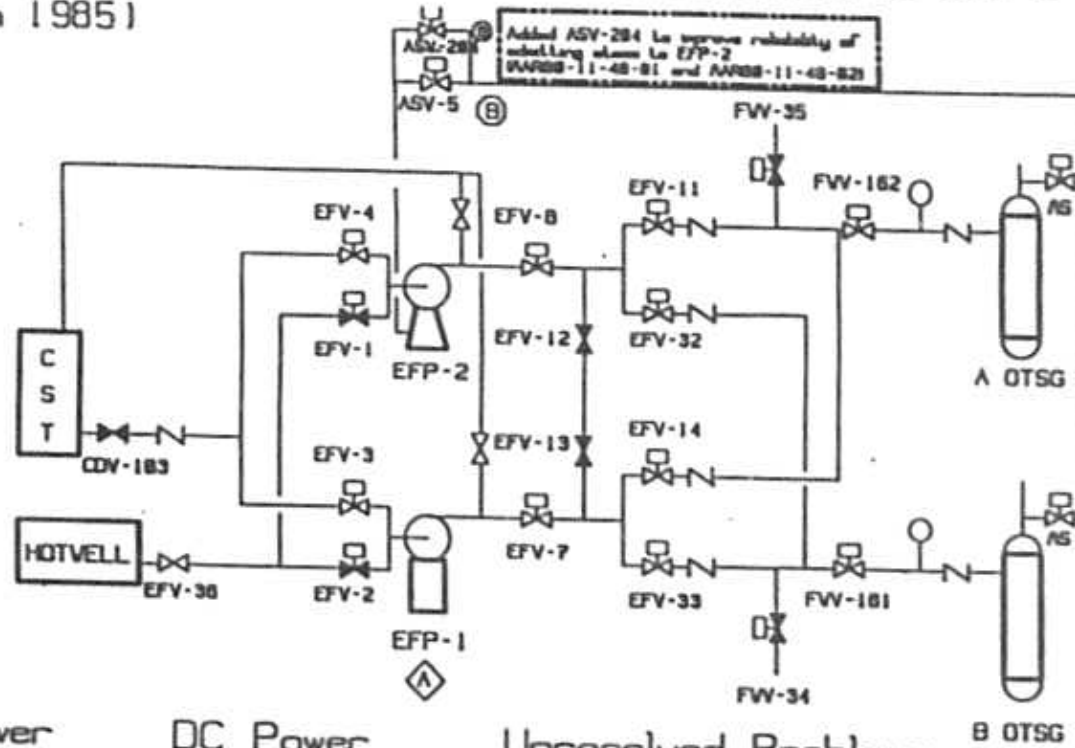
Configuration #3 - Valve ASV-204 Installed Parallel to ASV-5 (March 1985)

Unresolved Problems:
Previous Problems 2-1, 2-2 not addressed

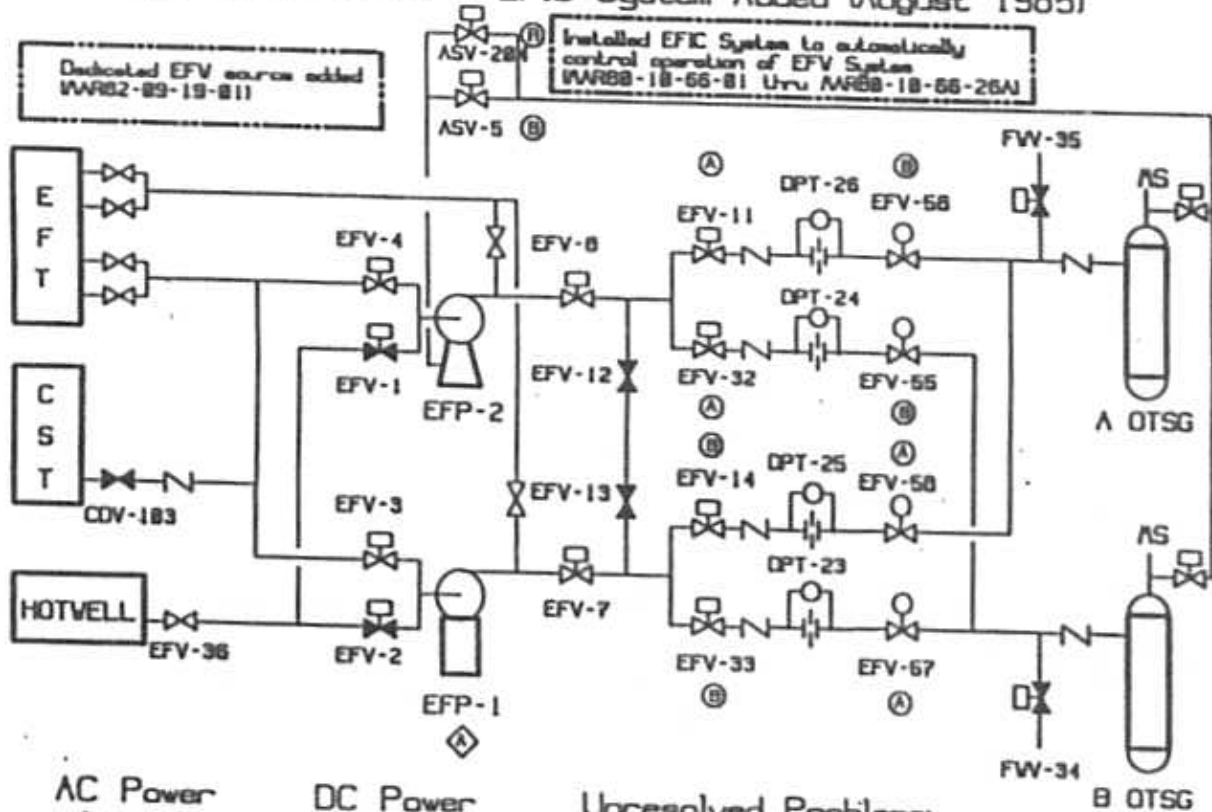
Configuration #4 - EFW System Added (August 1985)

Dedicated EFV source added
 WWR82-89-19-811

Installed EFW System to automatically
 control operation of EFW System
 WWR88-18-66-81 Uru WWR88-18-66-26A

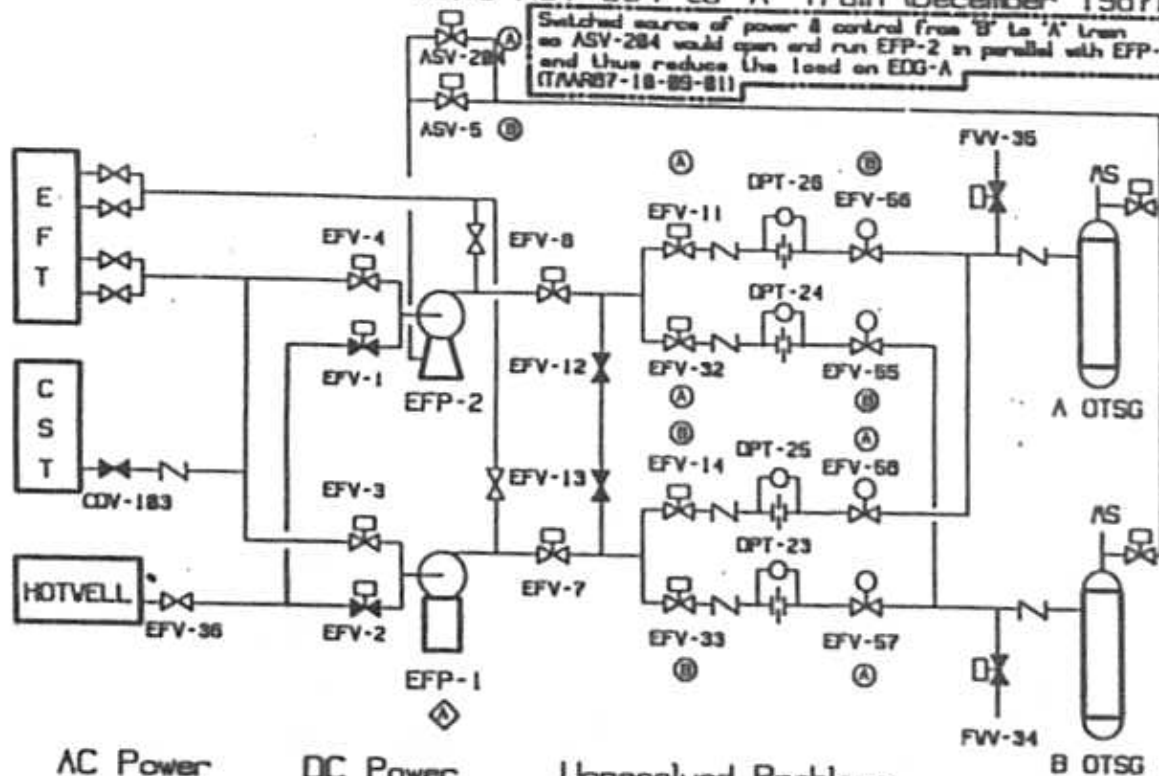
Configuration #5 - Switched Source of Power & Control for Valve ASV-204 to 'A' Train (December 1987)

Switched source of power & control from 'B' to 'A' Train as ASV-204 would open and run EFP-2 in parallel with EFP-1 and thus reduce the load on EDG-A (T/MAR87-18-89-811)

Unresolved Problems:

- 2-2, 4-1 Previous problems not addressed
- 5-1 Cross-train dependency
- 5-2 Cycling of block valves to control OTSG level
- 5-3 Benefits of flow limiting change in Conf #6 negated by this change

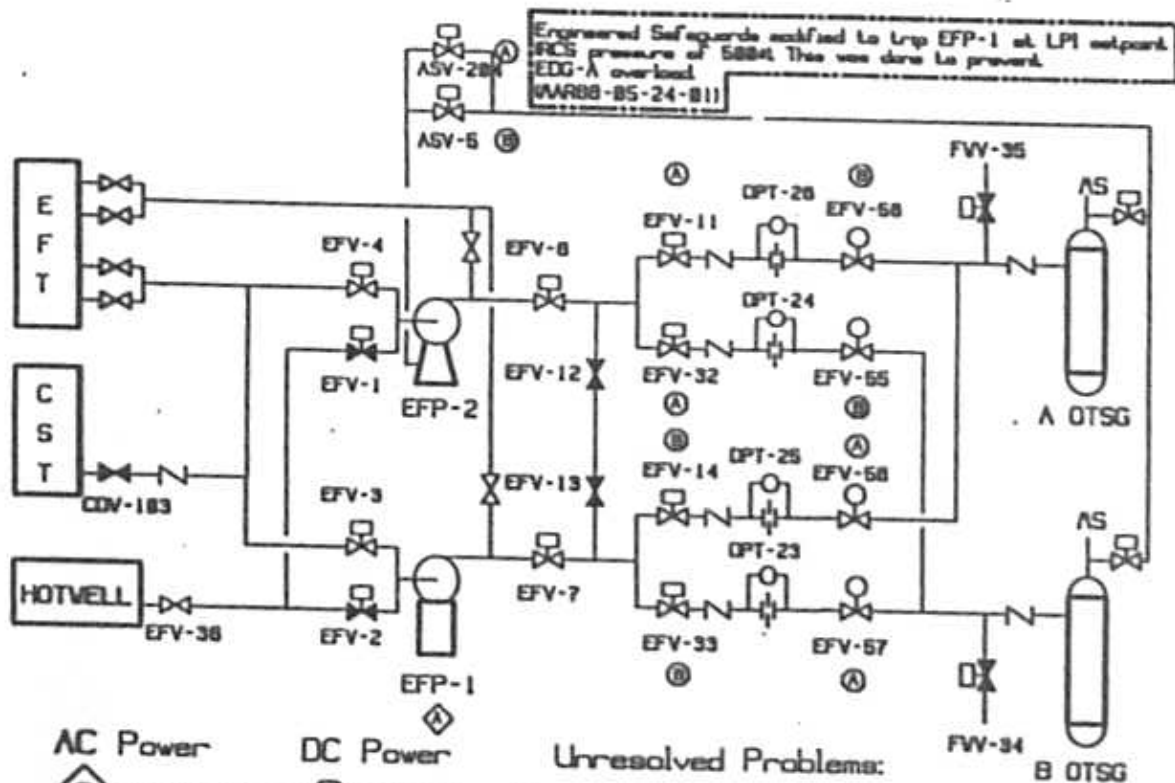
Configuration #7 - EFP-1 Tripped When LPI Pumps Auto Start
(June 1990)

Unresolved Problems:

2-2, 4-1, 5-1, 6-1 Previous Problems not addressed

7-1 Cross-train dependency on EFP-2 if insufficient EDG-1A margin to restart EFP-1 when needed

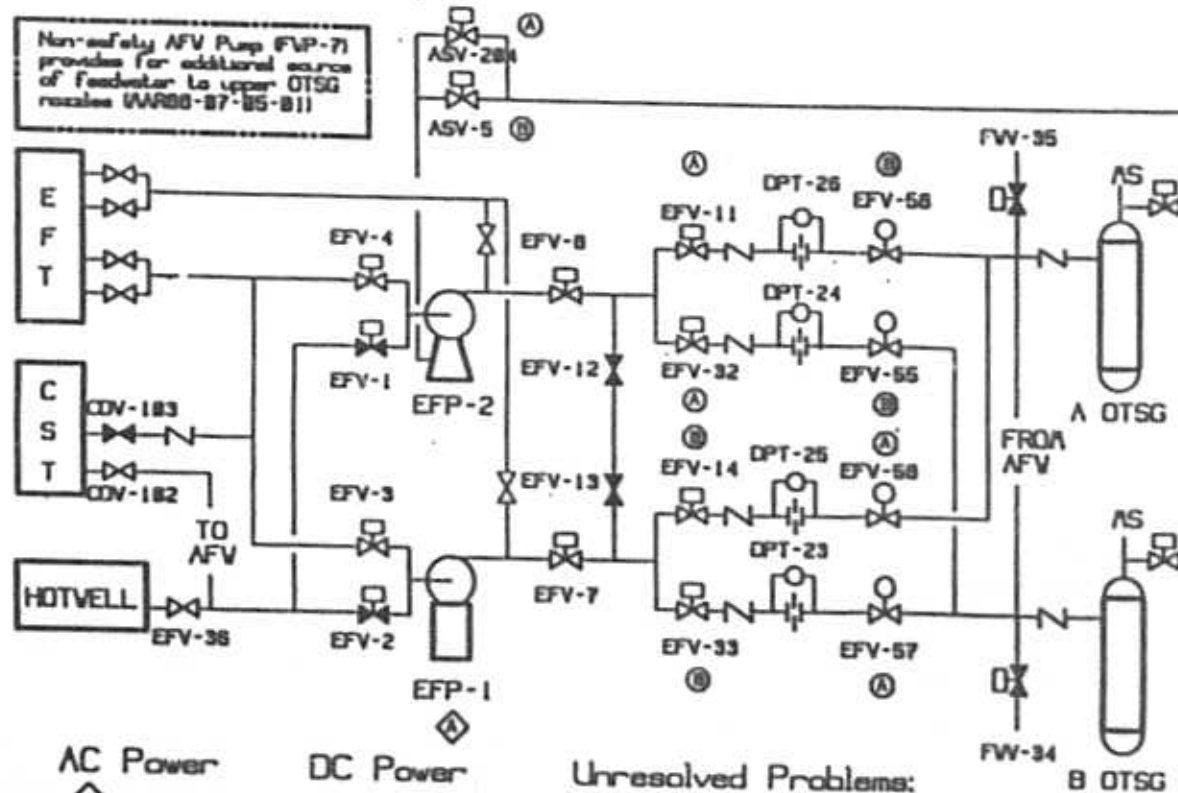
Configuration #8 - Addition of Auxiliary Feedwater System (AFW)
(April 1993)

Non-safety AFV Pump (FVP-7) provides for additional source of feedwater to upper OTSG nozzle (WAB8-87-85-811)

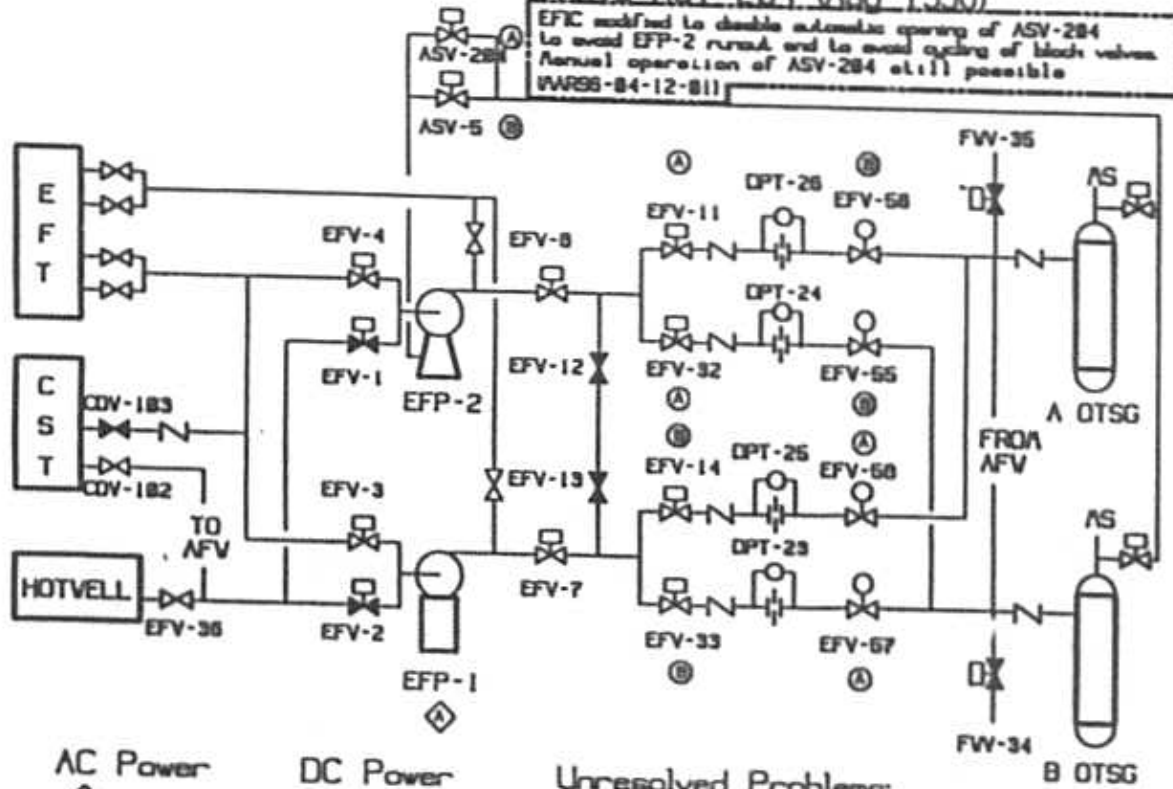
Configuration #9 - Disabled Auto Opening of
 Valve ASV-204 (May 1996)

Problem 9-2: This modification did not account for the fact that EFW may be needed below 500 psig during a LOOP when EFP-1 is tripped (see Configuration #7). This created an unanalyzed condition in that EFW would not be available for removal of decay heat below 500 psig.

EFIC modified to disable automatic opening of ASV-204
 to avoid EFP-2 runoff and to avoid cycling of block valves.
 Manual operation of ASV-204 still possible
 WARS-84-12-811

- Unresolved Problems:
- 2-1, 6-1, 7-1 Problems not addressed
 - 9-1 EFP-2 reliability reduced
 - 9-2 Unanalyzed condition created with no EFW below 500 psig
