Re: Indianwood Development Corporation  
v. Indiantown Company, Inc.

**Docket No. 990173-W/S  
Filed: February 12, 1999**

INDIANTOWN COMPANY/INDIANWOOD  
INDIANTOWN, FLORIDA

INDIANWOOD SUBDIVISION DEVELOPMENT  
OBSERVATION AND EVALUATION  
OF WATER AND  
WASTEWATER FACILITIES

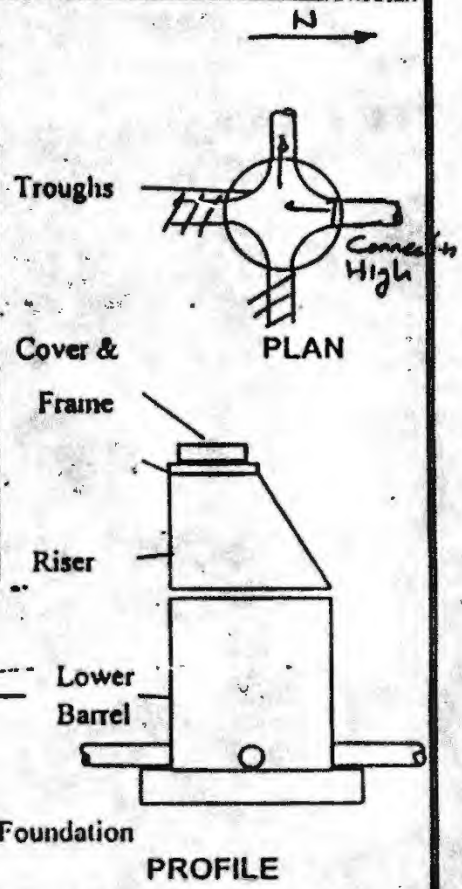
City Indiantown | Location Indianwood Sub. | Inspection by: RMS/SJD  
 Date: May 5, 1998 | Day: Tuesday | Time: 1:00 AM/PM  
 Location: MH 7B | Zone: \_\_\_\_\_  
 Inspector: RMS/SJD | Weather: Clear & Hot | Temp: 80° F

Item	Construction Material	Condition
COVER	Cast Iron (Vulcan Y-1344-I Type)	Good
FRAME	Cast Iron	Good
CHIMNEY	Brick and Mortor	Good
STEPS	None	
CORBEL WORK	None	
RISER WALLS	Concrete	Good
BARREL WALLS	Concrete	Good
BENCH	Concrete	Good
TROUGHS	Concrete	Good

**Manhole Cover:**  
 No. of Holes 0 | Size of Holes: 0  
 Depth of Manhole: 99" +/-  
 Depth To High Water Mark: 3" From Invert  
 Depth To Ground Water: None Observed  
 Unaccounted Connections: None Observed  
 Evidence of Leakage: Barrel Seams  
 Other Comments Flush Type Manhole

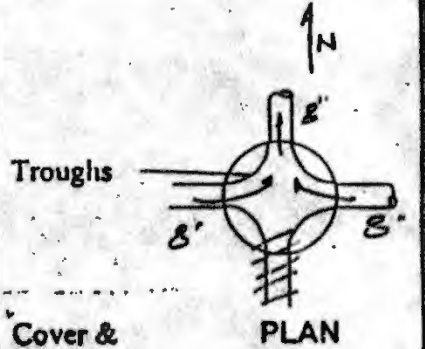
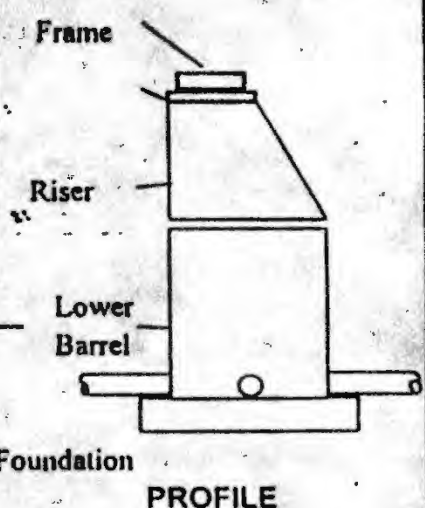
Location: _____	MH No. <u>2</u>	Zone: _____
Inspector: <u>RMS/SJD</u>	Weather: <u>Clear &amp; Hot</u>	Temp: <u>80° F</u>

Item	Construction Material	Condition
COVER	Cast Iron (Vulcan Y-1344-I Type)	Good
FRAME	Cast Iron	Good
CHIMNEY	Brick and Mortar	Good
STEPS	None	
CORBEL WORK	None	
RISER WALLS	Concrete	Good
BARREL WALLS	Concrete	Good
BENCH	Concrete	Good
TROUGHS	Concrete	Good

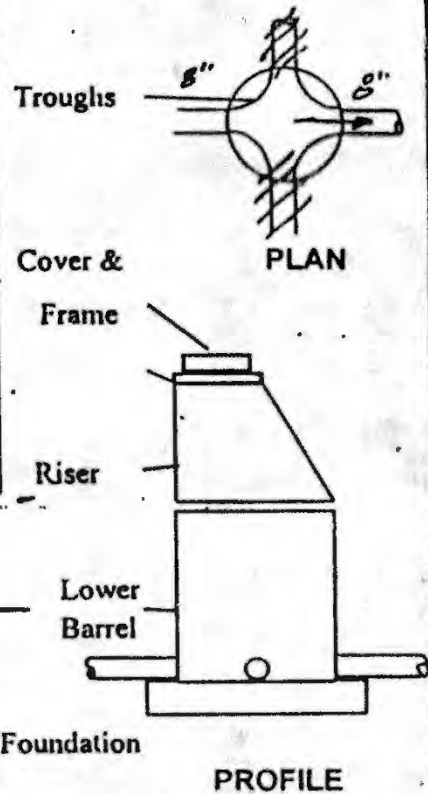
City: Indiantown	Location: Indianwood Sub.	Inspection by: RMS/SJD	
Date: May 5, 1998	Day: Tuesday	Time: 1:00	AM/PM
Location:	MH No. 1	Zone:	
Inspector:	RMS/SJD	Weather: Clear & Hot	Temp: 80° F

Item	Construction Material	Condition
COVER	Cast Iron (Vulcan Y-1344-I Type)	Good
FRAME	Cast Iron	Good
CHIMNEY	Brick and Mortar	Good
STEPS	None	
CORBEL WORK	None	
RISER WALLS	Concrete	Good
BARREL WALLS	Concrete	Good
BENCH	Concrete	Good
TROUGHS	Concrete	Good

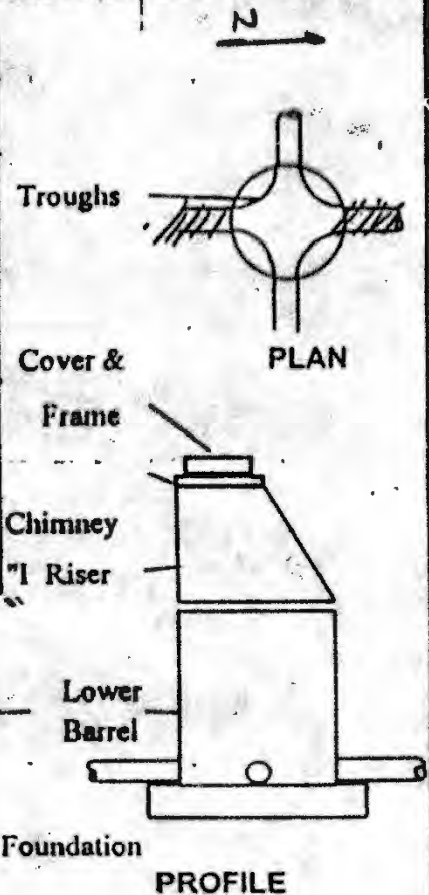
Item	Construction Material	Condition
COVER	Cast Iron (Vulcan Y-1344-I Type)	Good
FRAME	Cast Iron	Good
CHIMNEY	Brick and Mortar	Minor Corrosion
STEPS	None	
CORBEL WORK	None	
RISER WALLS	Concrete	Good
BARREL WALLS	Concrete	Good
BENCH	Concrete	Minor Corrosion
TROUGHS	Concrete	Grit Accumulation

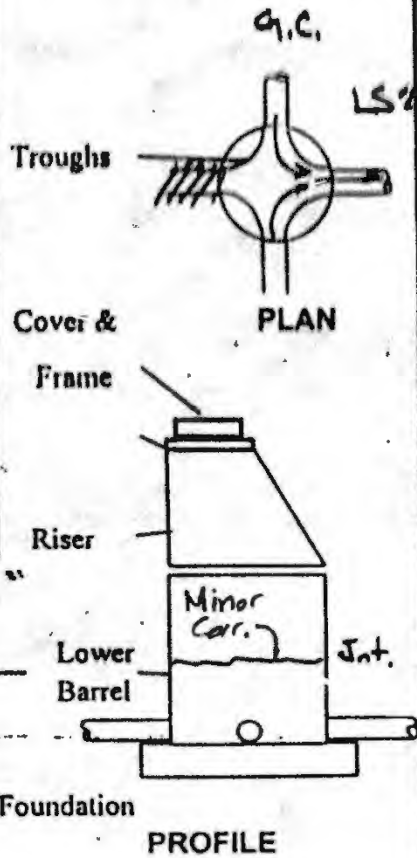
City: Indiantown	Location: Indianwood Sub.	Inspection by: RMS/SJD	
Date: May 5, 1998	Day: Tuesday	Time: 1:00	AM/PM
Location: MH 33A	Zone:		
Inspector: RMS/SJD	Weather: Clear & Hot	Temp: 80° F

Item	Construction Material	Condition
COVER	CAST IRON (VULCAN Y-1344-I Type)	Good
FRAME	Cast Iron	Good
CHIMNEY	Brick and Mortar	Good
STEPS	None	
CORBEL WORK	None	
RISER WALLS	Concrete	Good
BARREL WALLS	Concrete	Good
BENCH	Concrete	Good
TROUGHS	Concrete	Good

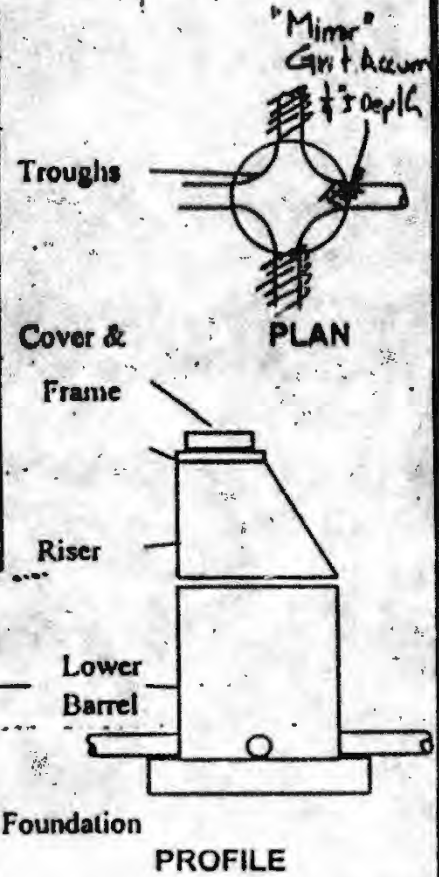
City: Indiantown	Location: Indianwood Sub.	Inspection by: RMS/SJD	
Date: May 5, 1998	Day: Tuesday	Time: 1:00	AM/PM
Location: MH 38	Zone:		
Inspector: RMS/SJD	Weather: Clear & Hot	Temp: 80° F

Item	Construction Material	Condition
COVER	Cast Iron (Vulcan Y-1344-I Type)	Good
FRAME	Cast Iron	Good
CHIMNEY	Brick and Mortar	Good
STEPS	None	
CORBEL WORK	None	
RISER WALLS	Concrete	Good
BARREL WALLS	Concrete	Good
BENCH	Concrete	Good
TROUGHS	Concrete	Good

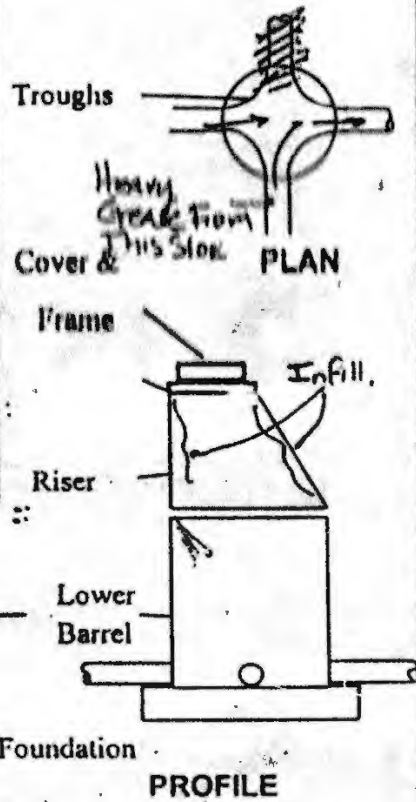
Location: MH 41 Zone: \_\_\_\_\_  
 Inspector: RMS/SJD Weather: Clear & Hot Temp: 80° F

4. Manhole barrels on most manholes were observed to be in good condition. Minor deterioration was noted for MHs 2, 15, 33A and 42. Severe deterioration was noted for MH 41.

Item	Construction Material	Condition
COVER	Cast Iron (Vulcan Y-1344-1 Type)	Good
FRAME	Cast Iron	Good
CHIMNEY	Brick and Mortar	Good
STEPS	None	
CORBEL WORK	None	
RISER WALLS	Concrete	Good
BARREL WALLS	Concrete	Good
BENCH	Concrete	Good
TROUGHS	Concrete	Good

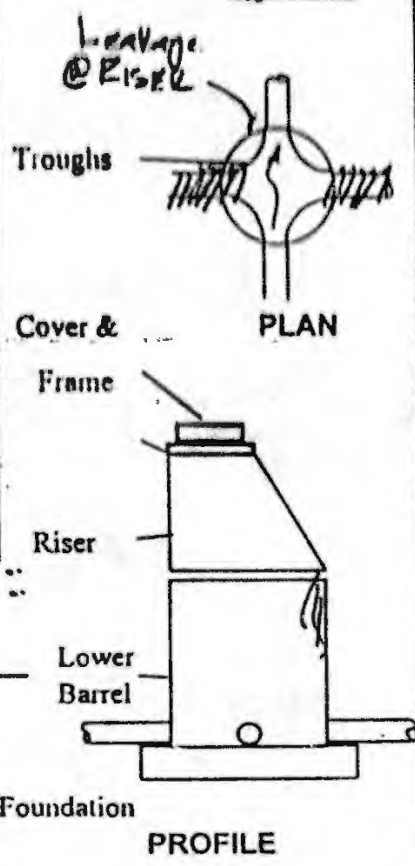
Location: MH 22 Zone: \_\_\_\_\_  
 Inspector: RMS/SJD Weather: Clear & Hot Temp: 80° F

Item	Construction Material	Condition
COVER	Cast Iron (VULCAN Y-1344-I Type)	Good
FRAME	Cast Iron	Good
CHIMNEY	Brick and Mortar	Good
STEPS	None	
CORBEL WORK	None	
RISER WALLS	Concrete	Good
BARREL WALLS	Concrete	Good
BENCH	Concrete	Good
TROUGHS	Concrete	Good

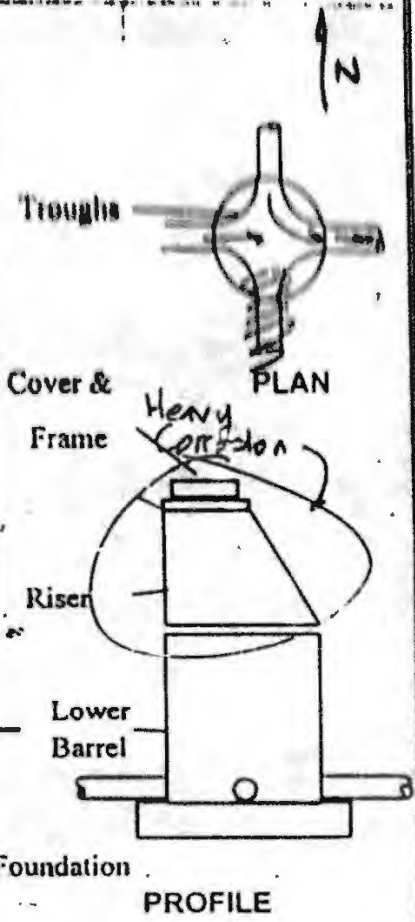
City: Indiantown	Location: Indianwood Sub.	Inspection by: RMS/SJD	
Date: May 5, 1998	Day: Tuesday	Time: 1:00	AM/PM
Location: MH 23	Zone:		
Inspector: RMS/SJD	Weather: Clear & Hot		Temp: 80° F

2. Most manhole chimneys were observed to be in good condition. However, severe deterioration was observed on the chimney of manhole (MH) 23.
3. Risers on all manholes appeared to be in good condition.

Item	Construction Material	Condition
COVER	Cast Iron (Vulcan Y-1344-1 Type)	Good
FRAME	Cast Iron	Minor Corrosion
CHIMNEY	Brick and Mortar	Heavy Corrosion
STEPS	None	
CORBEL WORK	None	
RISER WALLS	Concrete	Good
BARREL WALLS	Concrete	Good
BENCH	Concrete	Good
TROUGHS	Concrete	Good

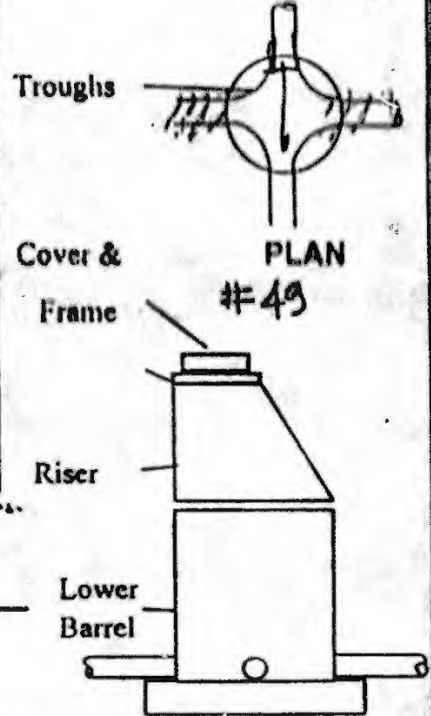
Item	Construction Material	Condition
COVER	Cast Iron (Vulcan Y-1344-I Type)	Good
FRAME	Cast Iron	Good
CHIMNEY	Brick and Mortar	Good
STEPS	None	
CORBEL WORK	None	
RISER WALLS	Concrete	Good
BARREL WALLS	Concrete	Good
BENCH	Concrete	Good
TROUGHS	Concrete	Good

*Accumulation of Calcium on U.S.P.*
