Public Service Commission  
CAPITAL CIRCLE OFFICE CENTER • 2540 SHUMARD OAK BOULEVARD  
TALLAHASSEE, FLORIDA 32399-0850

-M-E-M-O-R-A-N-D-U-M-

**RE:** DOCKET NO. 030834-EI - REQUEST TO EXCLUDE OUTAGE EVENT FROM ANNUAL DISTRIBUTION SERVICE RELIABILITY REPORT FOR CALENDAR YEAR 2003, BY PROGRESS ENERGY FLORIDA, INC.

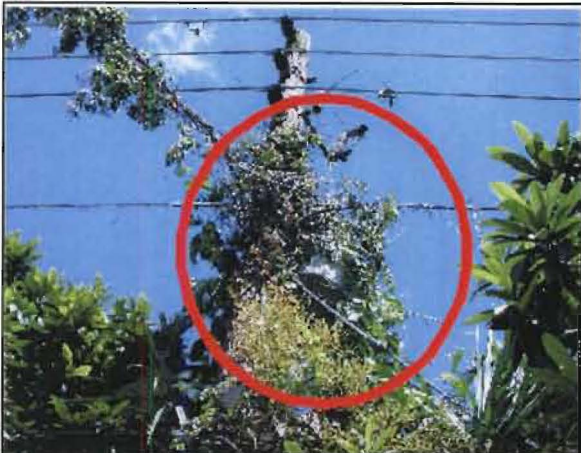
Velazquez No. 1: Pole 133647-039450 on Frontage Rd between Towerview Dr and 7th St. Vines have engulfed a transformer.

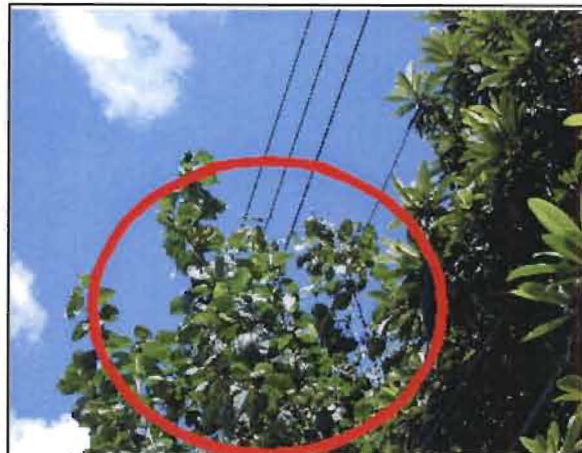
Velazquez No. 2: Adjacent to pole 133647-039450 on Frontage Rd between Towerview Dr and 7th St. Tree limbs at several locations in this general vicinity are contacting the power line.

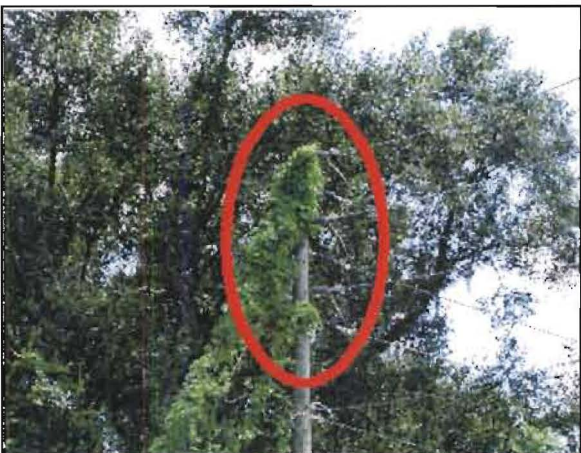
Velazquez No. 3: Across from pole 6357034 on Scenic Hwy (Alt 27) between Egg Farm Rd and Mountain Lake Cutoff Rd. Vines are encroaching on primary lines here and at various locations along this stretch of highway.

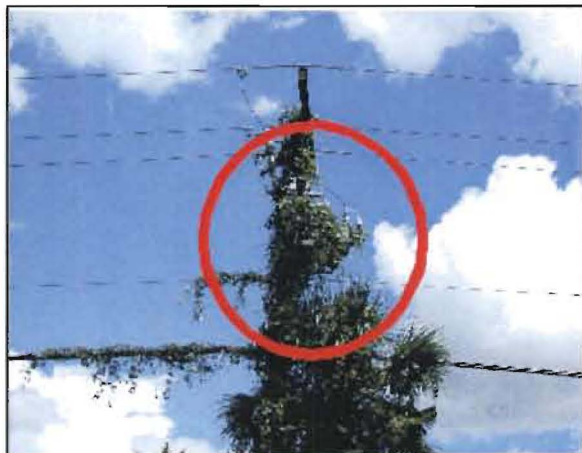
Velazquez No. 4: Approximately 1/10 of a mile south of pole 6357034 on Scenic Hwy (Alt 27). Vines have engulfed a capacitor bank.

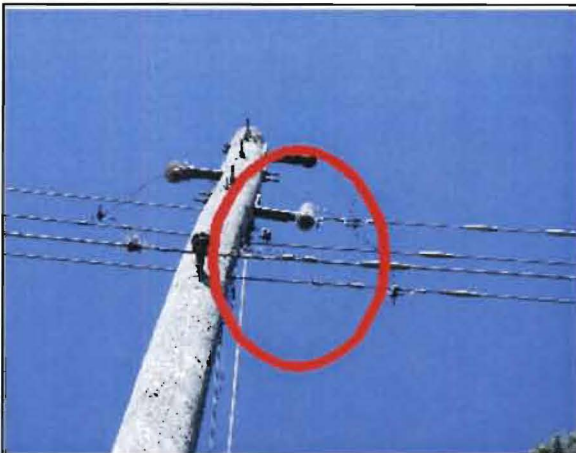
Staff believes the results of its field observations tend to indicate that PEFI allows defective lightning arresters to remain unrepaired for long periods of time and that PEFI did not survey its lightning arresters after the July 18 weather event. This is a concern because the next lightning event may cause even more outages due to fewer and fewer lightning arresters remaining functional with each passing storm.

Velazquez No. 5: Pole 6-61554 on Poinciana Pkwy approximately 1/2 mile south of Lake Marion Creek Drive. Bottom of lightning arrester on lowest phase failed.

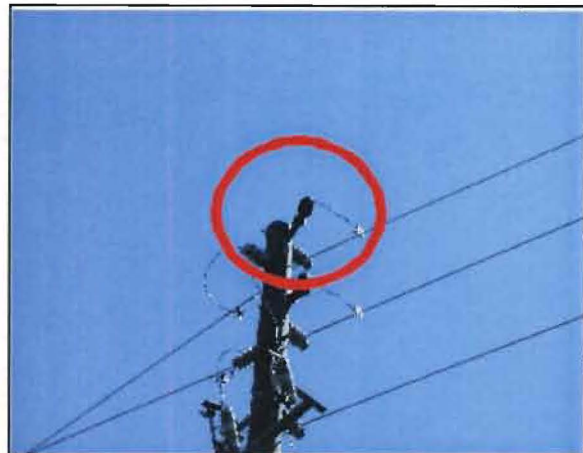
Velazquez No. 6: Next to pole 136062-045422 on Poinciana Pkwy approximately 2/10 of mile south of Lake Marion Creek Dr. Bottom of lightning arrester on top phase has failed. Note: The grounding conductor wraps around the highest insulator on the front side of the pole with the lightning arrester connection resting on top of the insulator. The grounding conductor-arrester connection can fall from its perch on the insulator and come in contact with the stinger wire of the top phase and cause a phase to ground fault on that phase.

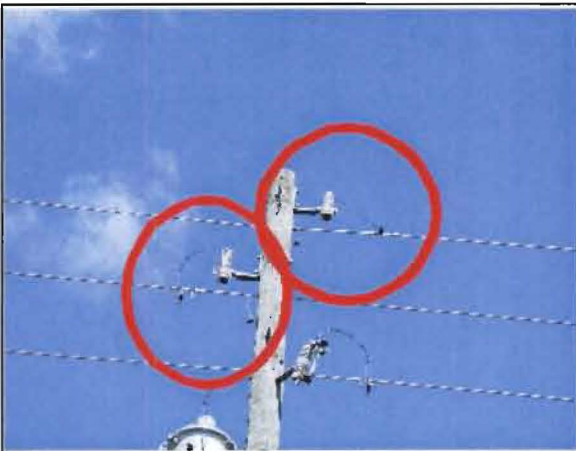
Velazquez No. 7: Pole 135140-045580 on Poinciana Pkwy, 2 poles north of Lake Marion Creek Dr. Lightning arresters on the top two phases failed.

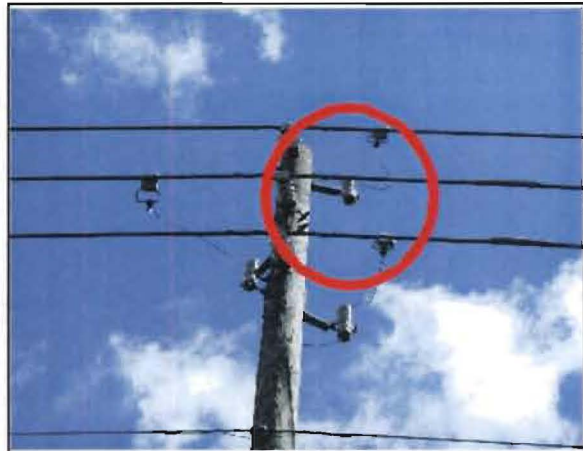
Velazquez No. 8: Pole 6-65409 on Hemlock Ave approximately 3/10 of a mile northwest of Poinciana Pkwy. Bottom of top phase lightning arrester failed.

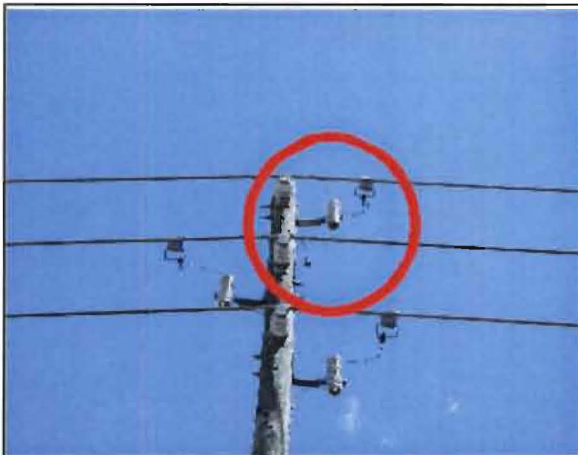
Velazquez No. 9: Pole 6-65413 on Hemlock Ave just southeast of Flounder Rd. Bottom of top phase lightning arrester failed.

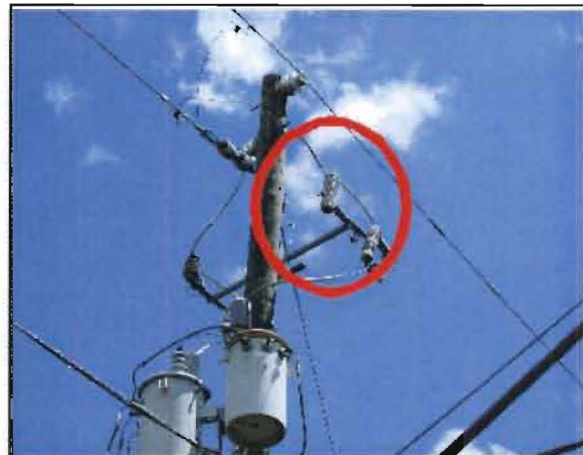
Velazquez No. 10: Pole at corner of Laurel Ave and Halibut Rd. Connection of failed lightning arrester can be seen between the arrester and the fuse holder on the right-hand side of the pole.

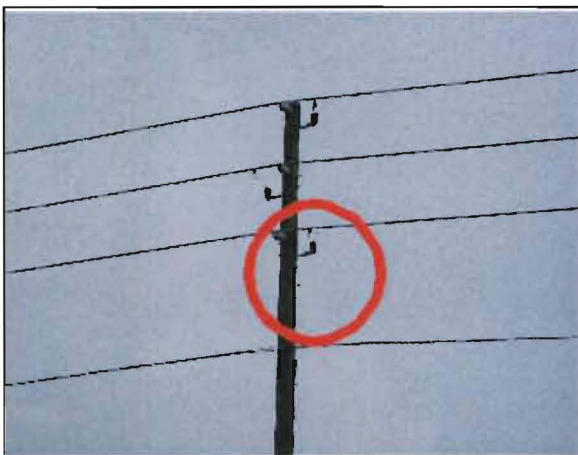
Velazquez No. 11: Pole on KOA St approximately 1/10 of a mile east of Monterey Rd. Lowest phase lightning arrester failed. Connection dangling beside pole.

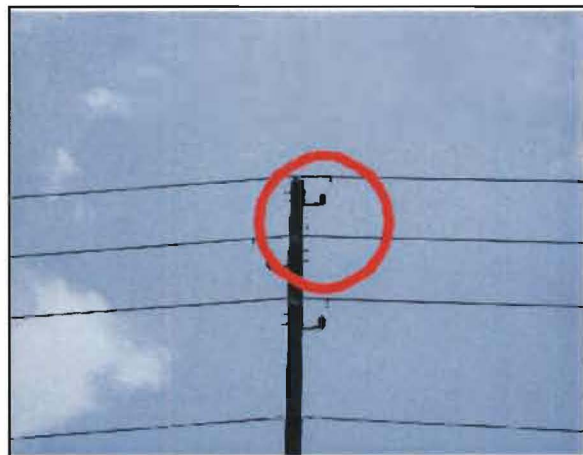
Velazquez No. 12: Pole on KOA St approximately 1/10 of a mile west of Monterey Rd. Highest phase lightning arrester failed.

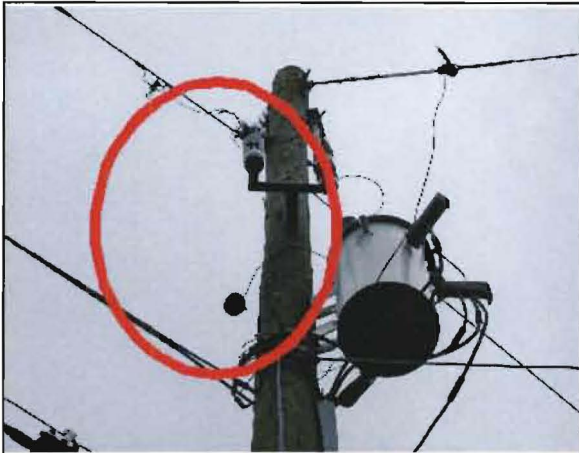
Velazquez No. 13: Pole 136852-049312 on San Lorenzo Rd just north of Taranto Wy. Bottom of failed lightning arrester dangling on left side of pole beside transformer.

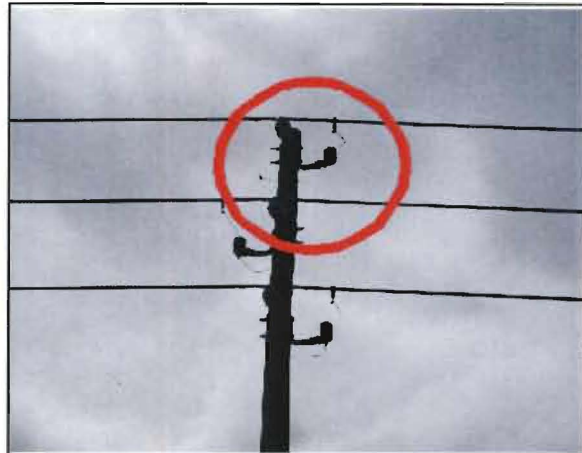
Velazquez No. 14: Pole on Laurel Ave. approximately 2/10 of a mile north of Monterey Rd. Highest phase lightning arrester failed. Bottom of arrester can be seen on left of pole between the top two phases.

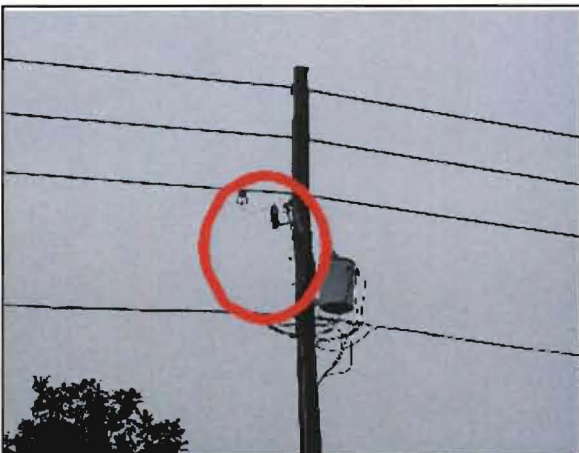
Velazquez No. 15: Pole next to 1915 10th St. Lightning arrester failed. The connector is dangling on left of pole beneath fuse holder.

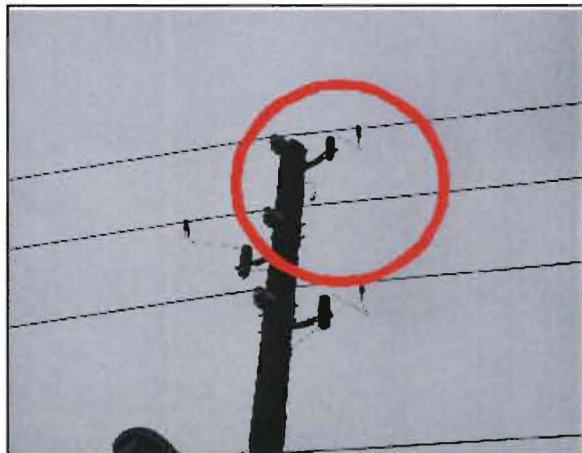
Velazquez No. 16: Pole 6-75351 in front of 2604 4th St South. Top phase lightning arrester failed. Connector dangling on right side of pole beneath arrester.

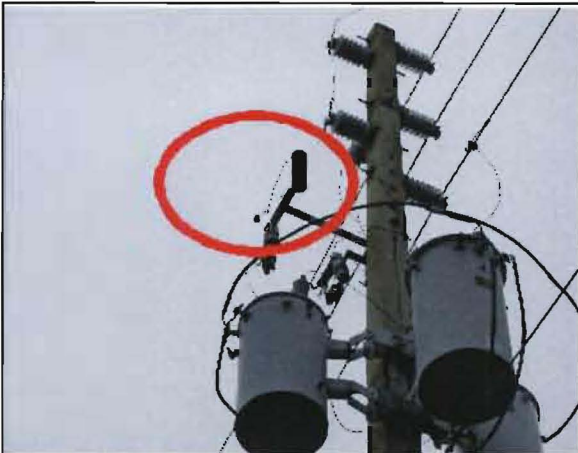
Velazquez No. 17 Pole 132108-047324 at Lily Ave East and 9th St North. Lightning arrester of leftmost transformer failed. Connector is dangling to left of fuse holder.

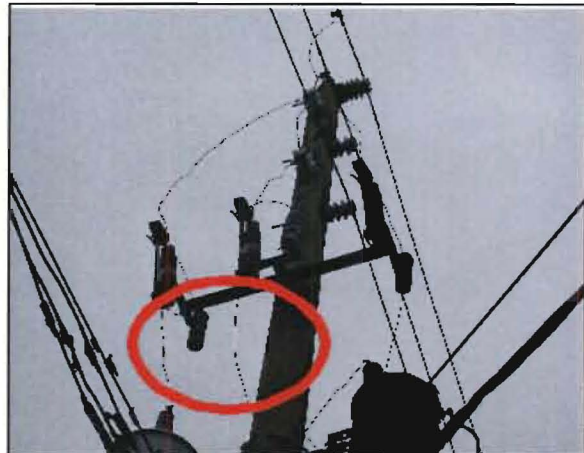
Velazquez No. 18: Pole 132110-047260 at Ingraham Ave and 9th St North. Lightning arrester of leftmost transformer failed. Connector cannot be seen in photo, it is hidden behind fuse holder.

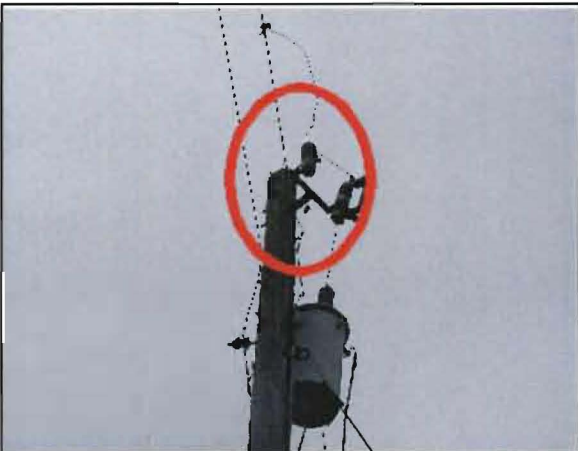
Velazquez No. 19: Pole 132477-044360 on Ridgewood Ave, first pole east of 6th St. Lightning arrester failed. Connector can be seen directly below arrester.

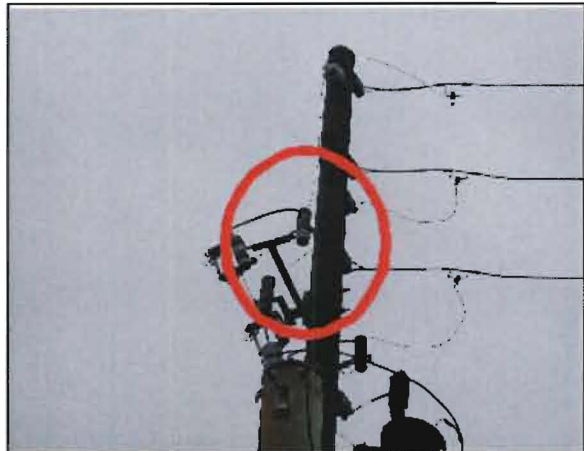
Velazquez No. 20: Pole 6-77498 on Lake Mabel Loop Rd just east of Lake Trask Rd. Lightning arrester failed. Connector can be seen next to fuse holder.

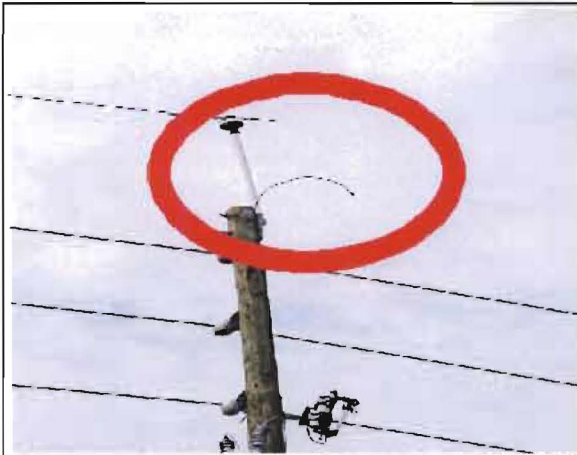
Sobriño No. 1: South side of US 192 just east of US 441 at Holopaw. Broken ground line on lightning arrester.

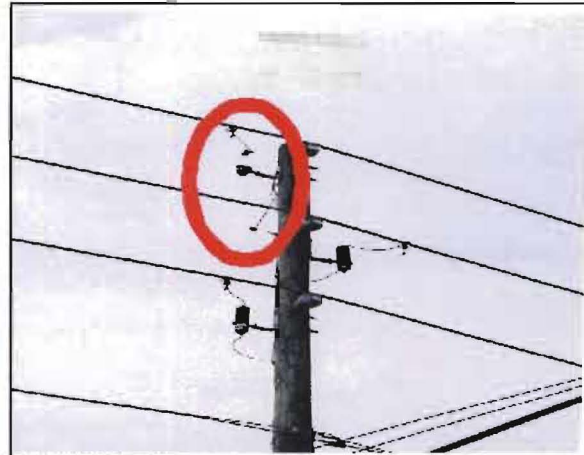
Sobriño No. 2: Pole #972990 on Sand Hill Rd., ½ mile west of Old Lake Wilson Rd. Failed lightning arrester.

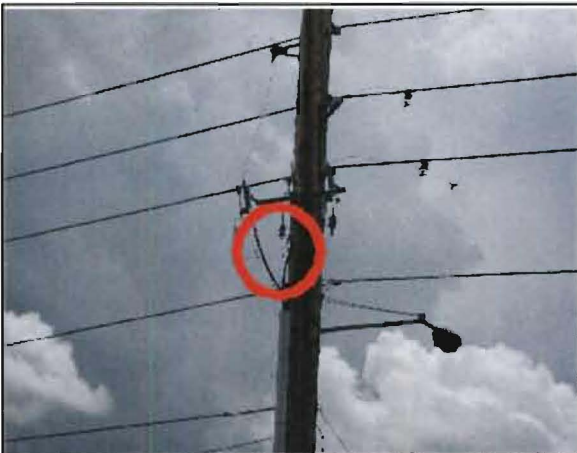
Sobriño No. 3: Pole #136404/056017, on SR 535, ½ mile north of US 192 on parking lot of Lake Buena Vista Factory Outlet. Failed lightning arrester.

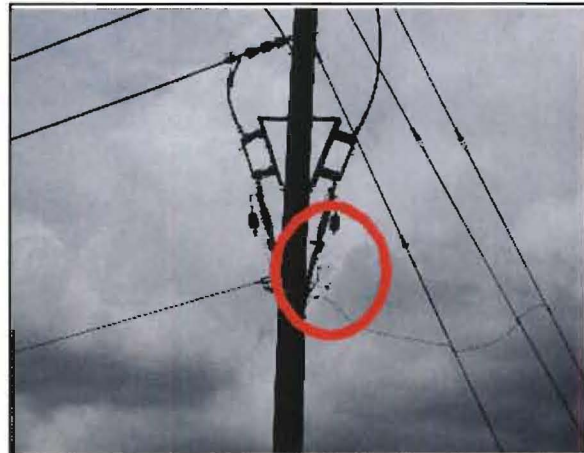
Sobriño No. 4: Pole #136344, ½ mile north of previous location on SR 535. Failed lightning arrester.

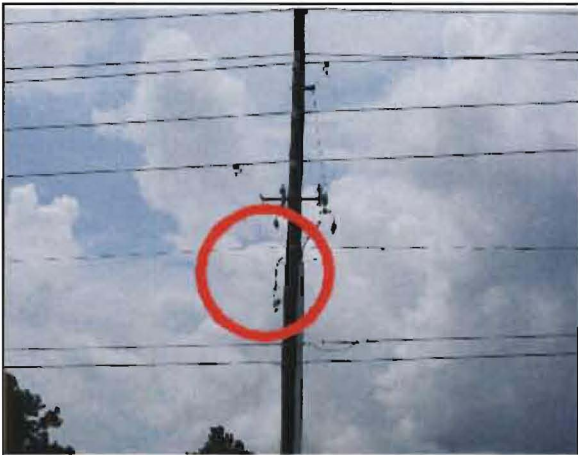
Sobrino No. 5: Pole is located by the Bay Meadows Elementary School on CR 435. Failed lightning arrester.

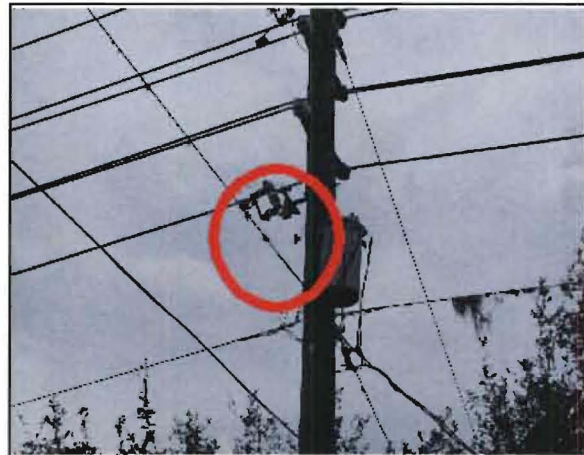
Sobrino No. 6: Pole is located at the intersection of Magnolia St. and 6th Ave., north on CR 435 and west on CR 439 towards Windermere. Failed lightning arrester.

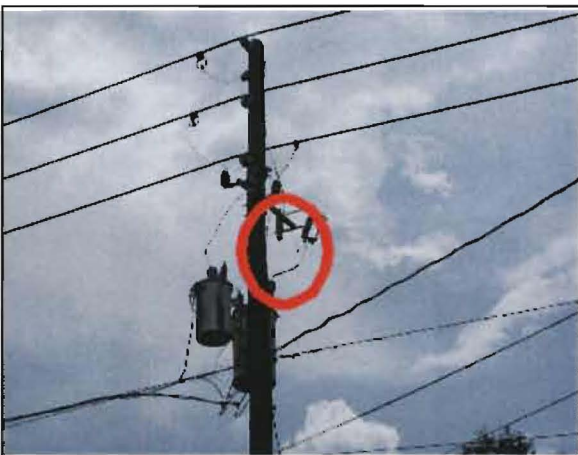
Sobrino No. 7: Pole is located across the street from 19 Main St., Windermere. Failed lightning arrester.

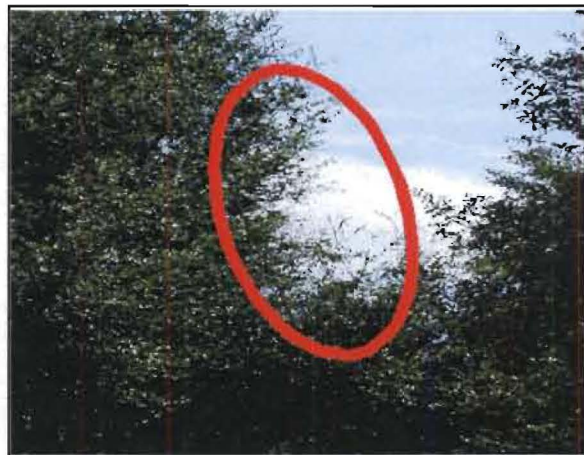
Sobrino No. 8: Vegetation problem at the intersection of Lake Butler Blvd. and Park Avenue, Windermere.

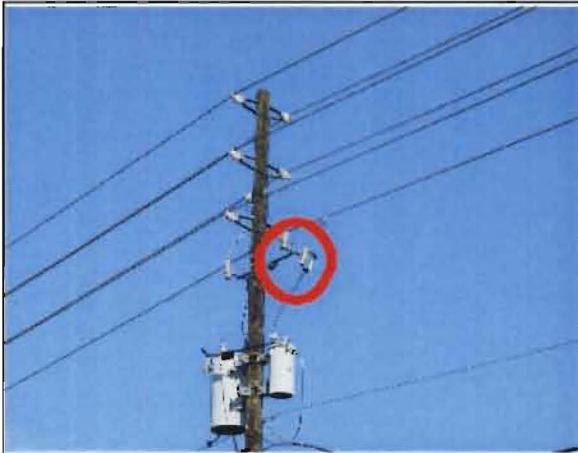
Sobrino No. 9: The pole is located just east of Lexington Avenue on US 92. Failed lightning arrester.

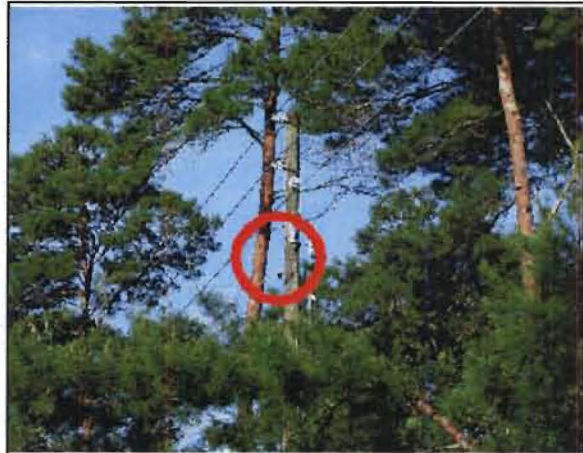
Sobrino No. 10: The pole at the intersection of CR 15A and Trail-in-the-Pines Ave. Failed lightning arrester.

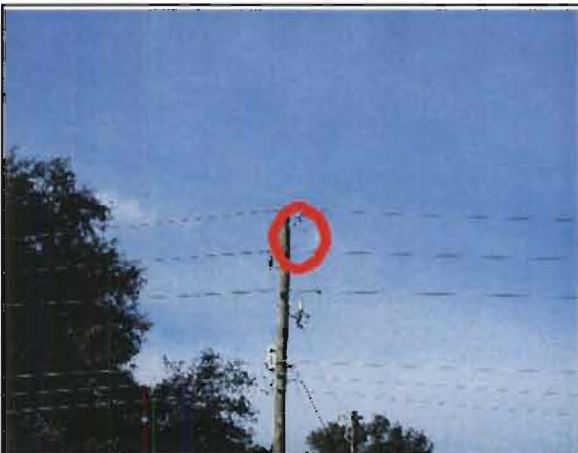
Sobrino No. 11: The pole is on US 17 south of De Leon Springs. Failed lightning arrester.

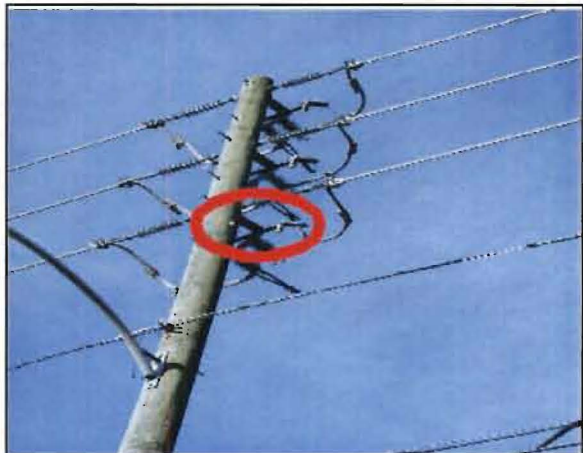
Sobrino No. 12: The pole is located at the northeast corner of Amelia Ave. and New York Ave., De Land. Failed lightning arrester.

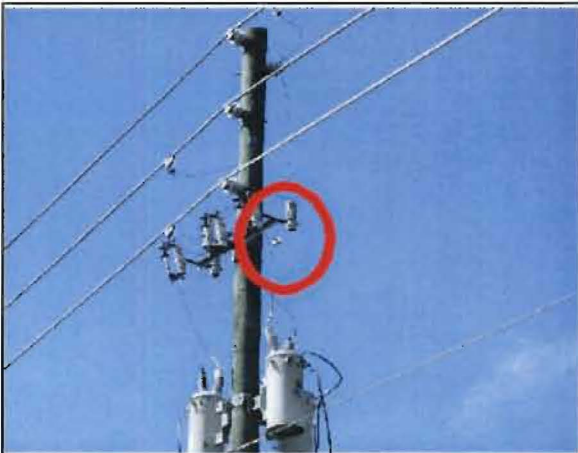
Sobrino No. 13: Pole #142597 located on Enterprise Road, 5 poles north of Saxon Road. Failed lightning arrester.

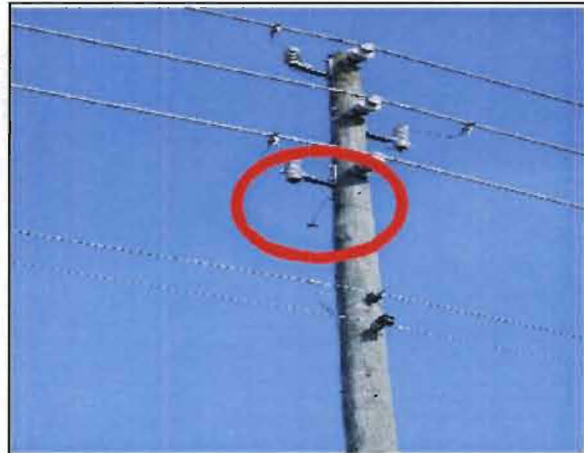
Sobrino No. 14: Failed lightning arrester on pole serving 1440 Normandy Blvd., Deltona.

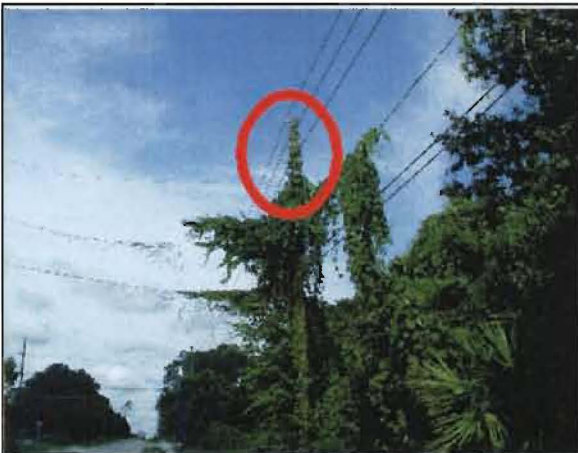
Sobrino No. 15: Vegetation variance at Highbanks Road and Gracie Road.

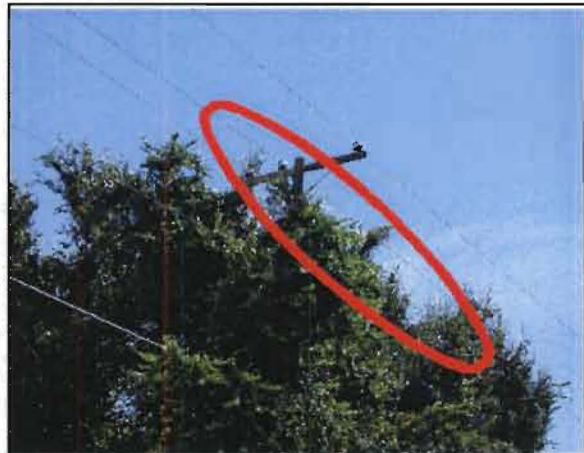
Sobrino No. 16: Vegetation variance on Dirksen Dr. and Aqua Vista St.

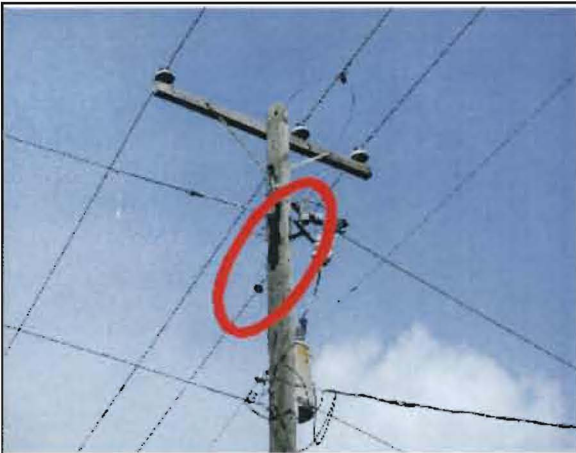
Sobrino No. 17: Failed lightning arrester on Dirksen Dr. and Fredricka Road.

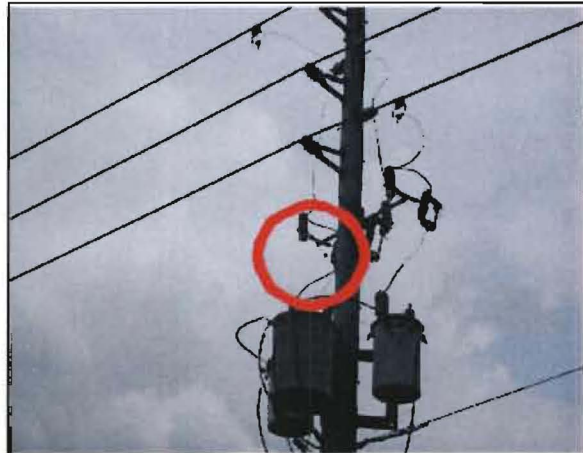
Sobrino No. 18: Failed lightning arrester at Semoran and Wilshire Blvd.

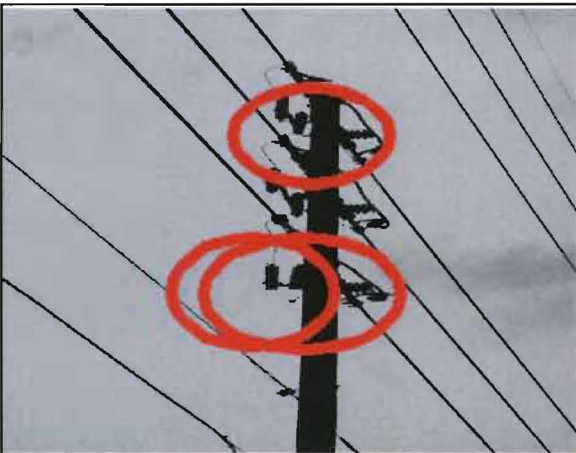
Sobrino No. 20: Three failed lightning arresters on the same pole at SR 426 and Eastbrook Ave. Photograph No. 19 is of the same pole and not included.

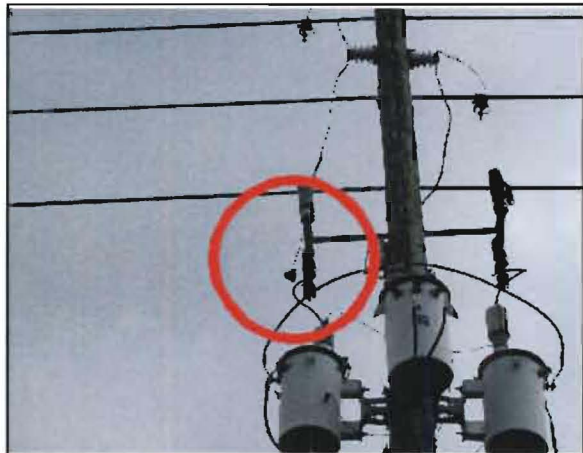
Sobrino No. 21: Two blocks east of previous pole in photograph No. 20. Failed lightning arrester.

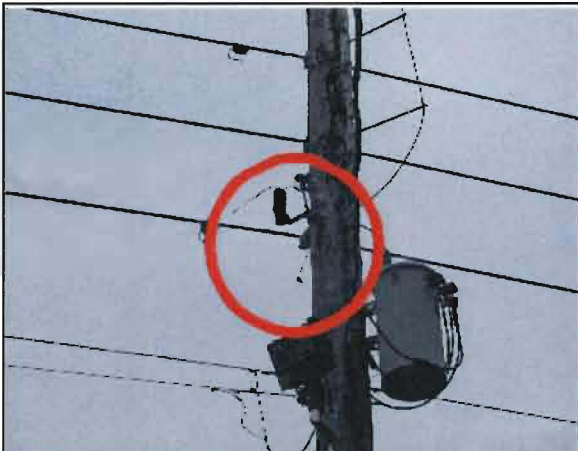
Sobriño No. 22: Pole # 131190, serving 18515 US 441, north of Mount Dora. Failed lightning arrester.

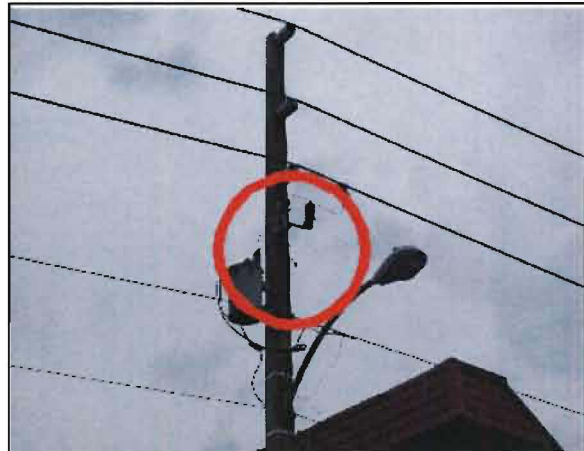
Sobriño No. 23: Failed lightning arrester in front of Eustis Square, on US 19, in Eustis, Florida.

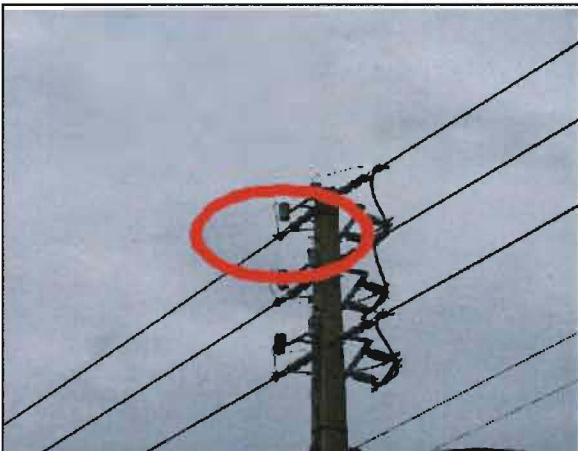
Sobriño No. 24: Failed lightning arrester just north of previous photographed pole along US 19 in Eustis.

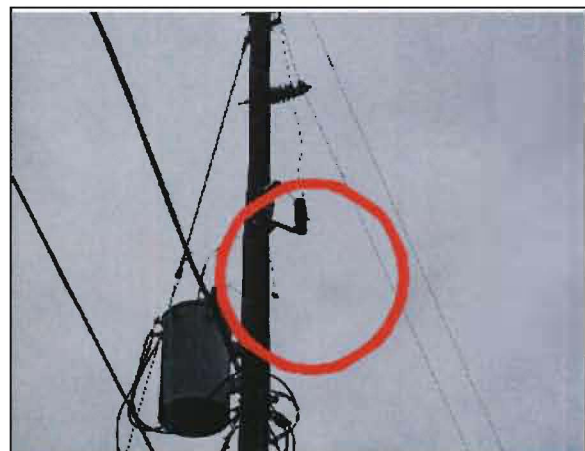
Sobriño No. 25: Pole #130168, located on Key Ave. and a half block east of S. Grove St. (US 19). Failed lightning arrester.

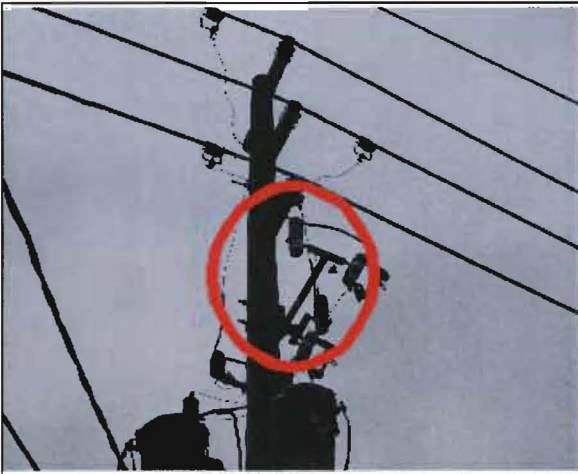
Sobriano No. 26: Failed lightning arrester one block north of the previous photograph (See No. 25). The pole is located on the corner of Ward Ave. and S. Grove St.

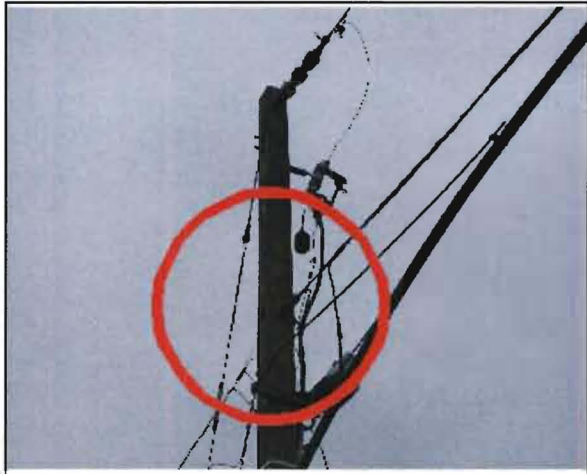
Sobriano No. 27: Failed lightning arrester at 38851 US 19, Umatilla, Florida.

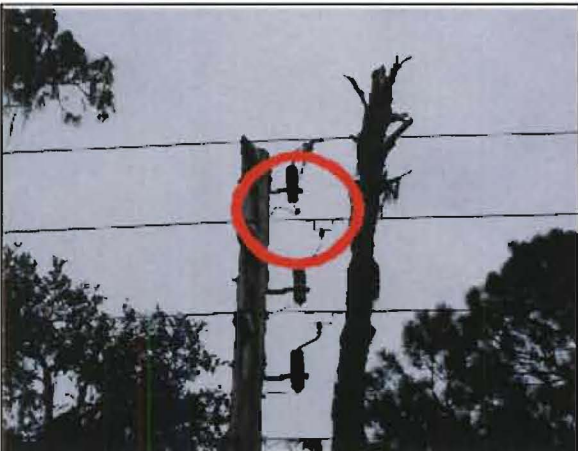
Sobriano No. 28: Failed lightning arrester on pole #723187.

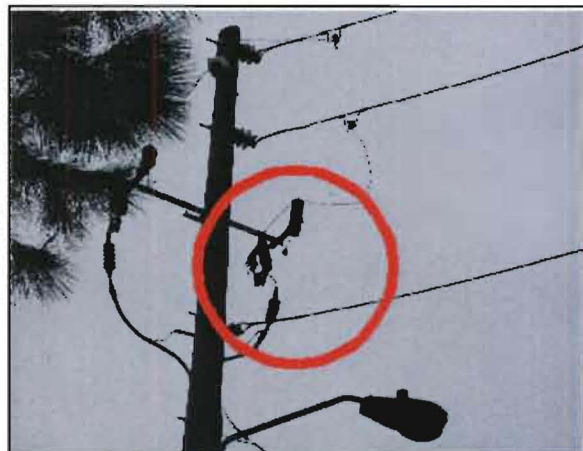
Sobriano No. 29: Failed lightning arrester on pole #129215 at the entrance to Lake Yale Landing.

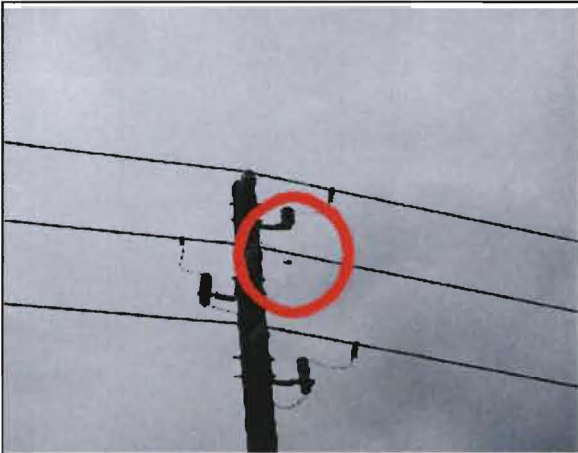
Sobrino No. 30: Failed lightning arrester at the pole on CR 561 near Leatrice Drive and at the entrance to Sugar Ridge Estates.

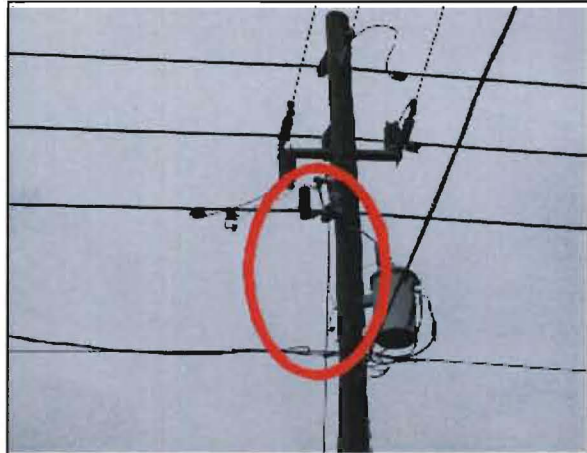
Sobrino No. 31: Failed lightning arrester at the corner of US 27 and Lake Minneola Shores Blvd.

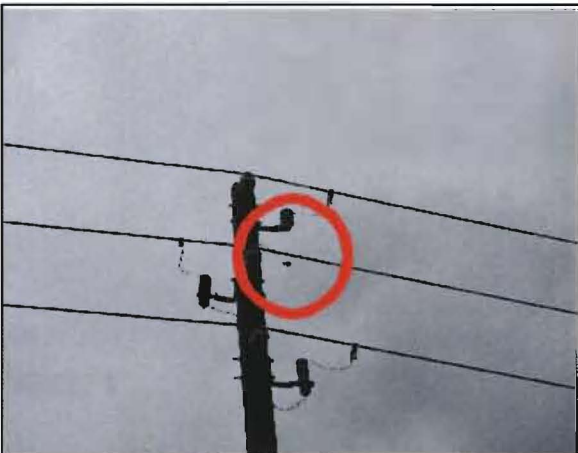
Sobrino No. 32: Failed lightning arrester along SR 50 between Clermont and Groveland at the entrance to Green Valley Country Club.

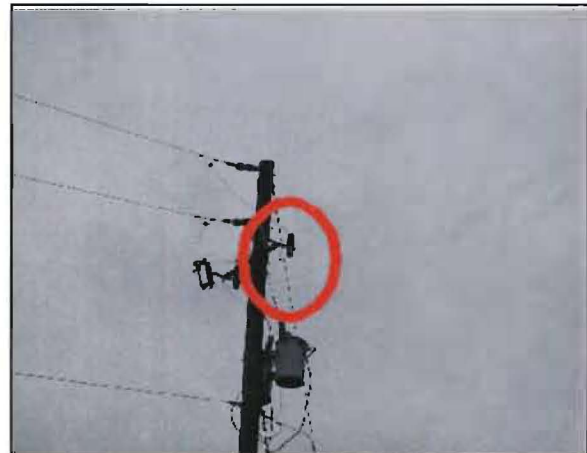
Sobrino No. 33: Failed lightning arrester along Hartwood Marsh Road approximately 1/4 mile south of the entrance to the Tarmac quarry.

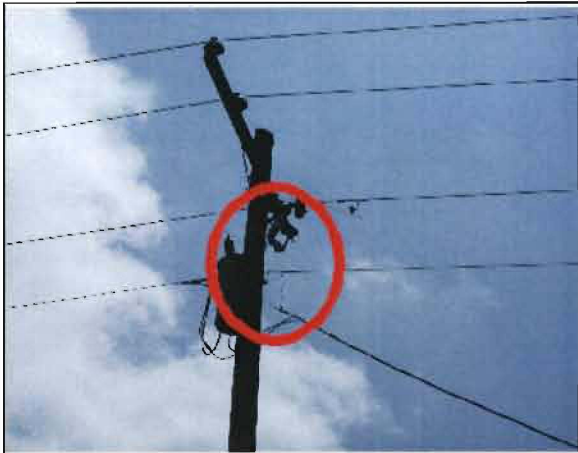
Sobrino No. 32: Failed lightning arrester approximately three miles from the entrance to Tarmac quarry on Hartwood Marsh Road.

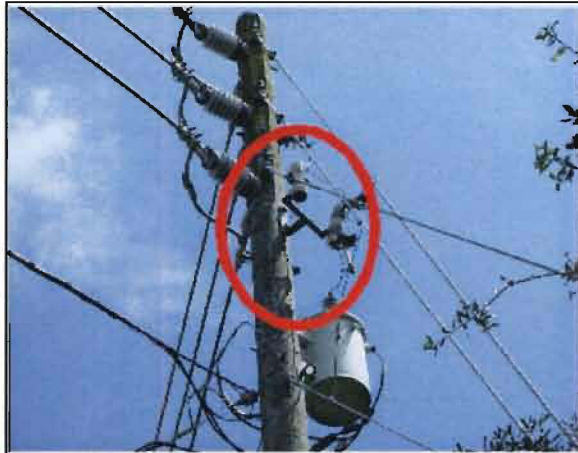
Sobrino No. 33: Failed lightning arrester on E. Bay Street one pole west of Ninth Street.
