DATE: December 5, 2003
TO: Mary Bane, Executive Director
FROM: Division of Economic Regulation (Breman) *JB 12/5/03*
RE: Request for Change of Recommendation Filed December 4, 2003, Docket No. 030834-EI.

RE: DOCKET NO. 030834-EI - REQUEST TO EXCLUDE OUTAGE EVENT
FROM ANNUAL DISTRIBUTION SERVICE RELIABILITY REPORT FOR
CALENDAR YEAR 2003, BY PROGRESS ENERGY FLORIDA, INC.

ISSUE 1: Should the Commission approve PEFI's amended petition to exclude from its 2003 Annual Distribution Service Reliability Report 9,220 service interruptions that occurred in PEFI's North Central Region on July 18, 2003?

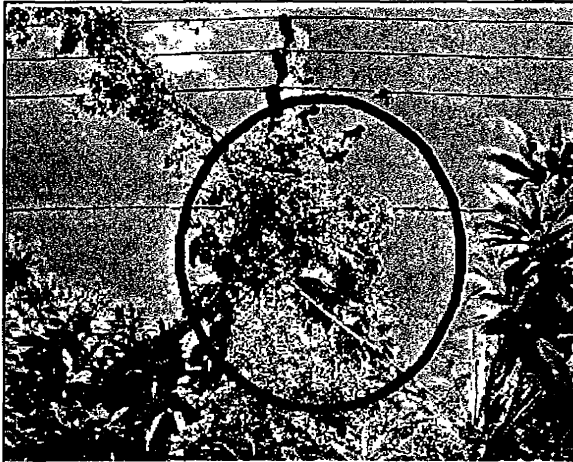
Velazquez No. 1: Pole 133647-039450 on Frontage Rd between Towerview Dr and 7th St. Vines have engulfed a transformer.

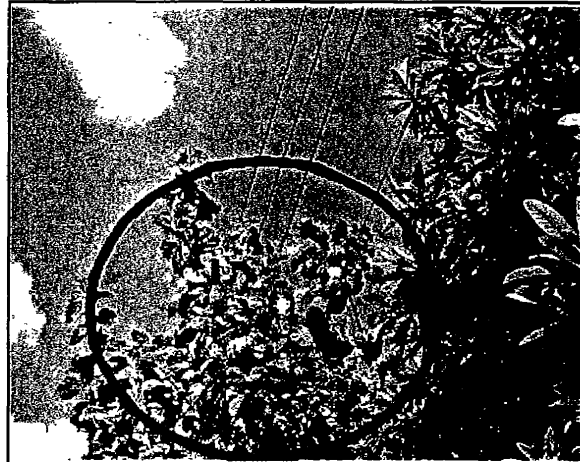
Velazquez No. 2: Adjacent to pole 133647-039450 on Frontage Rd between Towerview Dr and 7th St. Tree limbs at several locations in this general vicinity are contacting the power line.

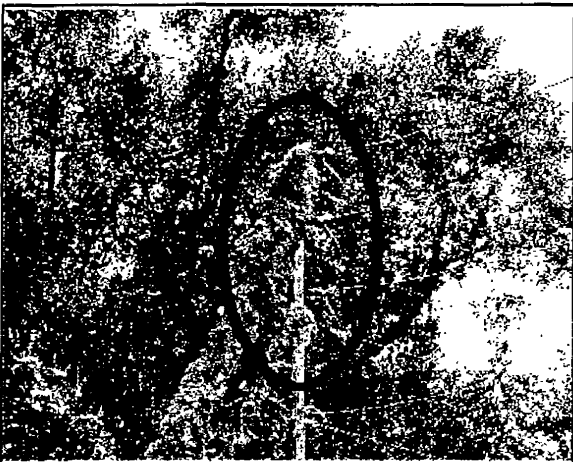
Velazquez No. 3: Across from pole 6357034 on Scenic Hwy (Alt 27) between Egg Farm Rd and Mountain Lake Cutoff Rd. Vines are encroaching on primary lines here and at various locations along this stretch of highway.

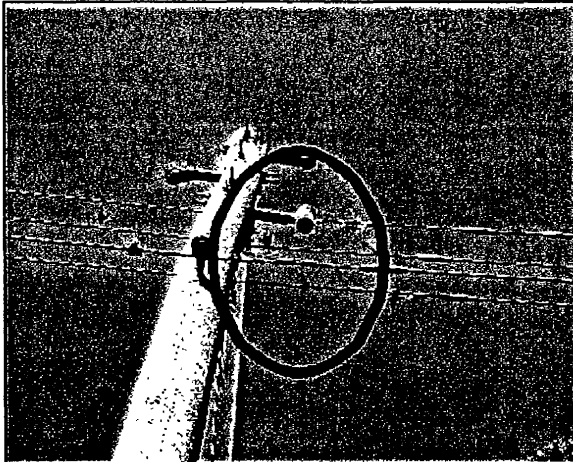
Velazquez No. 5: Pole 6-61554 on Poinciana Pkwy approximately 1/2 mile south of Lake Marion Creek Drive. Bottom of lightning arrester on lowest phase failed.

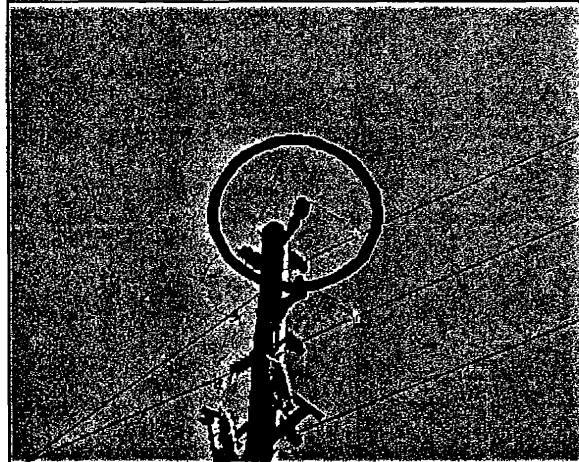
Velazquez No. 6: Next to pole 136062-045422 on Poinciana Pkwy approximately 2/10 of mile south of Lake Marion Creek Dr. Bottom of lightning arrester on top phase has failed. Note: The grounding conductor wraps around the highest insulator on the front side of the pole with the lightning arrester connection resting on top of the insulator. The grounding conductor-arrester connection can fall from its perch on the insulator and come in contact with the stinger wire of the top phase and cause a phase to ground fault on that phase.

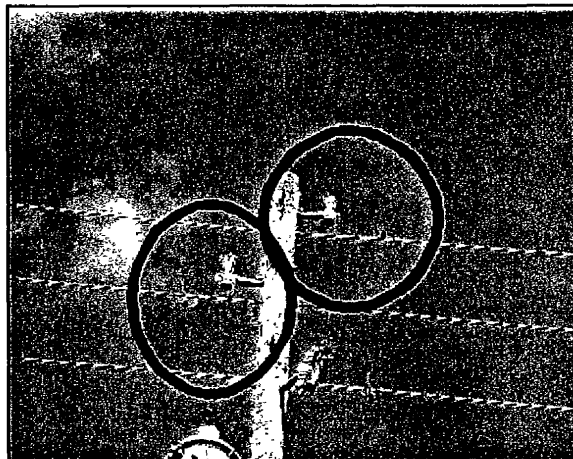
Velazquez No. 7: Pole 135140-045580 on Poinciana Pkwy, 2 poles north of Lake Marion Creek Dr. Lightning arresters on the top two phases failed.

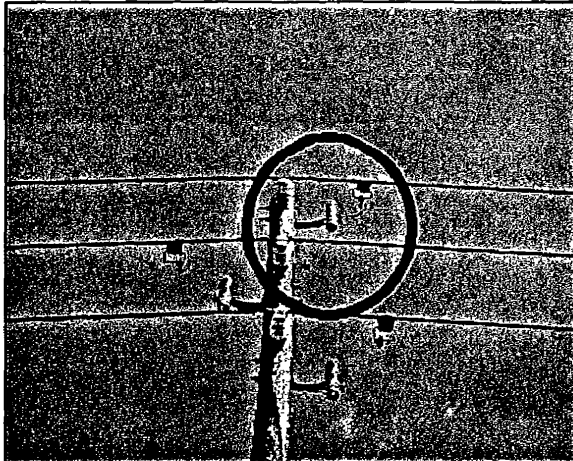
Velazquez No. 9: Pole 6-65413 on Hemlock Ave just southeast of Flounder Rd. Bottom of top phase lightning arrester failed.

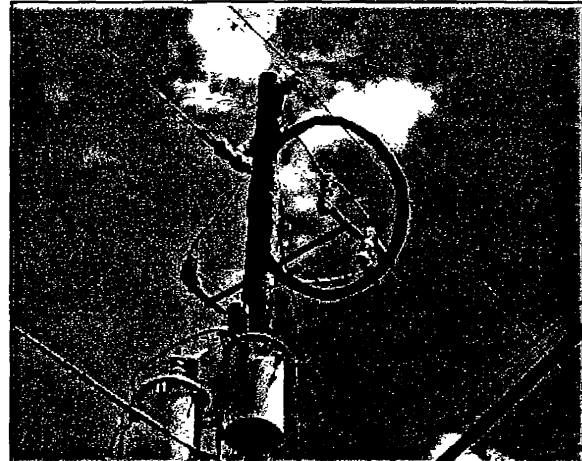
Velazquez No. 10: Pole at corner of Laurel Ave and Halibut Rd. Connection of failed lightning arrester can be seen between the arrester and the fuse holder on the right-hand side of the pole.

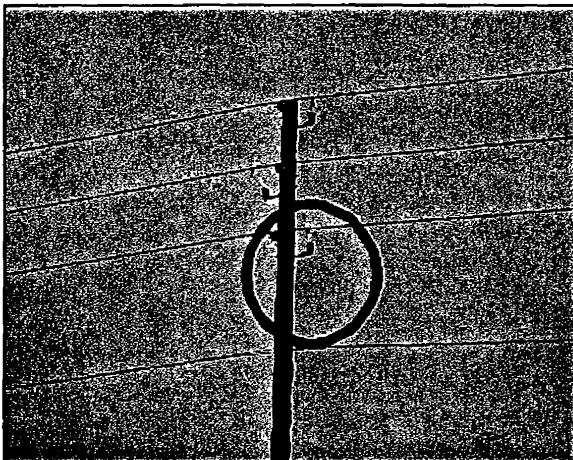
Velazquez No. 11: Pole on KOA St approximately 1/10 of a mile east of Monterey Rd. Lowest phase lightning arrester failed. Connection dangling beside pole.

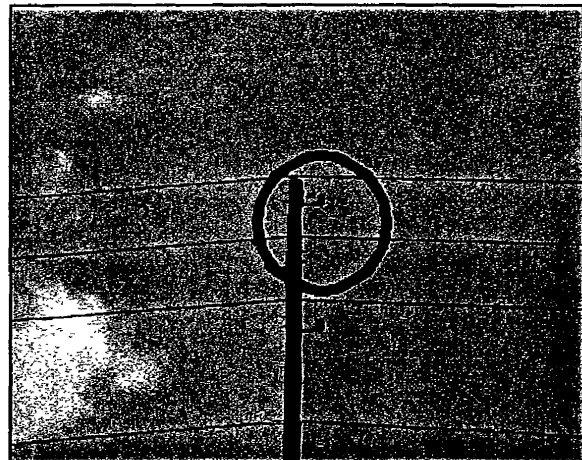
Velazquez No. 12: Pole on KOA St approximately 1/10 of a mile west of Monterey Rd. Highest phase lightning arrester failed.

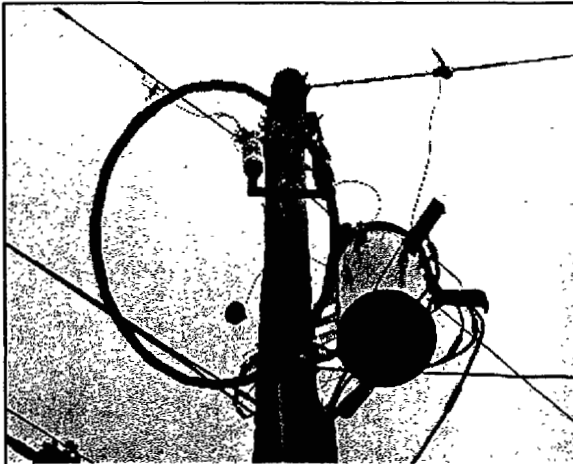
Velazquez No. 13: Pole 136852-049312 on San Lorenzo Rd just north of Taranto Wy. Bottom of failed lightning arrester dangling on left side of pole beside transformer.

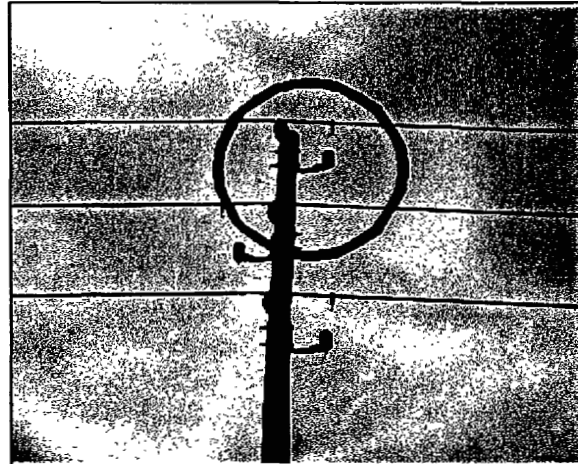
Velazquez No. 14: Pole on Laurel Ave. approximately 2/10 of a mile north of Monterey Rd. Highest phase lightning arrester failed. Bottom of arrester cab be seen on left of pole between the top two phases.

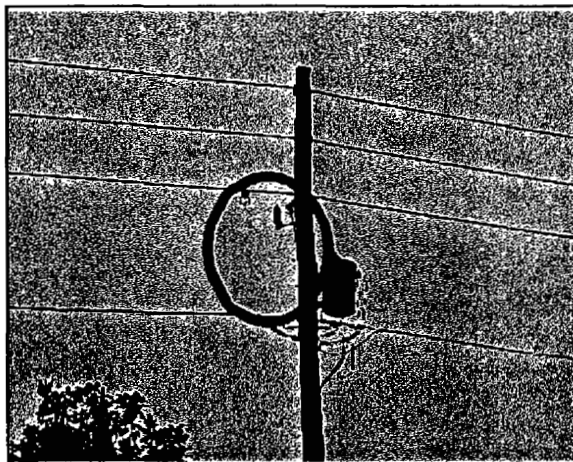
Velazquez No. 15: Pole next to 1915 10th St. Lightning arrester failed. The connector is dangling on left of pole beneath fuse holder.

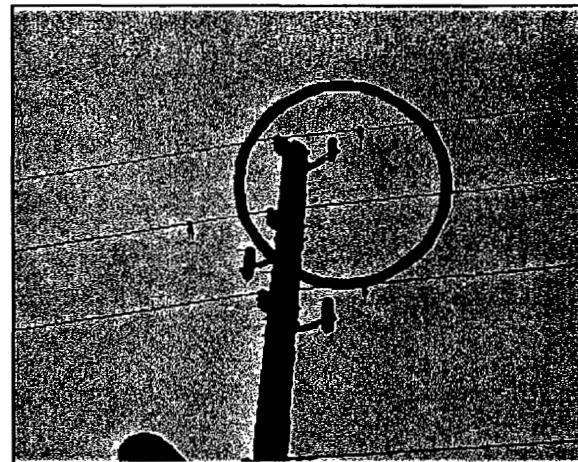
Velazquez No. 16: Pole 6-75351 in front of 2604 4th St South. Top phase lightning arrester failed. Connector dangling on right side of pole beneath arrester.

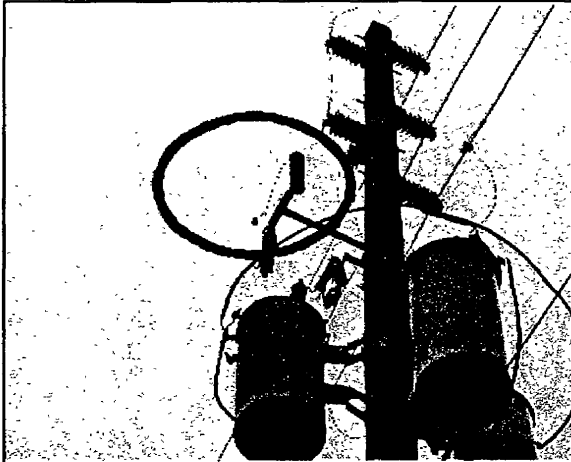
Velazquez No. 17 Pole 132108-047324 at Lily Ave East and 9th St North. Lightning arrester of leftmost transformer failed. Connector is dangling to left of fuse holder.

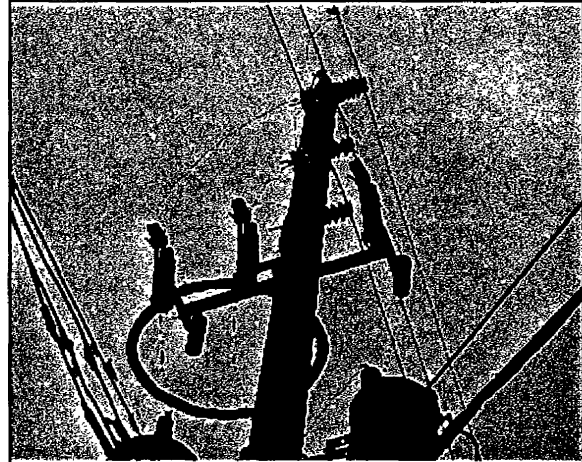
Velazquez No. 18: Pole 132110-047260 at Ingraham Ave and 9th St North. Lightning arrester of leftmost transformer failed. Connector cannot be seen in photo, it is hidden behind fuse holder.

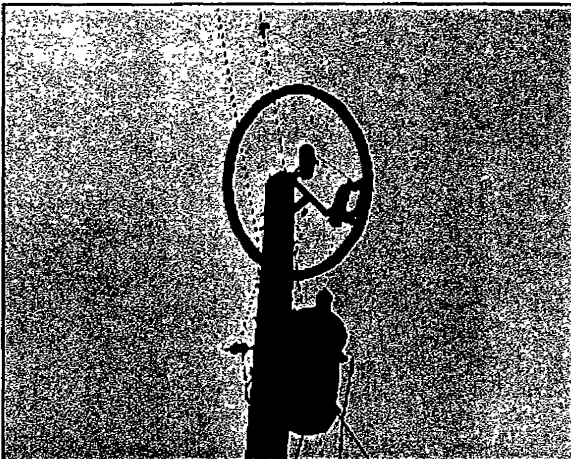
Velazquez No. 19: Pole 132477-044360 on Ridgewood Ave, first pole east of 6th St. Lightning arrester failed. Connector can be seen directly below arrester.

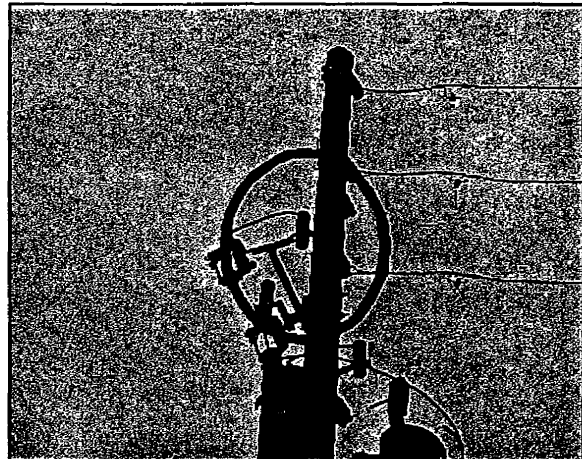
Velazquez No. 20: Pole 6-77498 on Lake Mabel Loop Rd just east of Lake Trask Rd. Lightning arrester failed. Connector can be seen next to fuse holder.

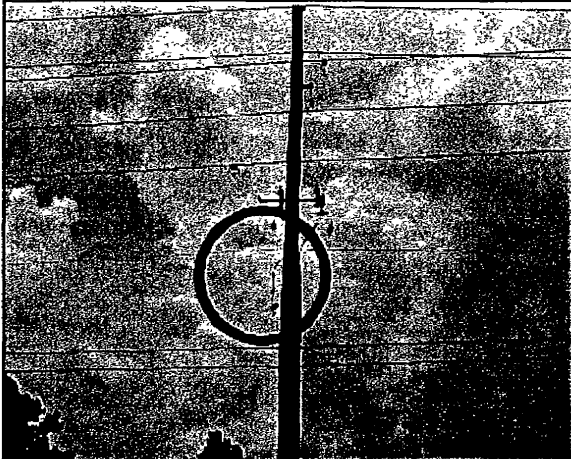
Sobrino No. 5: Pole is located by the Bay Meadows Elementary School on CR 435. Failed lightning arrester.

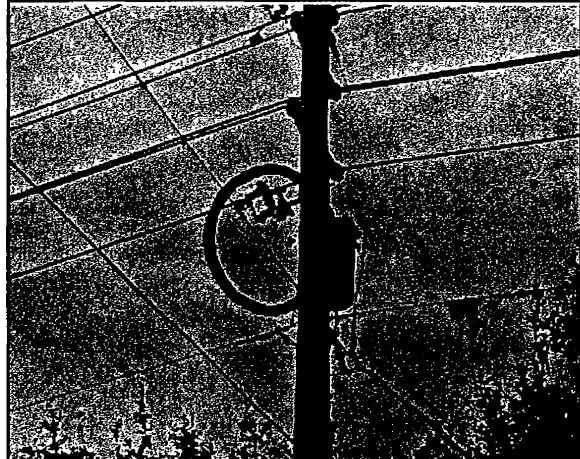
Sobrino No. 6: Pole is located at the intersection of Magnolia St. and 6th Ave., north on CR 435 and west on CR 439 towards Windermere. Failed lightning arrester.

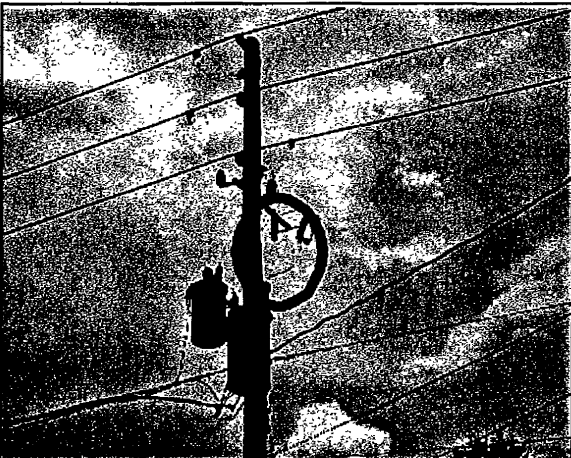
Sobrino No. 7: Pole is located across the street from 19 Main St., Windermere. Failed lightning arrester.

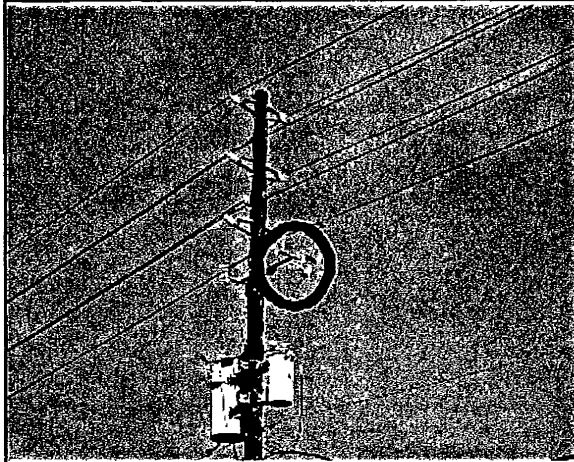
Sobrino No. 9: The pole is located just east of Lexington Avenue on US 92. Failed lightning arrester.

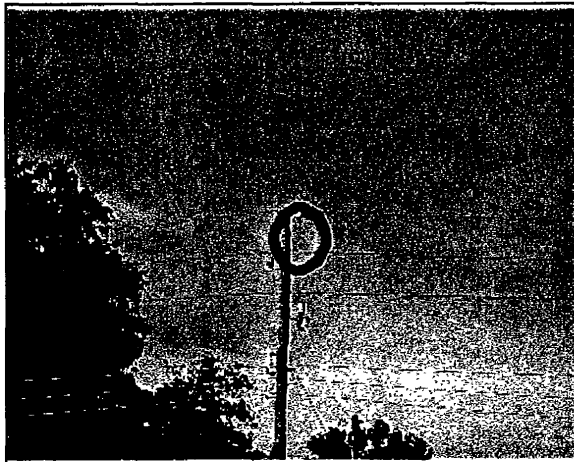
Sobrino No. 11: The pole is on US 17 south of De Leon Springs. Failed lightning arrester.

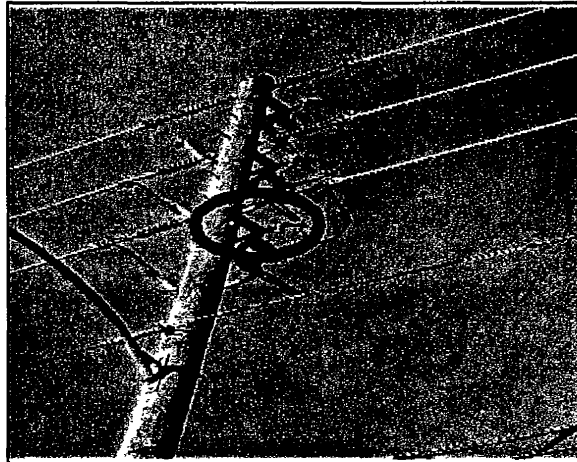
Sobrino No. 12: The pole is located at the northeast corner of Amelia Ave. and New York Ave., De Land. Failed lightning arrester.

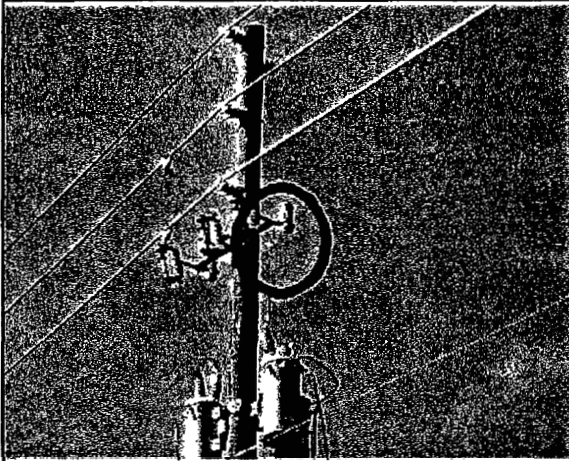
Sobrino No. 13: Pole #142597 located on Enterprise Road, 5 poles north of Saxon Road. Failed lightning arrester.

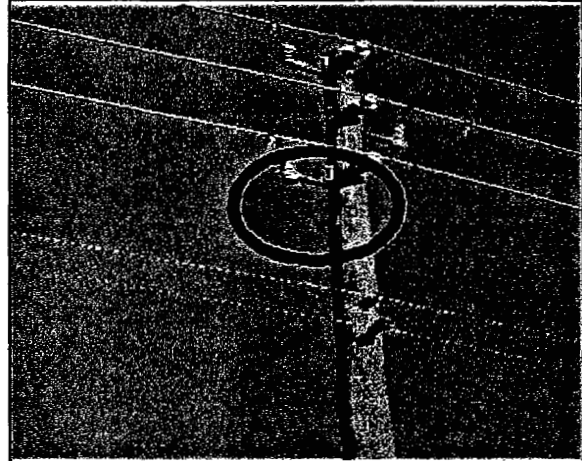
Sobrino No. 14: Failed lightning arrester on pole serving 1440 Normandy Blvd., Deltona.

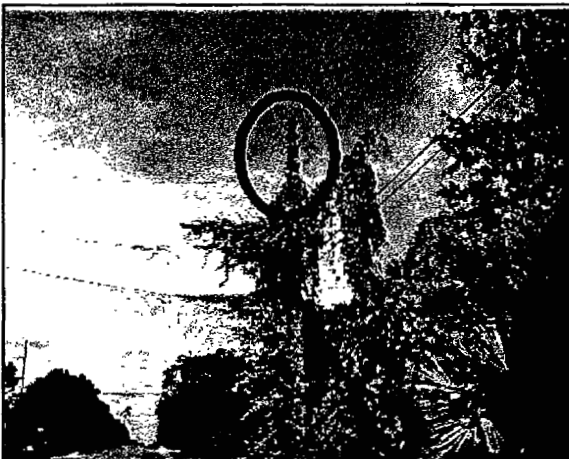
Sobrino No. 15: Vegetation variance at Highbanks Road and Gracie Road.

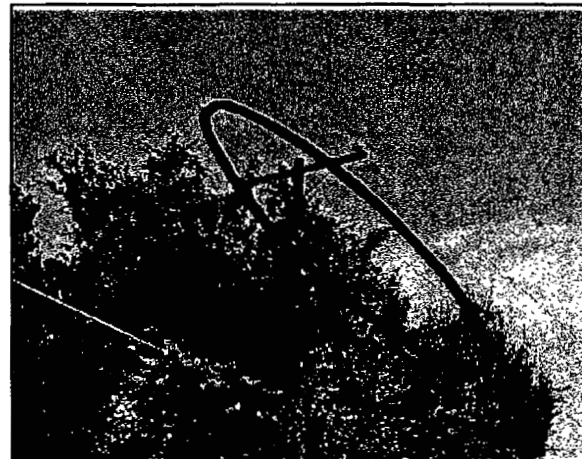
Sobrino No. 16: Vegetation variance on Dirksen Dr and Aqua Vista St.

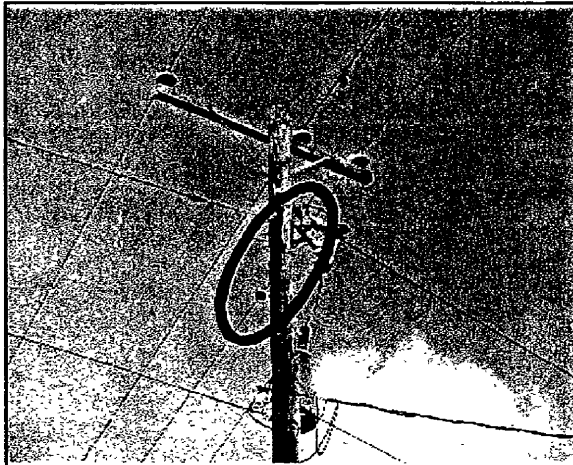
SobriNo No. 17: Failed lightning arrester on Dirksen Dr. and Fredricka Road.

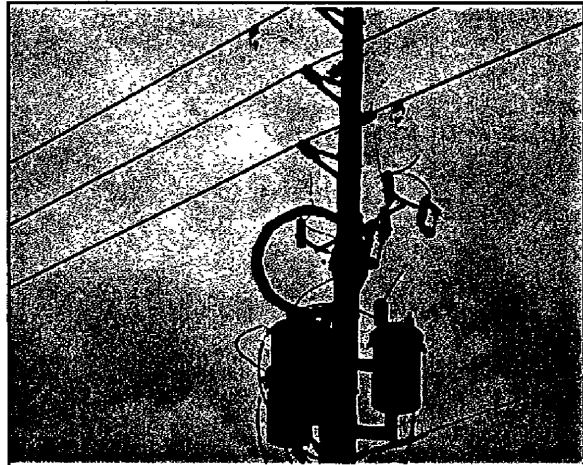
SobriNo No. 18: Failed lightning arrester at Semoran and Wilshire Blvd.

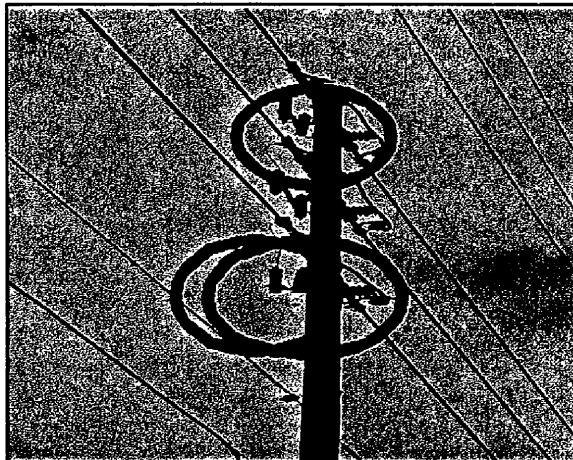
SobriNo No. 20: Three failed lightning arresters on the same pole at SR 426 and Eastbrook Ave. Photograph No. 19 is of the same pole and not included.

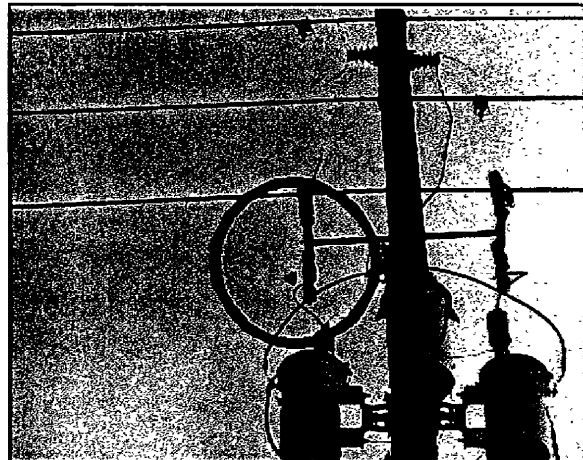
SobriNo No. 21: Two blocks east of previous pole in photograph No. 20. Failed lightning arrester.

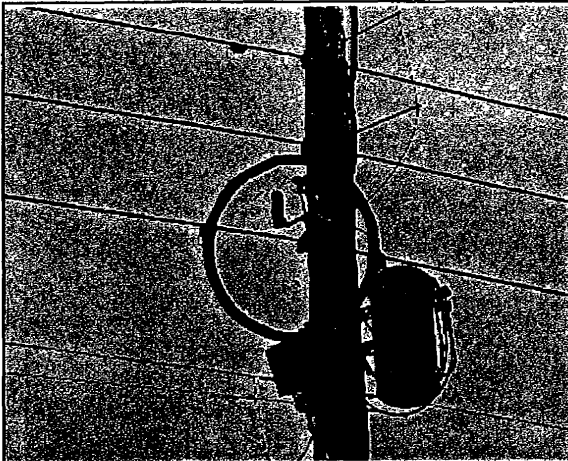
Sobriano No. 22: Pole # 131190, serving 18515 US 441, north of Mount Dora. Failed lightning arrester.

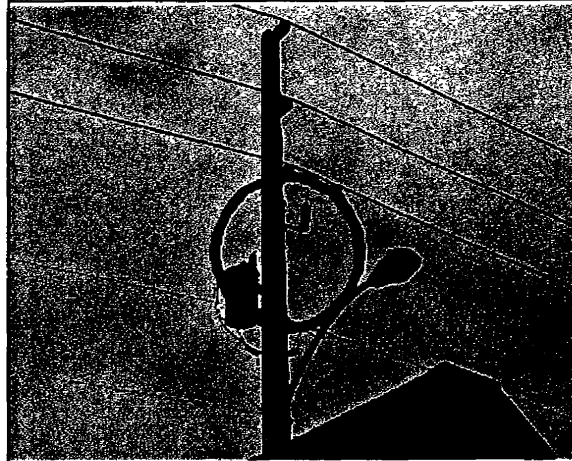
Sobriano No. 23: Failed lightning arrester in front of Eustis Square, on US 19, in Eustis, Florida.

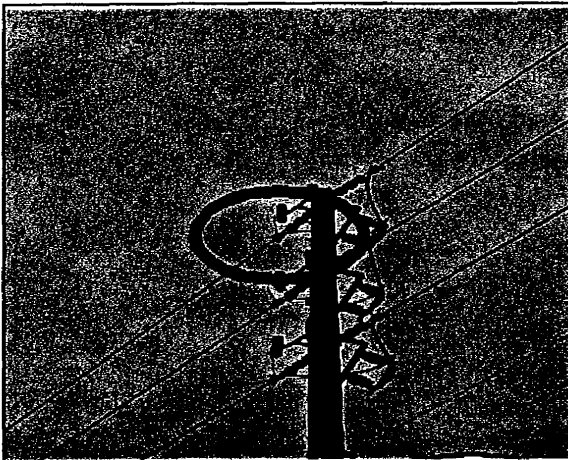
Sobriano No. 24: Failed lightning arrester just north of previous photographed pole along US 19 in Eustis.

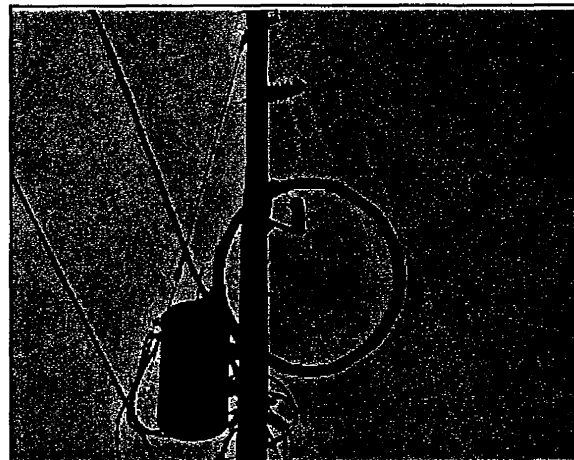
Sobriano No. 25: Pole #130168, located on Key Ave. and a half block east of S. Grove St. (US 19). Failed lightning arrester.

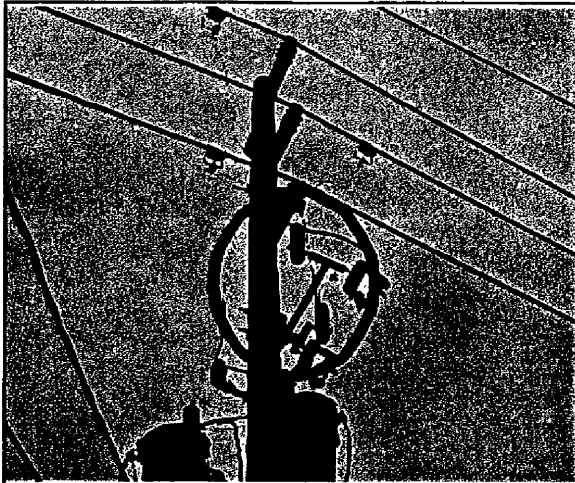
Sobrino No. 26: Failed lightning arrester one block north of the previous photograph (See No. 25). The pole is located on the corner of Ward Ave. and S. Grove St.

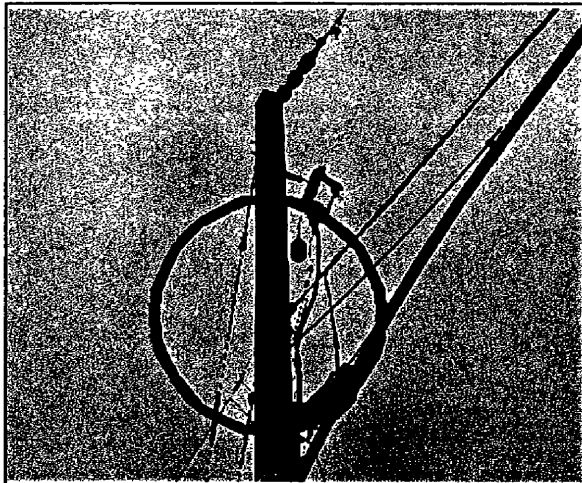
Sobrino No. 27: Failed lightning arrester at 38851 US 19, Umatilla, Florida.

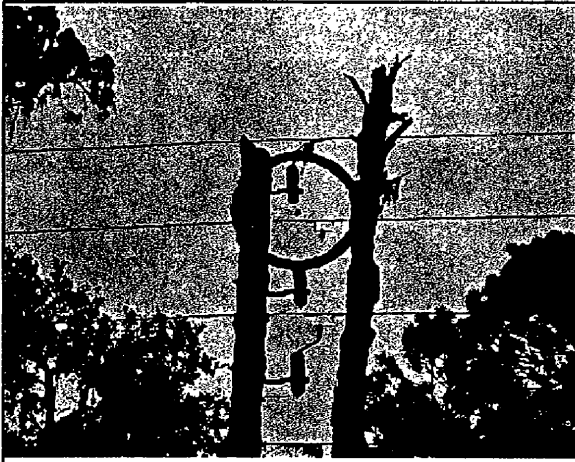
Sobrino No. 28: Failed lightning arrester on pole #723187.

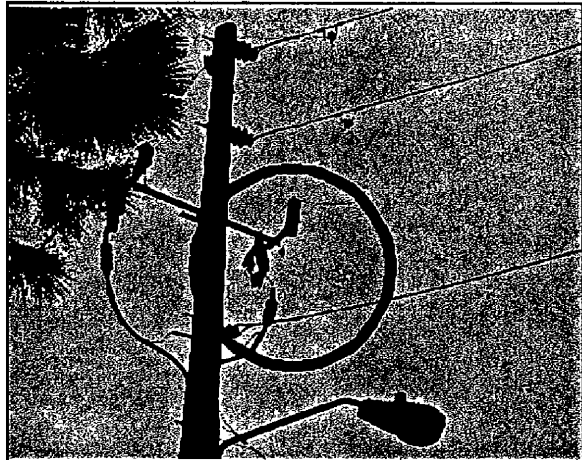
Sobrino No. 29: Failed lightning arrester on pole #129215 at the entrance to Lake Yale Landing.

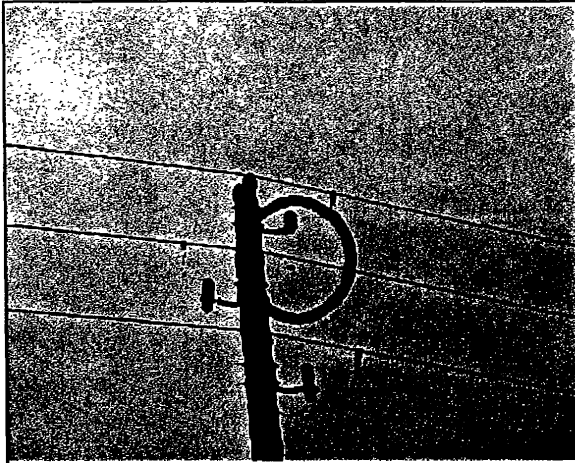
Sobrino No. 30: Failed lightning arrester at the pole on CR 561 near Leatrice Drive and at the entrance to Sugar Ridge Estates.

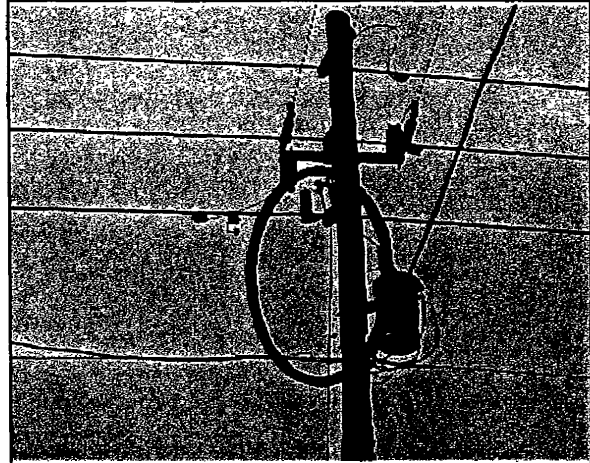
Sobrino No. 31: Failed lightning arrester at the corner of US 27 and Lake Minneola Shores Blvd.

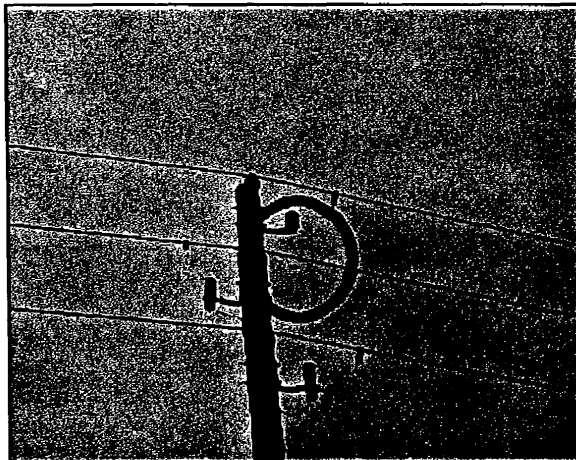
Sobrino No. 32: Failed lightning arrester along SR 50 between Clermont and Groveland at the entrance to Green Valley Country Club.

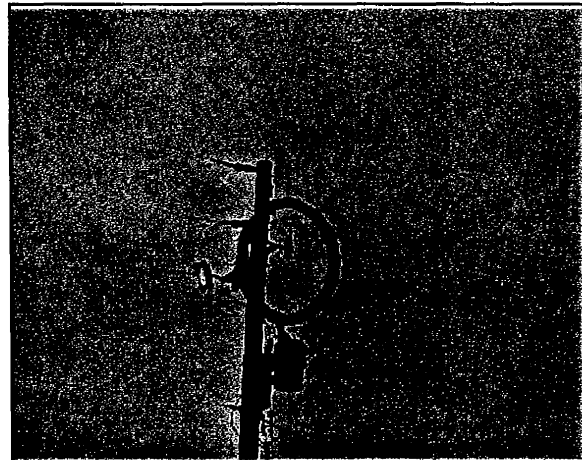
Sobrino No. 33: Failed lightning arrester along Hartwood Marsh Road approximately 1/4 mile south of the entrance to the Tarmac quarry.

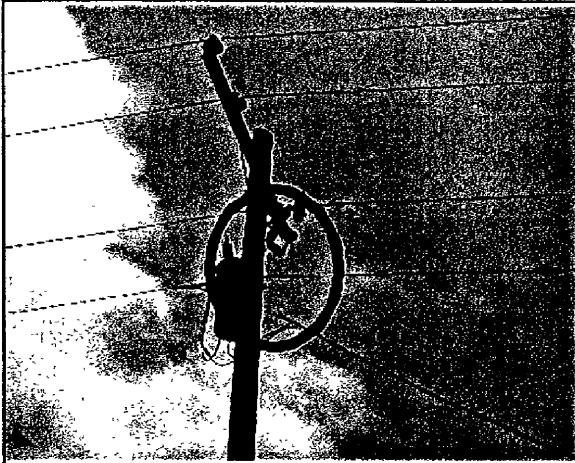
Sobriño No. 32: Failed lightning arrester approximately three miles from the entrance to Tarmac quarry on Hartwood Marsh Road.

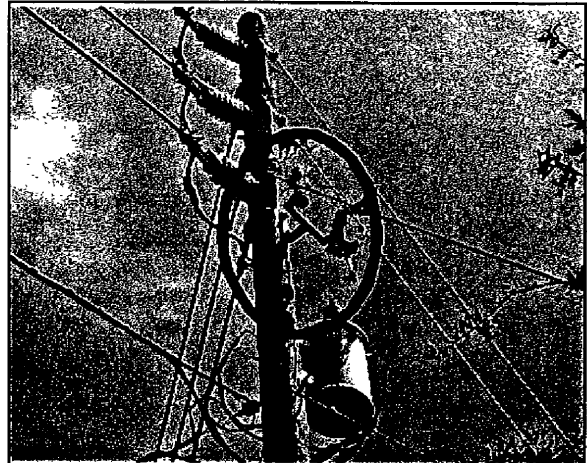
Sobriño No. 33: Failed lightning arrester on E. Bay Street one pole west of Ninth Street.
