RE: Request for Exclusion under Rule 25-6.0455(3)

Subject: Gulf Power Company request for Exclusion under Rule 25-6.0455 (3) for an outage event on March 17, 2004 which was caused by a self propelled deep water buoy tender. This vessel contacted the Bayou Chico 12.47 KV aerial water crossing on feeder 6522 served from Bayou Chico Substation.

Exhibit A
Map Showing Affected Feeder and Location of Event

Exhibit B
Pictures of Crossing Structure and Damaged Line

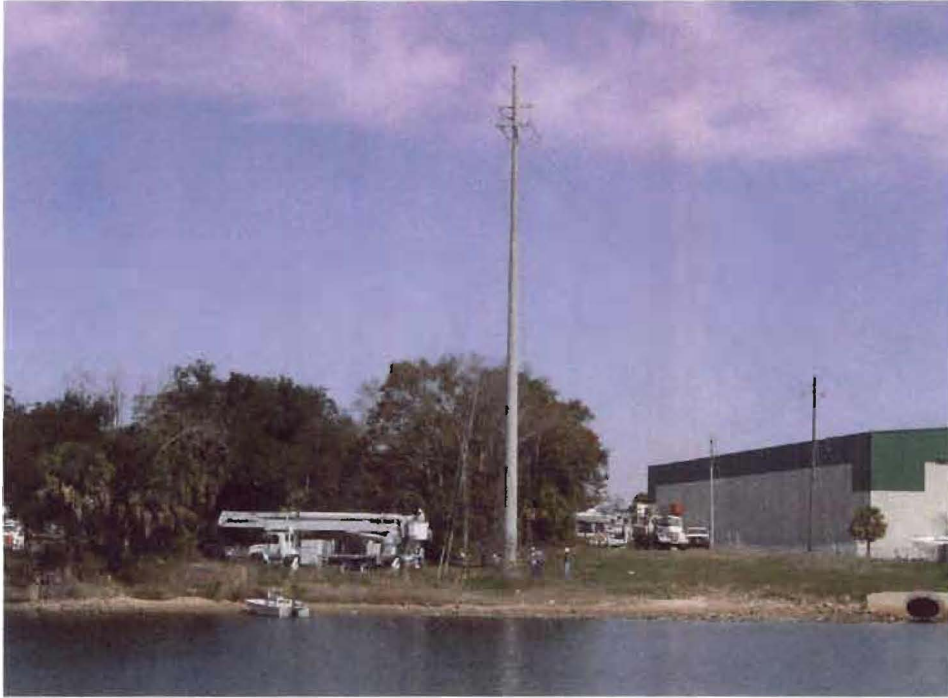
The above picture shows the 125 foot structure located on the North side of the crossing. The picture below is a close up of the 125 foot structure located on the South side of the crossing with the damaged primary phase hanging down.

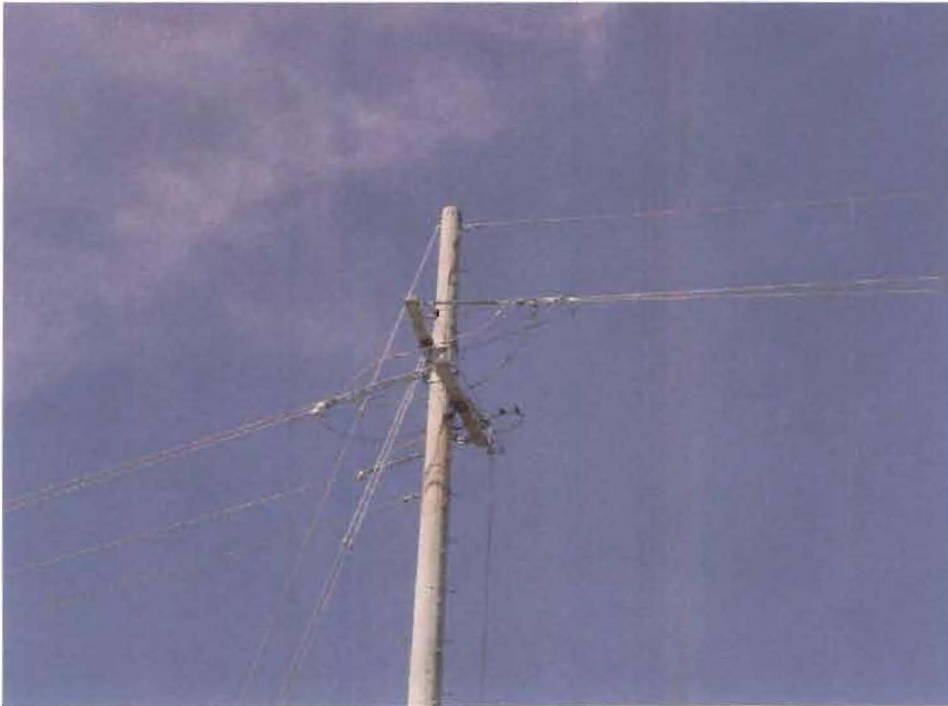
Summary of the Event: Wednesday, March 17, 2004 at approximately 8:45 am a buoy tender barge equipped with three deep water stabilizing legs called spuds contacted the primary feeder crossing Bayou Chico in Pensacola. The craft was observed entering Bayou Chico in the early morning of March 17th to refuel. Comments received from witnesses were that the barge personnel were looking up at the aerial crossing as they passed under it, apparently concerned with the amount of clearance, but they were able to make it under without incident. Upon attempting to leave Bayou Chico, the craft heavily laden with fuel was running low in the water. In order to keep the spuds from hitting and dragging on the bottom in the bayou they put them in the fully raised position resulting in the contact with the feeder as they passed underneath. The barge operator called our customer service center to report the incident and continued on into the Gulf. The contact burned down the west phase of the 12.47 KV feeder 6522 served from Bayou Chico Substation. Attached is Exhibit B, pictures of the crossing structures and damaged line. Gulf's review of the primary crossing using actual and calculated clearances shows that all code and permit requirements were met. Gulf's clearance at worst case high tide is 89.06 feet which exceeds the 85 foot permitted height. The owners have been identified and Gulf is in communication with the company to recover damages. They will also be sent a warning letter.
