**BEFORE THE FLORIDA
PUBLIC SERVICE COMMISSION**

**DOCKET NO. 06038-EI
FLORIDA POWER & LIGHT COMPANY**

**IN RE: FLORIDA POWER & LIGHT COMPANY'S PETITION FOR
ISSUANCE OF A STORM RECOVERY FINANCING ORDER**

Technical Report: Post Hurricane Wilma Engineering Analysis

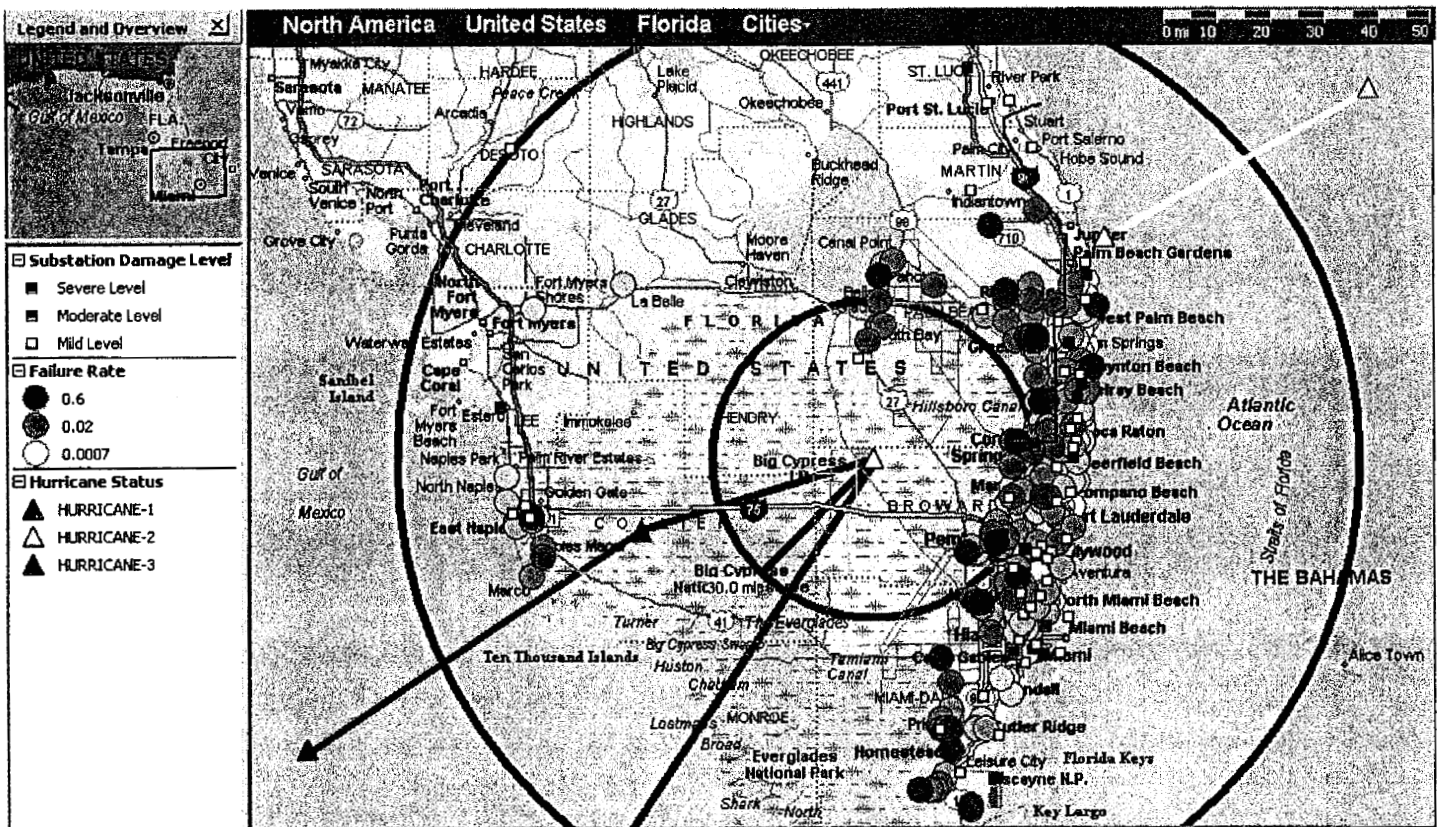
Figure 6-1. Location of substations requiring equipment replacement.

Damage assessment and repair records from Hurricane Wilma show that eight substations experience severe damage; eight stations experienced moderate damage; and forty-five stations had midlevel repairs required. Figure 6-1 illustrates the location of the substations in each of the above categories. Coincidence of location of substations requiring repair and high pole failure rates is evident in the graphic. The pole failure rate data is explained in detail in Section 7 of this report.

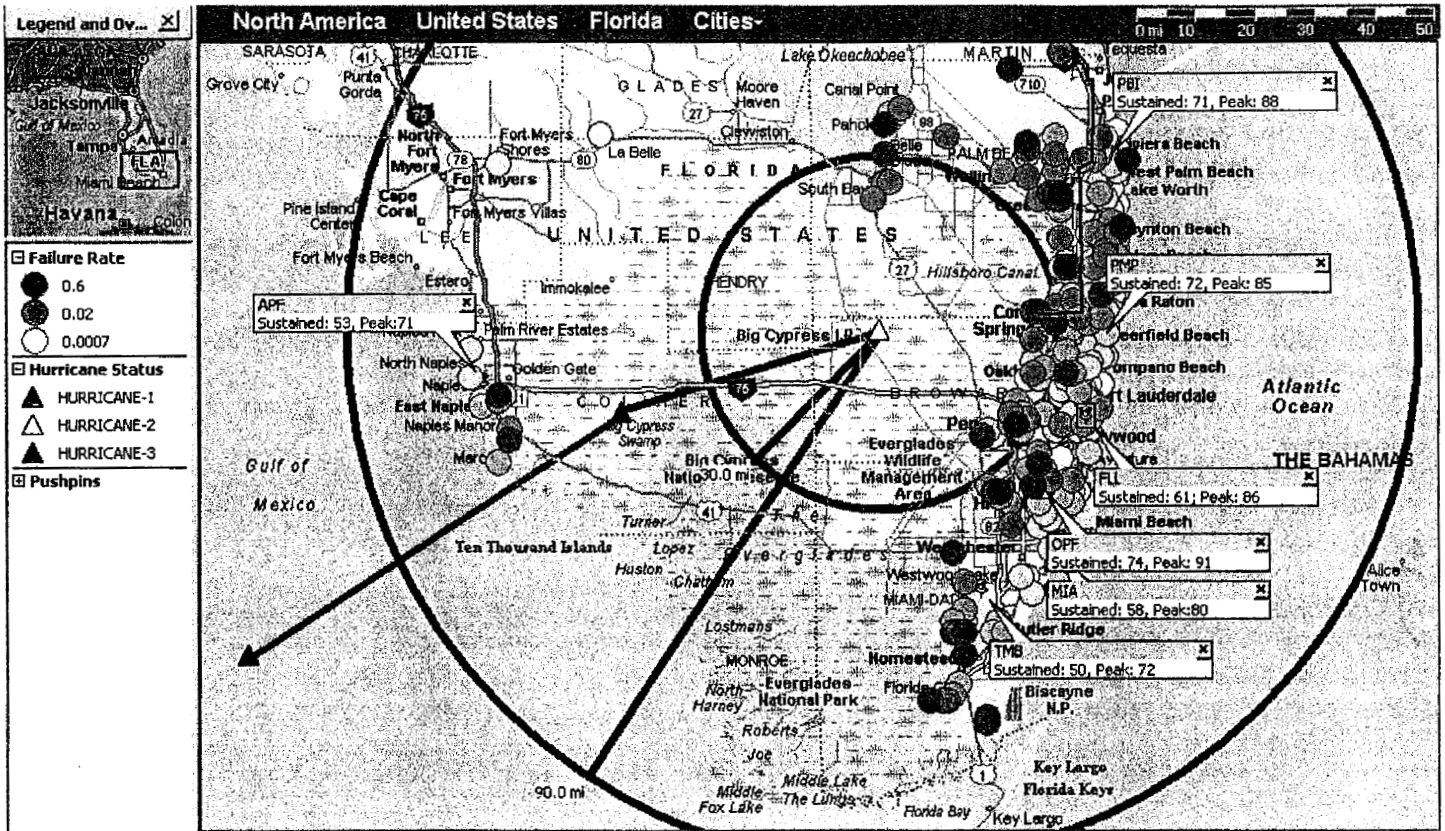
Figure 7-5. Pole failure rate for Hurricane Wilma

From this graphic it becomes apparent that the failure rates are highest at the west side of the Tri-County area. This corresponds with open areas. These places also coincide with the eye wall (red circle) at the last moment the hurricane had a Category 3 classification. Red represents the category 3 path and eye wall, yellow the Category 2 path and blue represents the area affected by hurricane force winds.

The dark blue line coming North-South in Palm Beach represents the grade B and C construction division, with Grade B construction towards the east of this division line.

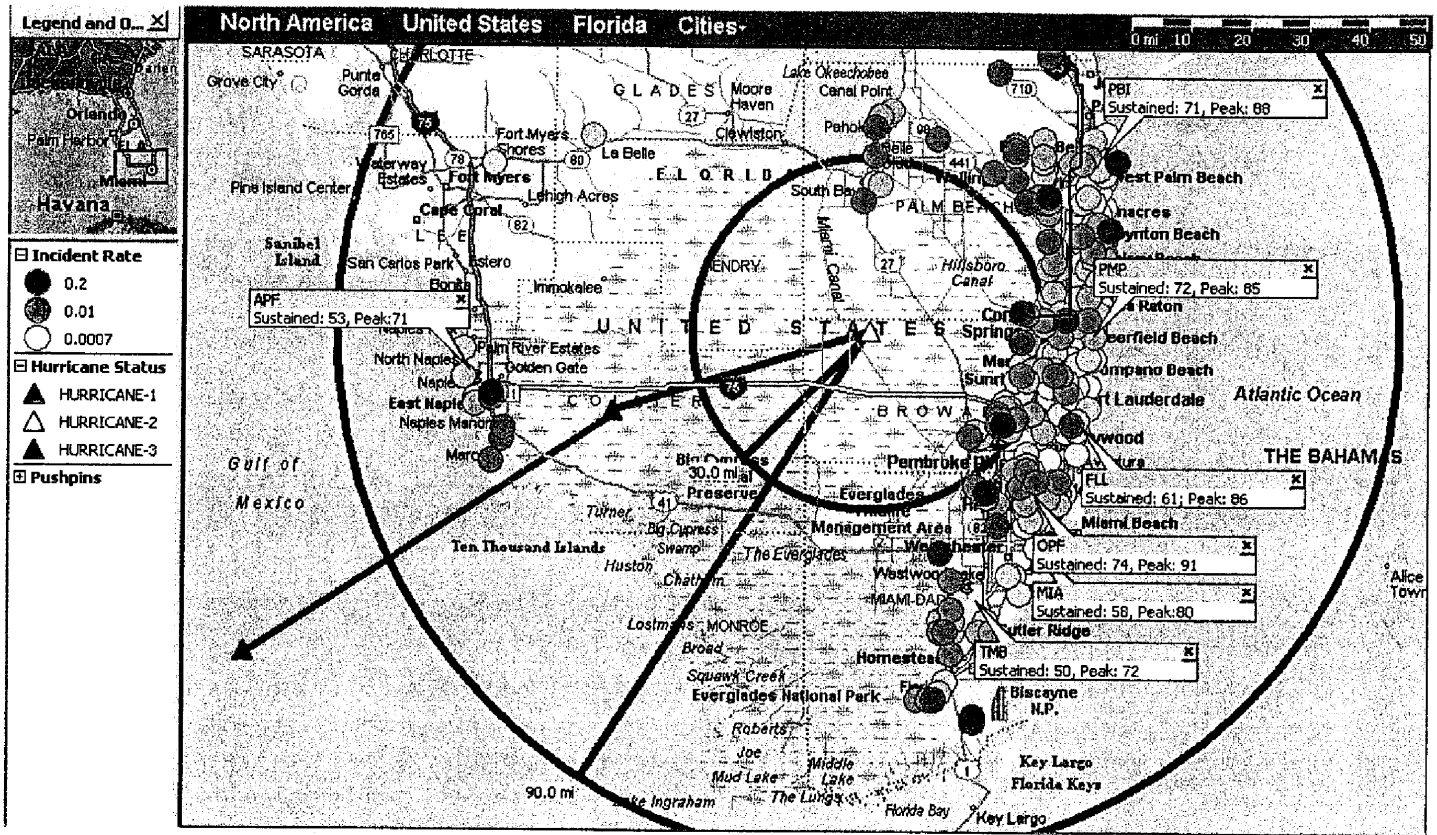
Figure 7-6. Pole breakage incident rate for Hurricane Wilma

This graphic has been produced to ensure proper interpretation of multiple failures. It was expected that the substantial amount of multiple failures, exceeding 85% of the recorded failures, could affect the analysis in general and geographic mapping in particular. However, this graphic with all multiple failures collapsed into single failures, shows similar results as the former graphic.

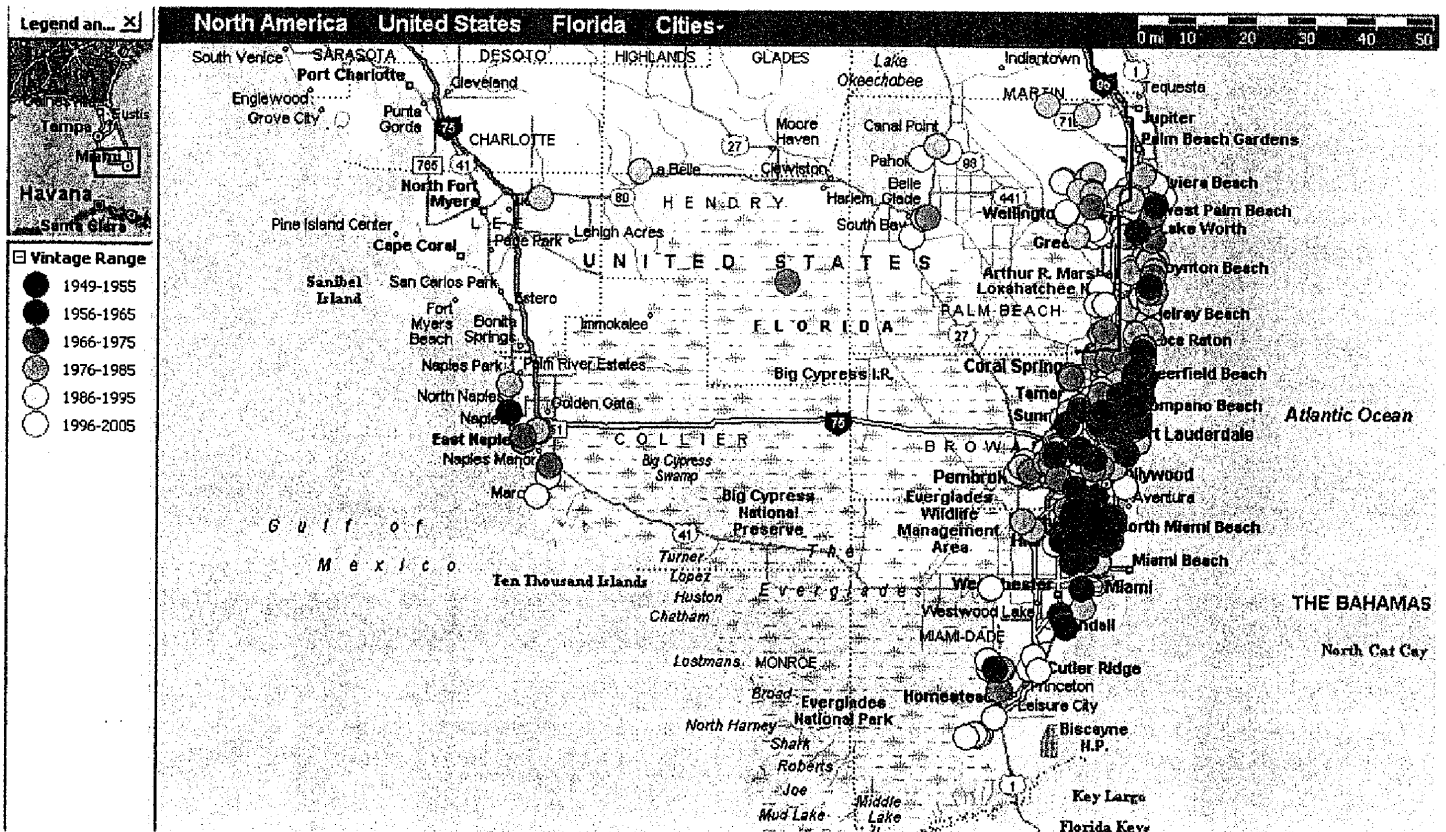
Figure 7-7. Age distribution of broken poles for Hurricane Wilma

This graphic shows opposite results compared to the former two graphics; where the failure rates are lowest the average age of the broken poles is highest and vice versa. It must be emphasized that these ages are the ages of broken poles and not general average pole ages. As Hurrttrak does not have age information, this general age versus area graphic can not be produced.

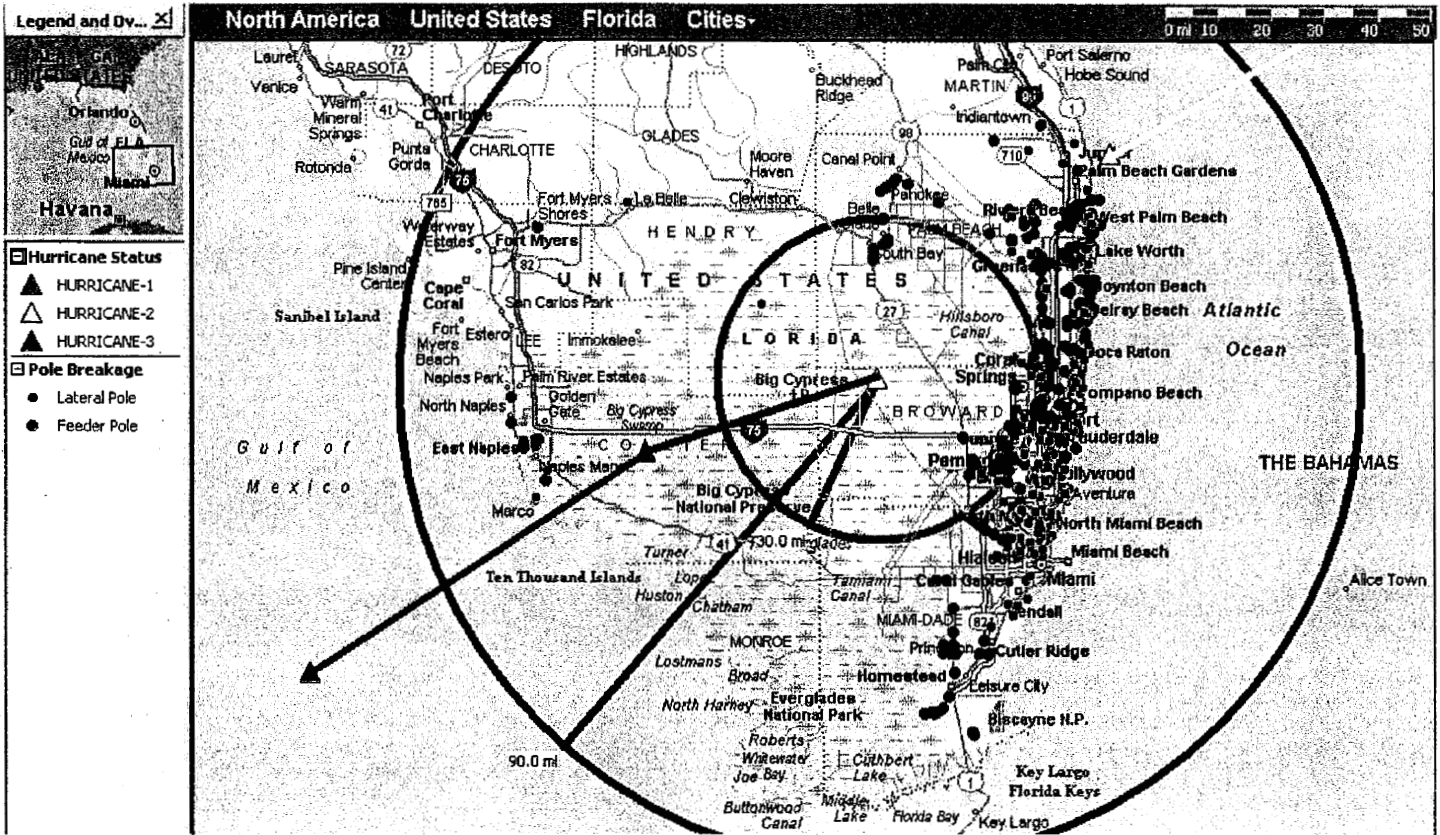
Figure 7-8. Lateral versus feeder pole breakages for Hurricane Wilma

This graphic shows a clear distinction in the investigated area where mostly feeder poles broke and where mostly lateral poles broke during Wilma. The majority of the feeder pole breakages coincide with the areas of higher failure rates and younger poles, except for the East coast of Palm Beach County. This finding triggers two further analyses; one focused on pole breakages for vintages between 1993 and 2004 (to verify potential construct grade effects – parts of Palm Beach allowed grade C construction during this period), the other focused on pole type differences.

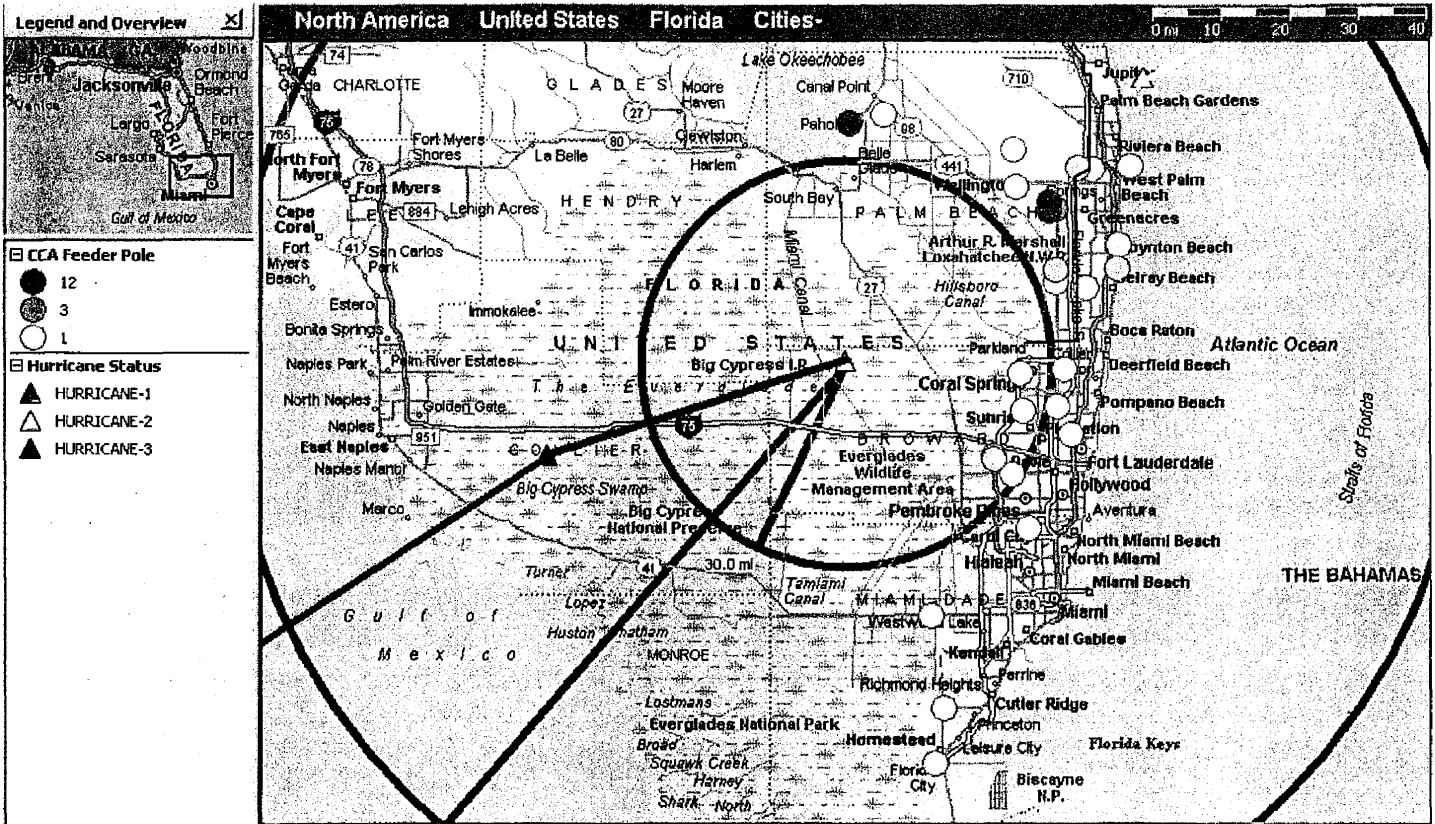
Figure 7-9 Pole breakages for pole vintages between 1993 to 2004

As lateral pole breakages were only found for vintages before 1990, these filtered pole breakages between 1993 and 2002 only included CCA feeder poles. Two concrete feeder pole breakages were recorded in Broward County but have been excluded from this map. Failure rates can not be produced for this aspect as the Hurrtrak data does not provide age data.

Firstly, it can be stated that amount of pole breakages for vintages between 1993 and 2004 was low. Secondly, in Palm Beach County there is some raised level of related incidences potentially indicating a minor construction grade issue. However, the dark green clustered area involved three nearby failures. The three incident locations have multiple breakages that are all caused by wind only. Half of these circuits were double circuits. Most poles had cross-arm construction and half of them fell to the east and half of them fell to the west (all having a North-South orientation). Most of these poles were class 2 poles.

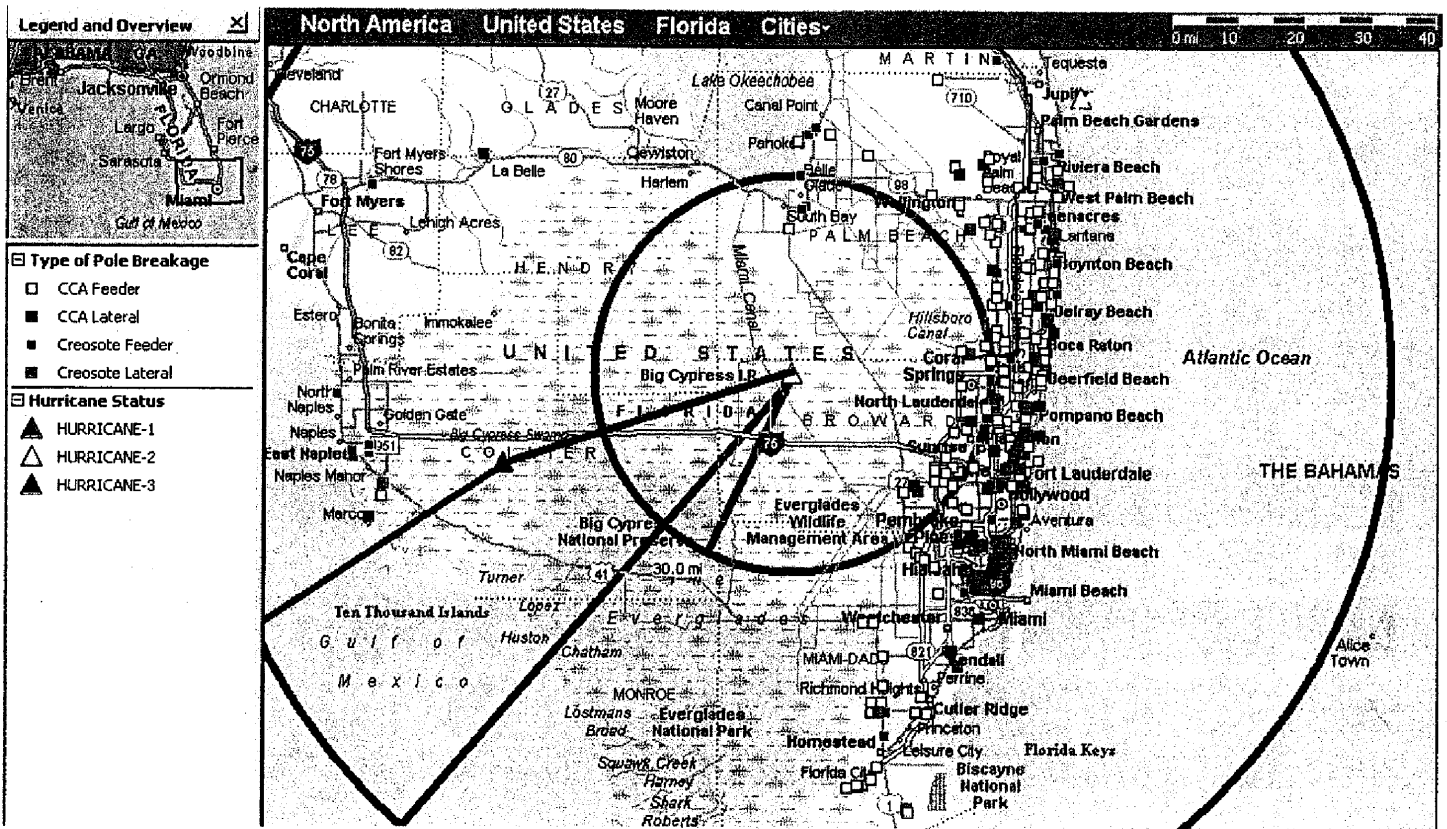
Figure 7-10 Pole breakage by feeder, lateral and pole type

This graphic confirms the findings above with respect to feeder and lateral pole breakages. The graphic adds the fact that most feeder pole breakages involve CCA type poles and lateral pole breakages involve Creosote type poles.

Many CCA feeder poles broke on the East coast of Palm Beach. However, these incidences result in low failure rates as the populations are high in this area. Further investigation revealed that the predominant root cause in this area was wind only, whereas falling trees prevail in the other coastal areas of Broward and Dade counties. From this analysis, is likely that Palm Beach County was hit hardest by the back side of the hurricane.

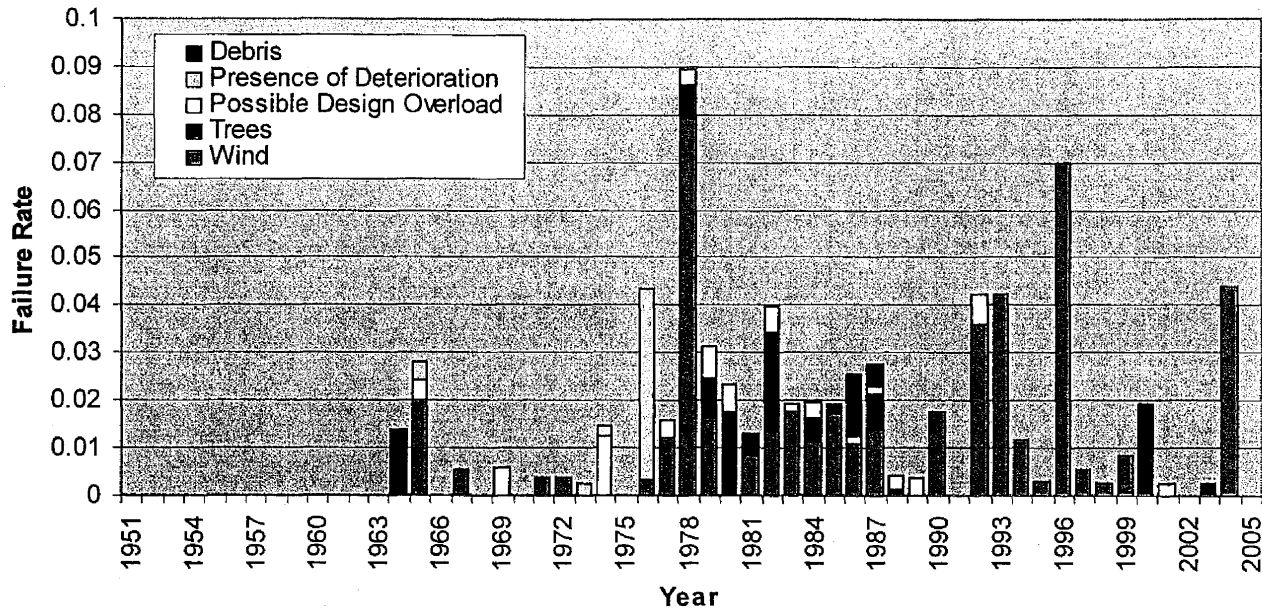
Figure 7-12. FPL owned wood pole failure rates (adjusted) by contributing factor in Palm Beach County

Failure records indicating vintages earlier than 1958 were discarded for this evaluation because the necessary population data was not available from accounting records. The year 1965 shows a relatively high failure rate because many investigated poles that did not have a recognizable age stamp, had been clustered into the age representing the surrounding area. The year 1978 shows a higher failure rate because of an abnormal ratio of 1978 vintage poles as per property accounting (refer to Figure 7-2) and many failed poles of this vintage. As the low balance of 1978 poles has been confirmed, this may indicate that this should be further investigated. Also the relative high failure rates for vintages between 1979 and 1987 also warrant potential further investigation. The relatively high failure rate of 1976, with large contribution of presence of deterioration, goes unexplained. Lastly, the increased failure rate of the year 1996 can be explained by a large multiple failure giving rise to a high failure rate (mostly class 2 poles involved).

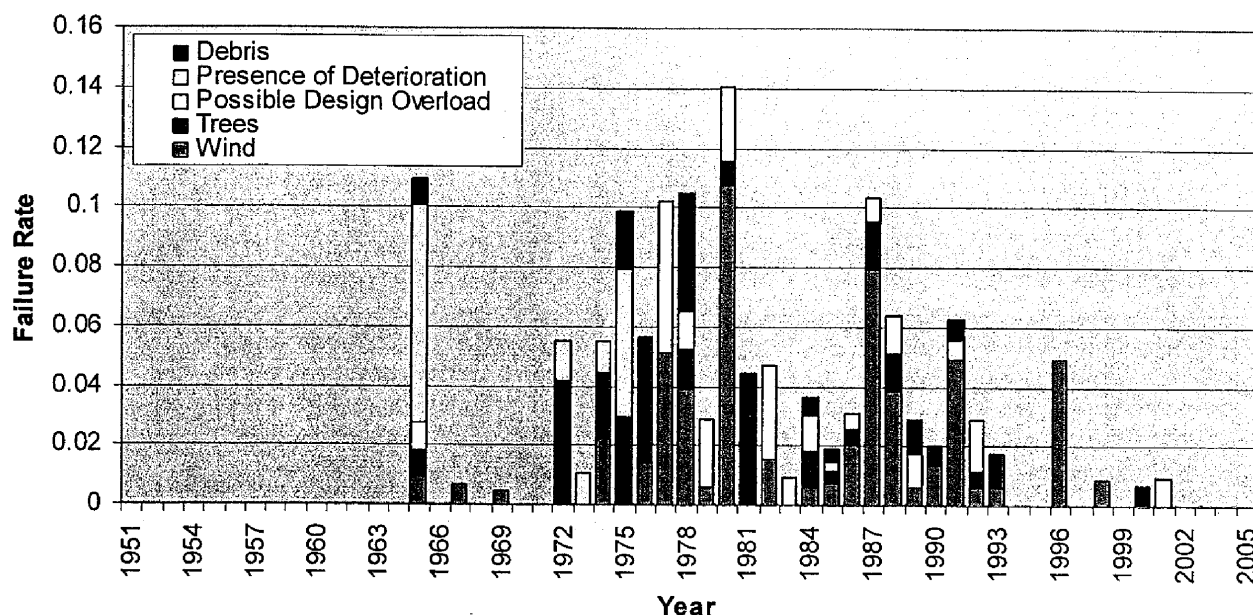
Figure 7-13. FPL owned wood pole failure rate (adjusted) by contributing factor in Broward County

Different from the other two counties, the pattern for Broward County shows a higher failure rate for 1980 instead of 1978 and more pronounced failure rates with presence of deterioration as a contributing factor for poles before 1976.

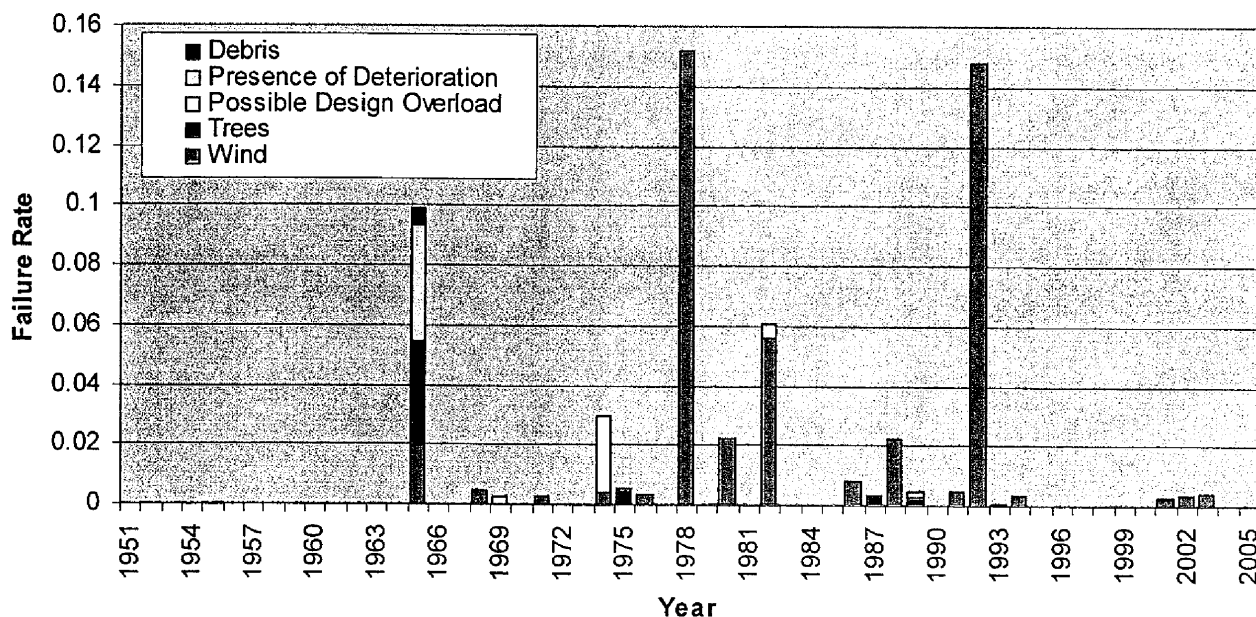
Figure 7-14. FPL owned wood pole failure rate (adjusted) by contributing factor in Dade County

The high failure rates of 1965 and 1978 are identical to the explanations provided for Palm Beach County. The high failure rate of 1992 indicates the potential influence of poles replaced due to hurricane Andrew; it could also be that these poles are simply in vulnerable areas. Mostly class 3 and 4 poles were involved in the 1992 failure records for Dade County. Further investigation revealed that the 1978 and 1992 failure rates were especially high due to multiple breaks.

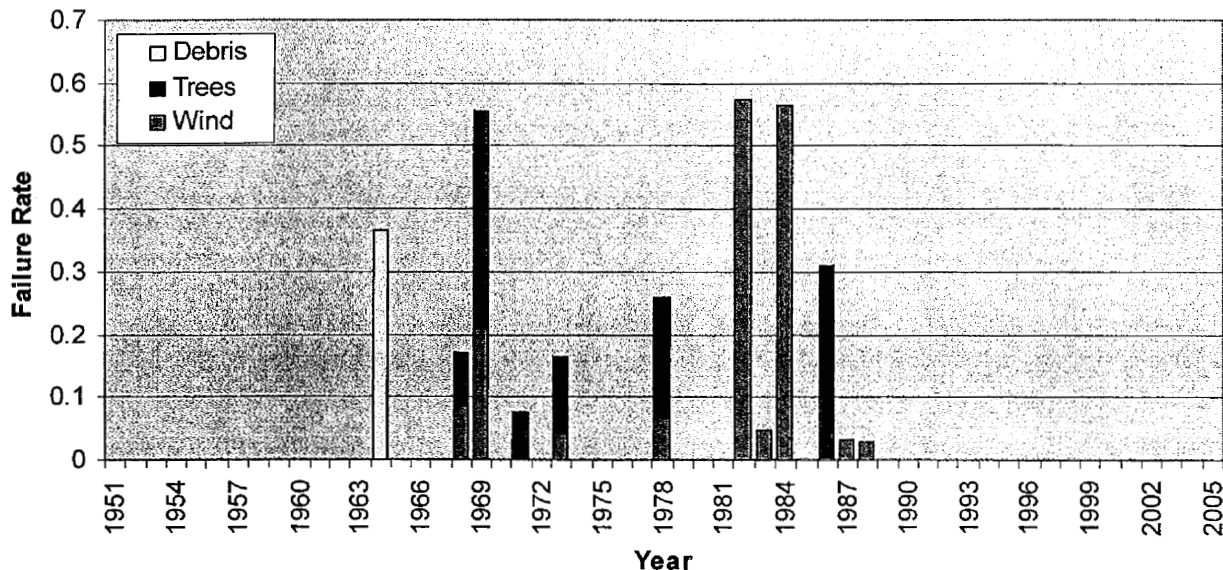
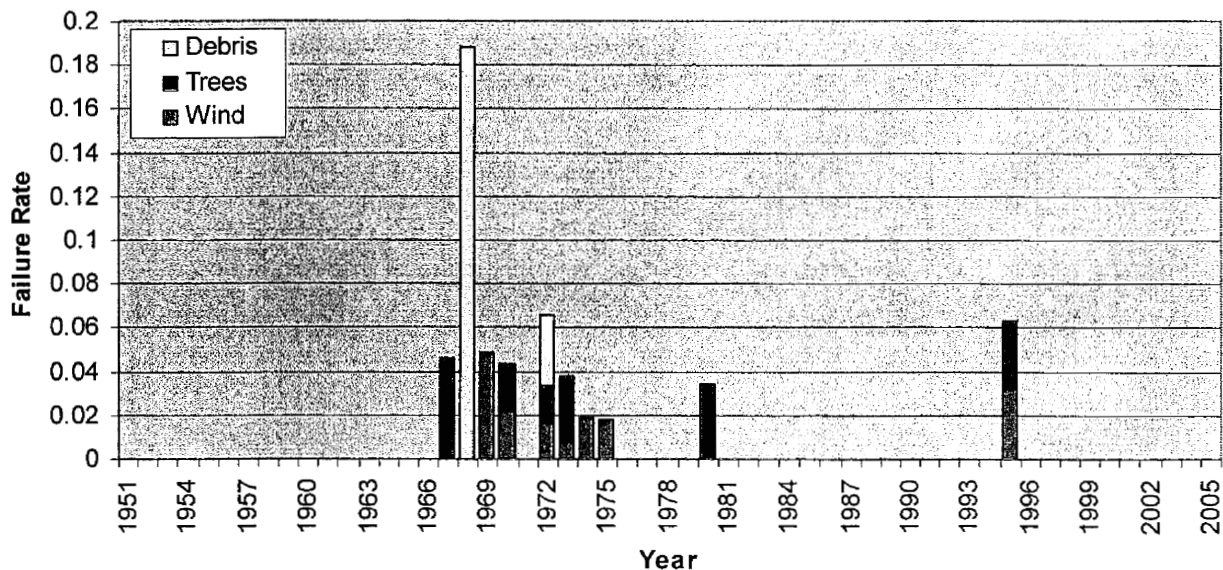
Here we note a specific pattern of higher failure rates for a selected set of vintages, especially for older vintages (before 1990), with high impact of wind only.
