RE: Annual Storm Hardening Reports of the Municipal and Cooperative Electric Utilities Pursuant to Rule 25-6.0343, F.A.C

Please add the following Storm Hardening Reports of the municipal and cooperative electric utilities for calendar year 2006 to Case Management, Docket Number 070000. The attached reports are the first filings pursuant to Rule 25-6.0343, F.A.C. If you have any questions, please let me know. Thank you.

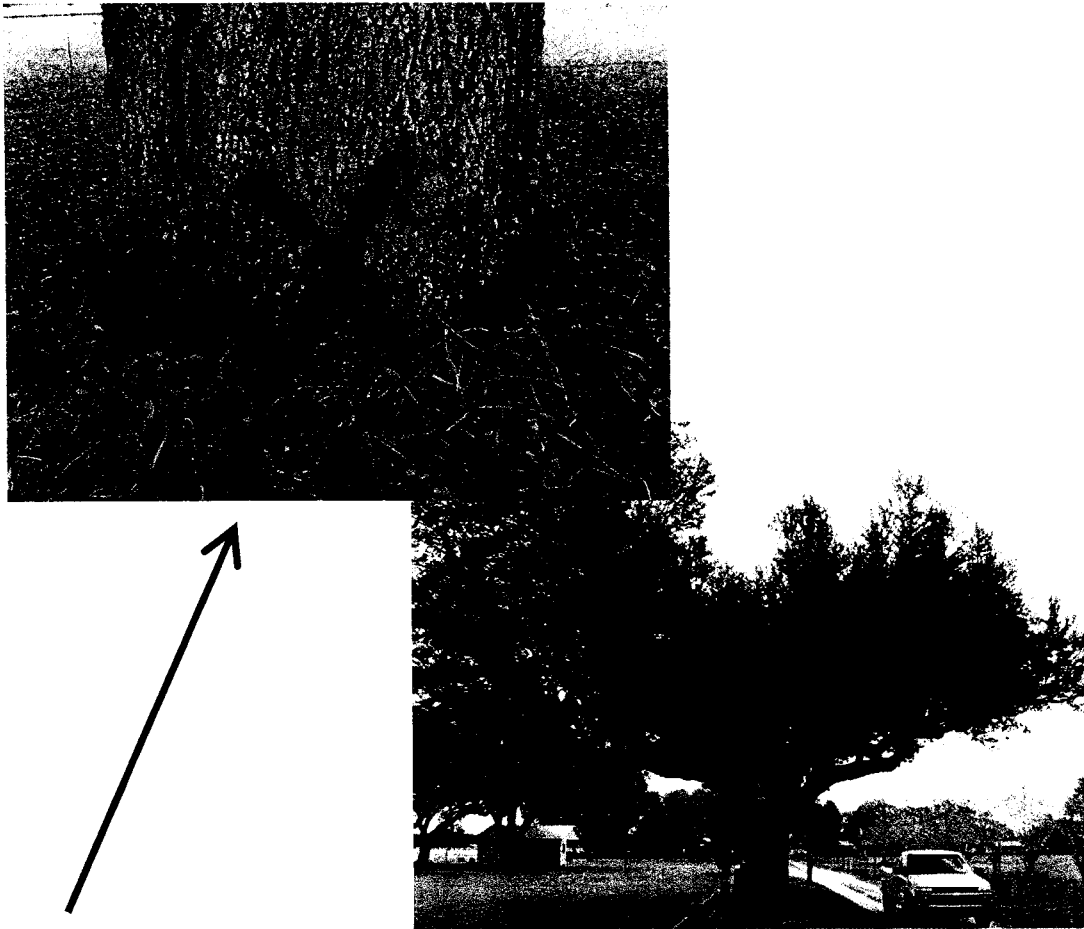
Example: Crown Reduction (Dot) to Remove ("X")

SECO marked this tree for a crown reduction with a "Dot". The member / customer modified the marking with their own paint to an "X". This signifies removing the tree. SECO has experienced this since the hurricanes of 2004.

This clearly illustrates the change in customer's willingness to trim / remove trees. It also presents the potential for a large increase in projected cost and time to trim (cycle). The price for a crown reduction is \$79.00. Since this tree is in the feeder circuit, SECO will remove it. Since this tree is over 40" in diameter, it will be removed at "hourly rates". The cost (including wood removal) is \$1,740.00. This is an increased cost of 2103% for one tree.
