RE: Docket No. 080248-SU; Tierra Verde Utilities, Inc.'s Application for an Increase in Wastewater Rates Increase in Pinellas County, Florida  
Our File No.: 30057.156

3(a) The "TV Sewer Mains" project reflects the effort to clean and video inspect two portions of the Tierra Verde collection system. The gravity main and manholes situated in the Pinellas Bayway right-of-way and the area west of the Pinellas Bayway along and adjacent to Madonna Avenue had not been cleaned and inspected for many years. A total of 6,229 LF of 18" diameter pipe was cleaned and inspected along the Pinellas Bayway. A total of 21,250 LF of 8" diameter pipe and manholes were inspected west of the Pinellas Bayway along Madonna Avenue. The project is justified for the following reasons:

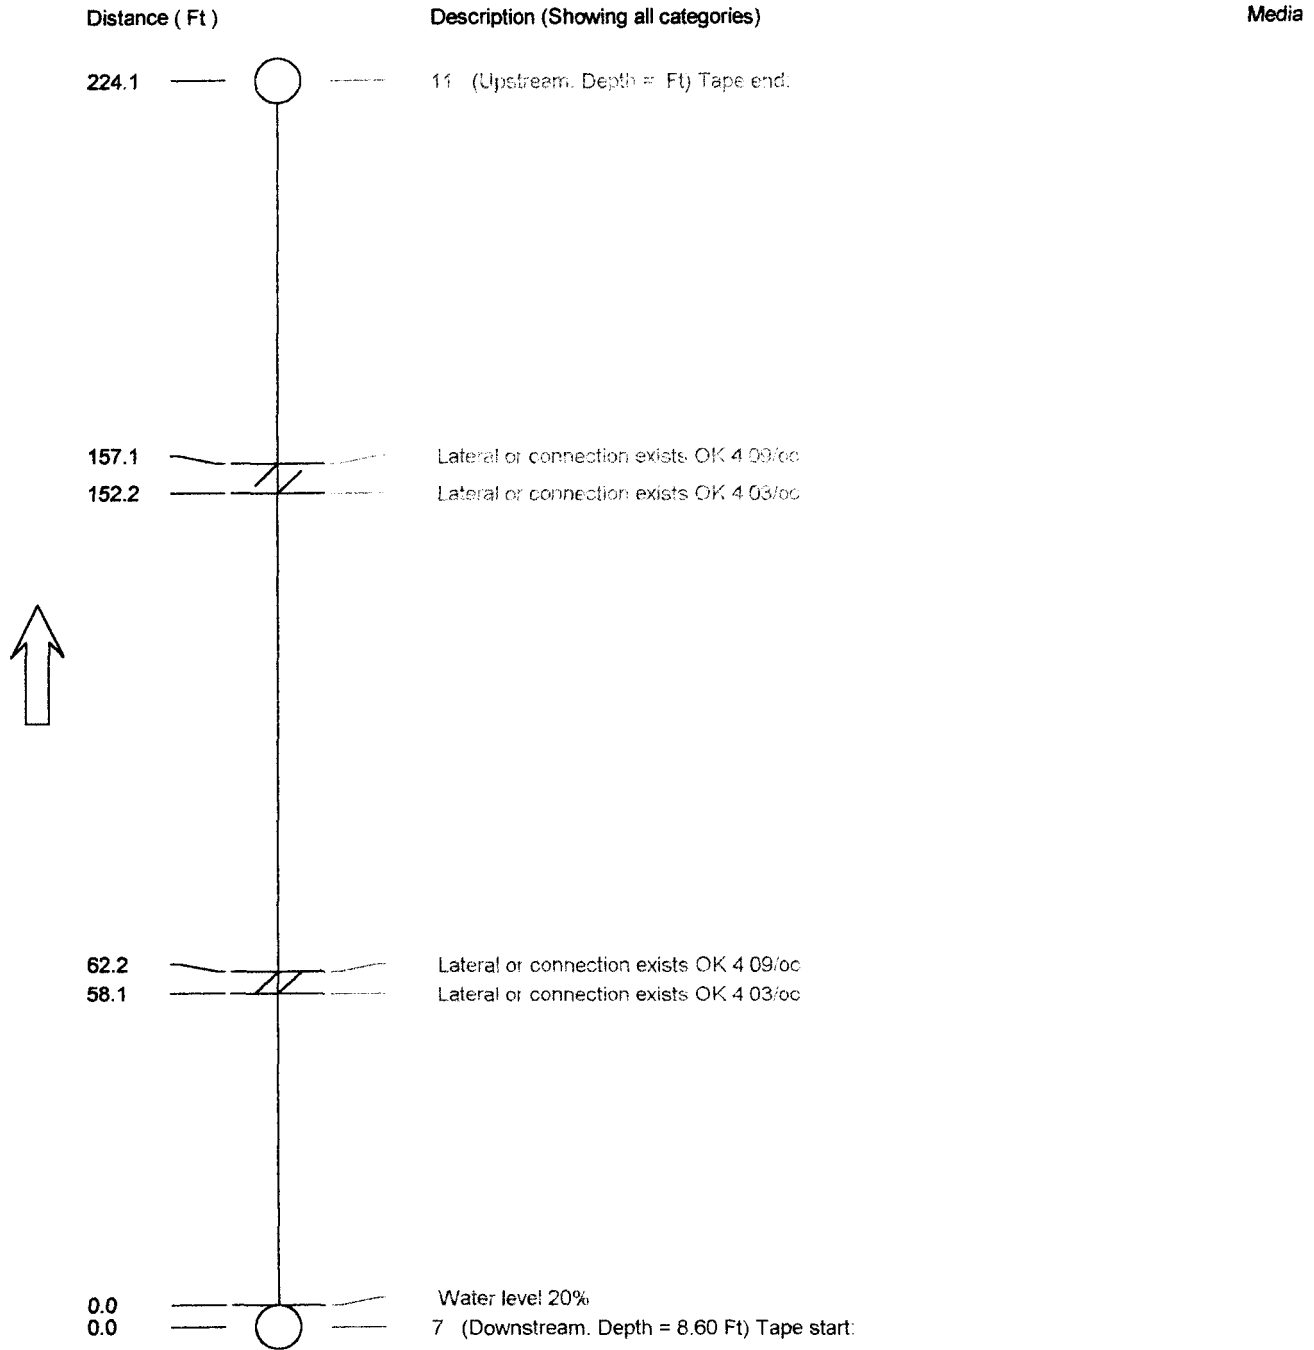
<b>Job</b> Operator BMN	<b>Contract</b> Van Reference	<b>Cassette</b> 1	<b>Surveyed On</b> 07/23/2004	<b>Sheet</b> 7
<b>Road Name</b> SW 5TH CT.		<b>Place Name</b> TIERRA VERDE		
<b>Location type</b> Light road (rural roads with lighter traffic, town & city back streets)				
<b>Surface</b>				
<b>Survey purpose</b> Sample survey to determine asset condition				
<b>Pipe Use</b> Foul	<b>Schedule length</b> 224.1 Ft	<b>From</b> 12	<b>Depth</b> 4.20 Ft	
<b>Shape</b> Circular	<b>Size</b> 8 by ins	<b>To</b> 11	<b>Depth</b> Ft	
<b>Material</b> Polyvinyl chloride	<b>Joint spacing</b> Ft	<b>Direction</b> Down		
<b>Lining</b>	<b>Year laid</b>	<b>Cat</b> A	<b>Pre-clean</b> Y	<b>Last cleaned</b>
<b>General note</b> SEE SHEET 15		<b>Structure</b>	<b>Service</b>	<b>Construction</b>
<b>Location note</b> 3.2' HARD DEBRIS		<b>Material</b>

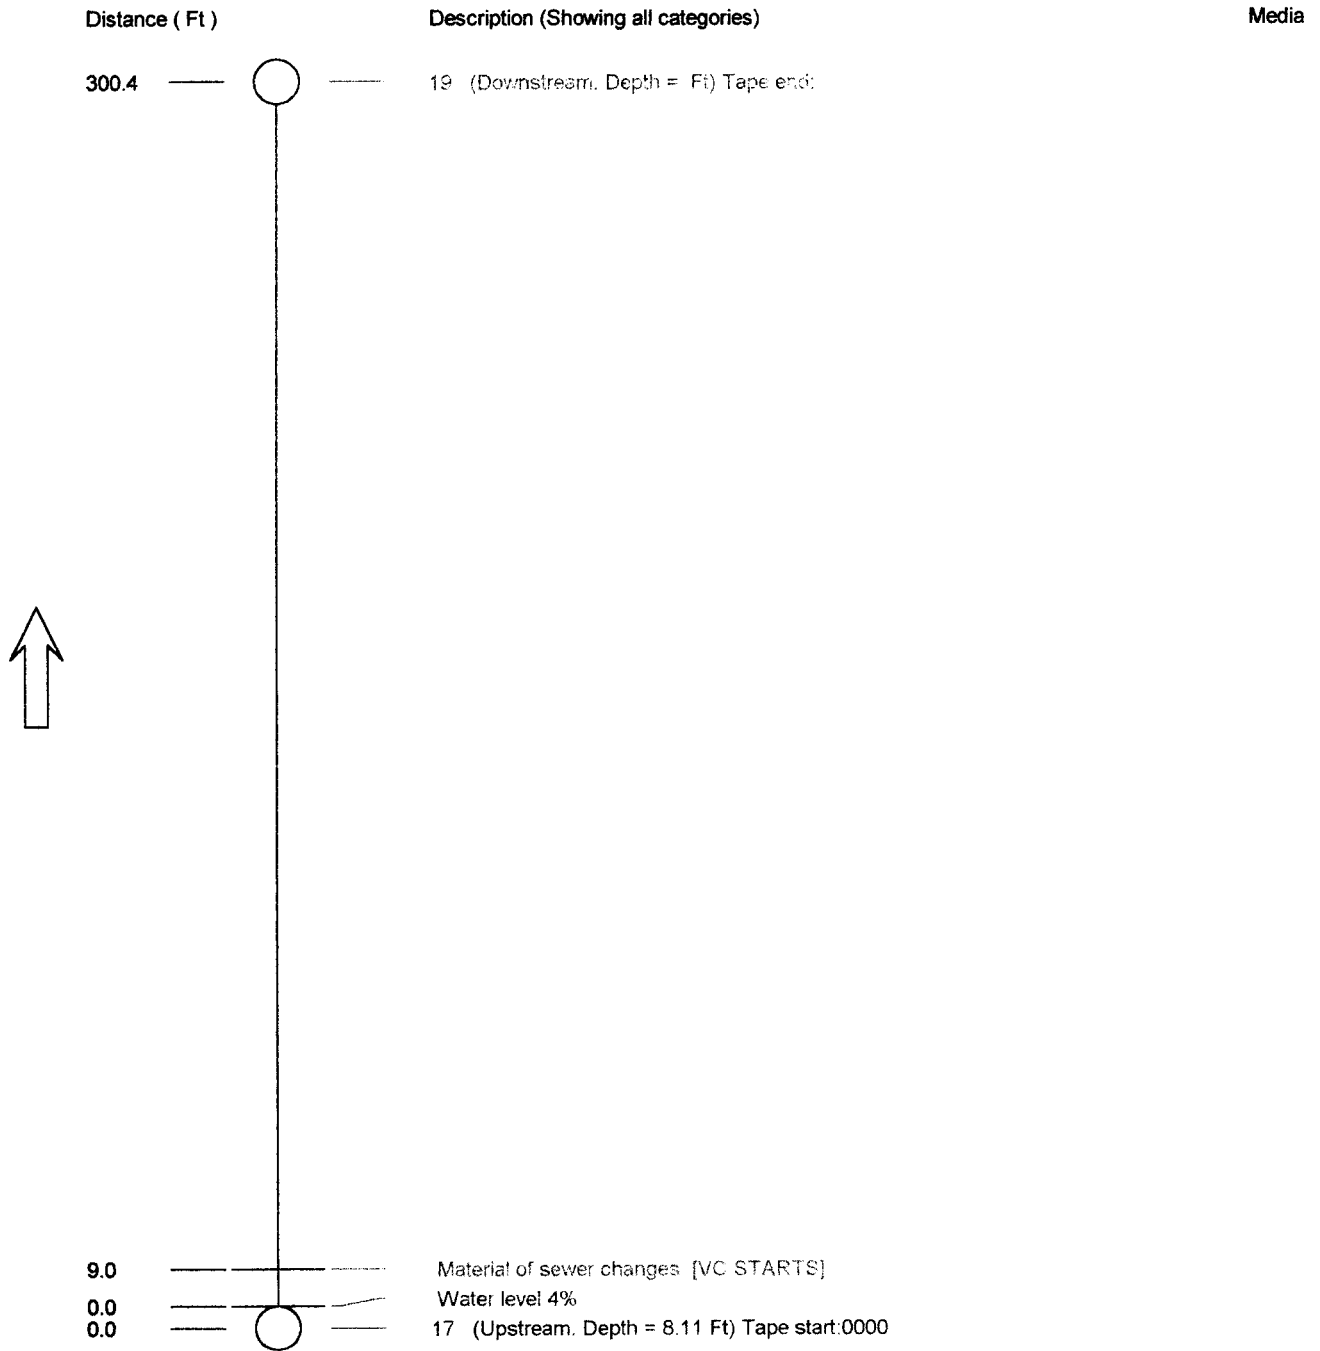
<b>Job</b>	<b>Contract</b>	<b>Cassette 3</b>	<b>Surveyed On</b> 08/06/2004	<b>Sheet</b> 23
<b>Operator</b> DWH	<b>Van Reference</b>	<b>Weather</b> Dry		
<b>Road Name</b> 6TH ST.		<b>Place Name</b> TIERRA VERDE		
<b>Location type</b> Light road (rural roads with lighter traffic, town & city back streets)				
<b>Surface</b>				
<b>Survey purpose</b> Sample survey to determine asset condition				
<b>Pipe Use</b> Foul	<b>Schedule length</b> 387.0 Ft	<b>From</b> 9	<b>Depth</b>	<b>Ft</b>
<b>Shape</b> Circular	<b>Size</b> 8 by ins	<b>To</b> 17	<b>Depth</b>	8.11 Ft
<b>Material</b> Vitrified clay	<b>Joint spacing</b> Ft	<b>Direction</b> Down		
<b>Lining</b>	<b>Year laid</b>	<b>Cat</b> A	<b>Pre-clean</b> Y	<b>Last cleaned</b>
<b>General note</b> SEE SHEET 20 FOR REVERSE SETUP		<b>Structural</b>	<b>Service</b>	<b>Condition</b>
<b>Location note</b>		Minor Blockage	None	Good

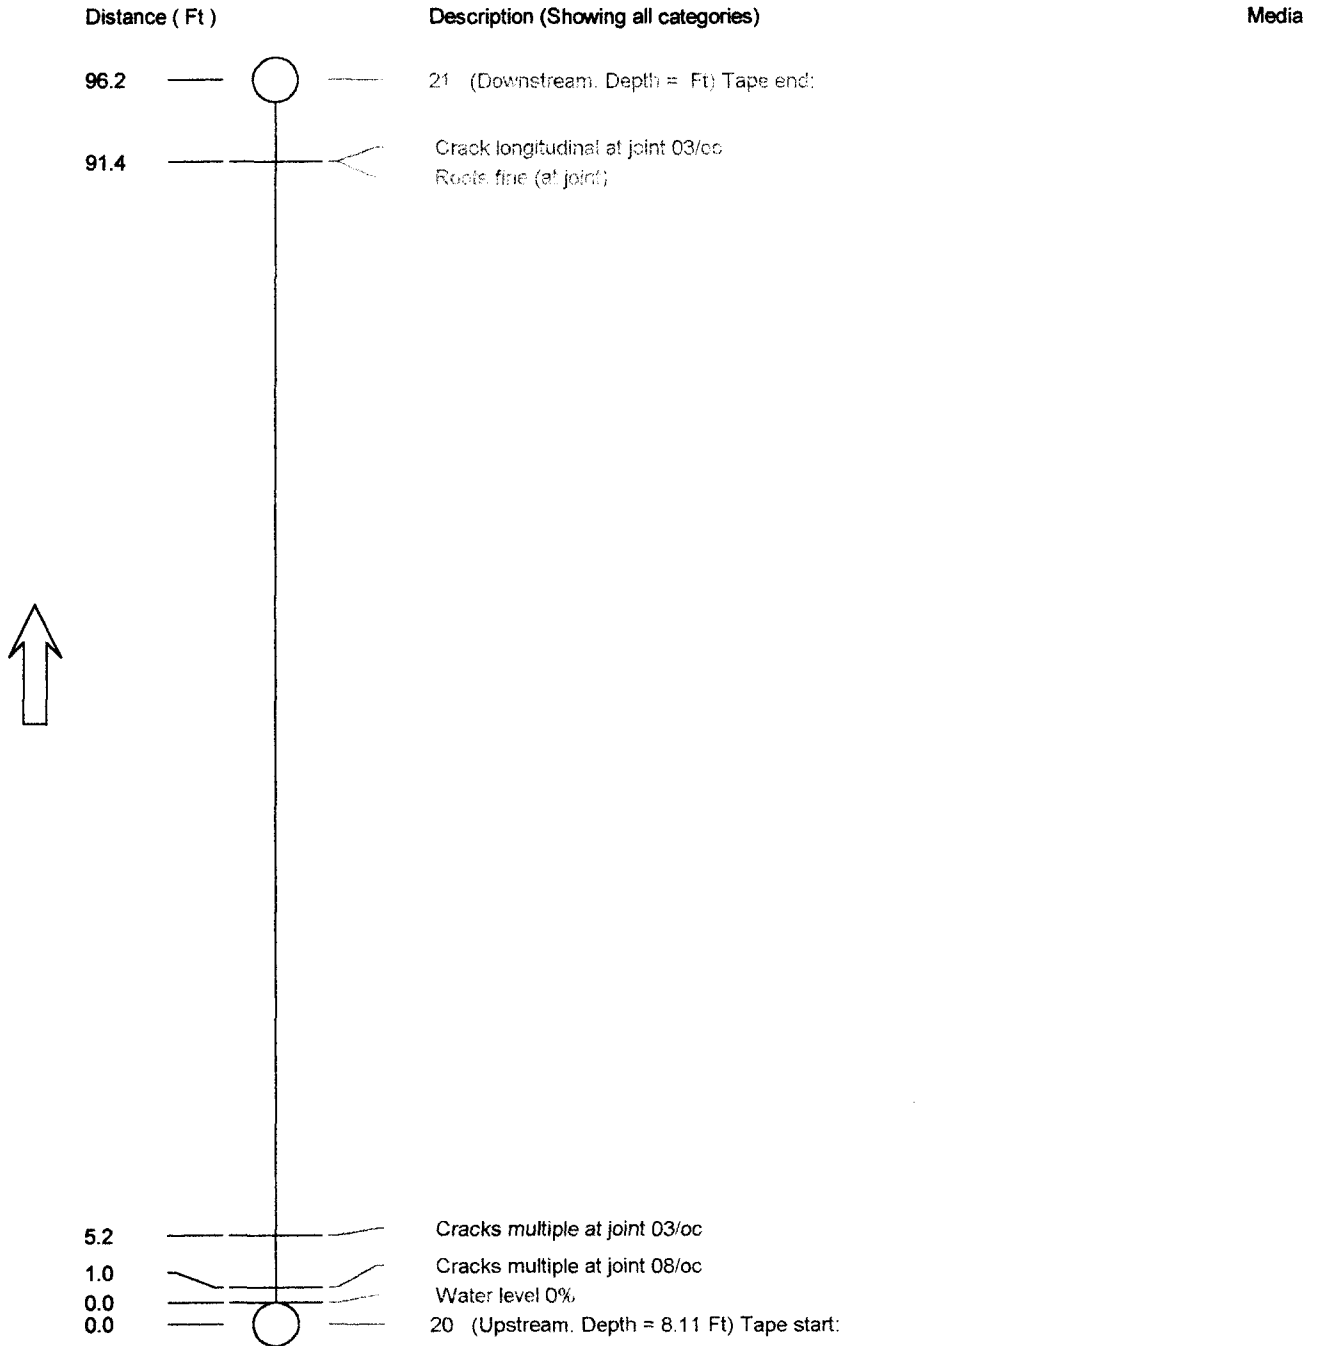
<b>Job</b> Operator DWH	<b>Contract</b> Van Reference	<b>Cassette</b> 3	<b>Surveyed On</b> 08/06/2004	<b>Sheet</b> 25
<b>Road Name</b> 8TH AVE N		<b>Place Name</b> TIERRA VERDE		
<b>Location type</b> Light road (rural roads with lighter traffic, town & city back streets)				
<b>Surface</b>				
<b>Survey purpose</b> Sample survey to determine asset condition				
<b>Pipe Use</b> Foul	<b>Schedule length</b> 101.5 Ft	<b>From</b> 22	<b>Depth</b>	<b>Ft</b>
<b>Shape</b> Circular	<b>Size</b> 8 by ins	<b>To</b> 21	<b>Depth</b>	<b>Ft</b>
<b>Material</b> Vitrified clay	<b>Joint spacing</b> Ft	<b>Direction</b> Up		
<b>Lining</b>	<b>Year laid</b> Cat A	<b>Pre-clean</b> Y	<b>Last cleaned</b>	
<b>General note</b>		Structural	Service	Crack circumferential
<b>Location note</b>		11/12/03

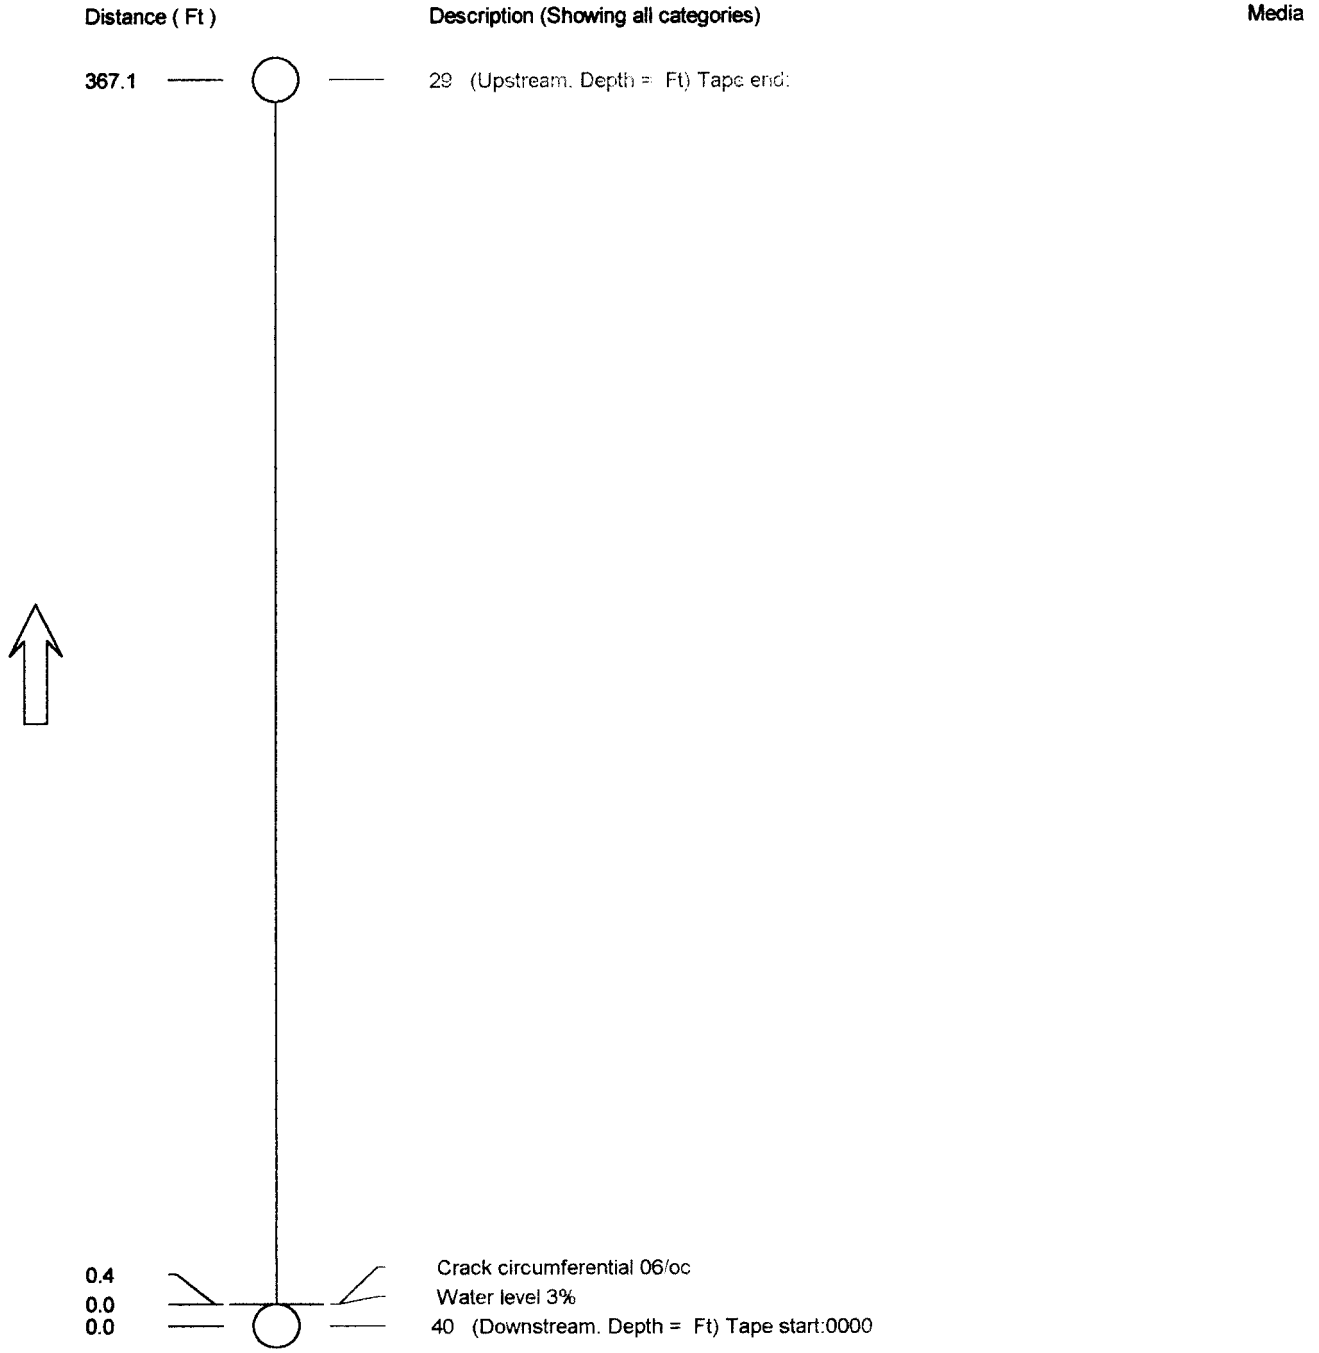
<b>Job</b> Operator DWH	<b>Contract</b> Van Reference	<b>Cassette</b> 6	<b>Surveyed On</b> 08/10/2004	<b>Sheet</b> 44
<b>Road Name</b> MADONNA BLVD.		<b>Place Name</b> TIERRA VERDE		
<b>Location type</b> Light road (rural roads with lighter traffic, town & city back streets)				
<b>Surface</b>				
<b>Survey purpose</b> Sample survey to determine asset condition				
<b>Pipe Use</b> Foul	<b>Schedule length</b> 280.3 Ft	<b>From</b> 40	<b>Depth</b> Ft	
<b>Shape</b> Circular	<b>Size</b> 8 by Ins	<b>To</b> 41	<b>Depth</b> Ft	
<b>Material</b> Vitrified clay	<b>Joint spacing</b> Ft	<b>Direction</b> Up		
<b>Lining</b>	<b>Year laid</b> Cat A	<b>Pre-clean</b> Y	<b>Last cleaned</b>	
<b>General note</b>		Structural	Service	Crack/Infect
<b>Location note</b>		Miscellaneous

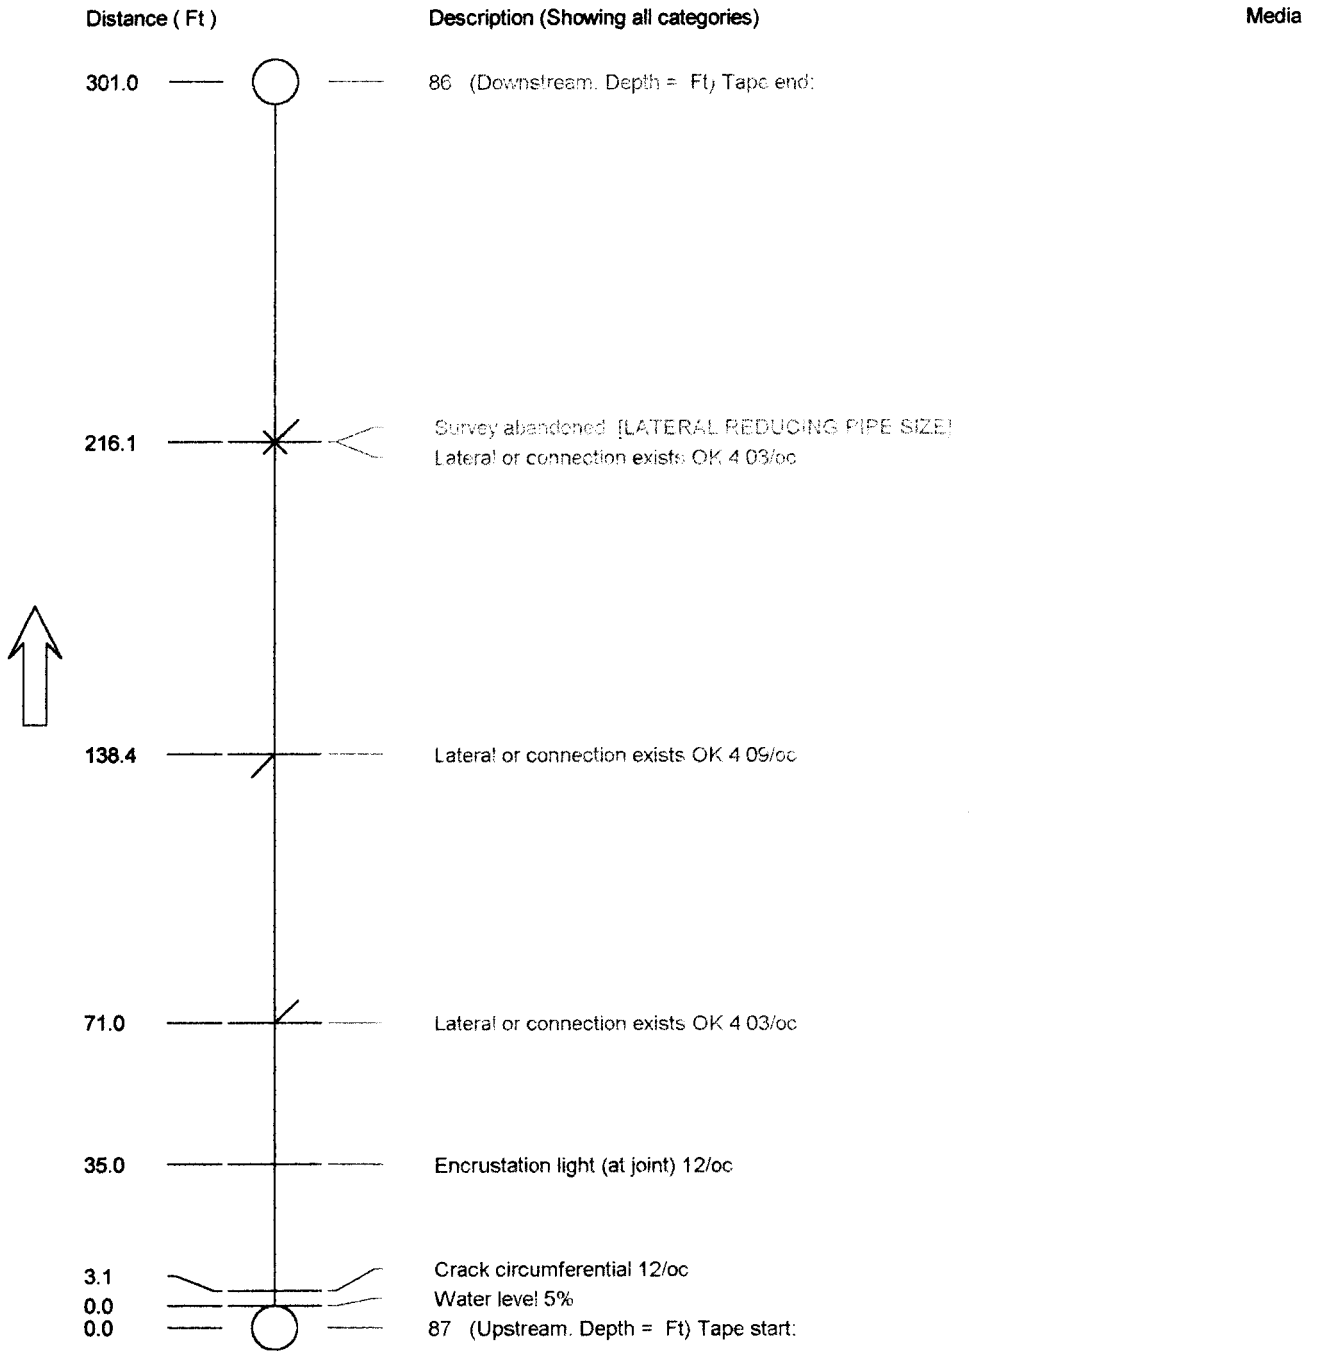
<b>Job</b>	<b>Contract</b>	<b>Cassette 11</b>	<b>Surveyed On</b> 08/17/2004	<b>Sheet</b> 85
<b>Operator</b> BMN	<b>Van Reference</b>	<b>Weather</b> Dry		
<b>Road Name</b> 1ST ST. W.		<b>Place Name</b> TIERRA VERDE		
<b>Location type</b> Light road (rural roads with lighter traffic, town & city back streets)				
<b>Surface</b>				
<b>Survey purpose</b> Sample survey to determine asset condition				
<b>Pipe Use</b> Foul	<b>Schedule length</b> 228.9 Ft	<b>From</b> 58	<b>Depth</b>	<b>Ft</b>
<b>Shape</b> Circular	<b>Size</b> 8 by ins	<b>To</b> 57	<b>Depth</b>	<b>Ft</b>
<b>Material</b> Vitrified clay	<b>Joint spacing</b> Ft	<b>Direction</b> Down		
<b>Lining</b>	<b>Year laid</b> Cat A	<b>Pre-clean</b> Y	<b>Last cleaned</b>	
<b>General note</b>	Structural		Service	Cracks multiple
<b>Location note</b>	Midstream
