STANDPIPE INSPECTION REPORT

JOB NO: (LEC) 22191-E DATE: 4/19/04 INSPECTOR: Team 13
TANK OWNER: Utilities Inc. of Florida OWNER'S ORDER NO: _____
OWNER'S REPRESENTATIVE: Mike Dunn TITLE: Primary Contact
MAILING ADDRESS: 200 Weathersfield Ave. PHYSICAL ADDRESS: 200 Weathersfield Ave.
CITY, STATE: Altamonte Springs, FL ZIP: 32714
COUNTY TANK IS LOCATED IN: Unknown SEISMIC ZONE OF COUNTY: 0
TELEPHONE: (407) 869-1919 FAX: (407) 869-6961
LOCATION OF TANK: LABRADOR RESERVOIR

ORIGINAL CONTRACT NO: unknown YEAR BUILT: 1970
ORIGINAL MANUFACTURER: unknown CAPACITY: 34,000 Gallon
DATE OF LAST INSPECTION: unknown TYPE: Potable
DIAMETER: 15' HEIGHT: 28'
TYPE CONSTRUCTION: WELDED: _____ RIVETED: _____ BOLTED: X
WHO IS CUSTOMER'S INSURANCE CARRIER: unknown

Utilities Inc. of Florida
34,000 Gallon Standpipe
(LEC) Job No. 22191-E

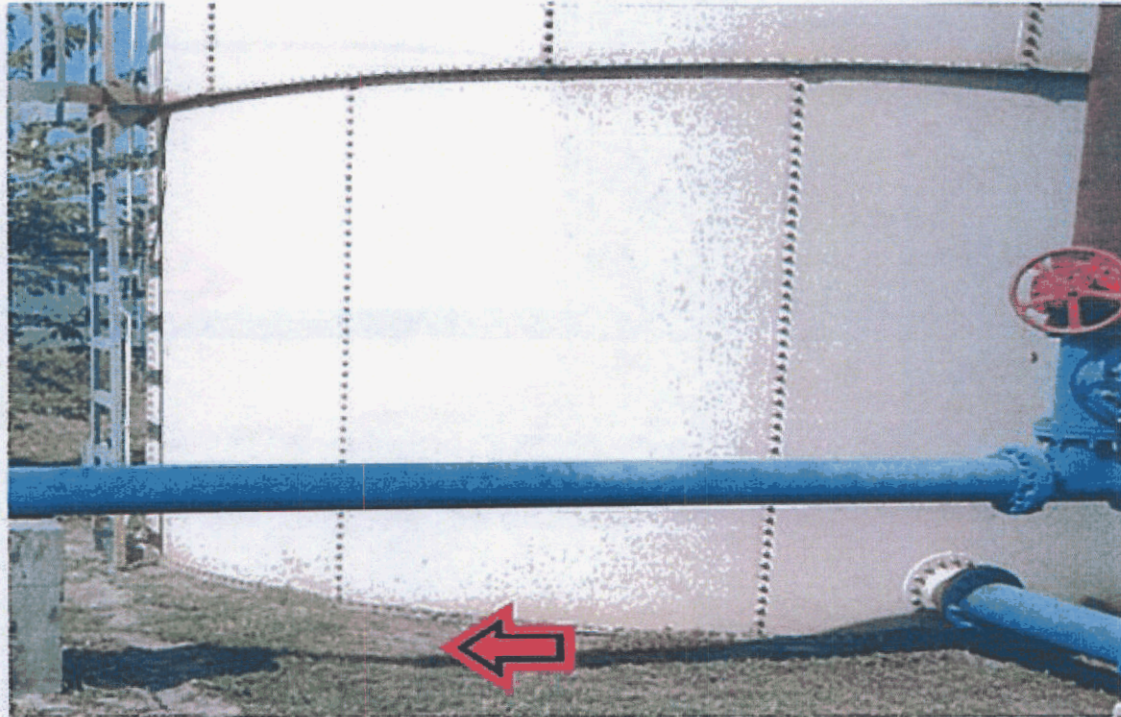
Photo shows the condition of the foundation. We recommend clearing any dirt, debris and other loose gravel away from the tank foundation, down to a minimum 6" below top of foundation as required by AWWA D100-96, Section 12.6.1: Foundations for flat bottom tanks. (see glossary pg. 3). This should be done by a local excavating company.

- 3. Repair any cracks and spalling in the concrete with a commercial non-shrinking grout, then caulking around the base of the tank to foundation connection to prevent water from entering under the tank and sealing the foundation with a concrete sealant..... \$1,450

- Electrically ground the tank for lightning protection as required by OSHA, (general duty clause) and NFPA..... \$1,275

We further recommend repairing any cracks and spalling in the concrete with a commercial non-shrinking grout, then caulking around the base of the tank to foundation connection to prevent water from entering under the tank and sealing the foundation with a concrete sealant.

We also recommend electrically grounding the tank for lightning protection as required by OSHA, (general duty clause) (see glossary).

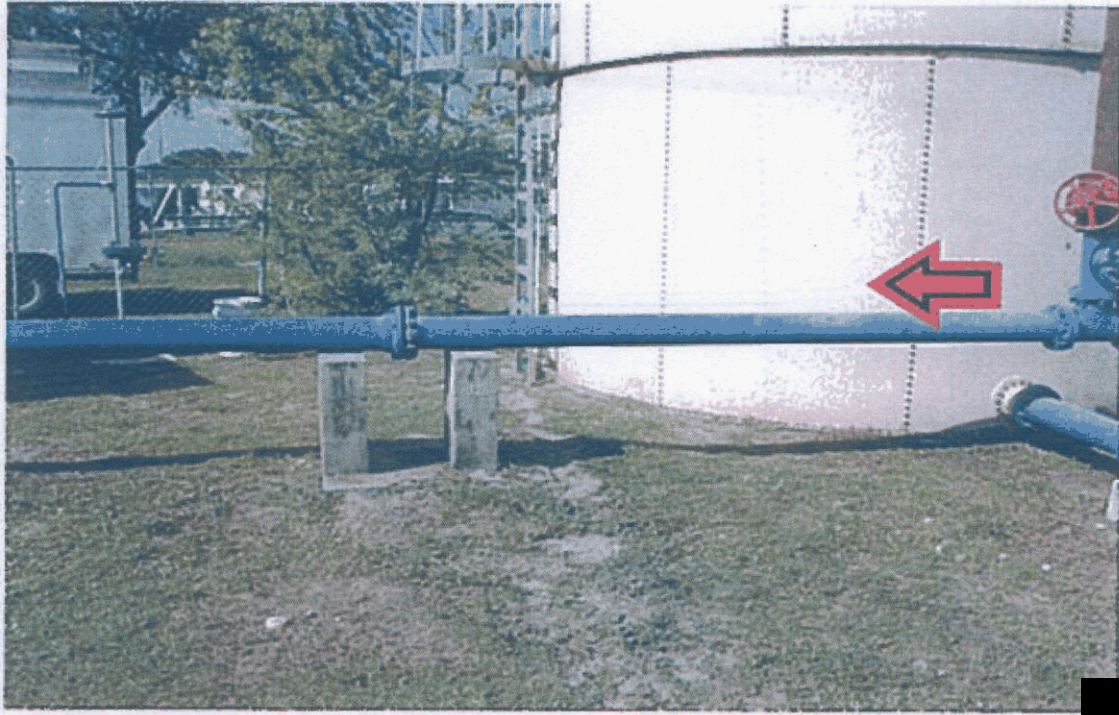
Photo shows the condition of the tank shell. The tank is not equipped with a manway. The following items are required to bring tank in compliance with AWWA D100-96, section 7.1: Shell Manways, OSHA, and TSS, (see glossary pg. 8):

- 4. Install 36" primary shell manway \$3,850
substitute a 30" manway for a 36" manway
- 5. Install a cable type ladder safety climb device \$1,850
 Post a **Fall Protection Required** sign \$25

Install a 36" manway

Note: For safety reasons we have recommended a 36" manway instead of the required 24" manway.

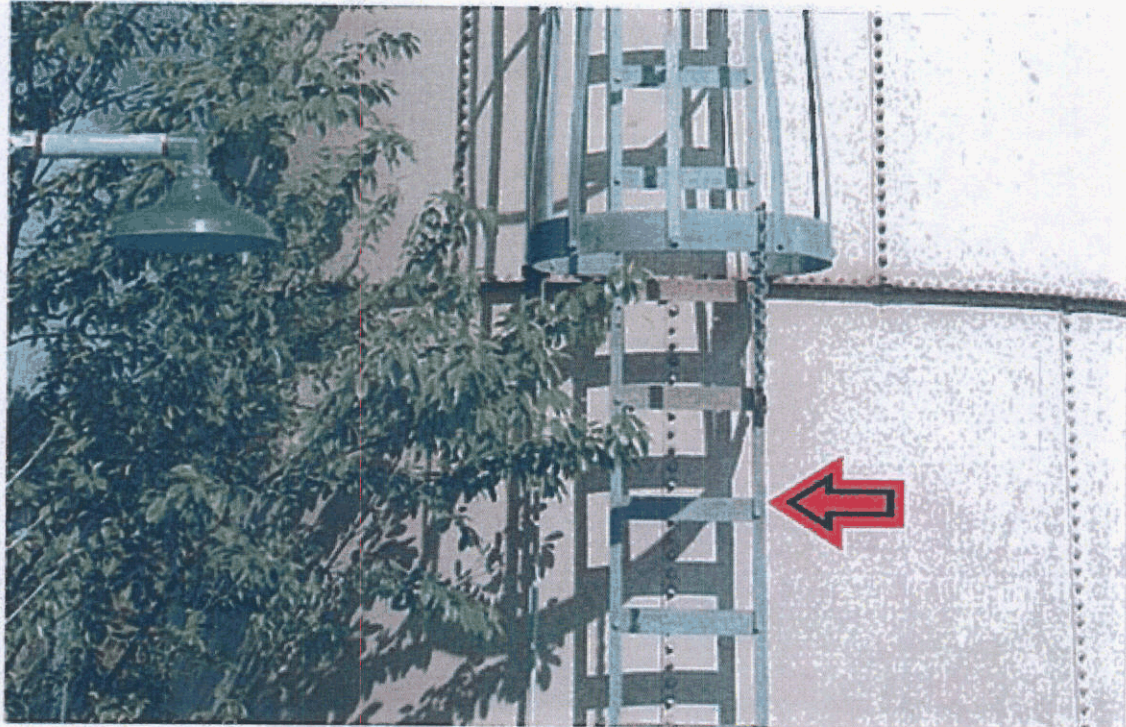
Shell ladder in above photo is in compliance with OSHA and AWWA D100-96, Section 7.4: Ladders, 7.4.1: Outside Tank Ladder, regulations. We recommend installing a cable type ladder safety device, and posting a **Fall Protection Required** sign.

For adequate fall protection, we have recommended installing a cable type ladder device.

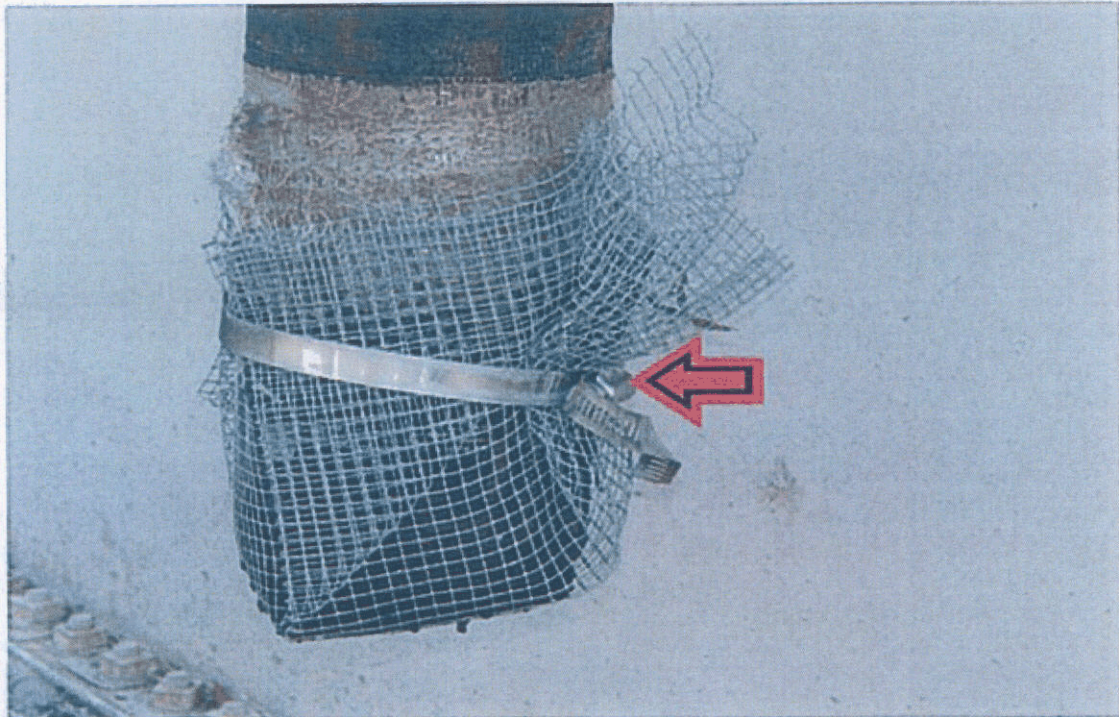
Photo shows the overflow pipe. The overflow pipe is not equipped with a flapper valve. We recommend installing an elbow to direct water away from the tank, a flapper valve and new screen on the existing overflow pipe and a splash pad to direct water away from the tank foundation.

- 6. Install an elbow, a flapper valve and new screen on the existing overflow pipe and splash pad to direct the water away from the tank's foundation..... \$1,150

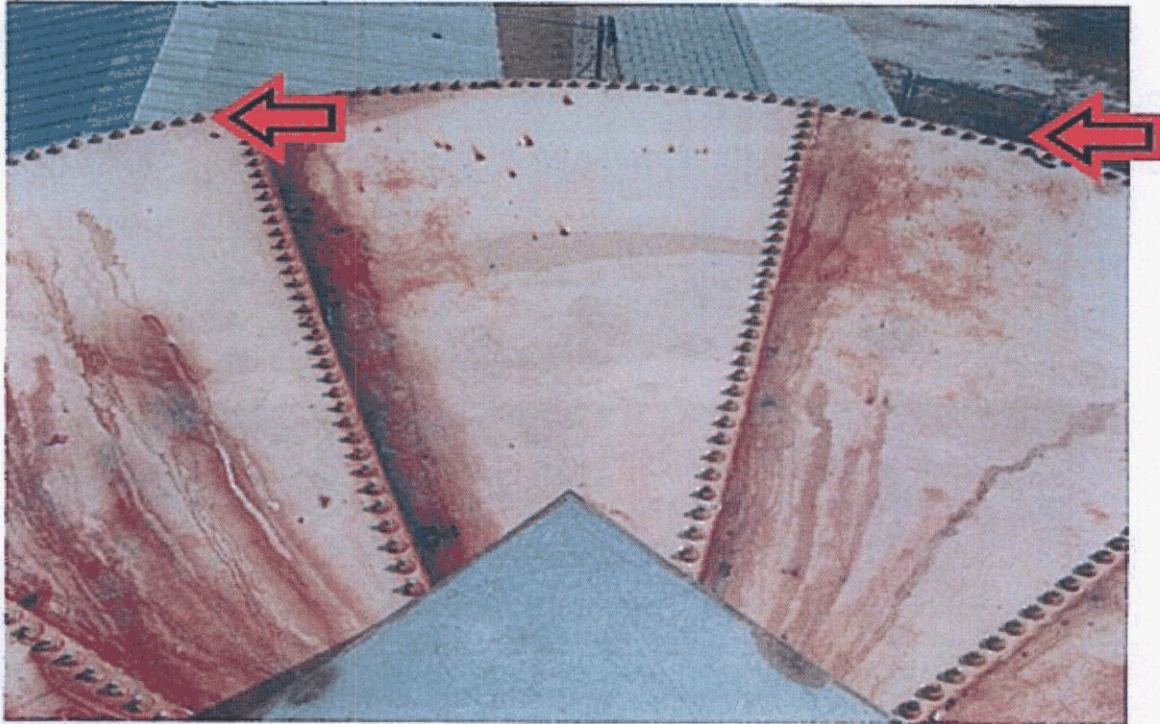
Photo shows the tank roof is not equipped with an OSHA required fall protection system. We recommend installing an approved 42" high handrail system around the circumference of the tank roof, complete with toeboard, intermediate rail and a stainless steel gate chain at the junction of the shell-to-roof access ladder and tank roof as required by OSHA (see glossary).

- 7. Install an approved 42" high handrail system around the circumference of the tank roof, complete with toeboard, intermediate rail and a stainless steel gate chain at the junction of the shell-to-roof access ladder and tank roof as required by OSHA \$2,345

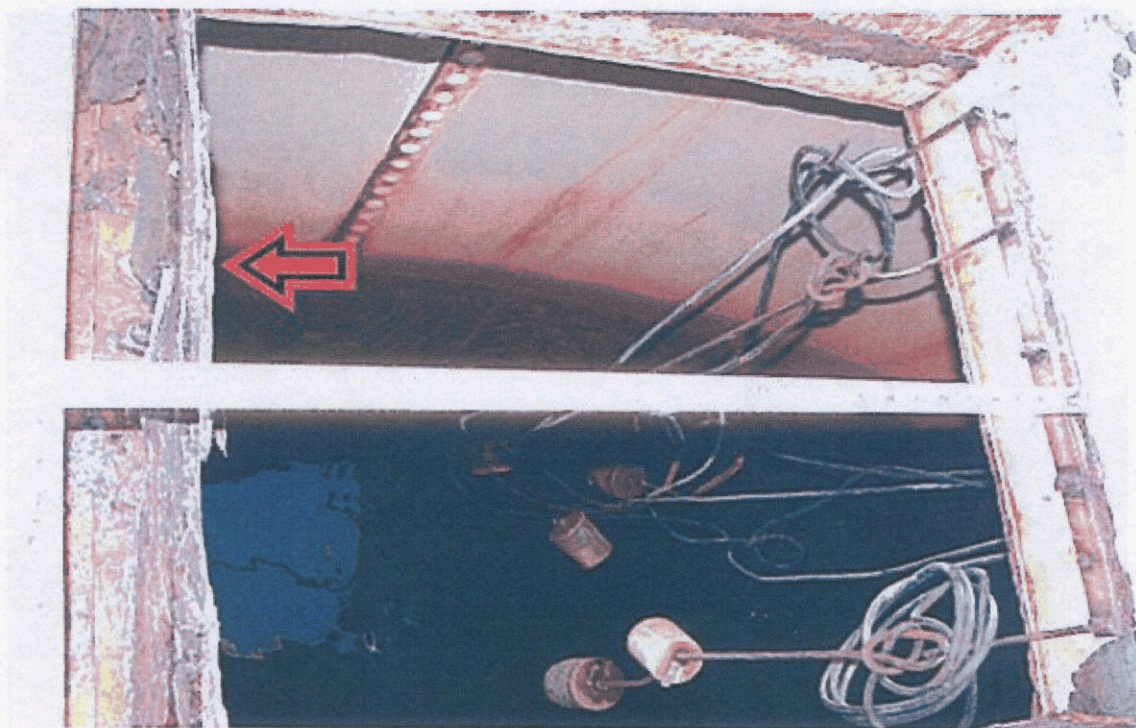
Photo shows the condition of the roof manway. Notice the manway curb is severely deteriorated. Roof openings on this tank require the following to be in compliance with OSHA, AWWA and TSS Section 7.0.8: Access, (see glossary pg. 23):

- 8. Replace existing roof manway with 36" manway..... \$3,350
 Install exterior platform for rescue tripod complete with tripod and winch \$5,000
 Replace the existing roof vent with a vacuum-pressure, frost proof vent and screen in compliance with AWWA..... \$4,810

Replace existing manway with 36" manway

Install exterior platform for rescue tripod, complete with tripod and winch

Note: For safety reasons we have recommended a 36" manway instead of the required 24" manway.

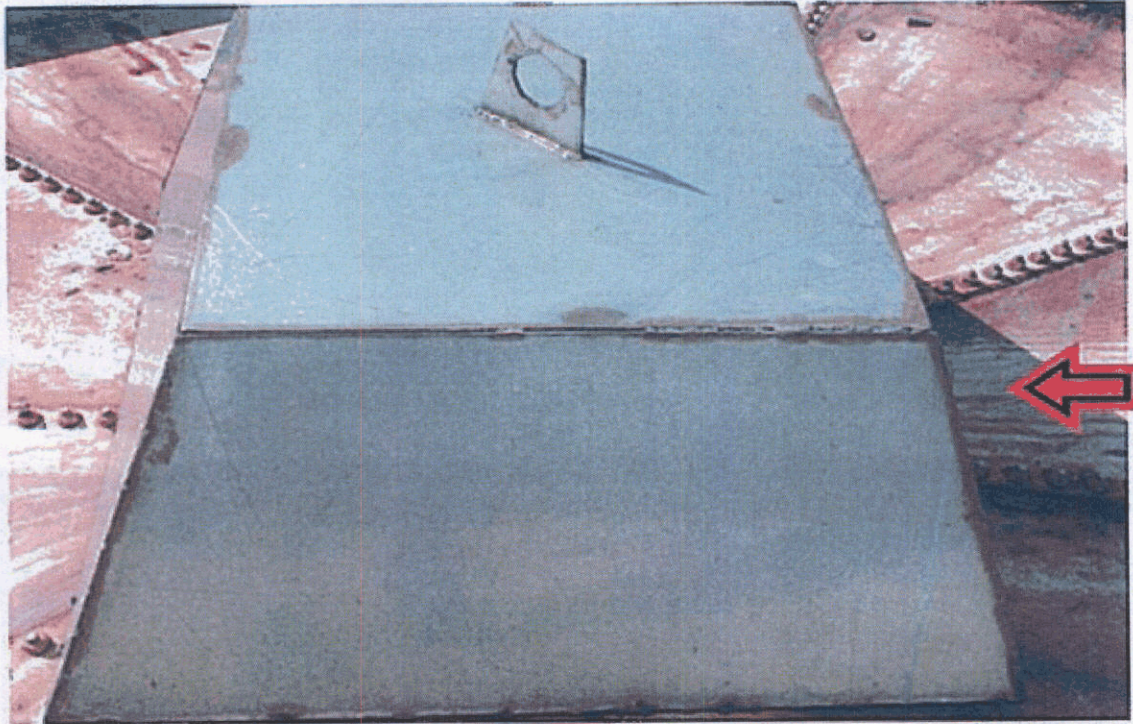
Photo shows the condition of the existing roof vent. **An improperly vented tank may cause external pressure to act on the tank which can cause buckling even at low pressure differential.** We recommend replacing the existing roof vent with a vacuum-pressure, frost proof vent and screen in compliance with AWWA and TSS, (see glossary).

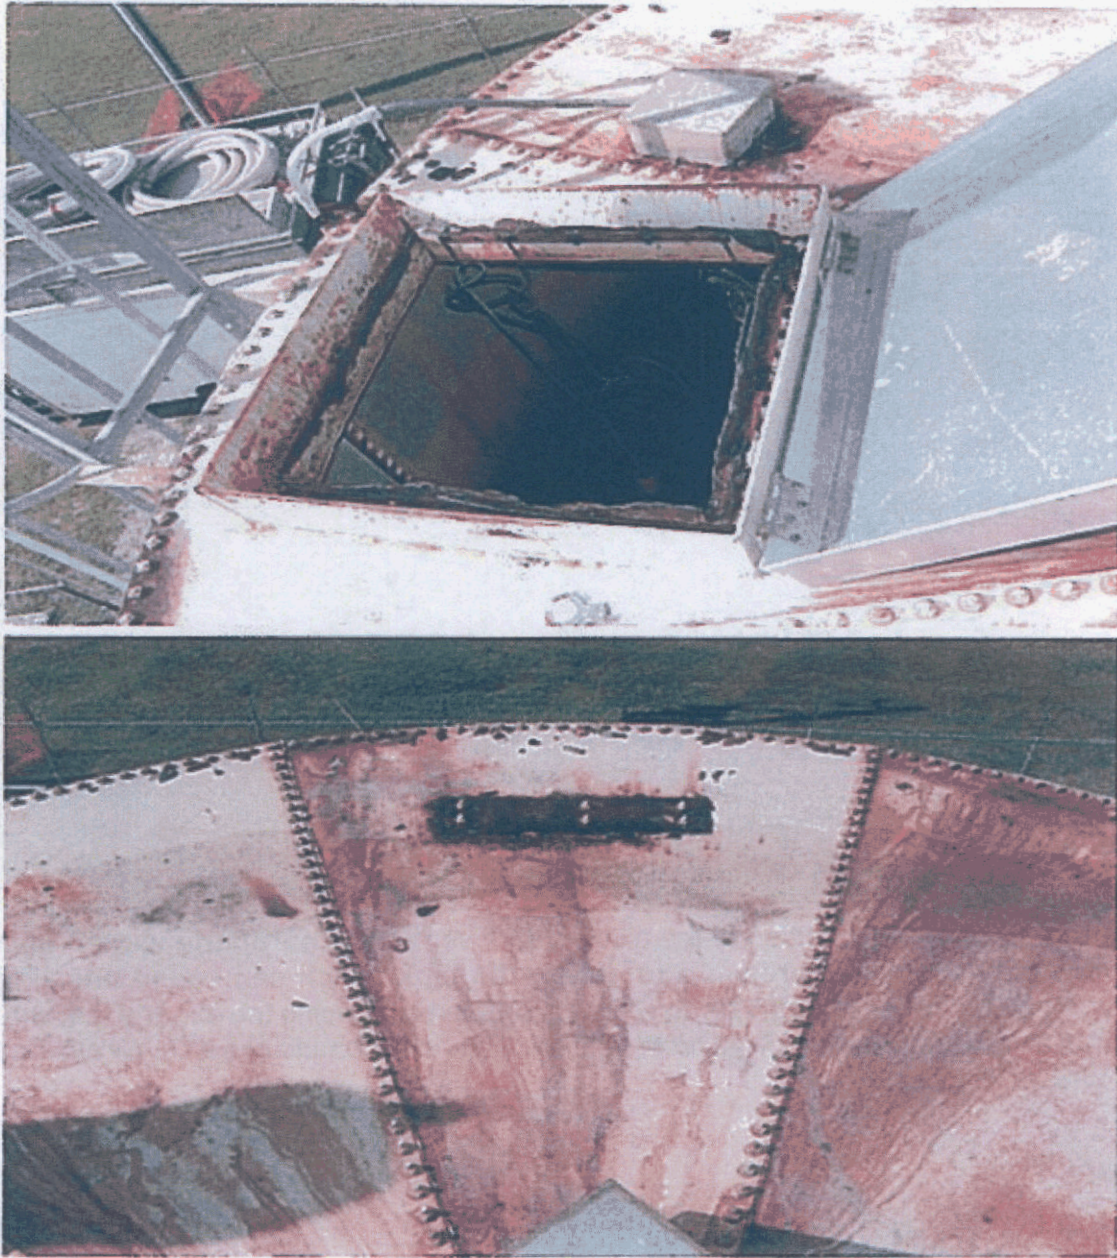
Photos show the condition of the exterior paint system. We recommend sand-blasting the tank exterior to an SSPC #6 (commercial) blast, apply one (1) full coat of primer, then applying one (1) finish coat of Alkyd.

- 10. EXTERIOR PAINT SYSTEM: Sandblast all rusted and abraded areas of the tank exterior to an SSPC #6 (commercial) blast, brushblast all remaining areas, apply one (1) full coat of epoxy-mastic and one (1) finish coat of urethane \$11,500
epoxy mastic finish

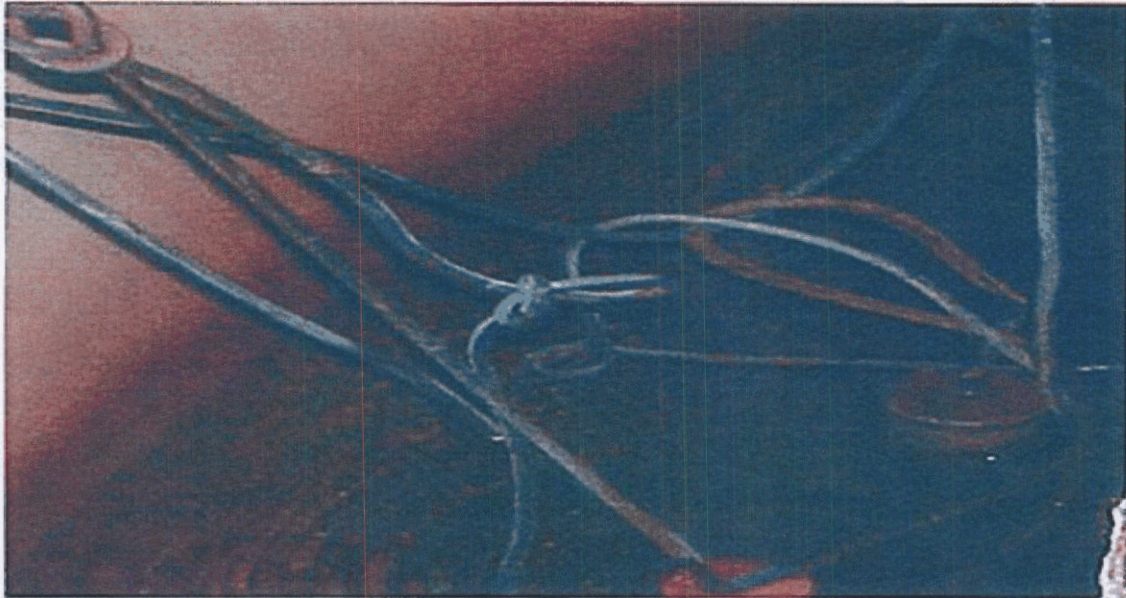
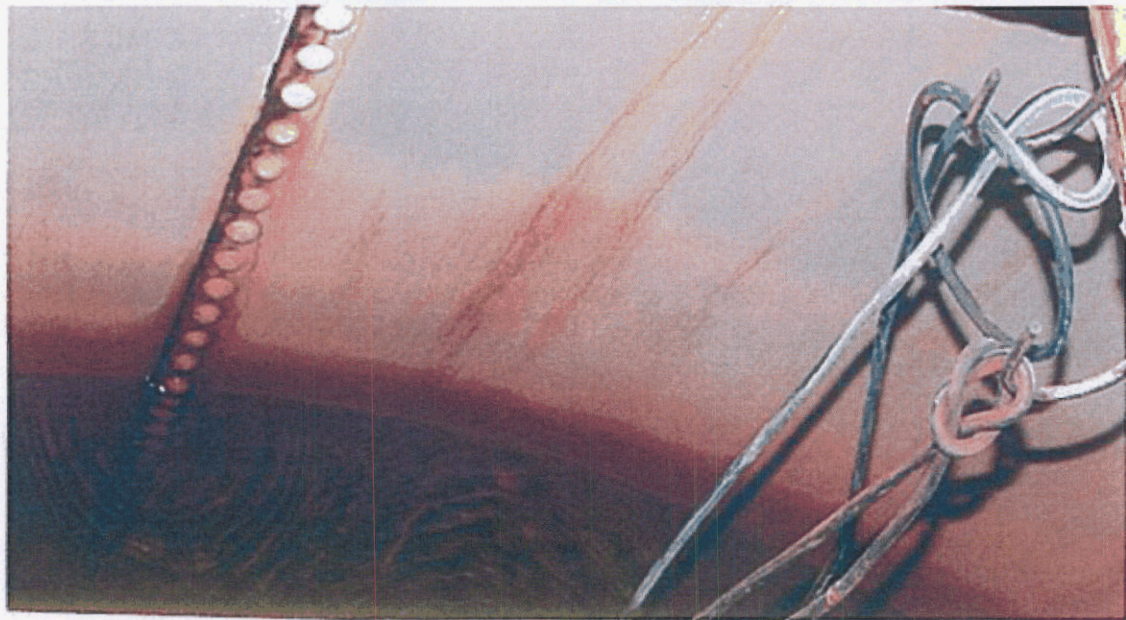
Photos show the condition of the interior liner. We recommend sandblasting all rusted and abraded areas of the tank interior to an SSPC #10 (near white) blast, brushblast all remaining areas, stripe coating all seams and welds, then applying an epoxy liner to achieve 8-10 mils of dry film thickness.

11. INTERIOR PAINT SYSTEM: Sandblast all rusted and abraded areas of the tank interior to SSPC #10 (near white), brushblast all remaining areas, stripe coat all seams and welds, then apply an epoxy liner to achieve 8-10 mils dry film thickness..... \$12,000
