RE: Docket No. 110264-WS; Application for increase in water and wastewater rates in Pasco County by Labrador Utilities, Inc.  
Our File No.: 30057.199

**Utilities Inc. of Florida  
200 Weathersfield Ave.  
Altamonte Springs, FL 32714  
34,000 Gallon Standpipe  
RE: Labrador Reservoir**

**Liquid Engineering Corporation (LEC) Job No. 22191-E**

**Utilities Inc. of Florida  
34,000 Gallon Standpipe  
(LEC) Job No. 22191-E**

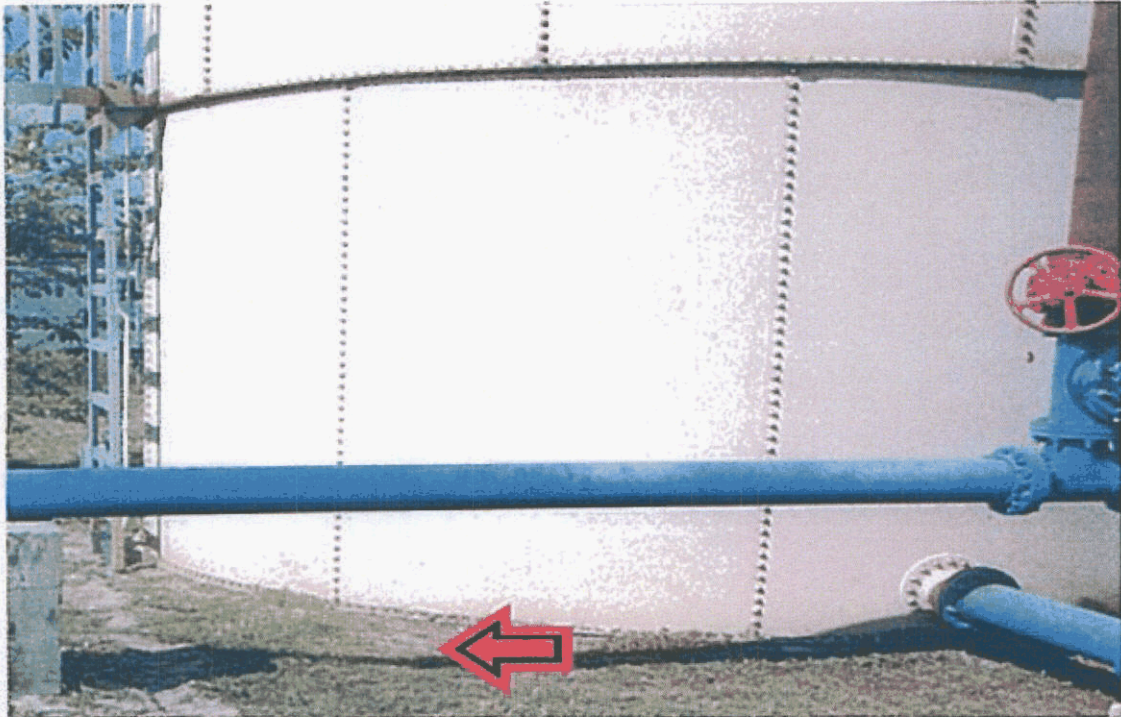
Photo shows the condition of the foundation. We recommend clearing any dirt, debris and other loose gravel away from the tank foundation, down to a minimum 6" below top of foundation as required by AWWA D100-96, Section 12.6.1: Foundations for flat bottom tanks. (see glossary pg. 3). This should be done by a local excavating company.

We further recommend repairing any cracks and spalling in the concrete with a commercial non-shrinking grout, then caulking around the base of the tank to foundation connection to prevent water from entering under the tank and sealing the foundation with a concrete sealant.

We also recommend electrically grounding the tank for lightning protection as required by OSHA, (general duty clause) (see glossary ).

- 3. Repair any cracks and spalling in the concrete with a commercial non-shrinking grout, then caulking around the base of the tank to foundation connection to prevent water from entering under the tank and sealing the foundation with a concrete sealant..... \$1,450

- Electrically ground the tank for lightning protection as required by OSHA, (general duty clause) and NFPA..... \$1,275

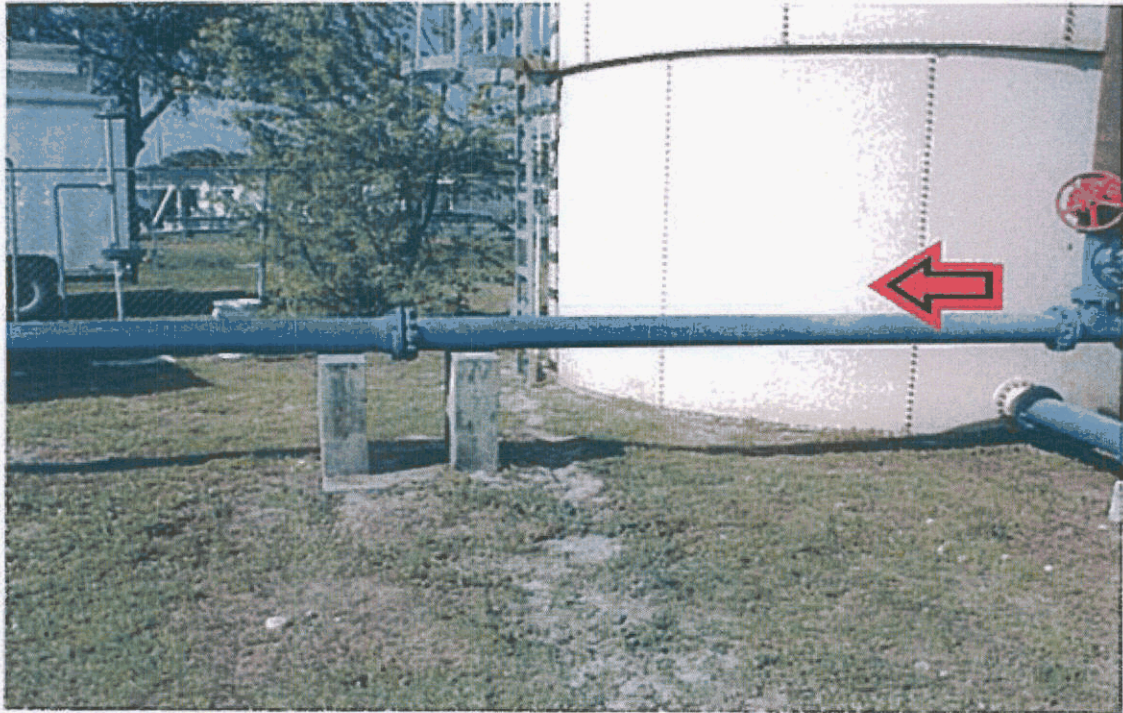
Photo shows the condition of the tank shell. The tank is not equipped with a manway. The following items are required to bring tank in compliance with AWWA D100-96, section 7.1: Shell Manways, OSHA, and TSS, (see glossary pg. 8):

Install a 36" manway

Note: For safety reasons we have recommended a 36" manway instead of the required 24" manway.

- 4. Install 36" primary shell manway ..... \$3,850  
*Substitute a 30" manway for a 36" manway*
- 5. Install a cable type ladder safety climb device ..... \$1,850  
 Post a **Fall Protection Required** sign ..... \$25

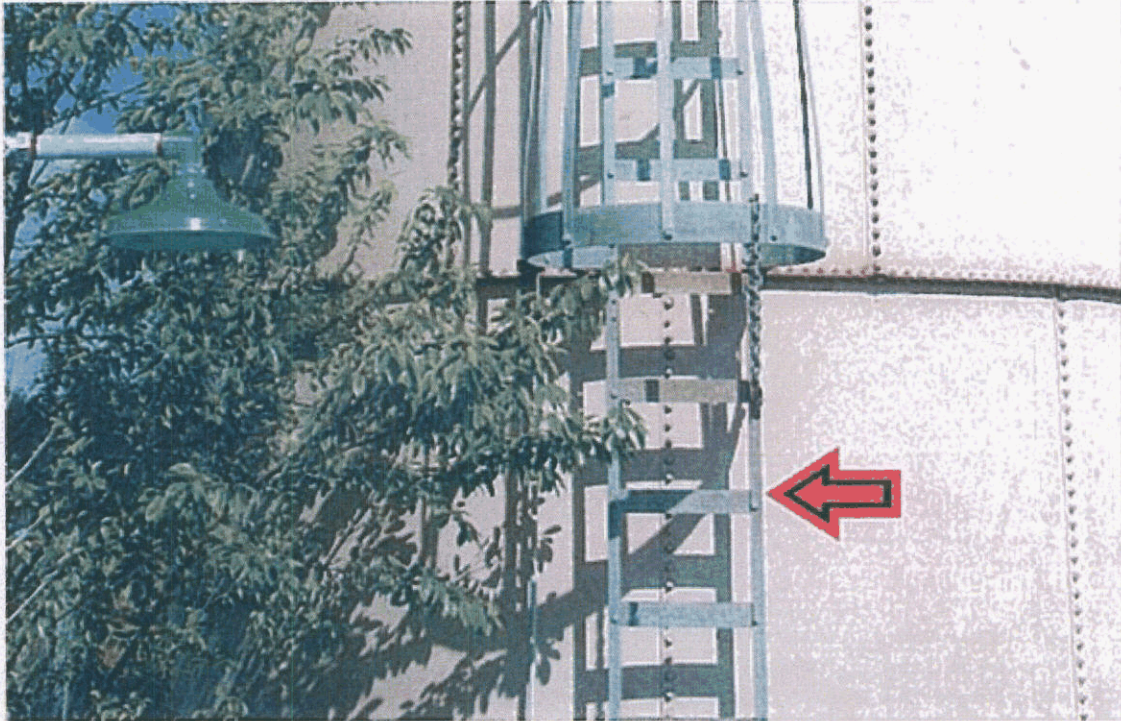
Shell ladder in above photo is in compliance with OSHA and AWWAD100-96, Section 7.4: Ladders, 7.4.1: Outside Tank Ladder, regulations. We recommend installing a cable type ladder safety device, and posting a **Fall Protection Required** sign.

For adequate fall protection, we have recommended installing a cable type ladder device.

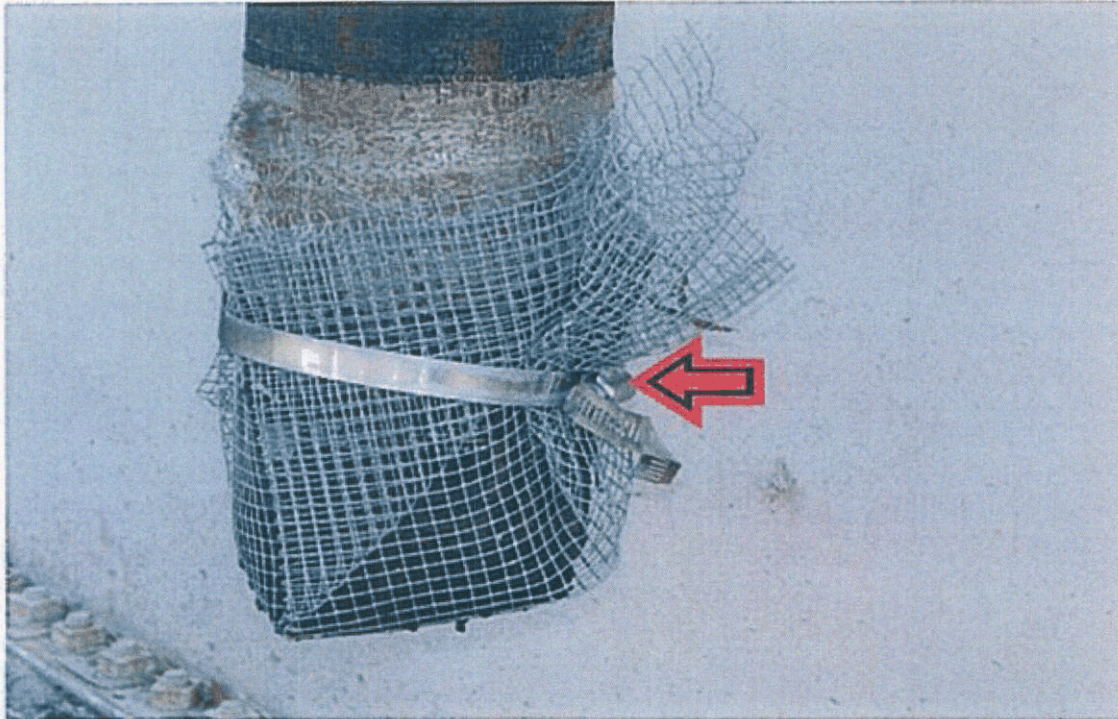
Photo shows the overflow pipe. The overflow pipe is not equipped with a flapper valve. We recommend installing an elbow to direct water away from the tank, a flapper valve and new screen on the existing overflow pipe and a splash pad to direct water away from the tank foundation.

- 6. Install an elbow, a flapper valve and new screen on the existing overflow pipe and splash pad to direct the water away from the tank's foundation..... \$1,150

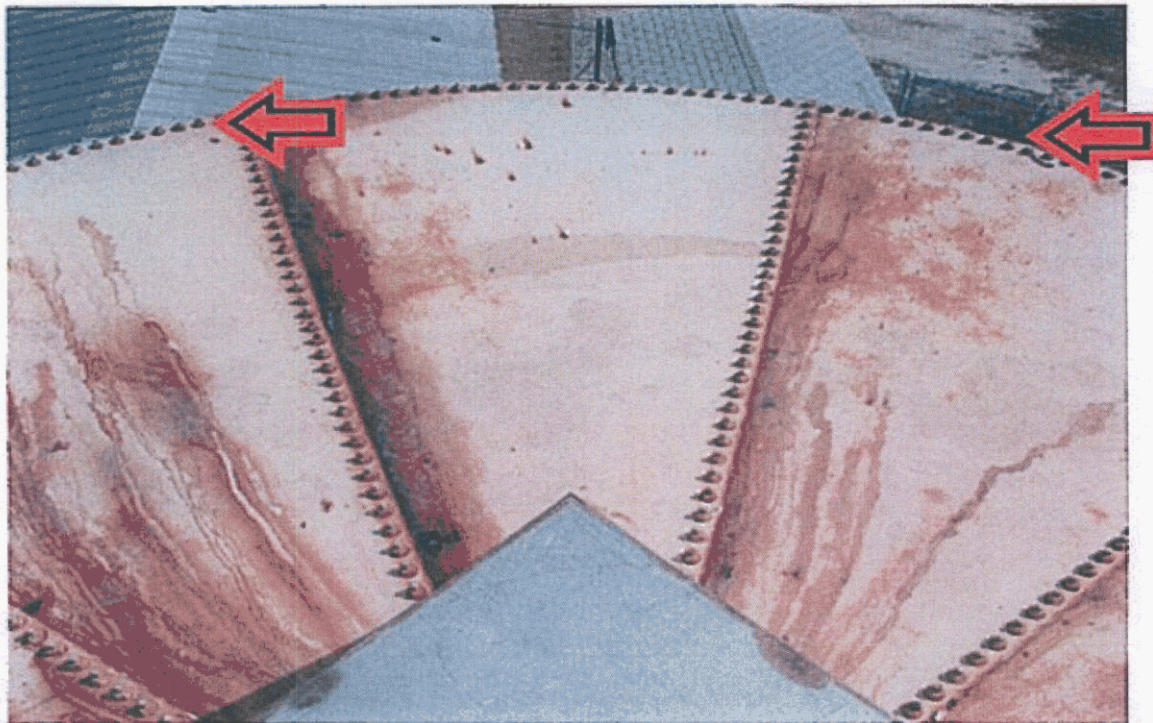
Photo shows the tank roof is not equipped with an OSHA required fall protection system. We recommend installing an approved 42" high handrail system around the circumference of the tank roof, complete with toeboard, intermediate rail and a stainless steel gate chain at the junction of the shell-to-roof access ladder and tank roof as required by OSHA (see glossary).

- 7. Install an approved 42" high handrail system around the circumference of the tank roof, complete with toeboard, intermediate rail and a stainless steel gate chain at the junction of the shell-to-roof access ladder and tank roof as required by OSHA ..... \$2,345

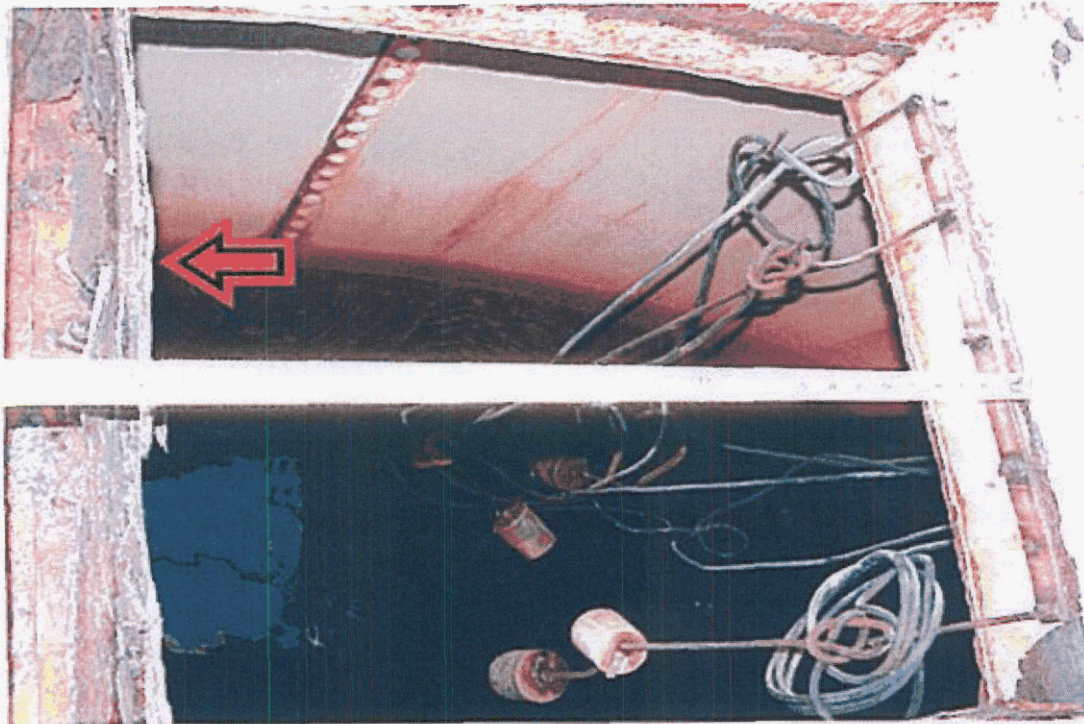
Photo shows the condition of the roof manway. Notice the manway curb is severely deteriorated. Roof openings on this tank require the following to be in compliance with OSHA, AWWA and TSS Section 7.0.8: Access, (see glossary pg. 23):

Replace existing manway with 36" manway

Install exterior platform for rescue tripod, complete with tripod and winch

Note: For safety reasons we have recommended a 36" manway instead of the required 24" manway.

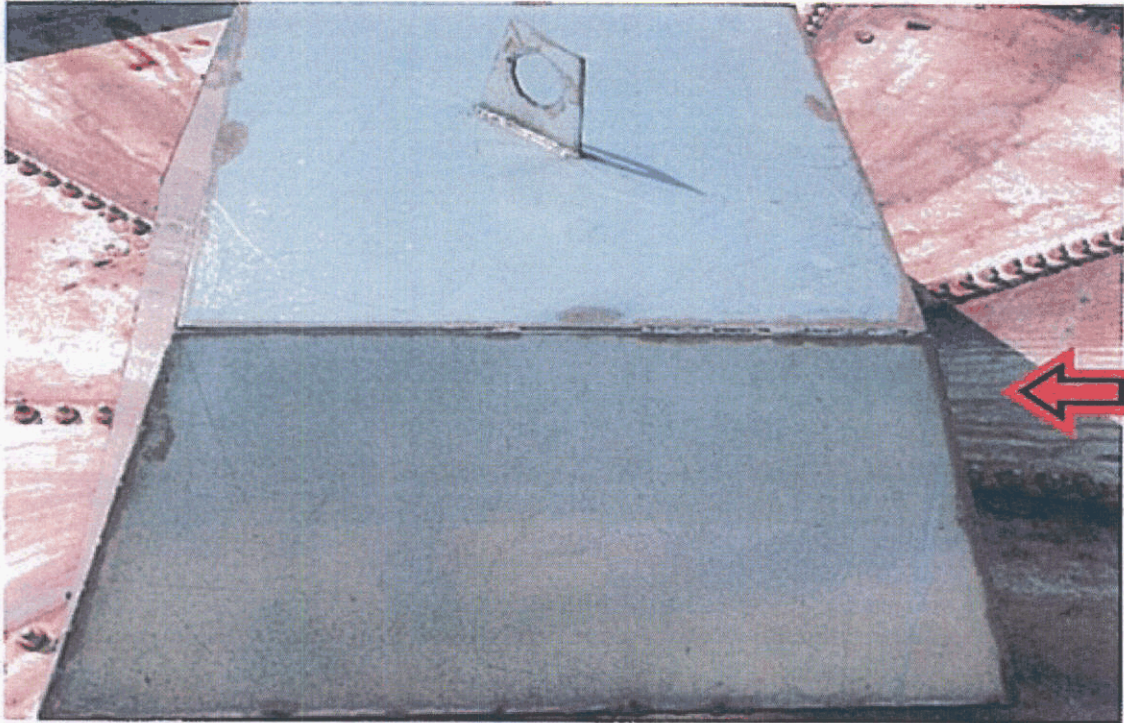
Photo shows the condition of the existing roof vent. **An improperly vented tank may cause external pressure to act on the tank which can cause buckling even at low pressure differential.** We recommend replacing the existing roof vent with a vacuum-pressure, frost proof vent and screen in compliance with AWWA and TSS, (see glossary).

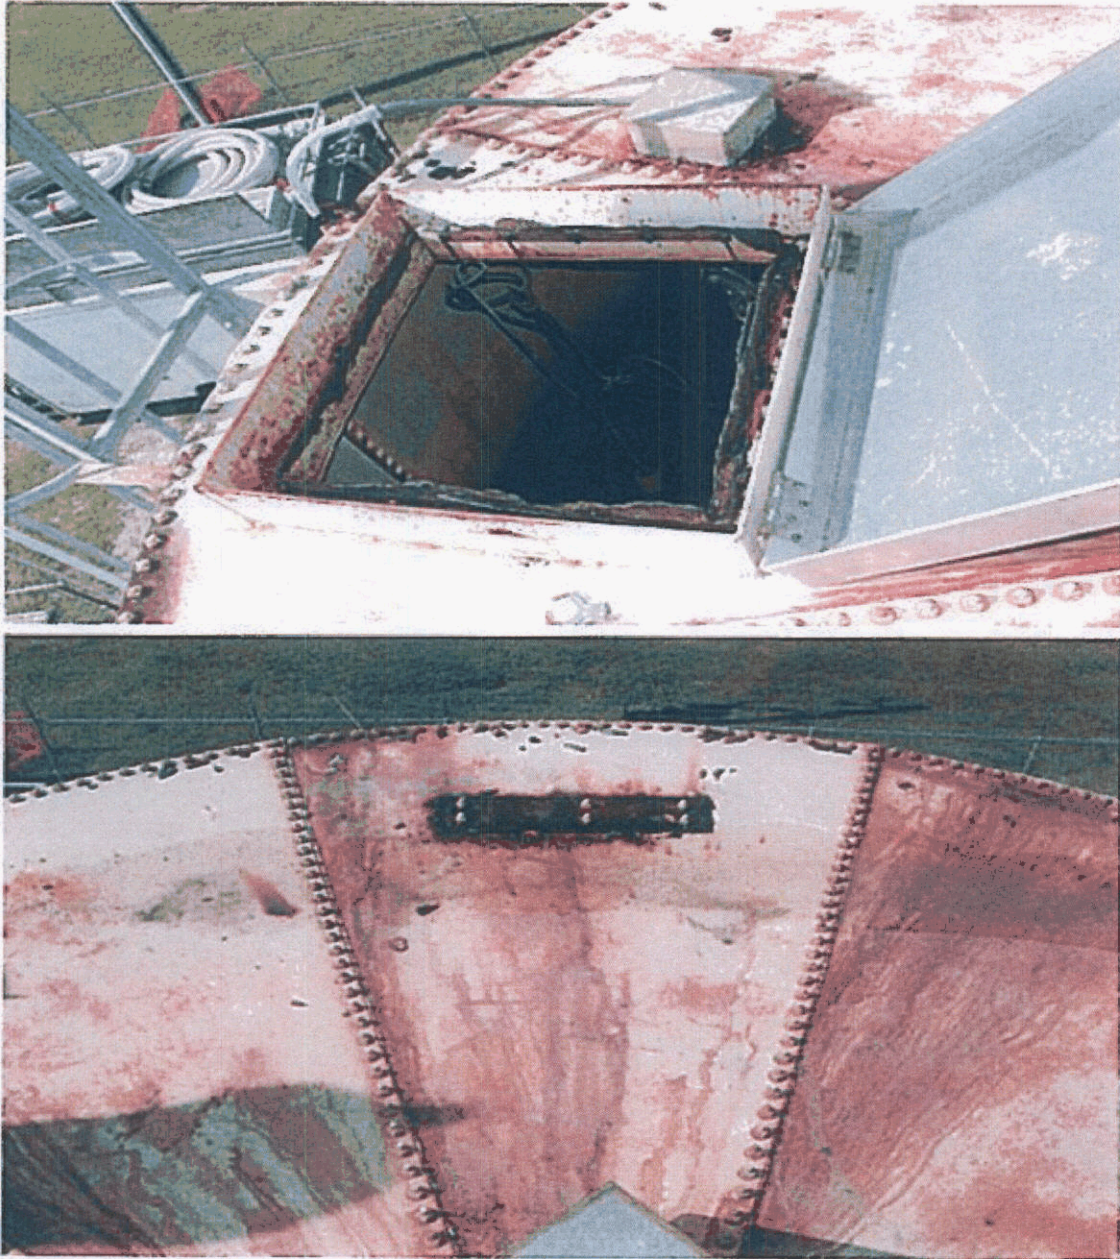
Photos show the condition of the exterior paint system. We recommend sand-blasting the tank exterior to an SSPC #6 (commercial) blast, apply one (1) full coat of primer, then applying one (1) finish coat of Alkyd.

- 10. EXTERIOR PAINT SYSTEM: Sandblast all rusted and abraded areas of the tank exterior to an SSPC #6 (commercial) blast, brushblast all remaining areas, apply one (1) full coat of epoxy-mastic and one (1) finish coat of urethane ..... \$11,500

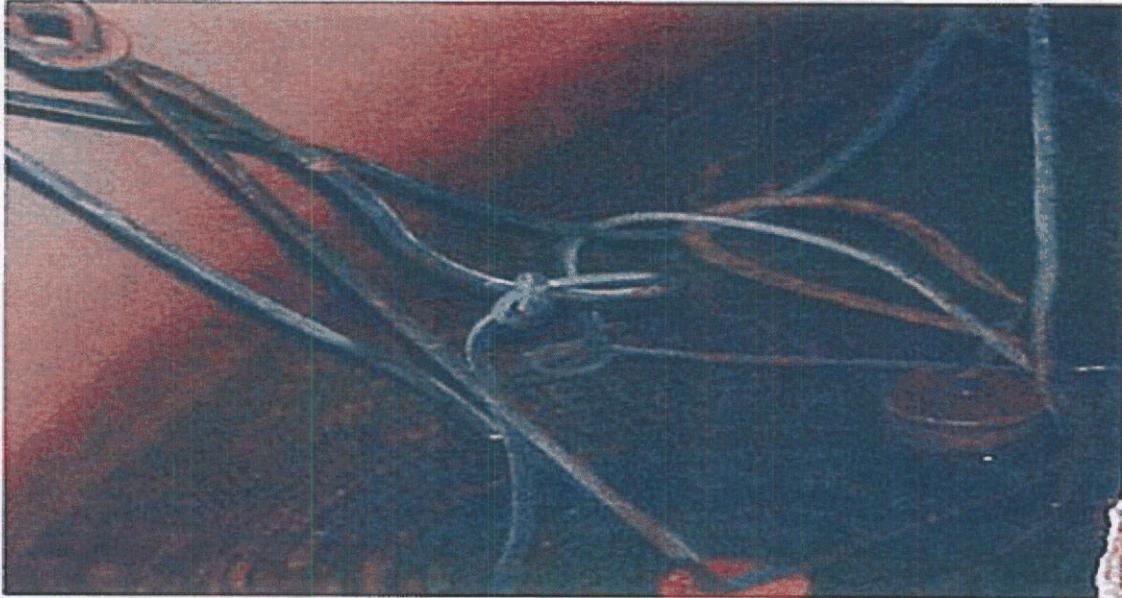
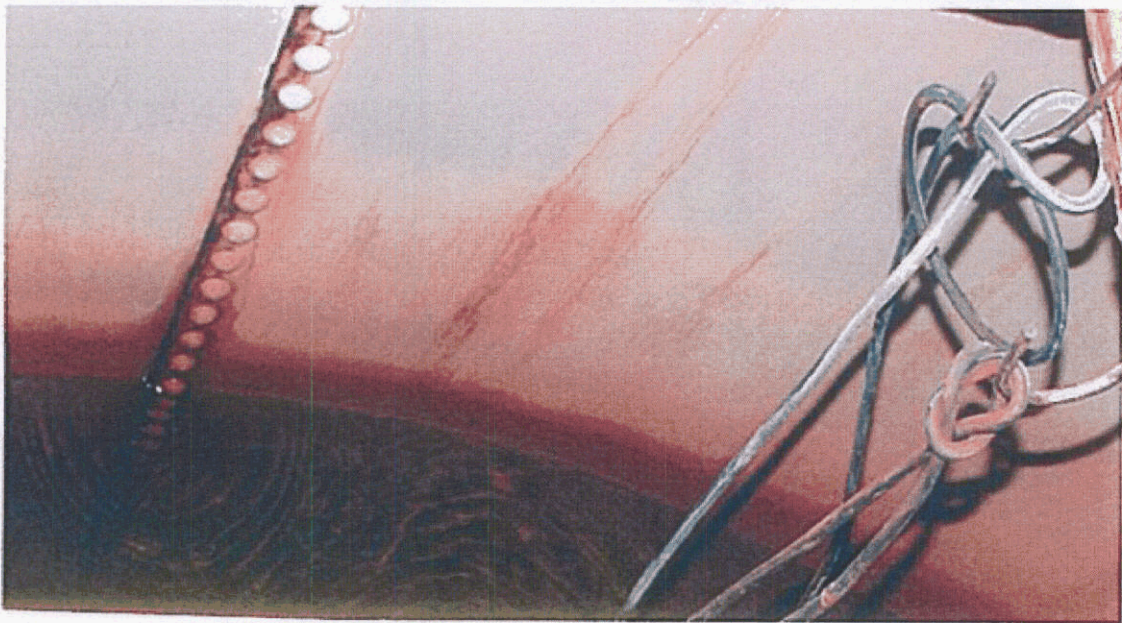
Photos show the condition of the interior liner. We recommend sandblasting all rusted and abraded areas of the tank interior to an SSPC #10 (near white) blast, brushblast all remaining areas, stripe coating all seams and welds, then applying an epoxy liner to achieve 8-10 mils of dry film thickness.

11. INTERIOR PAINT SYSTEM: Sandblast all rusted and abraded areas of the tank interior to SSPC #10 (near white), brushblast all remaining areas, stripe coat all seams and welds, then apply an epoxy liner to achieve 8-10 mils dry film thickness..... \$12,000
