Condition Analysis

Block: 01 Northwest Unit of the plant. Includes Gasification Unit, Brine Unit, Acid Unit, Coal Slurry Building, and pipe lines to flares.

Subblock: A On West side of Block 1. Contains Flare, pipe racks to flare, and conveyor belt.

Section: 01 Flare and associated structure.

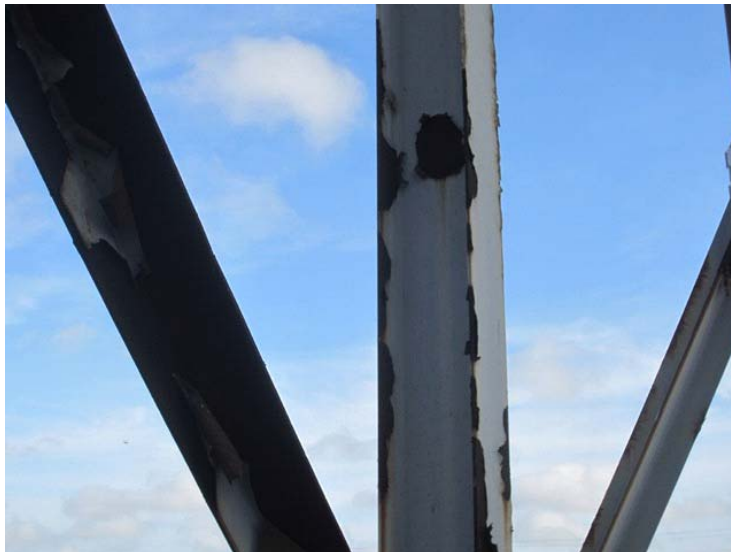
Environment Rating 3 - Moderate
Visibility: 5 - Moderate Traffic or Visibility
Corrosion Rating: 5.0 - 3% rust
Corrosion Type: E - Pitting or Rust Nodules
Priority: 4 - Substandard

Comments: Heavy Undercutting- Beginning Stages of Pittings.

Corrosion on structure

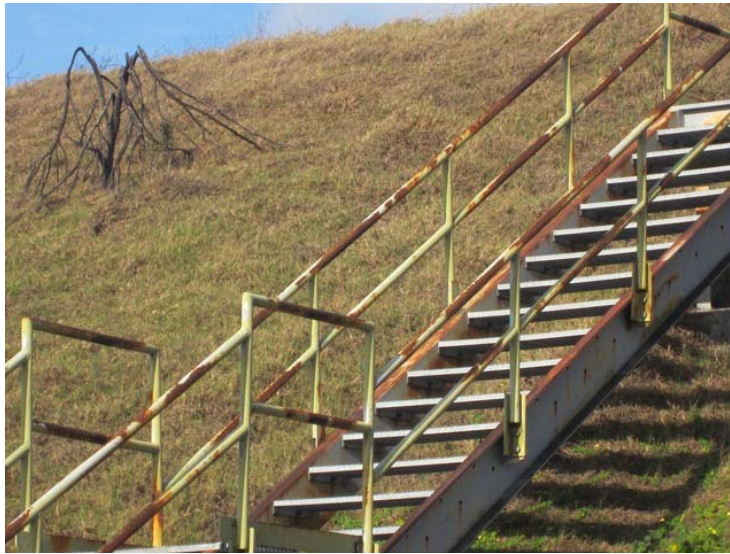
Corrosion Rating: 4.0 - 10% rust

Corrosion Type: C - Edge or Pinhole Corrosion

Corrosion on stairway

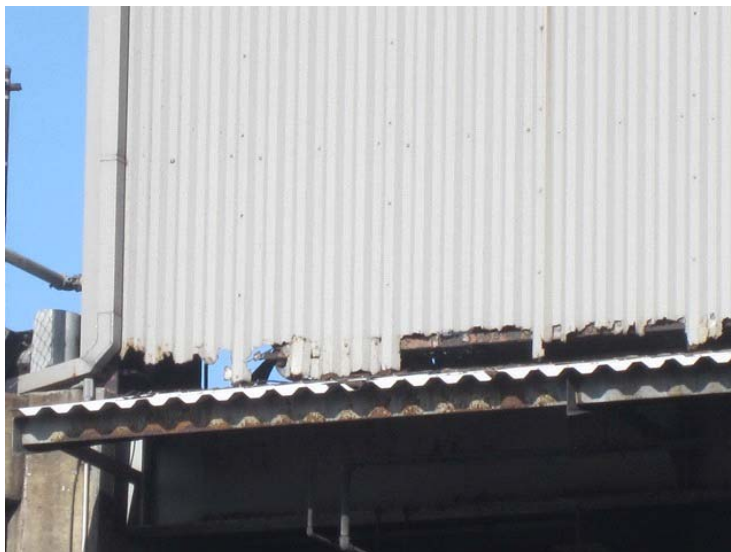
Corrosion on siding

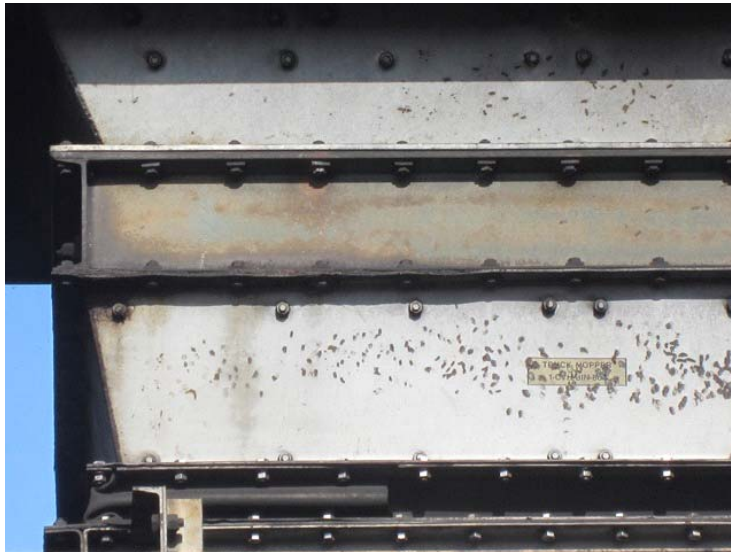
Corrosion Rating: 7.0 - 0.3% rust

Corrosion Type: A - No or Minimal Corrosion

Corrosion on equipment

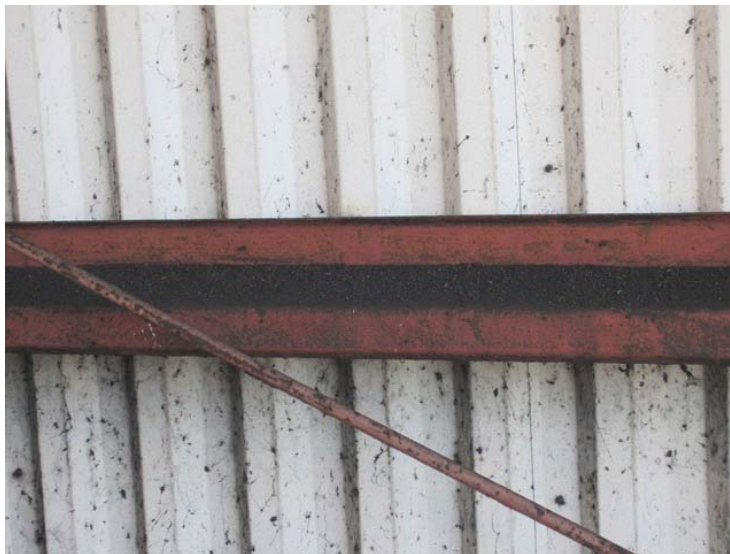
Corrosion Rating: 7.5 - 0.2% rust

Corrosion Type: B - Surface Rust

View of corrosion on structure

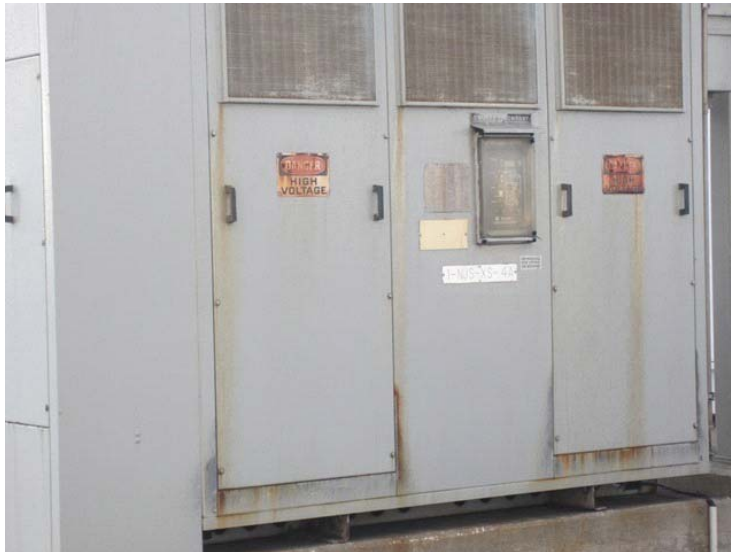
Environment Rating 3 - Moderate
Visibility: 5 - Moderate Traffic or Visibility
Corrosion Rating: 7.5 - 0.2% rust
Corrosion Type: C - Edge or Pinhole Corrosion
Priority: 7 - Fair

View of corrosion

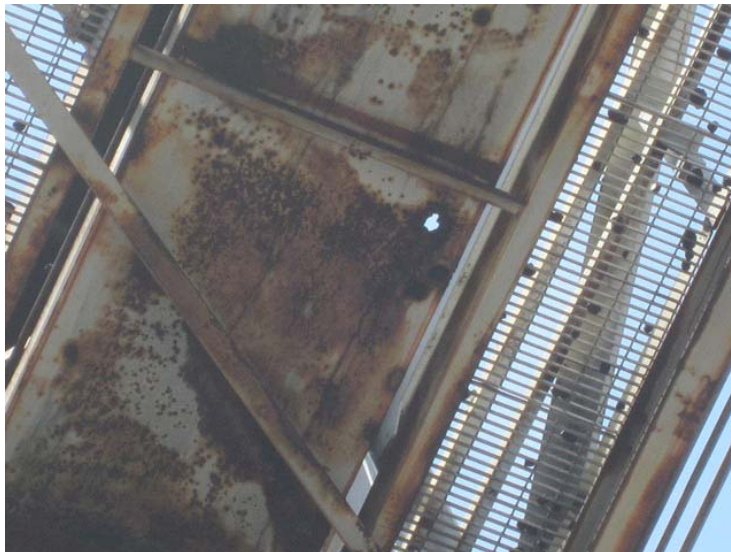
Corrosion Rating: 4.0 - 10% rust

Corrosion Type: C - Edge or Pinhole Corrosion

Comments: Heavy surface rust, edge corrosion.

View of corrosion on structure

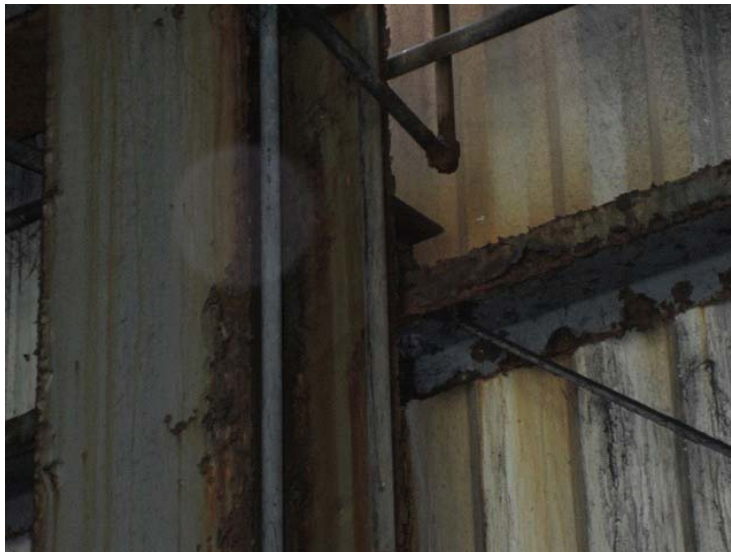
Environment Rating 3 - Moderate
Visibility: 6 - Low Traffic or Visibility
Corrosion Rating: 4.5 - 7% rust
Corrosion Type: E - Pitting or Rust Nodules
Priority: 1 - Advanced Corrosion

Corrosion on structure

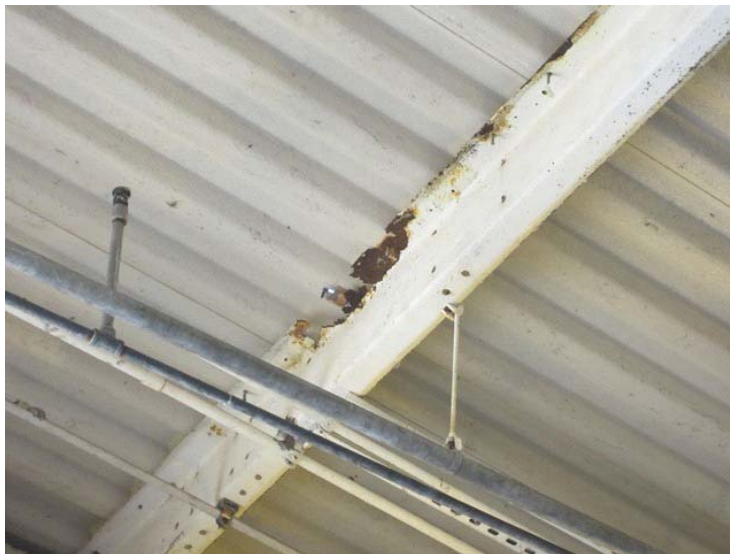
Corrosion Rating: 6.0 - 1% rust

Corrosion Type: E - Pitting or Rust Nodules

Comments: Heavy Corrosion- Localized

Corrosion on structure

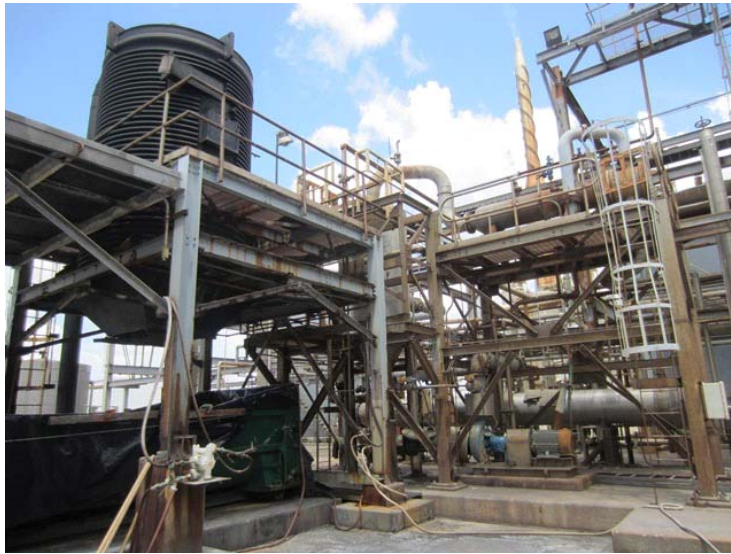
Corrosion Rating: 4.5 - 7% rust

Corrosion Type: F - Holes or Stratifications

General view of section

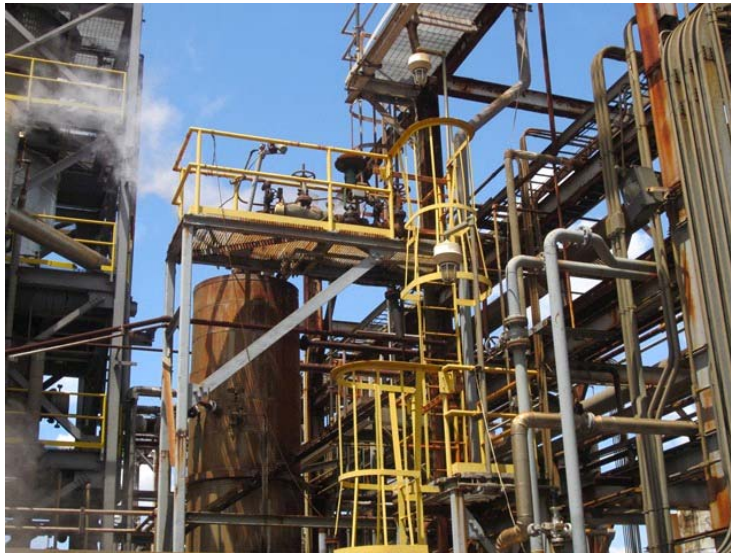
Corrosion Rating: 4.0 - 10% rust

Corrosion Type: F - Holes or Stratifications

General view of section

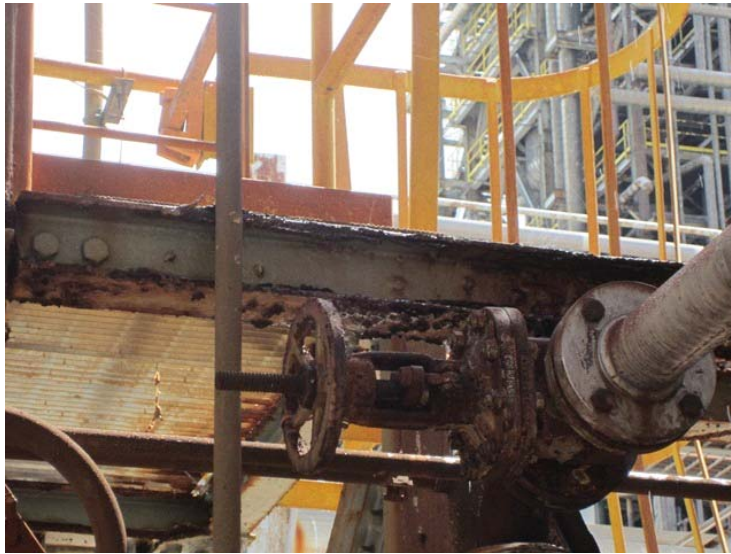
Corrosion Rating: 4.0 - 10% rust

Corrosion Type: F - Holes or Stratifications

View of corrosion on structure

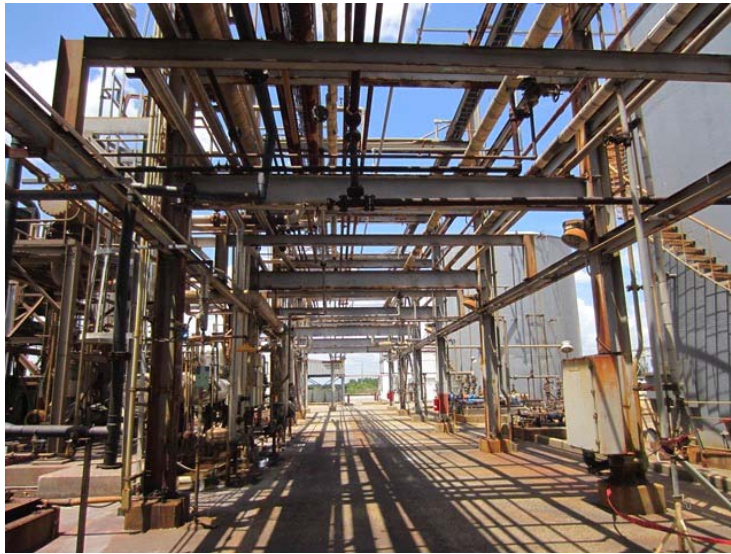
Corrosion Rating: 3.5 - 13% rust

Corrosion Type: E - Pitting or Rust Nodules

Comments: Heavy Corrosion- Pitting Apparent

General view of section

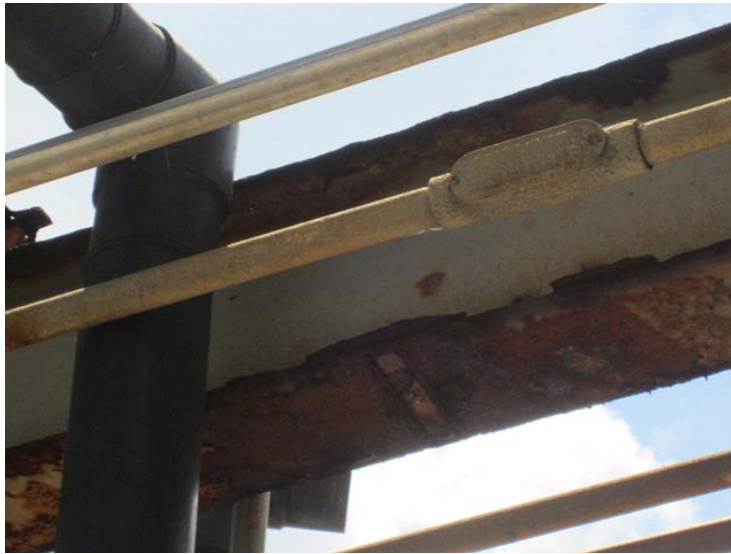
Corrosion Rating: 3.5 - 13% rust

Corrosion Type: E - Pitting or Rust Nodules

Comments: Heavy Corrosion- Pitting Apparent

View of Corrosion

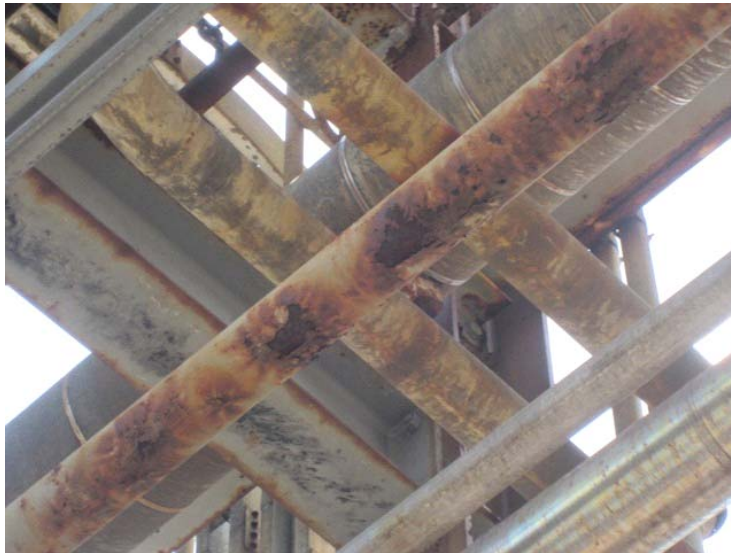
Corrosion Rating: 3.5 - 13% rust

Corrosion Type: E - Pitting or Rust Nodules

Comments: Heavy Corrosion- Pitting Apparent

Corrosion on piping

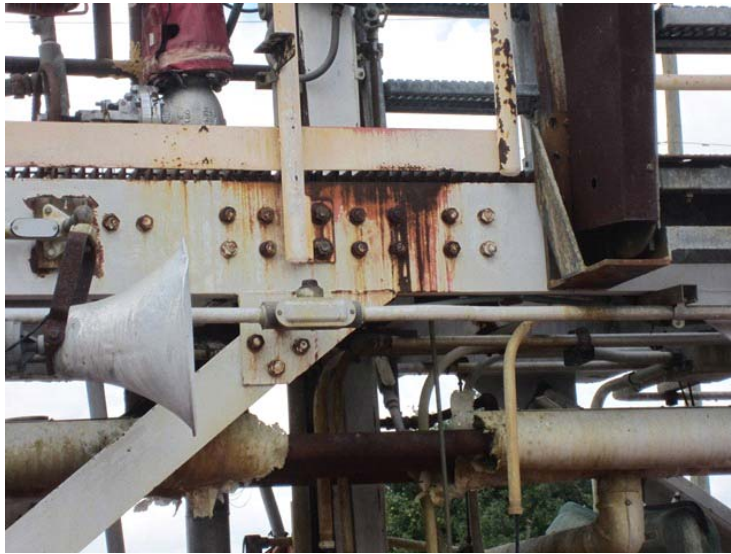
Corrosion Rating: 5.0 - 3% rust

Corrosion Type: D - Undercutting or Mill Scale

Corrosion on structure

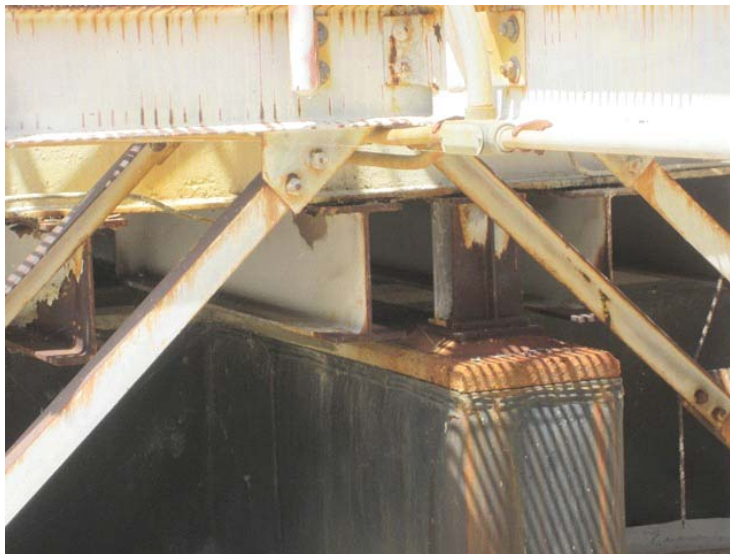
Corrosion Rating: 6.0 - 1% rust

Corrosion Type: D - Undercutting or Mill Scale

Comments: Tank Fair, Handrails, Ladder, Platform Southside needs repair.

Corrosion on structure

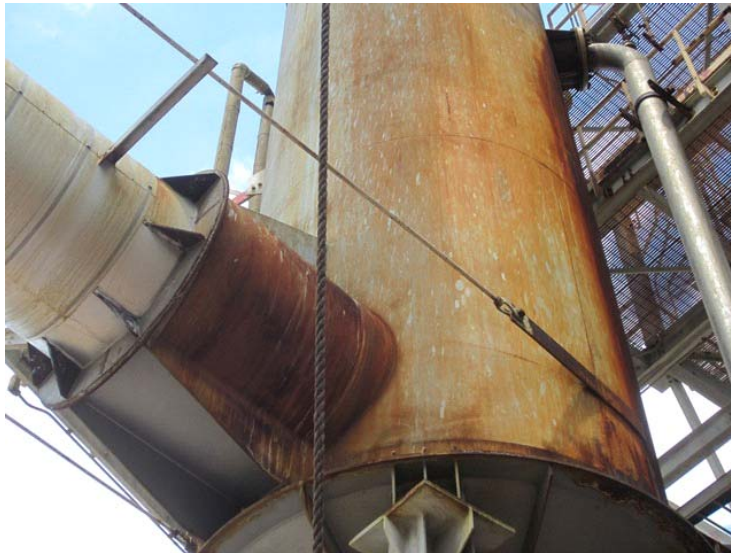
Corrosion Rating: 6.0 - 1% rust

Corrosion Type: B - Surface Rust

Corrosion on stack

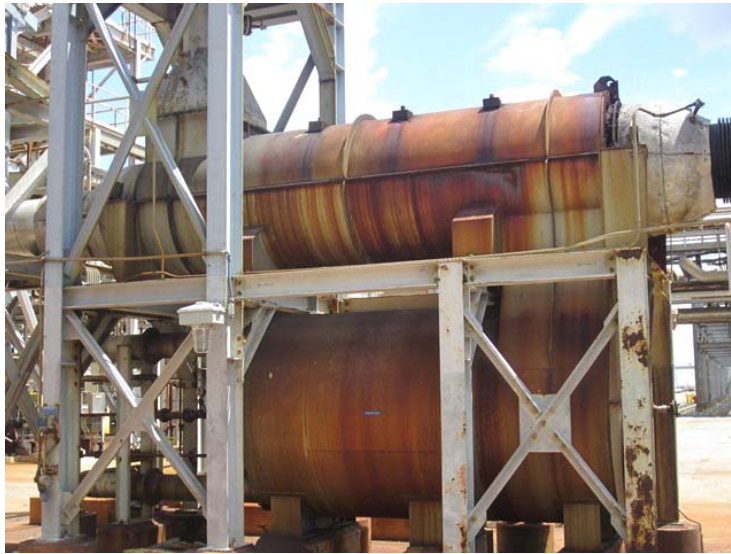
Corrosion Rating: 6.0 - 1% rust

Corrosion Type: D - Undercutting or Mill Scale

Comments: Undercutting on Preheater Structure.

Corrosion on equipment

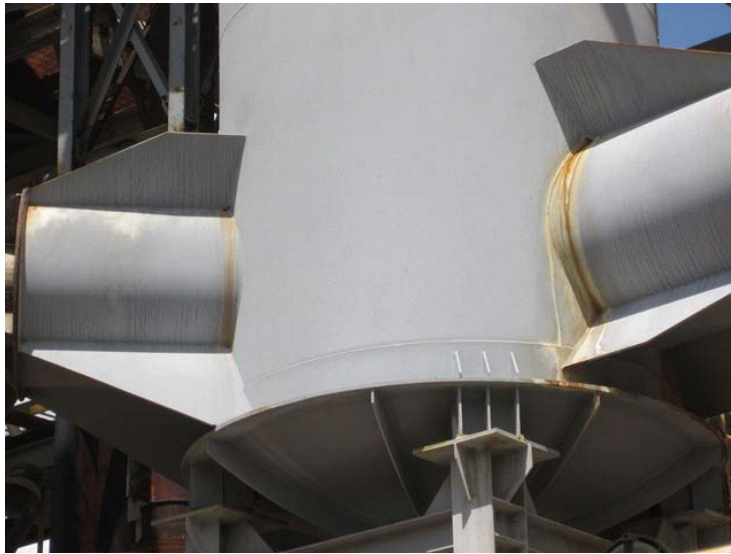
Comments: Localized, Undercutting on Structure Southeast side of Section.

minor corrosion on stack

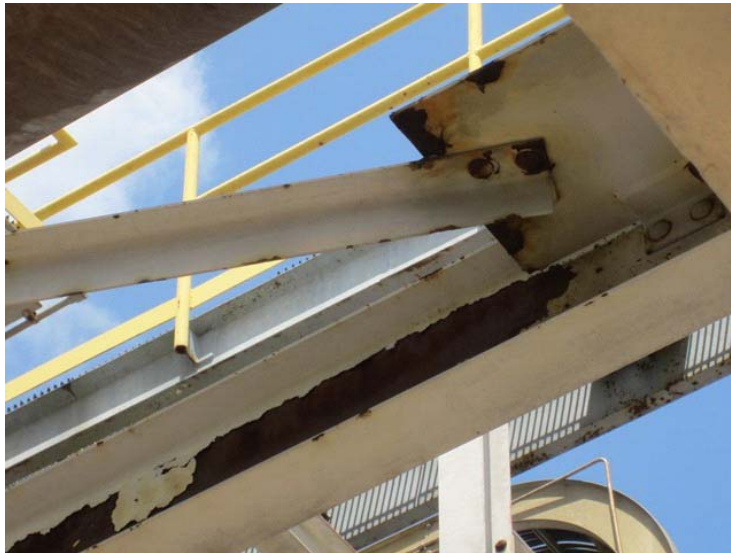
Comments: Localized, Undercutting on Structure Southeast side of Section.

Corrosion on structure

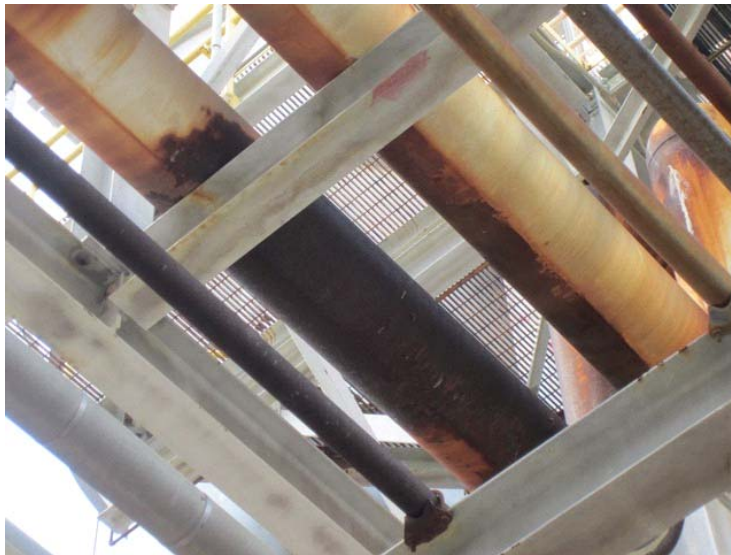
Corrosion Rating: 6.0 - 1% rust

Corrosion on piping

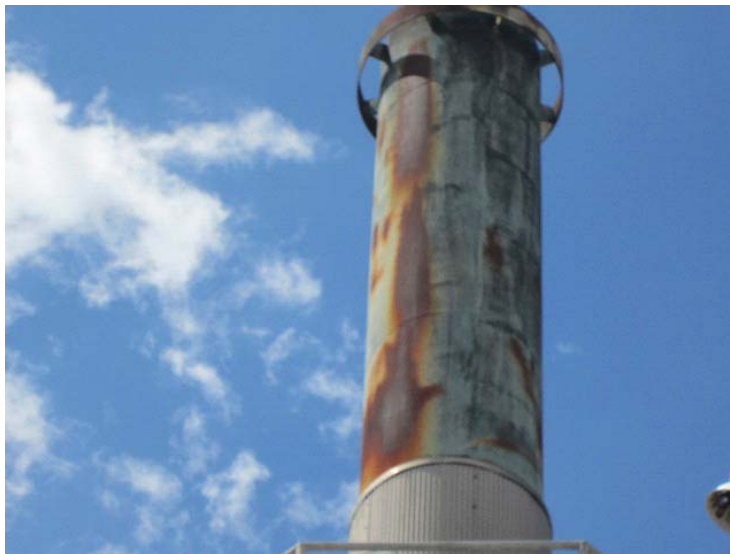
Corrosion on stack

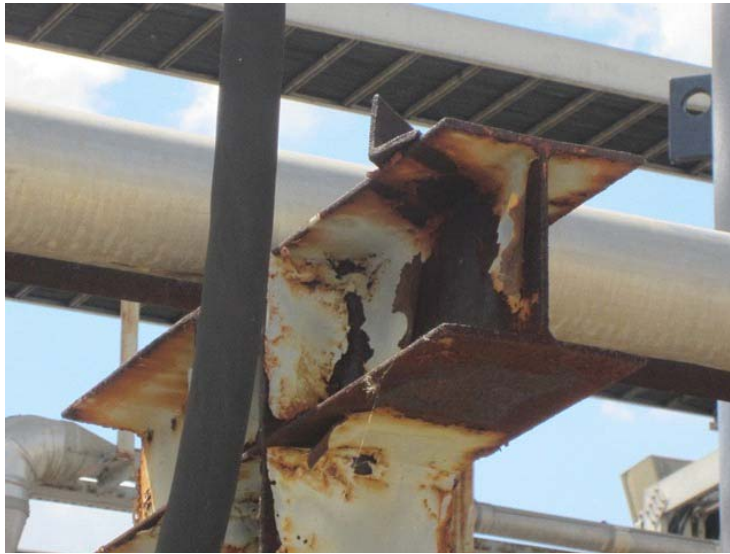
Corrosion on structure

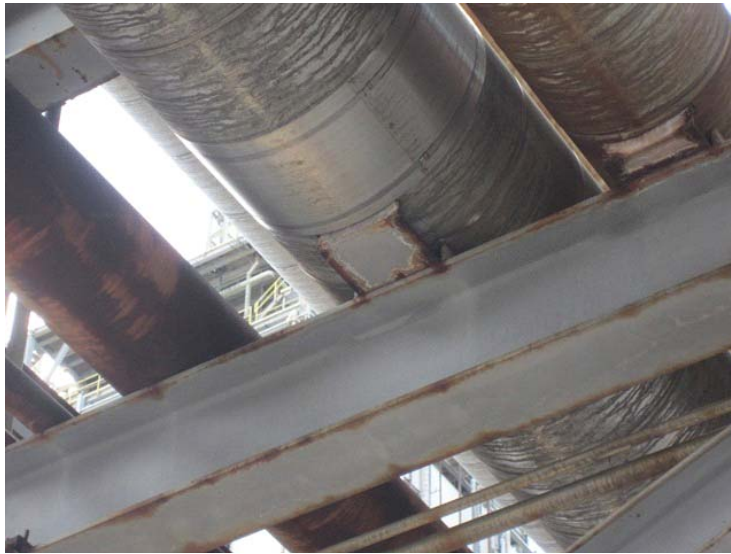
View of corrosion in section

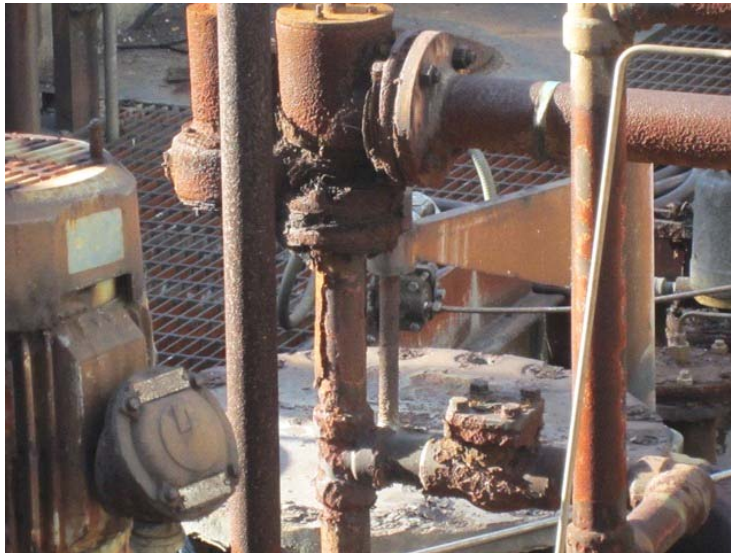
Comments: Metal lose on Structure on Southwest side of tank.

Corrosion on piping

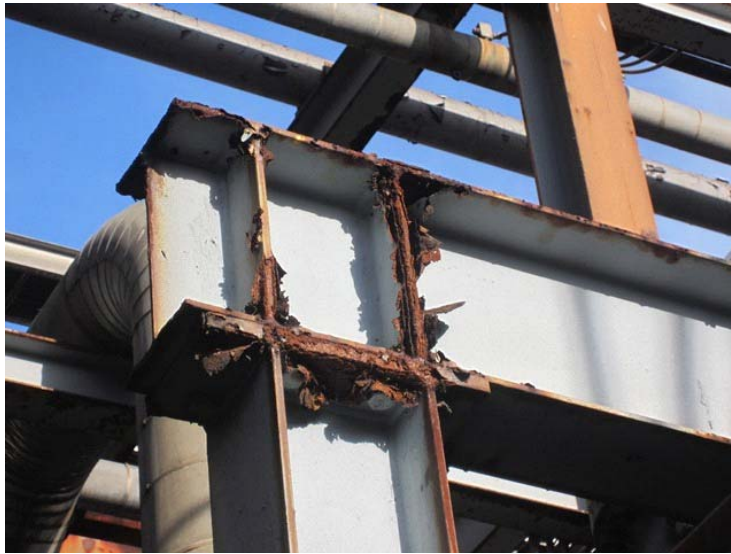
Comments: Metal lose on Structure on Southwest side of tank.

Corrosion on structure

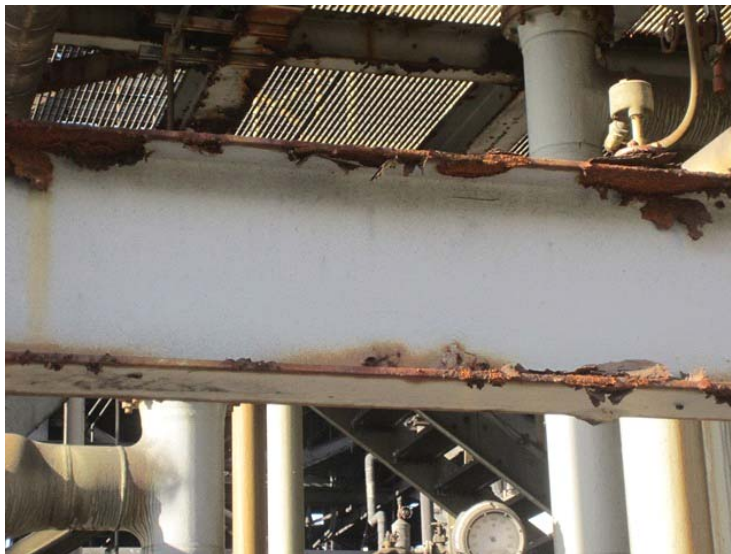
Comments: Metal Loss Throughout.

Corrosion on structure

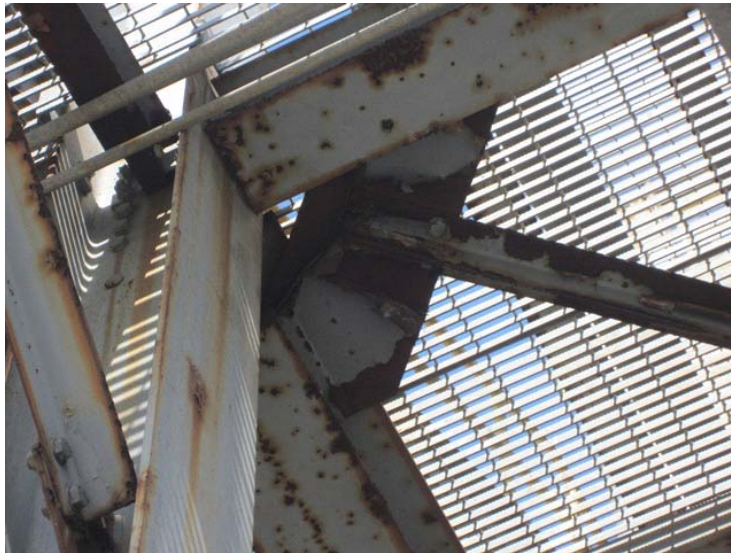
Priority: 1 - Advanced Corrosion

Corrosion on structure

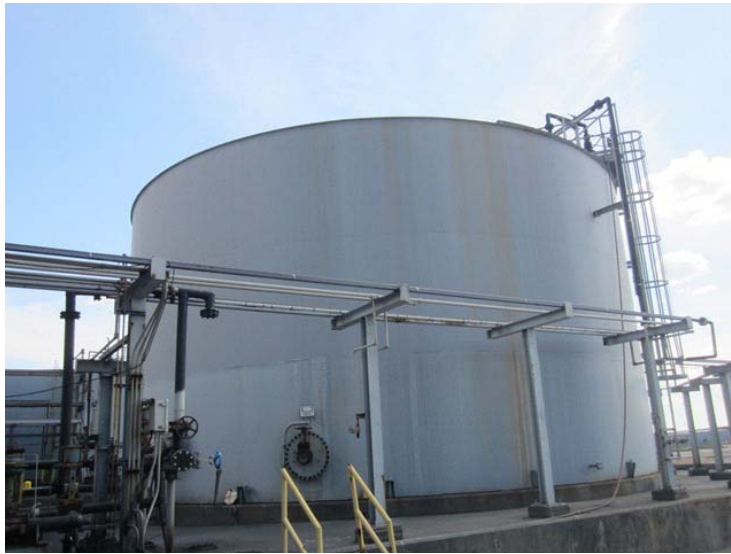
Comments: Optimum- Pinhole Corrosion Northwest side.

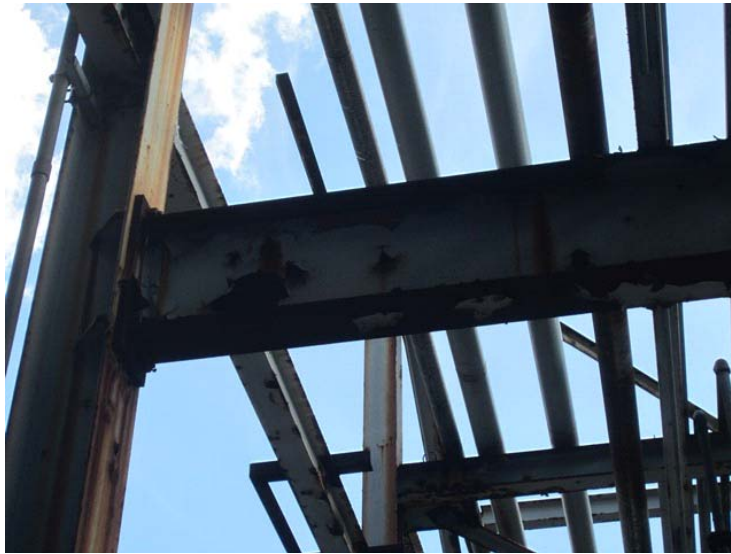
Corrosion in piperack

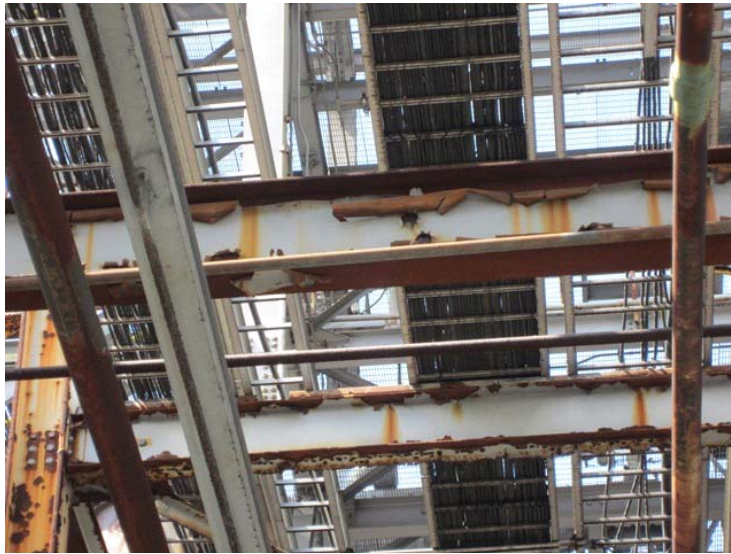
Heavy corrosion on structural steel

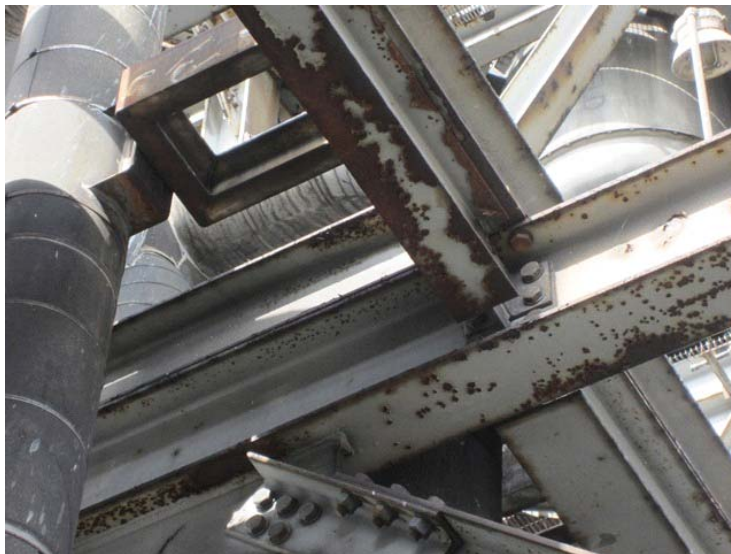
Corrosion on structure

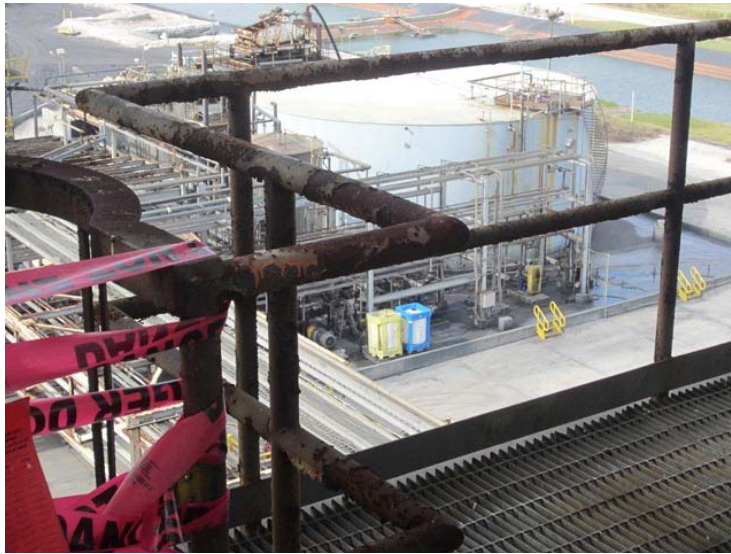
Corrosion on handrails

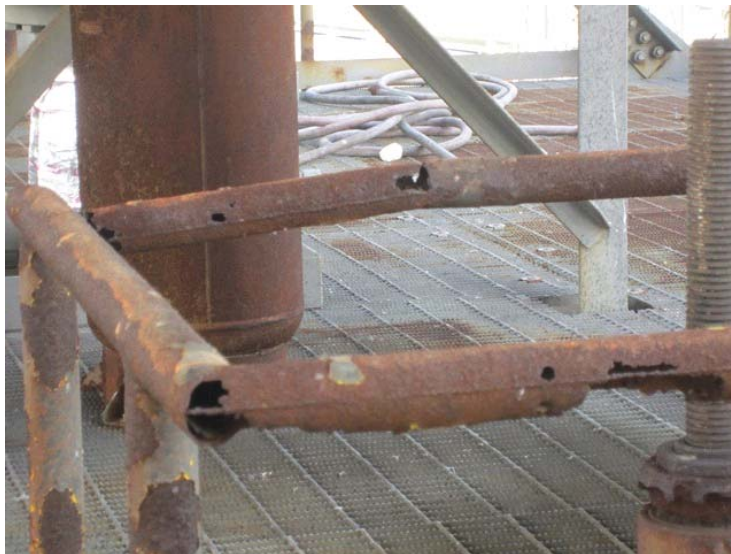
Metal loss on rails

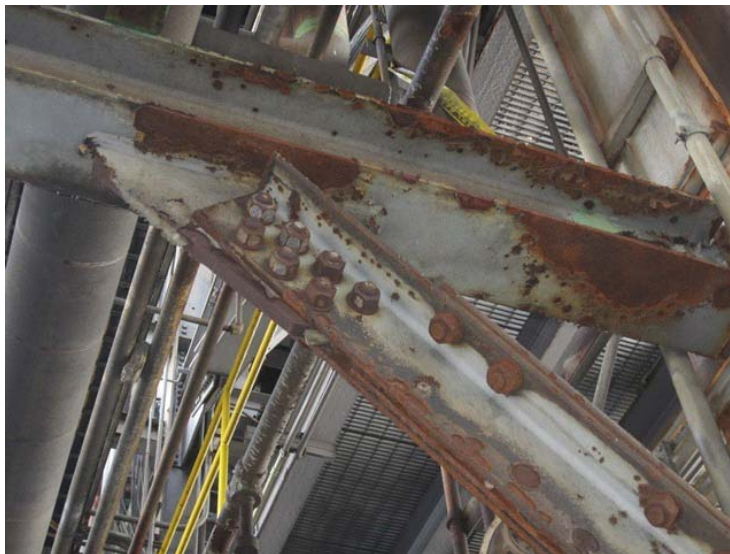
Corrosion occurring on structure

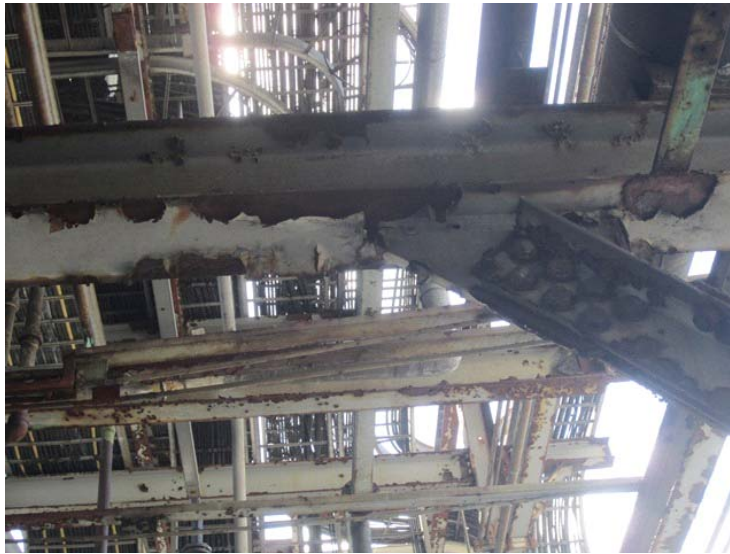
Priority: 1 - Advanced Corrosion

Corrosion on structure

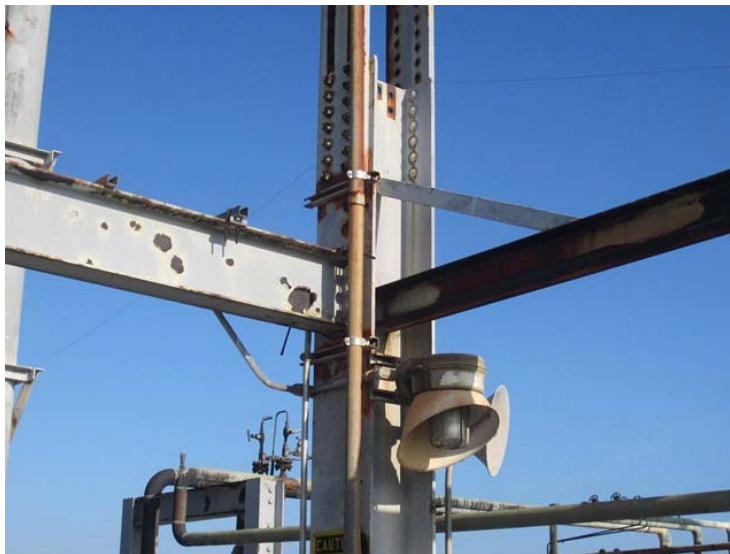
View of corrosion on support structure

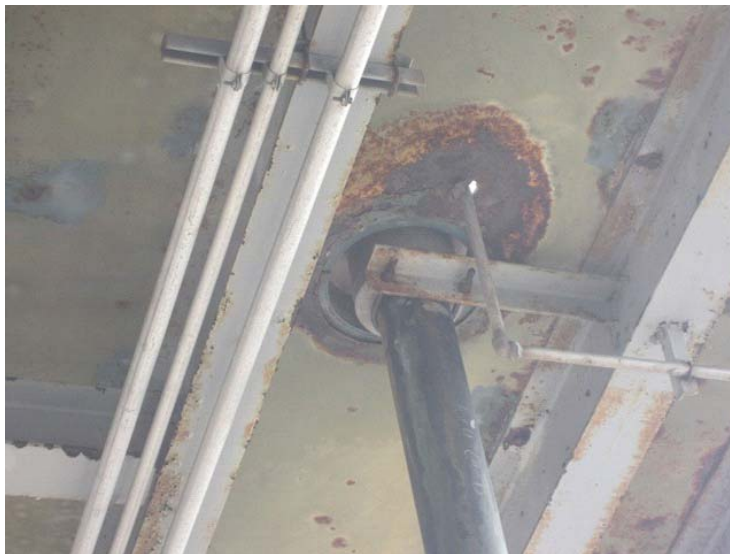
Comments: Pitting and Rust Nodules on Bottom of Roof Deck.

Severe corrosion occurring

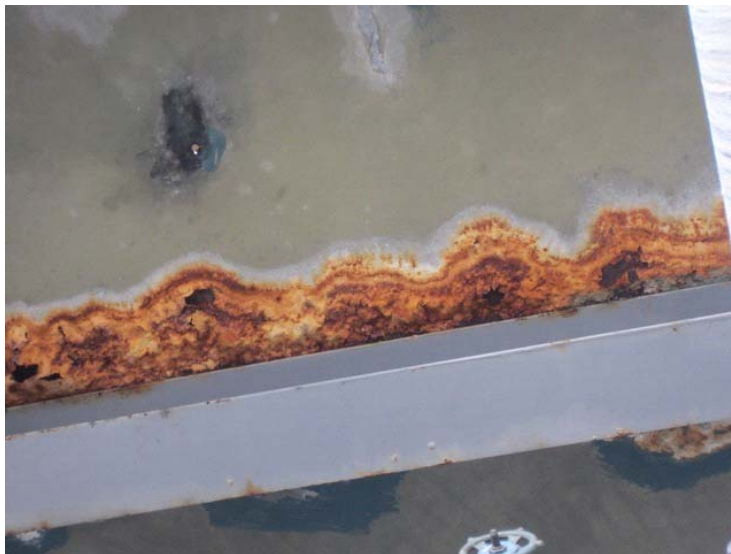
Comments: Pitting, Rust Nodules on Bottom of Roof Deck, and Metal Loss

Severe corrosion on structural steel

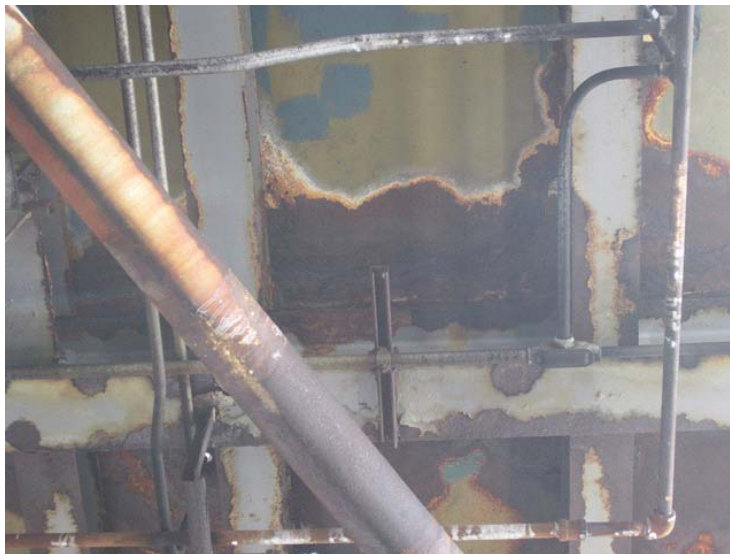
Comments: Pitting, Rust Nodules on Bottom of Roof Deck, and Metal Loss

General view of corrosion in section

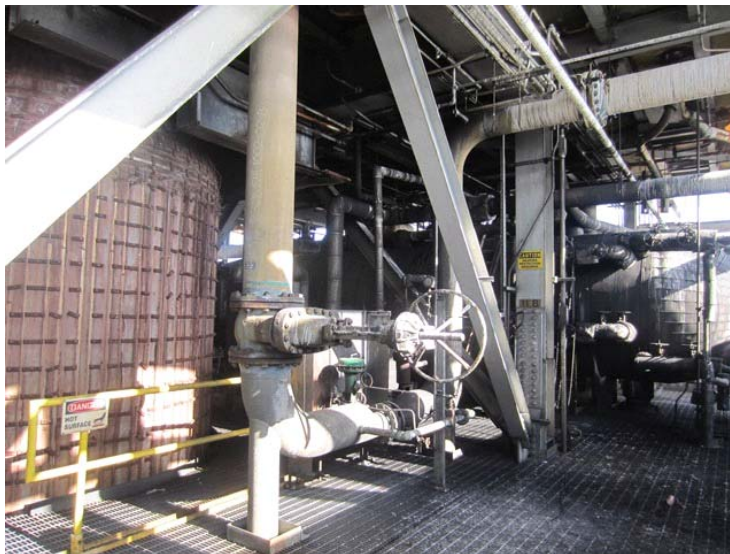
Comments: Pitting, Rust Nodules on Bottom of Roof Deck, and Metal Loss

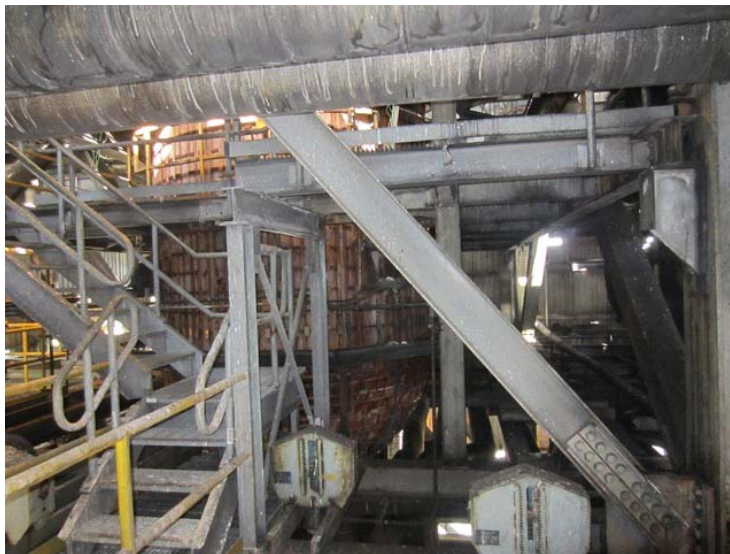
Comments: Localized Corrosion on Structure

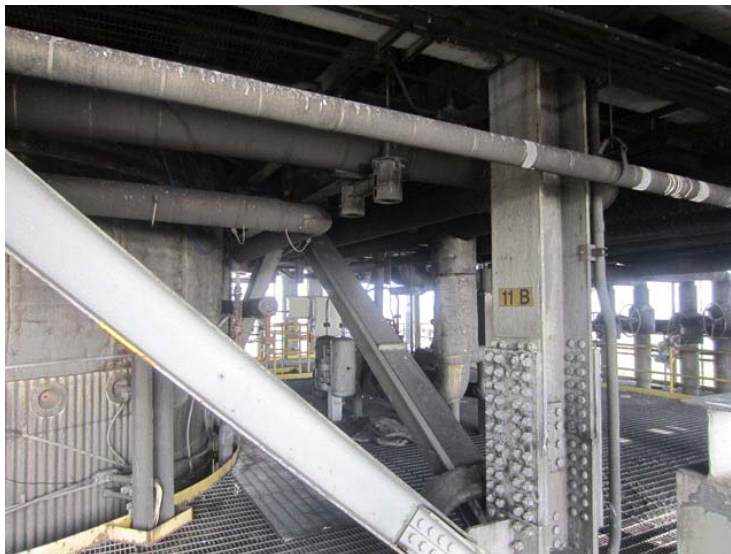
Comments: Heavy Undercutting and some Rust Nodules viewed

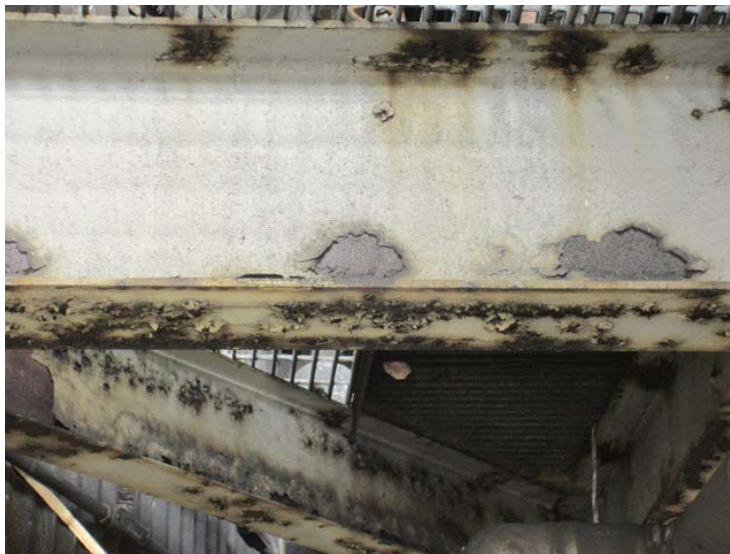
Comments: Heavy Corrosion Throughout

Heavy corrosion on structure

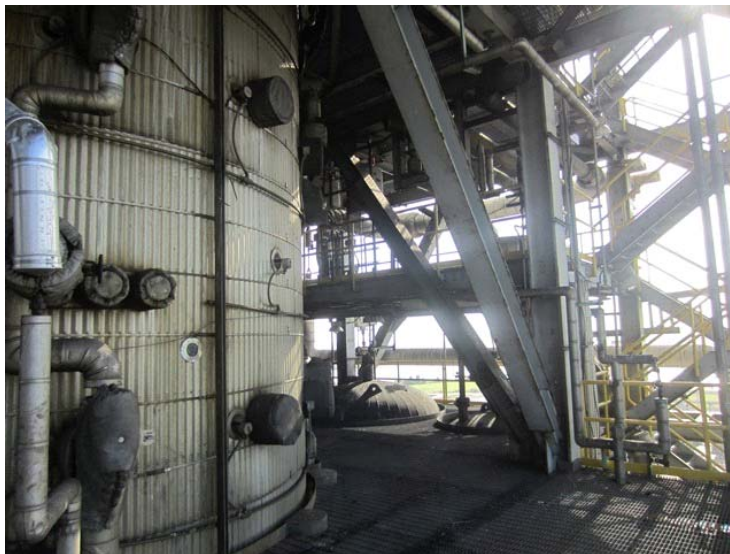
Comments: Heavy Corrosion Throughout

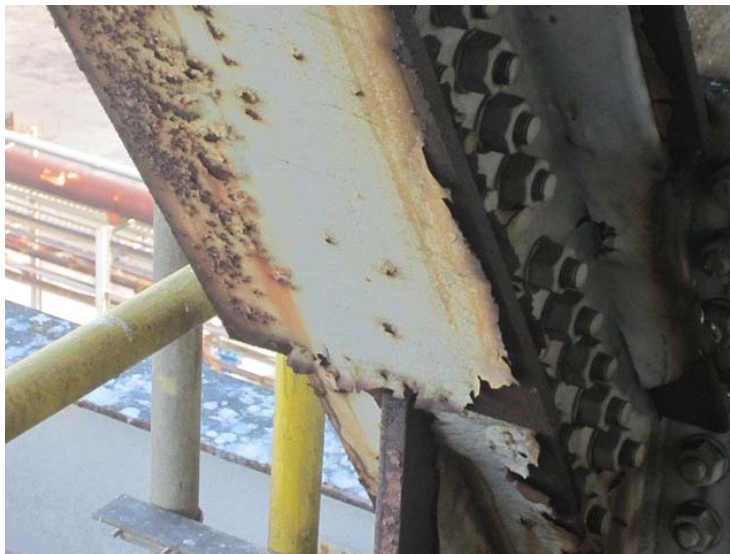
Comments: Pitting Apparent- Heavy Undercoating

Close up view of corrosion

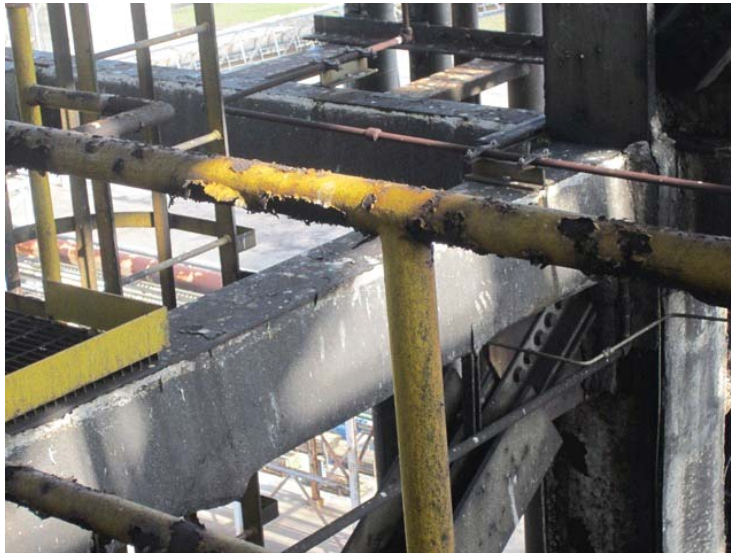
Priority: 1 - Advanced Corrosion

Corrosion on handrails

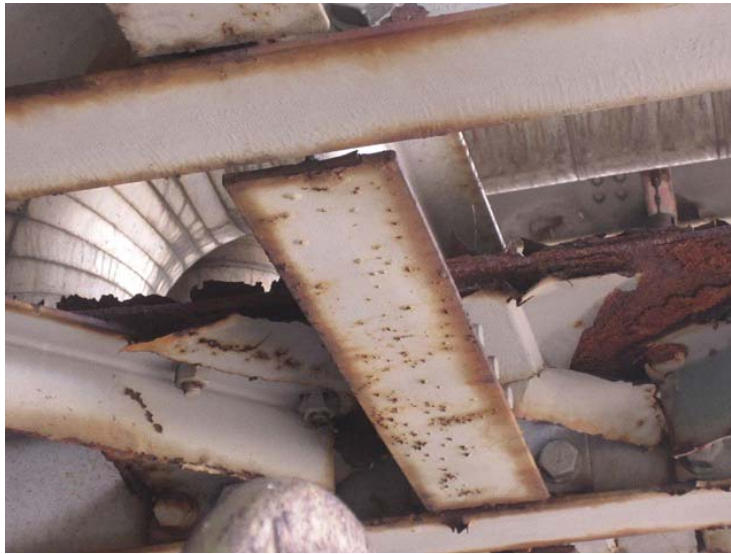
Priority: 1 - Advanced Corrosion

Heavy corrosion

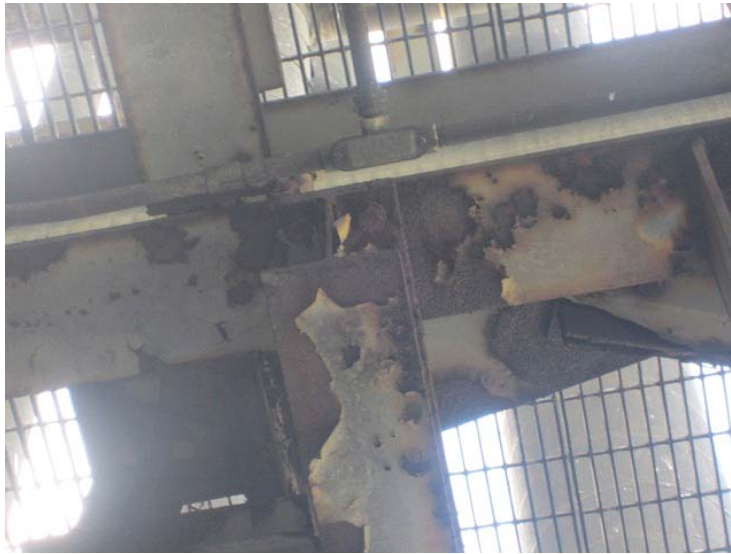
Priority: 1 - Advanced Corrosion

Heavy corrosion on structure

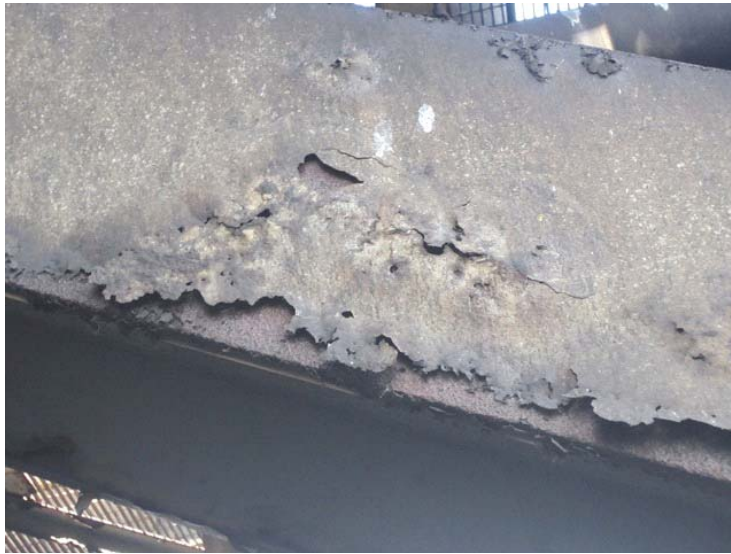
Priority: 1 - Advanced Corrosion

Severe corrosion occurring

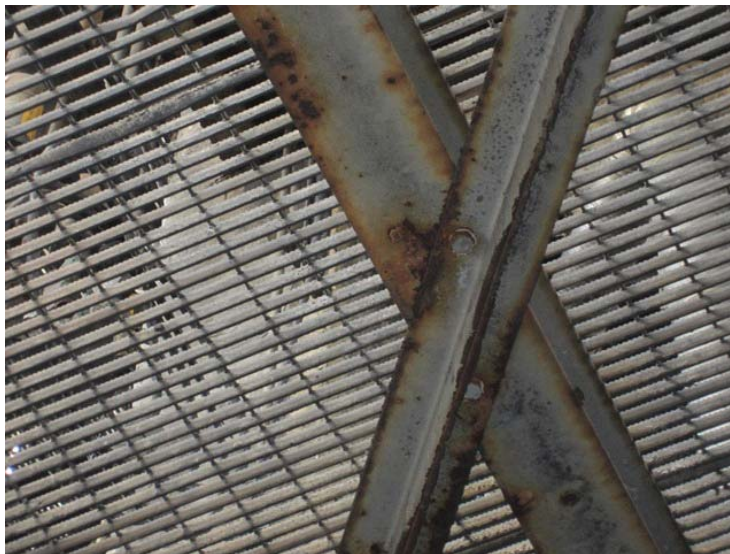
Corrosion occurring on supports

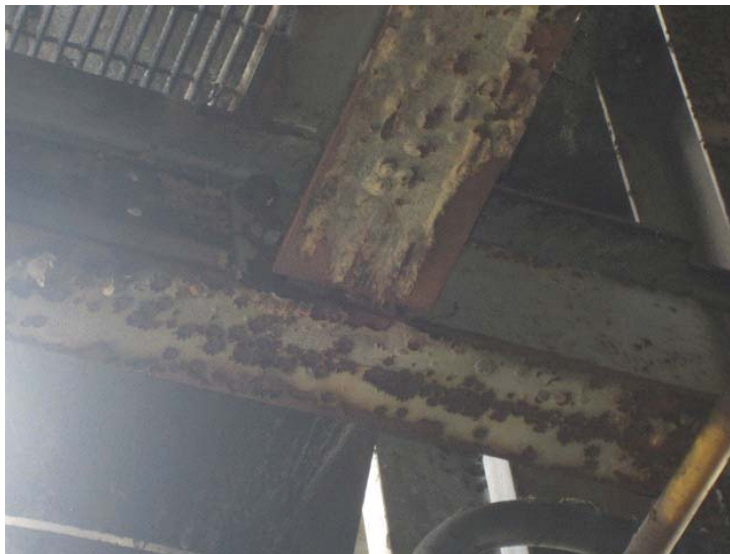
Comments: Heavy Undercoating, Pitting Visible and Metal Loss

Heavy corrosion on structural steel

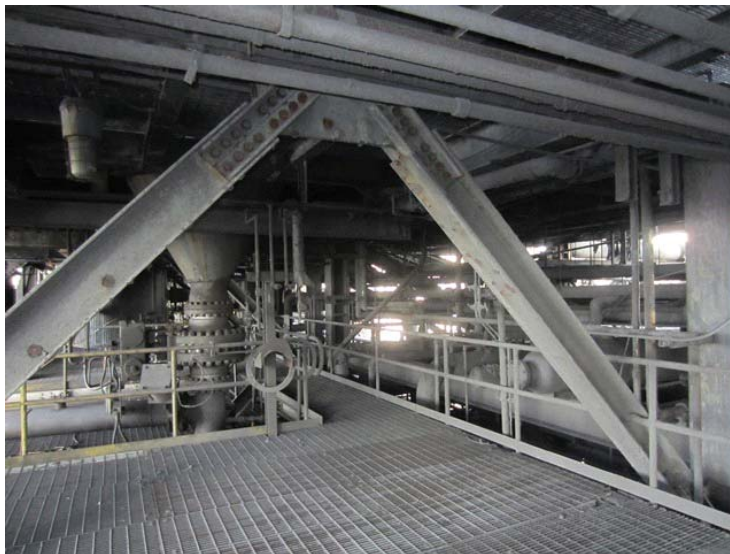
Comments: Heavy Corrosion- Metal Loss
