Condition Analysis

Block: 01 Northwest Unit of the plant. Includes Gasification Unit, Brine Unit, Acid Unit, Coal Slurry Building, and pipe lines to flares.

Subblock: A On West side of Block 1. Contains Flare, pipe racks to flare, and conveyor belt.

Section: 01 Flare and associated structure.

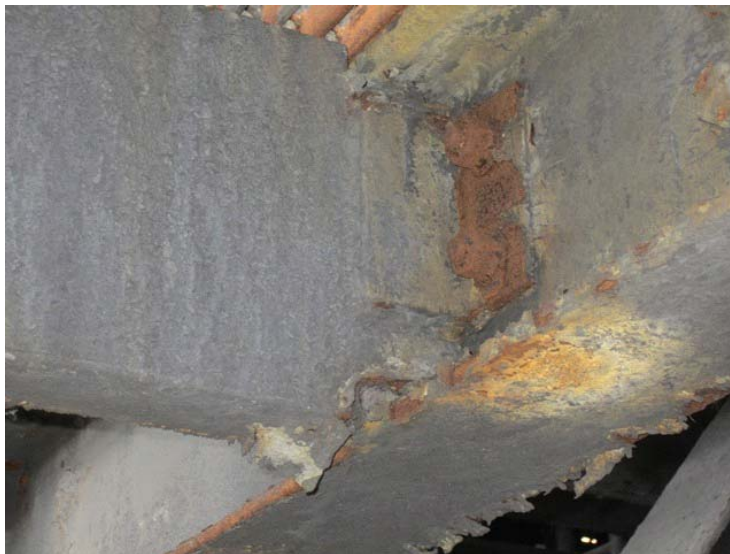
Comments: Very Hard to View Corrosion- Covered with Coal Dust

Corrosion on structure

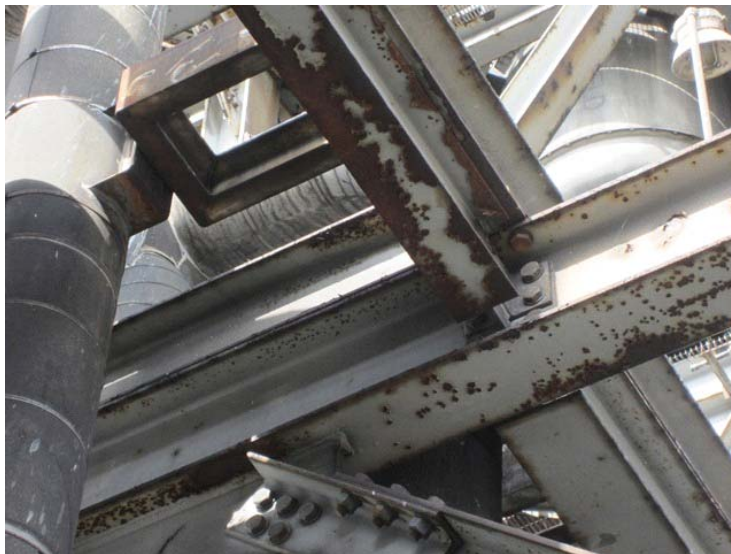
Corrosion on Structure

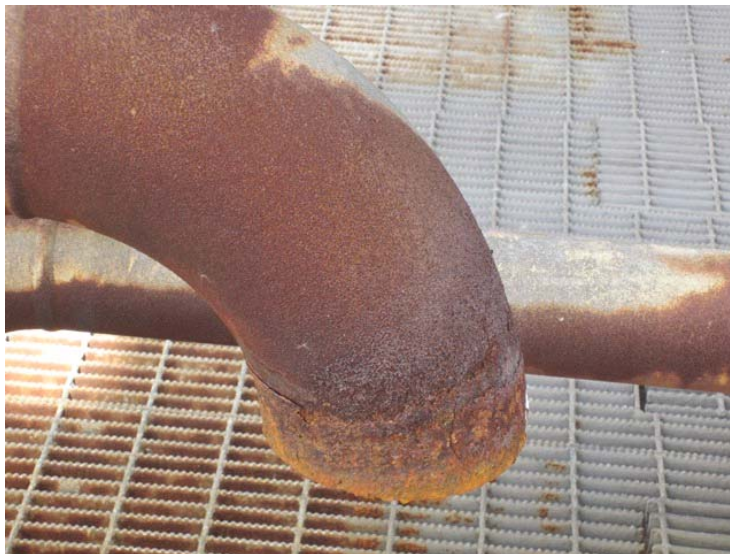
Comments: Localized- Miscellaneous Pipe and Handrails- Structure Good.

Corrosion on piping in section

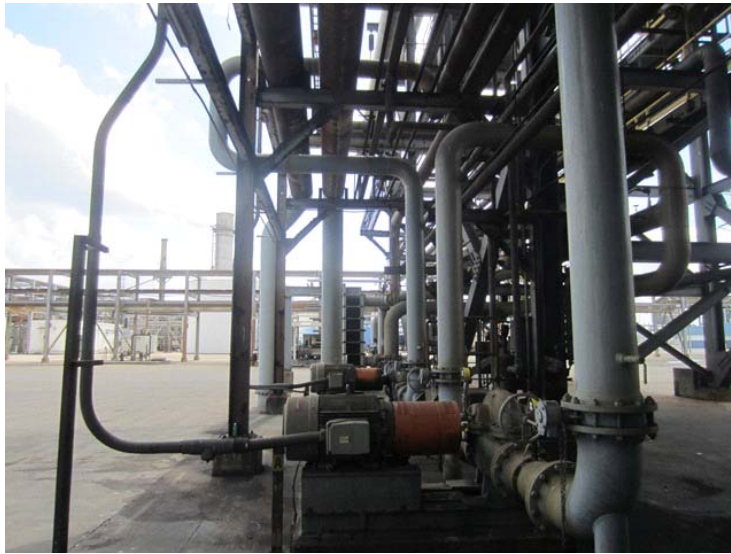
Comments: Pipe Rack, Pumps, and Structure- Structure in Bad Condition- Heavy Pitting on Structure in Center of Pipe Rack.

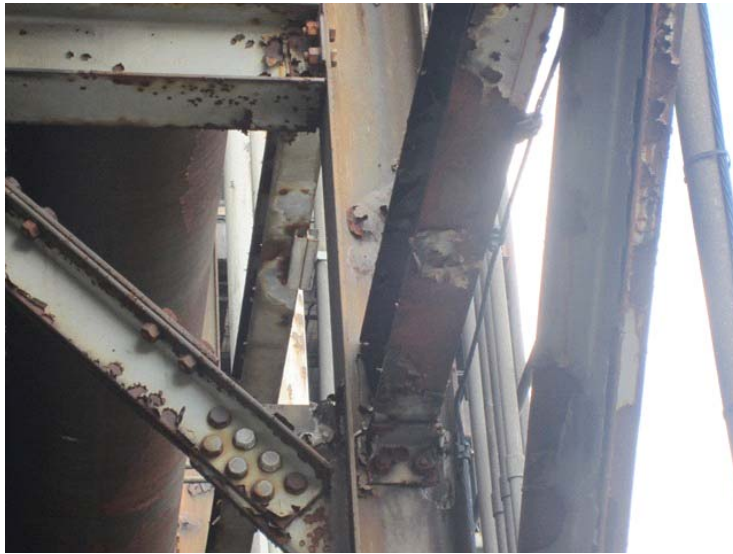
Comments: Pipe Rack, Pumps, and Structure- Structure in Bad Condition- Heavy Pitting on Structure in Center of Pipe Rack.

Corrosion on structure

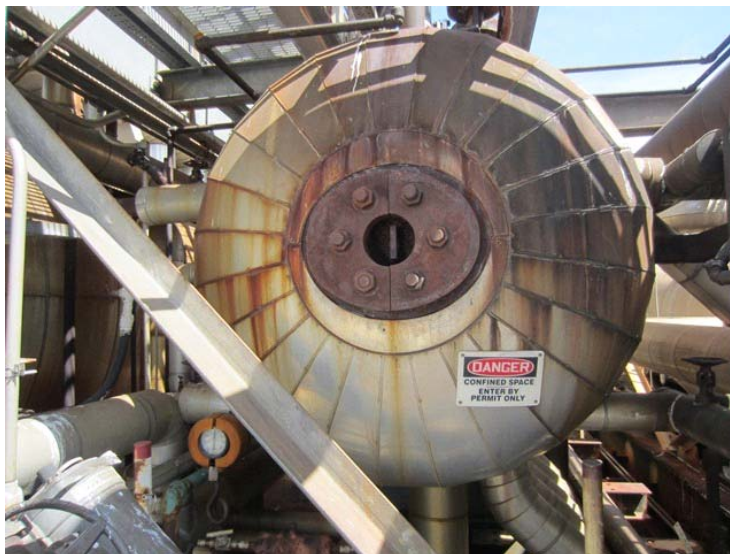
Corrosion on equipment

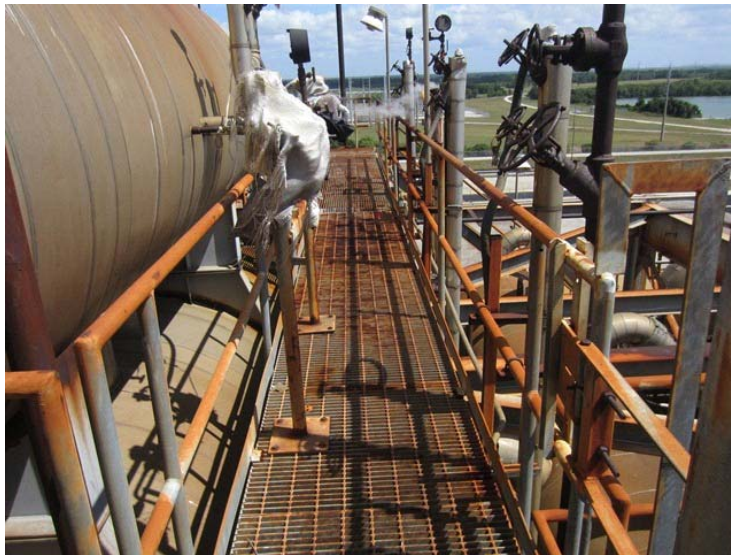
Corrosion on handrails and valves

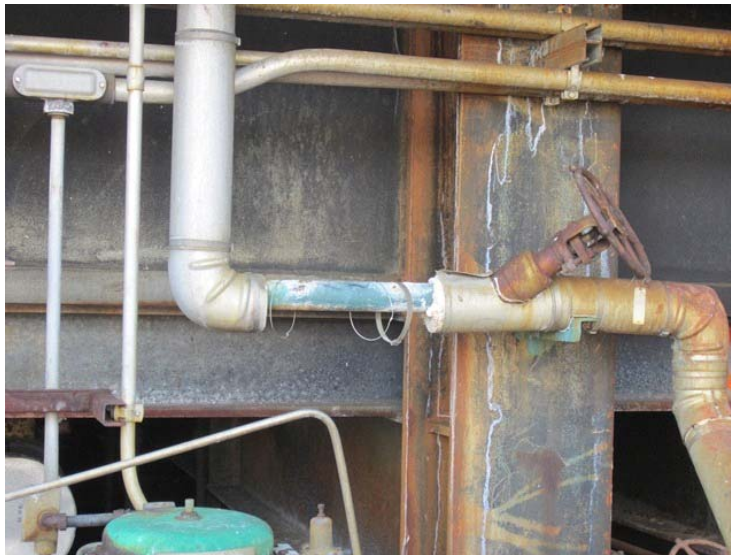
Corrosion on piping in section

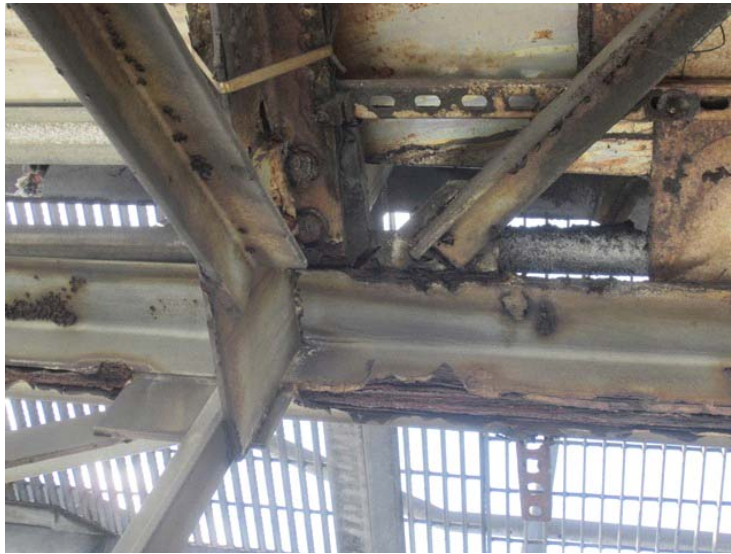
Corrosion on structure

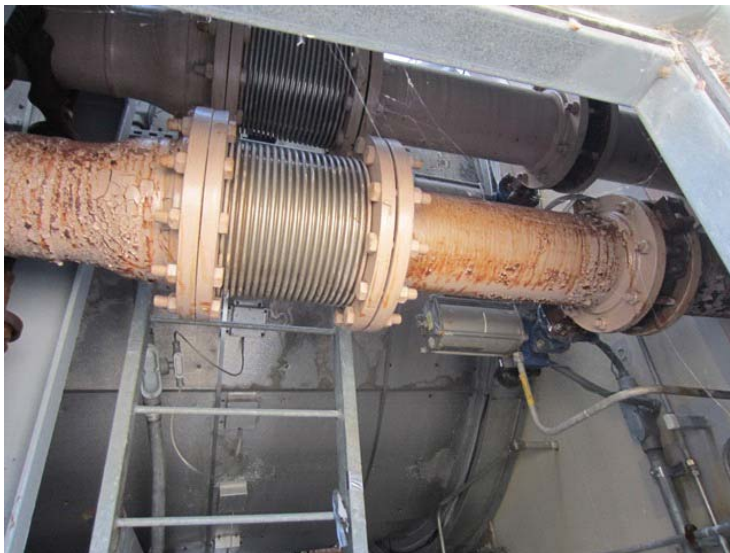
Heavy corrosion on piping
