**Tampa Electric Company  
(TECO)  
Coal Yard Mechanical,  
Electrical and Structural  
Assessment**

Results from field review of the  
coal unloading equipment,  
structures and conveyors.

June 21, 2010

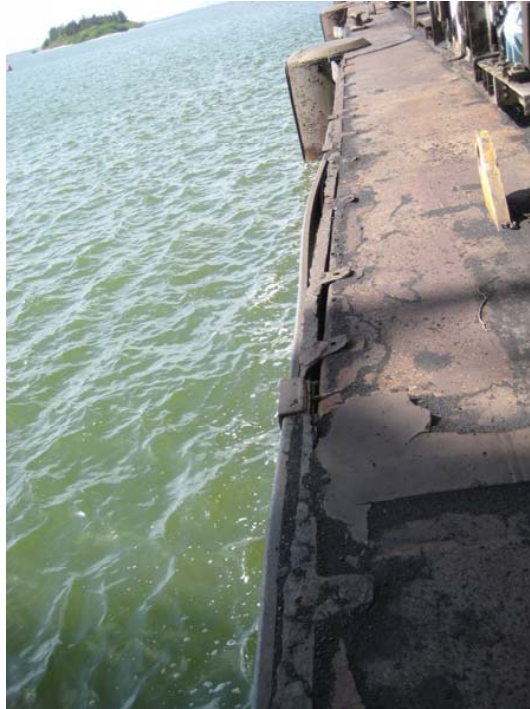
PICTURE DOCK-P

Some of the dock bumpers may not be performing as intended. In some instances, the attachment of the backing steel to the top of the deck has broken free and the bumpers are loose, as in Pictures DOCK-P and DOCK-R. Also, in some cases, the bumper surface has been removed or fallen off into the water below, as in Picture DOCK-S. Additionally, the backing steel is severely corroded in some cases, as seen in the pictures. In these locations, the bumper surface should be removed and the backing steel repaired/replaced. The

underside of the deck should be repaired, if necessary, before new bumper backing steel is installed.

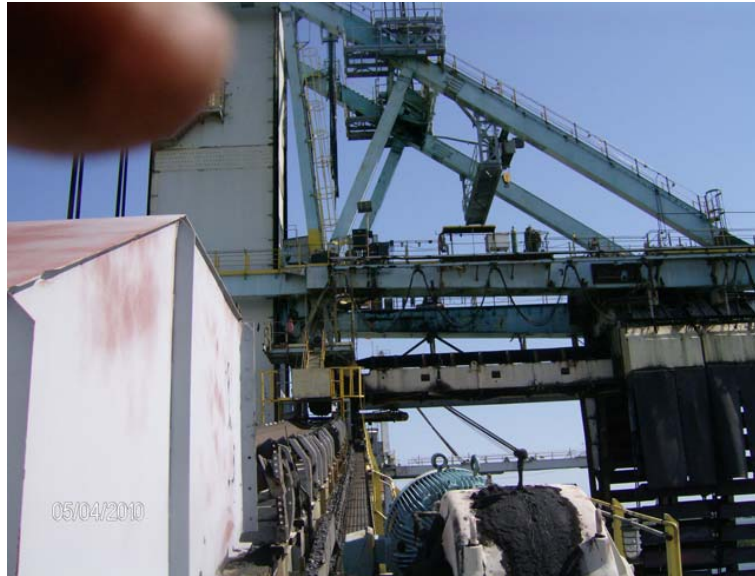
Conveyor B gearbox has an oil leak and is need of repair. The proximity of the gearbox to the digging head has resulted in significant coal dust buildup.

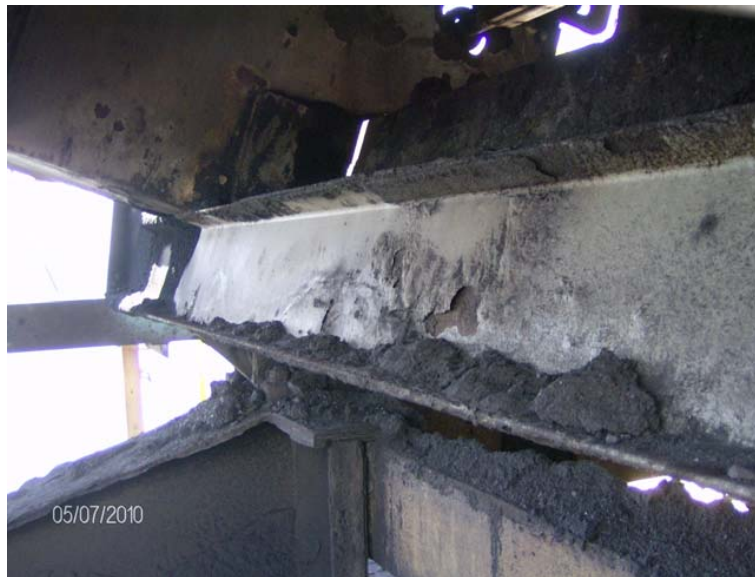
The hinged head end support of conveyor B, below, has corroded and is need of repair. Also the hinge point is in need of lubrication.

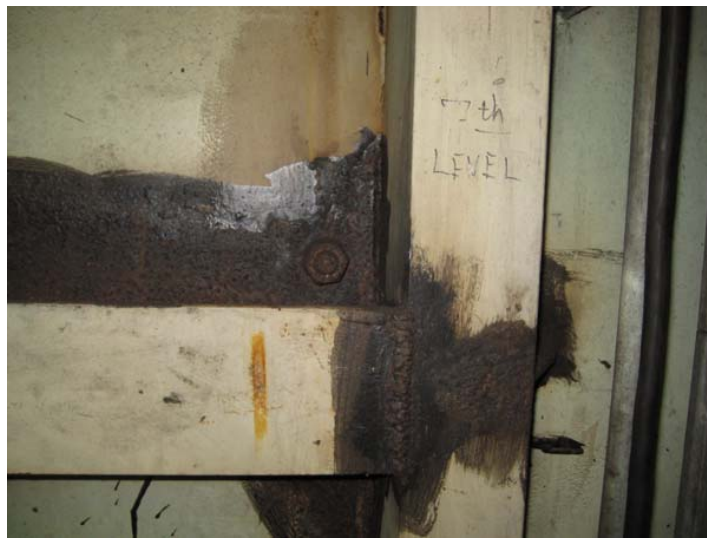
PICTURE DLU-B

Some corrosion within the Unloader Tower was noted on the east side of the tower at the 7<sup>th</sup> Level, as seen in Pictures DLU-B and DLU-C. This appears to be where guides for the counterweight were added and occurs in a number of locations. The new steel added in this area should be cleaned and painted to minimize further corrosion

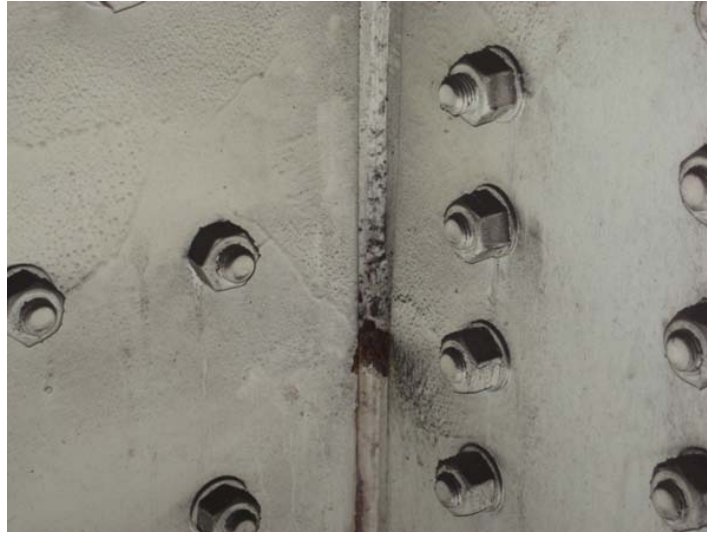
PICTURE DLU-D

The bolts at the various horizontal splice levels within the tower, in general, show no signs of corrosion, as seen in Pictures DLU-D and DLU-E.

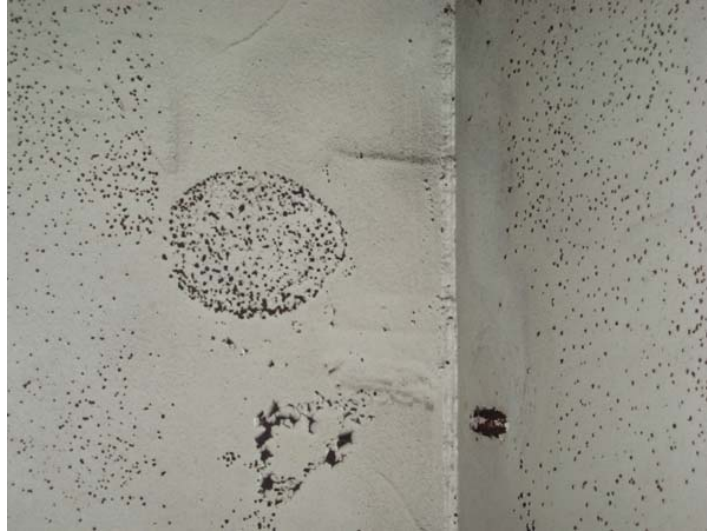
PICTURE DLU-F

Minor speckled-like corrosion was noted throughout the tower, such as seen in Picture DLU-F, but this is negligible.

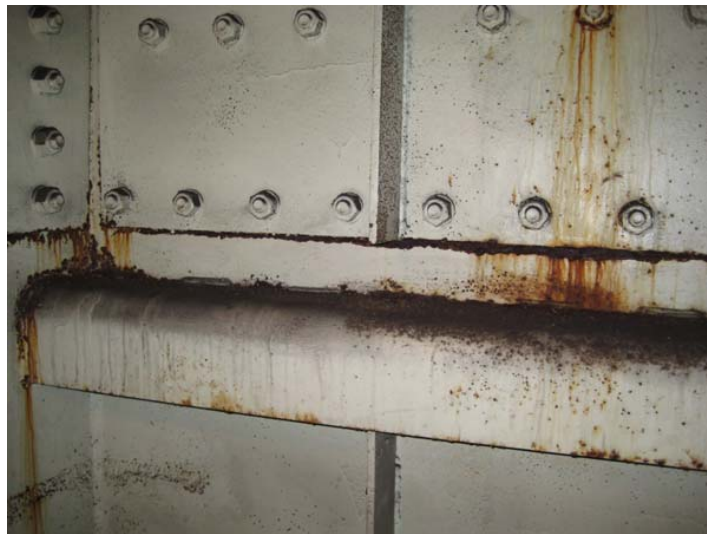
PICTURE DLU-G

Some minor corrosion was noted in the northwest corner of the tower at the 13<sup>th</sup> Level, as seen in Pictures DLU-G and DLU-H, but this was of little concern.

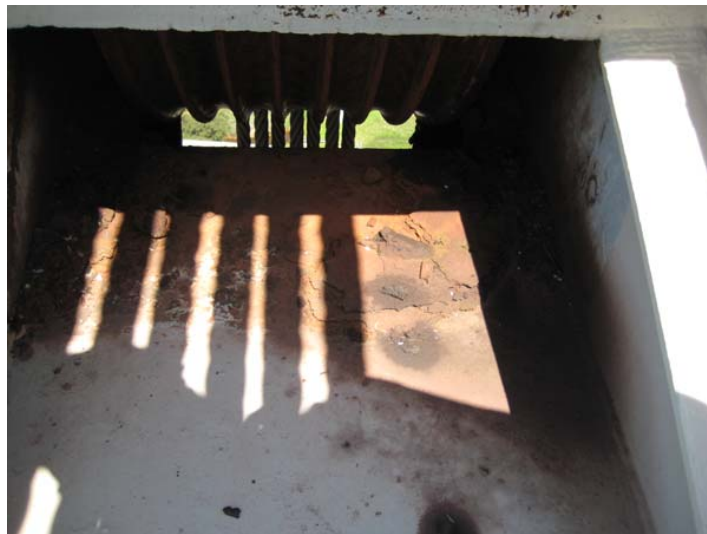
PICTURE DLU-J

There is some minor corrosion under the northeast sheave, as seen in Picture DLU-J. Cleaning and painting is recommended.

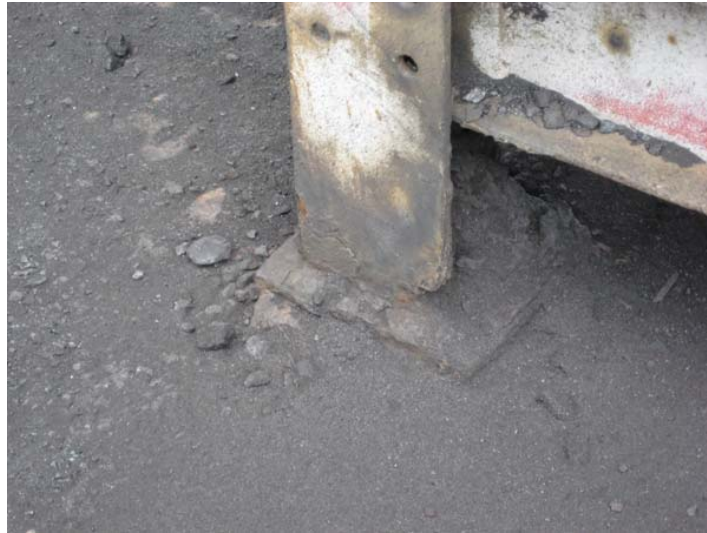
PICTURE CONV-D1-P

Extensive corrosion at the bottoms of the columns and their base plates (Pictures CONV-D1-P thru CONV-D1-T),

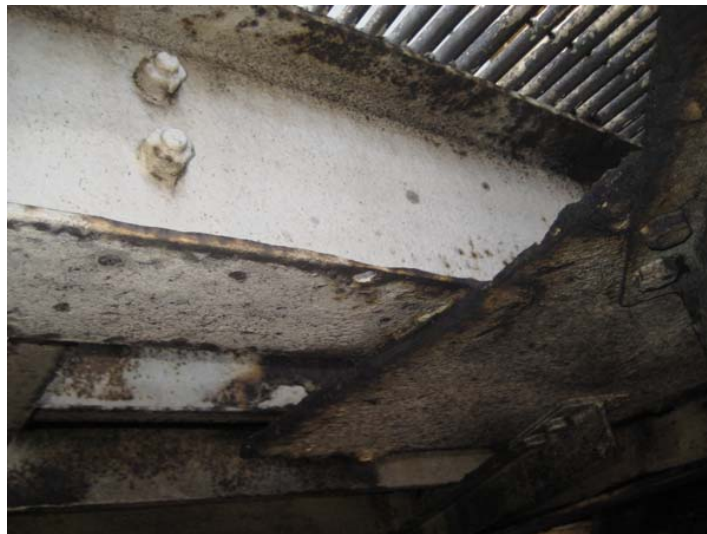
PICTURE TTWR-T2-G

- C-5 Floor beam has developed holes in web and flange. Recommend grinding holes in web back to sound metal and welding a patch over hole. Weld should be at plate and through hole to ensure moisture cannot get between the two. The flange could be cut out back to sound metal and plate welded back in to replace flange. Ensure beam is unloaded prior to cutting out damaged section. See included photos TTWR-T2-G and TTWR-T2\_H.

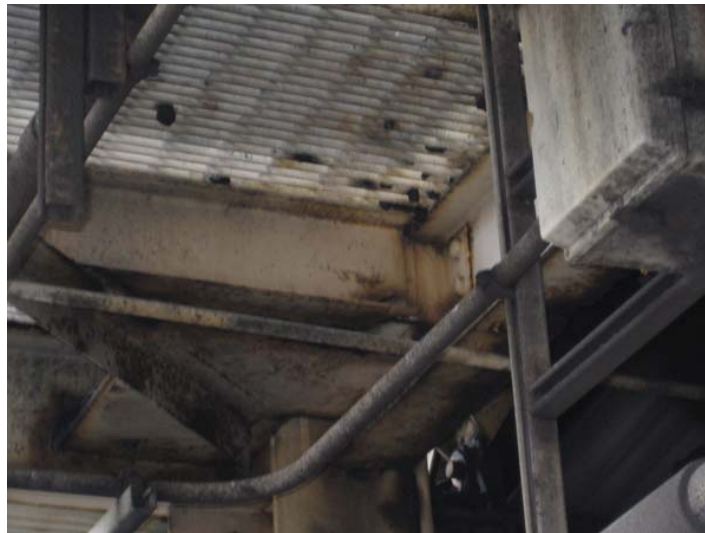
PICTURE TTWR-T2-D

- C-6 Floor beam has severe metal loss at North connection. Recommend replacement in kind. See included photo TTWR-T2-D.

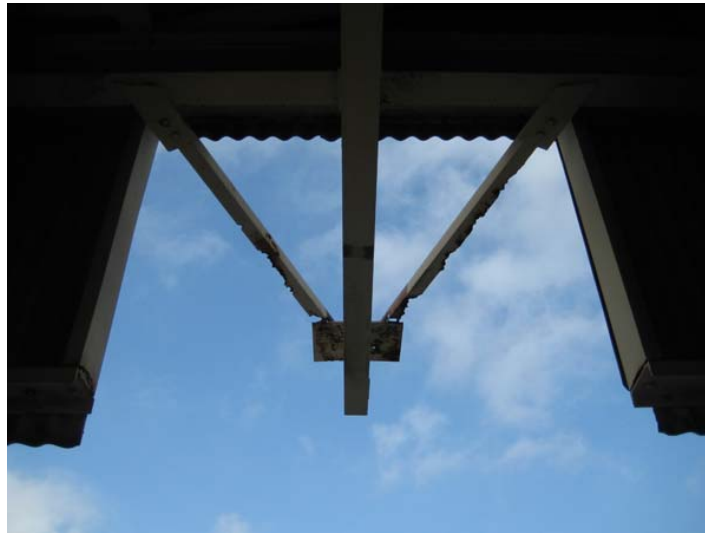
PICTURE TTWR-T2-B

- C-19 Monorail support brace has severe rot. Recommend replacement in kind. See included photo TTWR-T2-B.

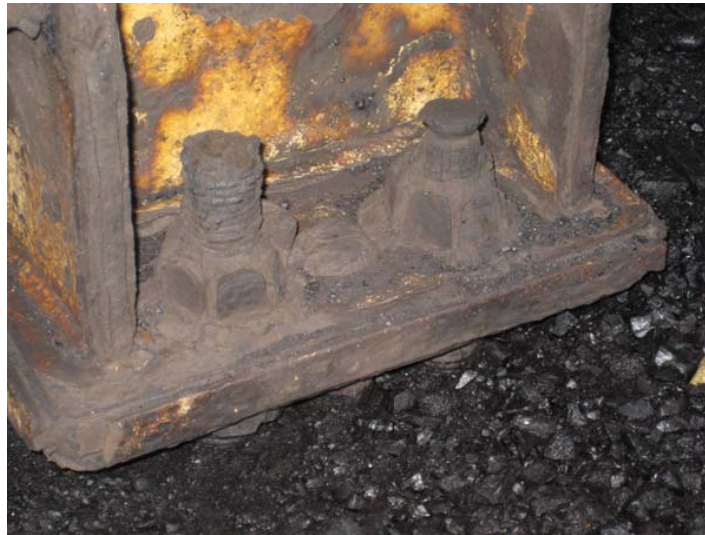
PICTURE CONV-F1-A

- C-1 The grout beneath the base plates of the frame supporting the tail end of Conveyor F1 has disappeared over time as can be seen in Pictures CONV – F1 – A and CONV – F1 – B. Additionally, as can be seen in Picture CONV – F1 – C, the condition of the anchor bolts and nuts is poor. The bottom of the columns and their base plates should be cleaned and painted and repaired, as necessary. The underside of the base plates should be cleaned of any coal and the grout should be replaced. The anchor bolts should be cleaned and painted and the nuts replaced, if possible; otherwise a new means of anchorage will be required.

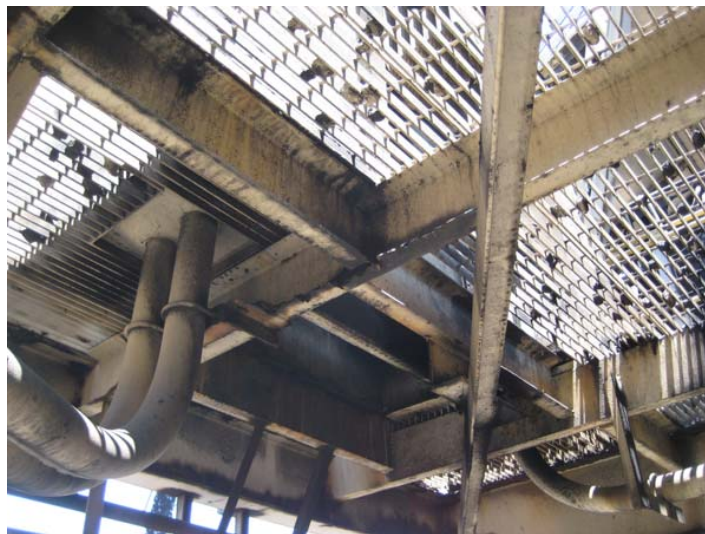
PICTURE DSR-B

- C-18 Beam has severe metal loss and rot in the bottom flange at midspan. See included photo DSR-B. Recommend grinding bottom flange back to sound metal or cutting out damaged section and either cover plating or installing new plate for bottom flange. Beam may require temporary support. Alternative recommendation would be replacement in kind.

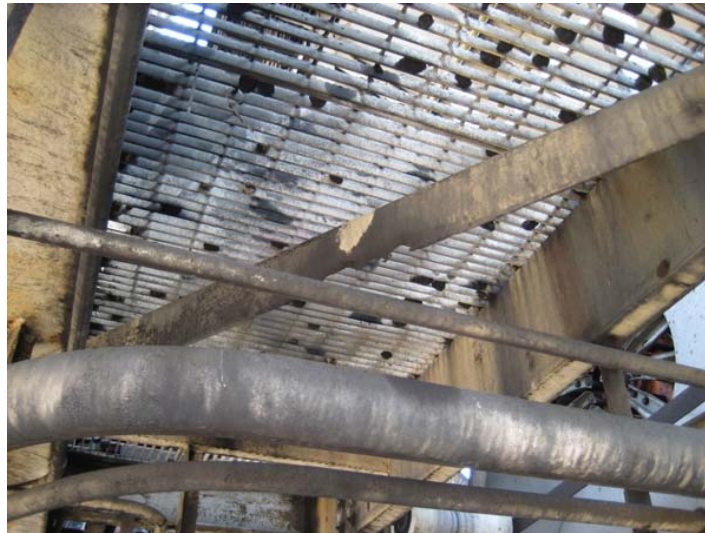
PICTURE DSR-A

- C-19 Beam has considerable delamination and metal loss of the top flange. Recommend grinding top flange back to sound metal or cutting out damaged section and either cover plating or installing new plate for top flange. Beam may require temporary support. Alternative recommendation would be replacement in kind.
- C-20 Beam has several areas of severe corrosion. Recommend cleaning, inspection to determine extent of damage, repairing with cover plates as required and painting to prevent further damage.
- C-21 Vertical leg of angle brace has severe rot. See included photo DSR-A. Recommend cutting out bad section and replacing with same steel shape.

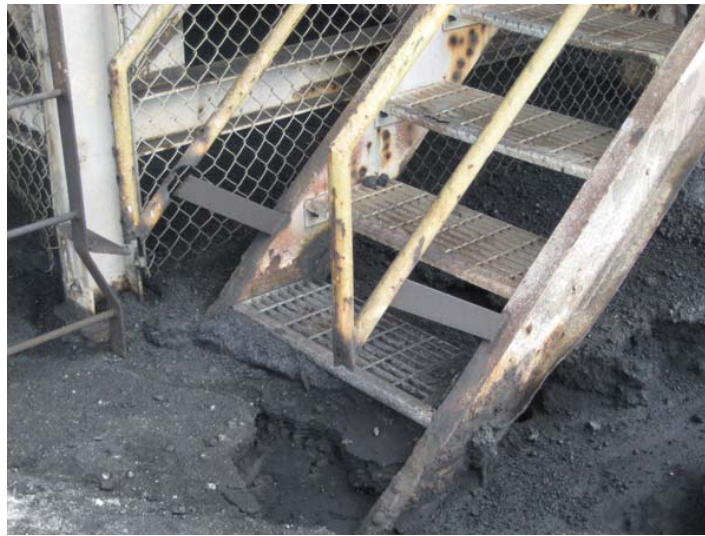
PICTURE TTWR-T3-B

- C-1 The bottoms of stair stringers are embedded in coal which has caused extensive corrosion as seen in Picture TTWR-T3-B. Additionally, the inboard handrail has corroded free of its support. Coal needs to be cleaned away from the bottom of the stairs and the stringers and handrail repaired.

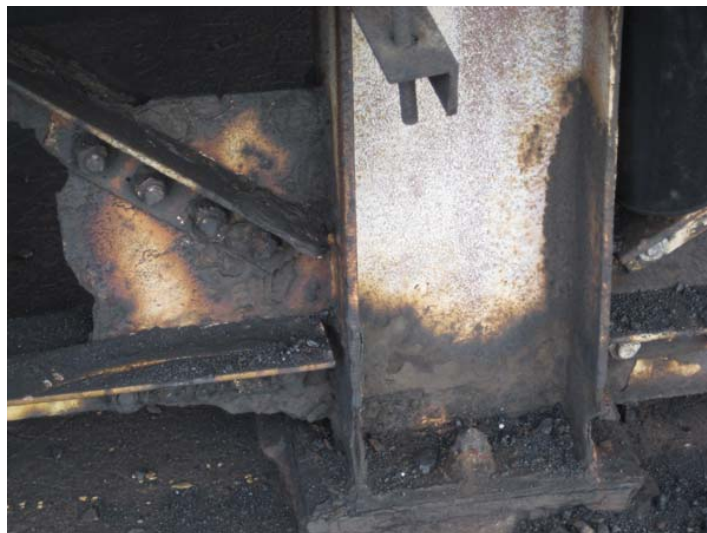
PICTURE TTWR-T3-D

- C-3 The bottom of Column A-1.5 is similar as seen in Picture TTWR-T3-D. The anchor rod nuts are corroded as are the column flanges. Also, the gusset plates and the vertical bracing are similarly corroded. This column will need to be repaired similar to Column A-1.

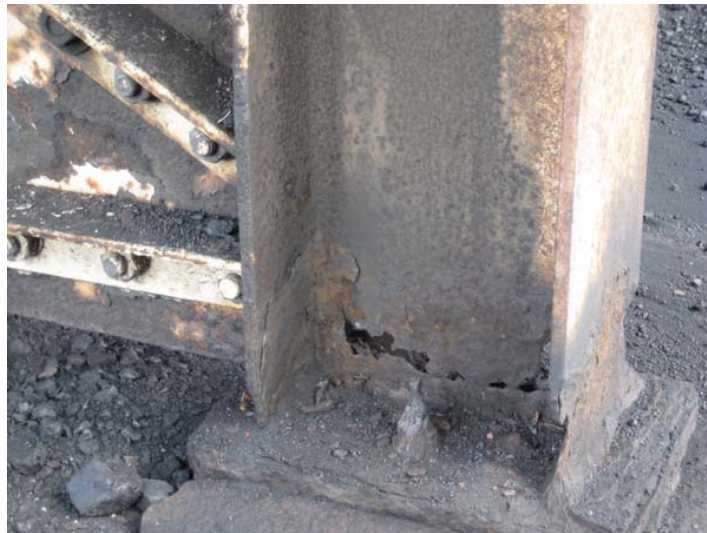
PICTURE TTWR-T3-G

- C-7 The bottom of Column A-2 is severely corroded with holes through the web and loss of flange section, as seen in Pictures TTWR-T3-G and TTWR-T3-H. Additionally, anchor bolt nuts have corroded away. Column bottom needs to be repaired and cleaned and painted and anchor bolts repaired and new nuts installed, if possible. Otherwise a new anchorage system will be required.

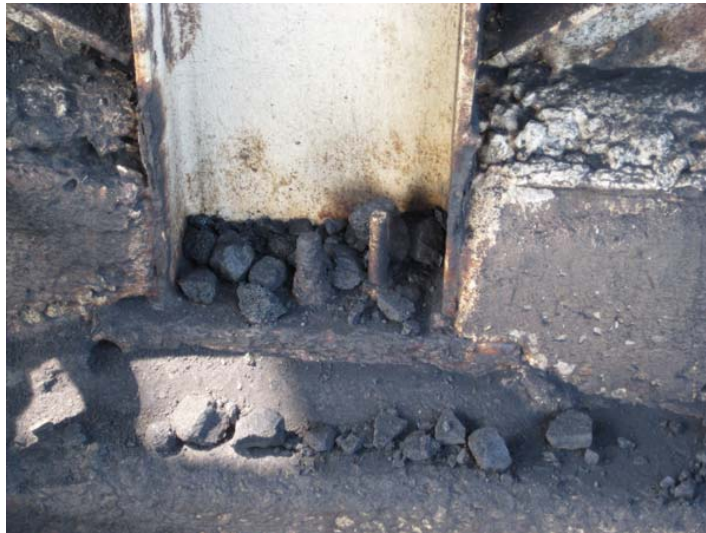
TTWR-T3-P

- C-11 The bottom of Column D-1.5 is seen in Picture TTWR-T3-P. Column base needs to be cleaned and painted and anchor bolts repaired and new nuts installed, if possible. Otherwise a new anchorage system will be required. Vertical braces and gussets also need cleaning and painting/repair as required.

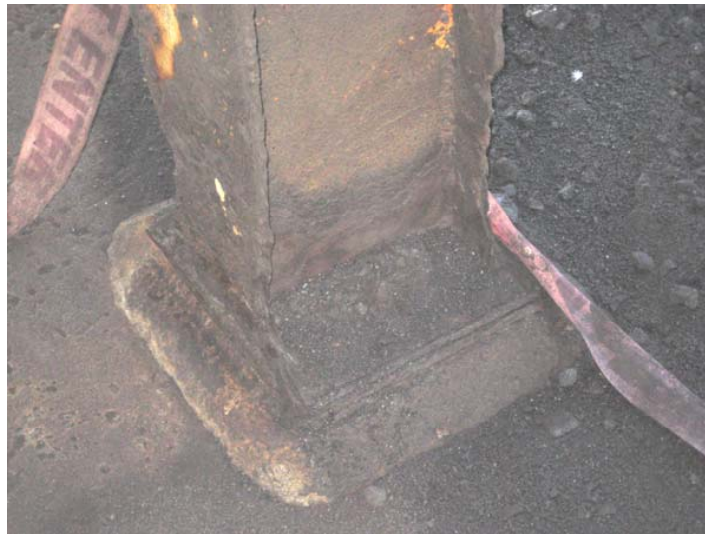
- C-14 The bottom of Column B-1, as seen in Pictures TTWR-T3-T and TTWR-T3-U, is in poor condition. Corrosion is severe and column bottom needs to be repaired and cleaned and painted and anchor bolts repaired and new nuts installed, if possible. Otherwise a new anchorage system will be required.

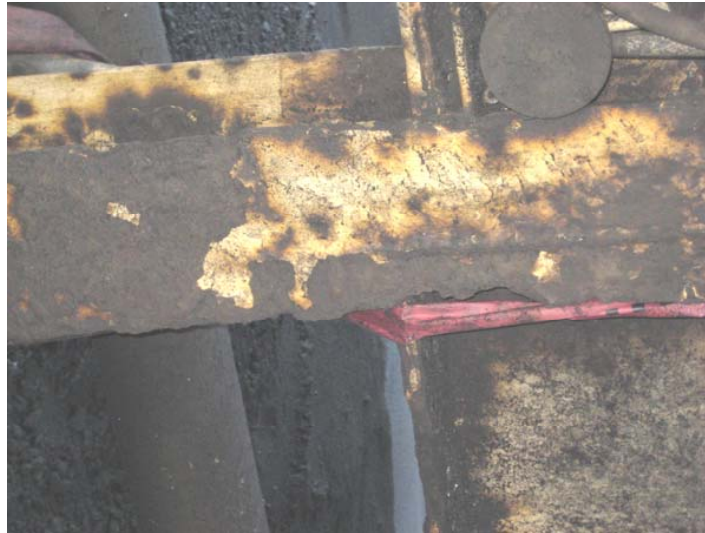
- C-15 At Column B-1 at the first framing level on the east side of the column there is considerable corrosion of the column and the beam framing in including the connection, as seen in Picture TTWR-T3-V This will require repair and cleaning and painting.

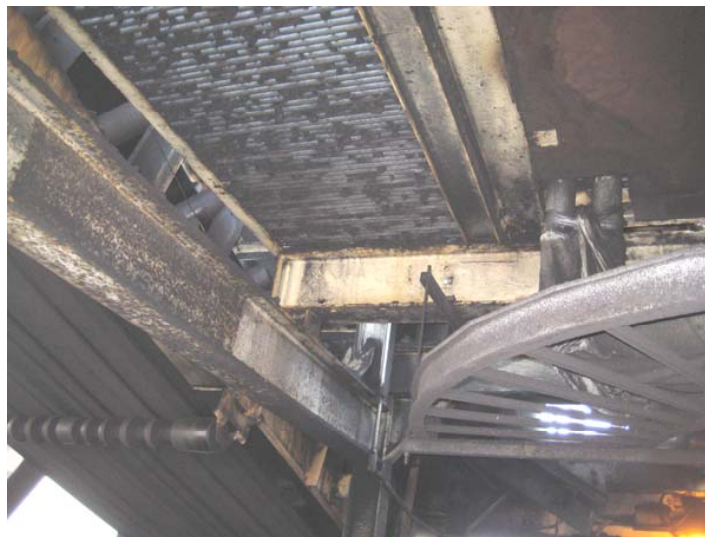
PICTURE TTWR-T3-AA

Pictures TTWR-T3-AA, TTWR-T3-AB and TTWR-T3-AC show the general condition of the floor framing systems. Coal accumulation on the grating surfaces and the presence of moisture have lead to corrosion of the grating and the support steel in many areas. The grating surfaces should be kept free of coal and the corroded areas cleaned and painted to minimize further corrosion. Should cleaning of the members back to solid metal expose significant corrosion, repairs or replacement will be required.

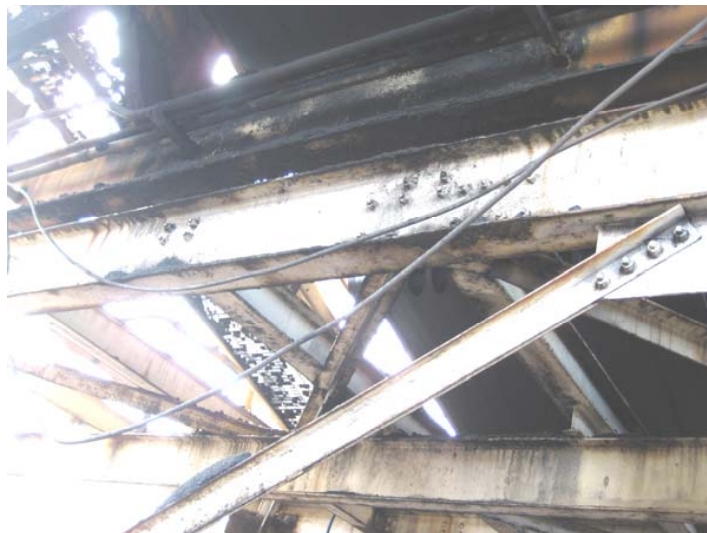
PICTURE TTWR-T3-AD

C-1 Framing supporting Conveyor J1 has severe corrosion as seen in Picture TTWR-T3-AD. Framing needs cleaning and painting/repair as required.

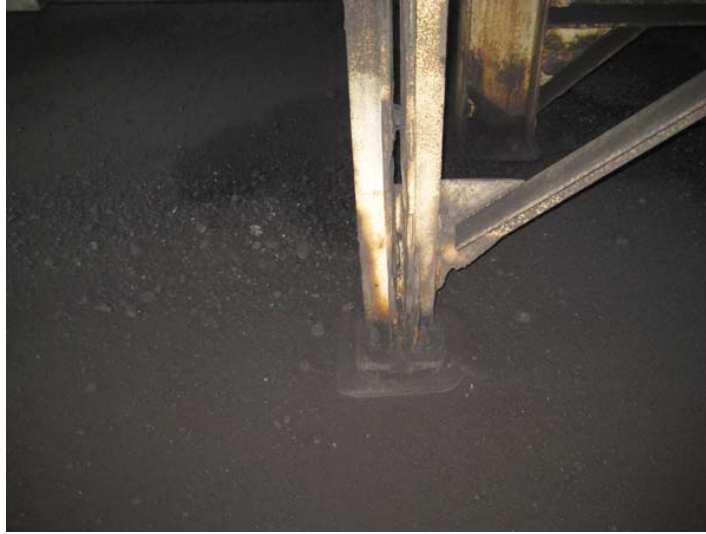
PICTURE CONV-Y-D

- C-1 The double angle support legs for Conveyor Y are separating due to the corrosion forming between the angles as seen in Pictures CONV-Y-D, CONV-Y-E AND CONV-Y-F. These legs should be removed and replaced with WT-sections to eliminate the corrosion between the angles.

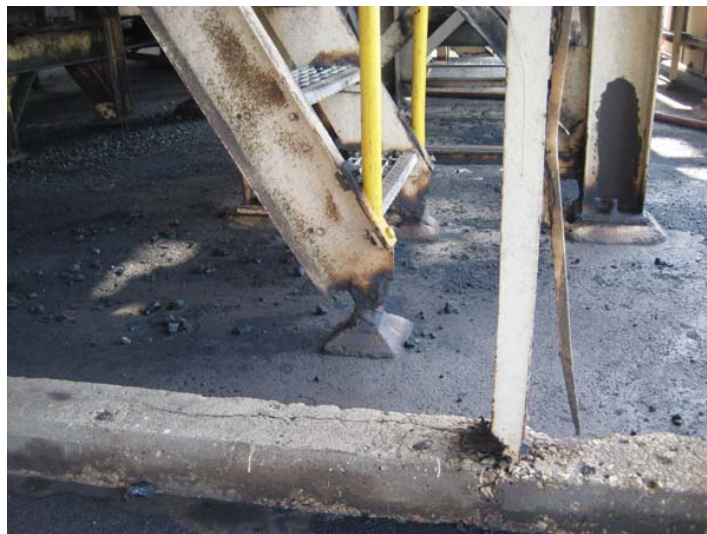
PICTURE CONV-Y-G

C-1 The bottoms of the stair stringers on the west side of Conveyor Y have corroded severely, as seen in Picture CONV-Y-G and need to be repaired.

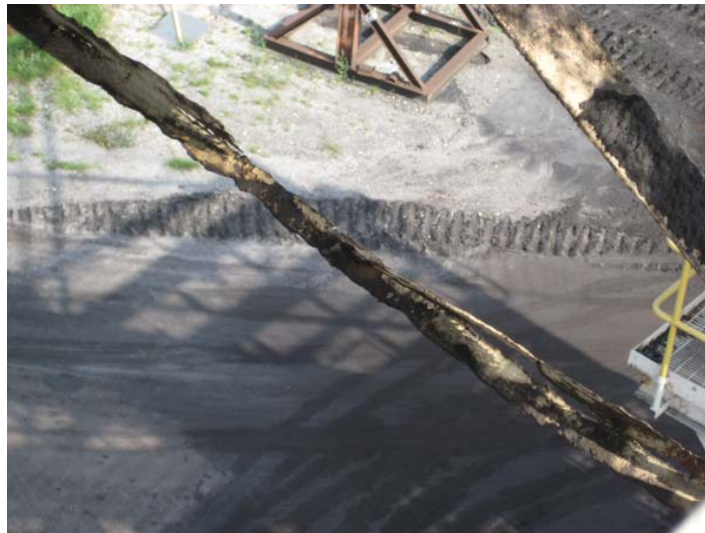
PICTURE CONV-Z-M

- C-1 There is considerable loss of section in the bottom chord brace members and the vertical sway frames between the trusses, as can be seen in Pictures CONV-Z-M thru CONV-Z-P.

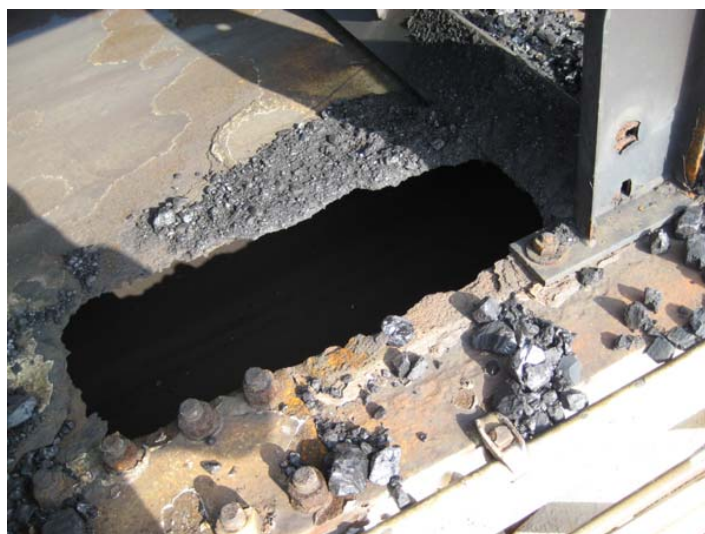
C-3 Accumulation of coal on spill pan subjected to moisture has lead to corrosion causing holes in the spill pan. Corrosion of the top chord is also evident, as seen in Picture CONV-Z-U.

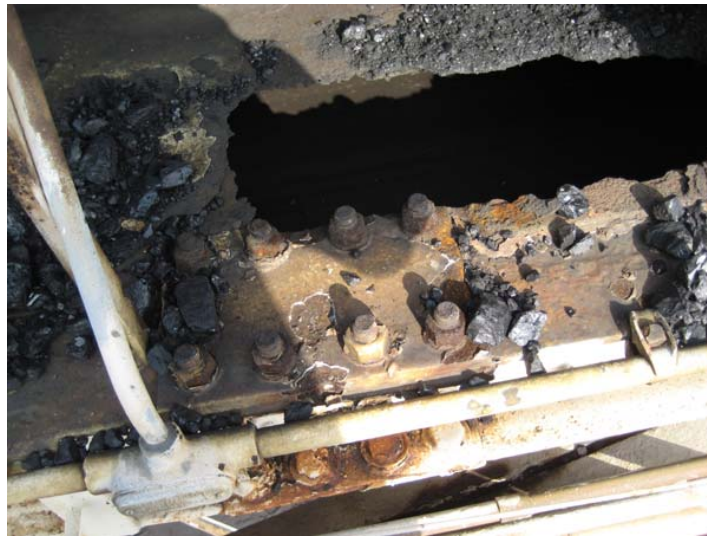
PICTURE CONV-Z-V

- C-4 Accumulation of coal subjected to moisture is corroding the top flange of the truss and also the bolts in the splice connection. In some instances the nuts are no longer hexagonal but are becoming more rounded. Refer to Pictures CONV-Z-V thru CONV-Z-Y.

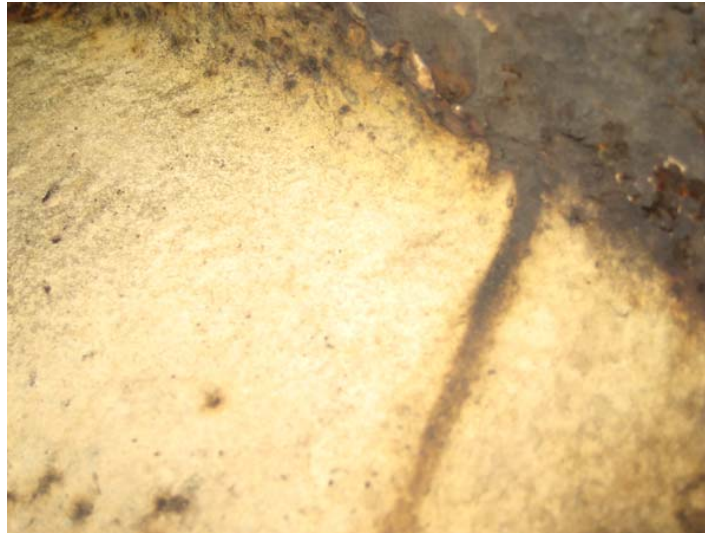
PICTURE CONV-Z-Z

- C-5 The undersides of the top flanges are also corroding where moisture is seeping between the plate and the top flange as seen in Picture CONV-Z-Z.

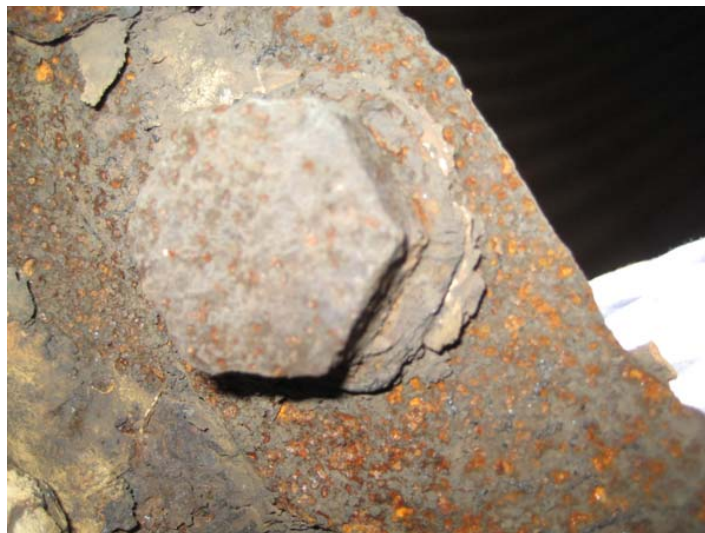
PICTURE CONV-Z-AA

- C-6 Bolt head on underside of beam flange showing excessive corrosion of both the bolt and the flange, as seen in Picture CONV-Z-AA

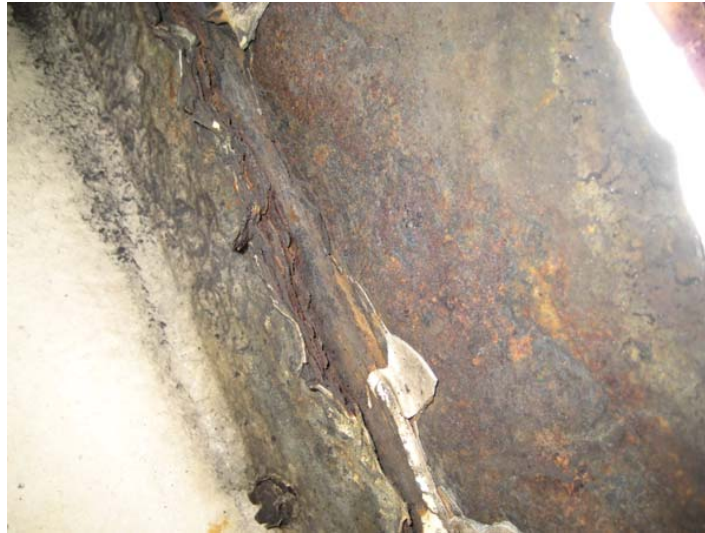
PICTURE CONV-Z-AB

- C-7 Beam flange to web intersection, as seen in Picture CONV-Z-AB showing excessive corrosion.

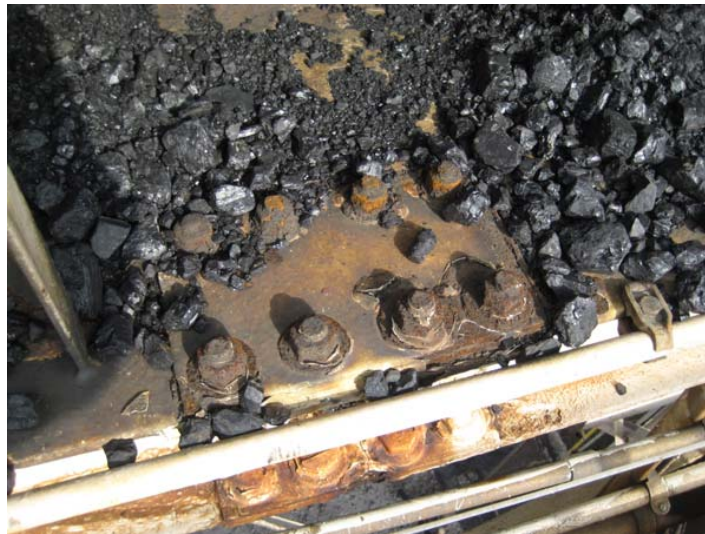
PICTURE CONV-Z-AC

- C-8 Typical truss top chord splice showing corrosion of plates and fasteners at both the top and bottom flanges of the top chord, Pictures CONV-Z-AC thru CONV-Z-AF.

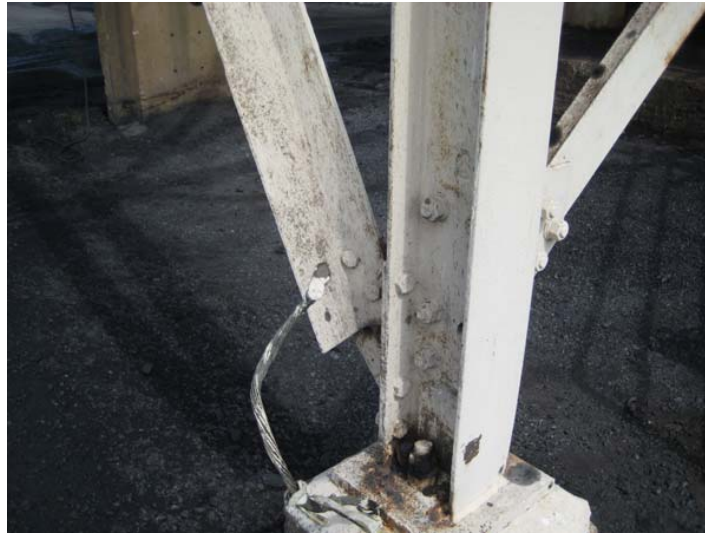
PICTURE TTWR-T4-A

- C-1 The grounding lead at the Column N-11(southeast corner) is disconnected, as seen in Picture TTWR-T4-A.

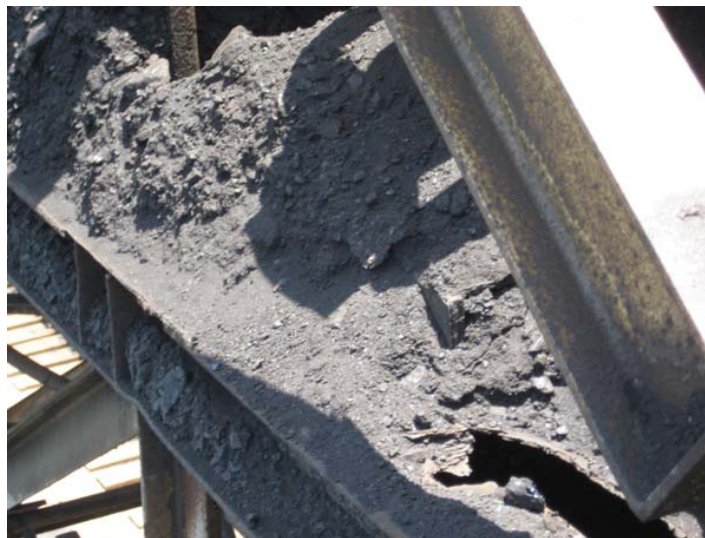
PICTURE MSR-AC

C-1 & 2 Tops chords of conveyor support truss have uneven metal loss of the top flange. The flanges inboard towards the conveyor have lost approximately half their thickness. See included photo MSR-AC. Recommend cover plating the top flange. There will be difficulties getting good contact between cover plate and top flange, as well as, solid metal to weld to due to the unevenness of the top flange.

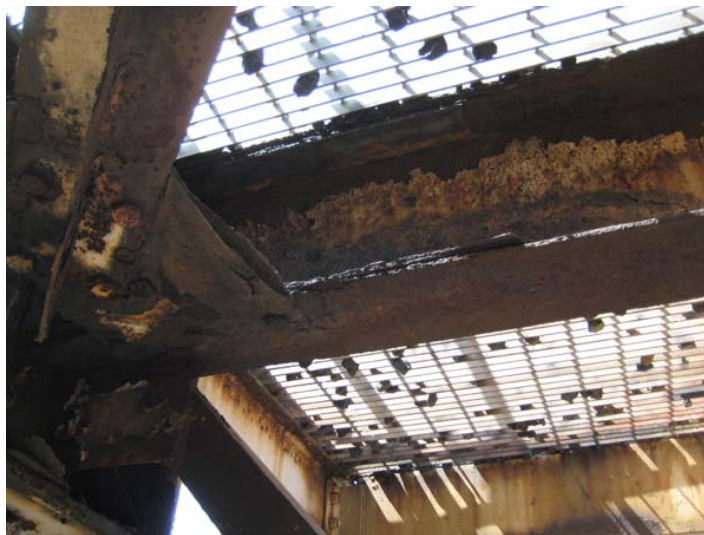
PICTURE MSR-W

- C-9 All members framing into the gusset have severe corrosion and moderate to severe metal loss. See included photo MSR-W. Recommend replacing rotten members back to sound steel or replacement in kind.

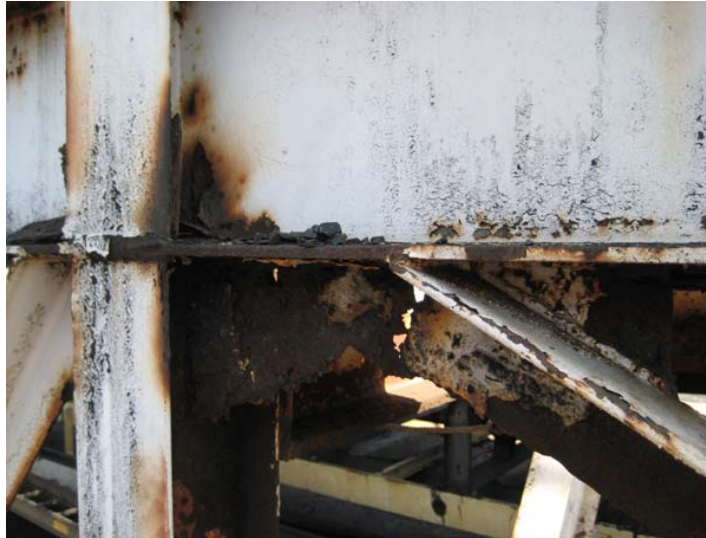
PICTURE MSR-R

- C-10 Gusset plate is completely rotten. See included photo MSR-R. Recommend replacing gusset and re-attaching vertical angle.

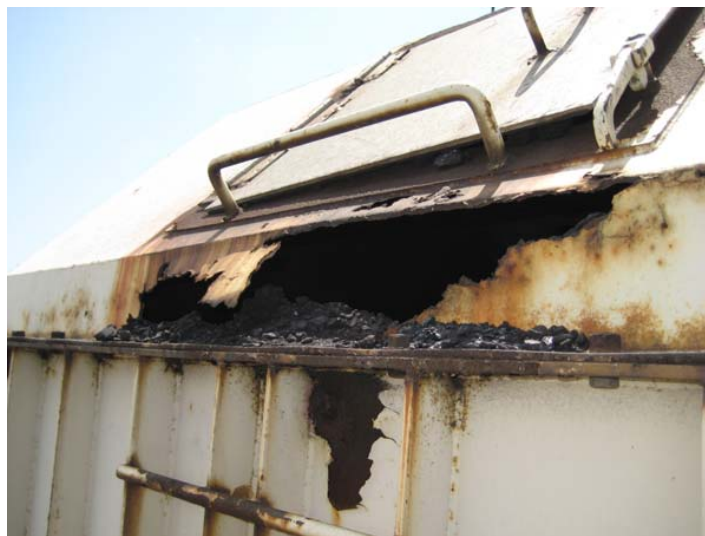
PICTURE MSR-H

- C-16 There is a large hole in the cover that allows coal to spill onto grating which creates a tripping hazard and heavily loads grating. See included photo MSR-H. Recommend putting a plate over hole to prevent coal from spilling out.

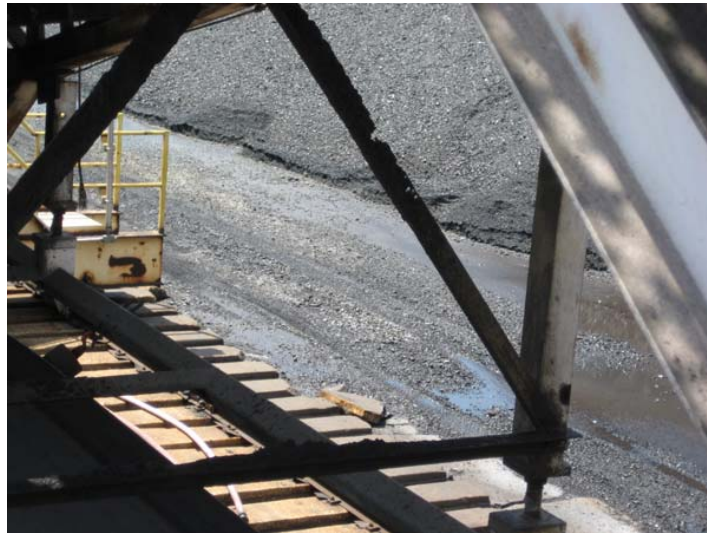
PICTURE MSR-M

Vertical braces and cross member have severe corrosion and are rotten. See thru 20 included photos MSR-M and MSR-N. Recommend replacement in kind.

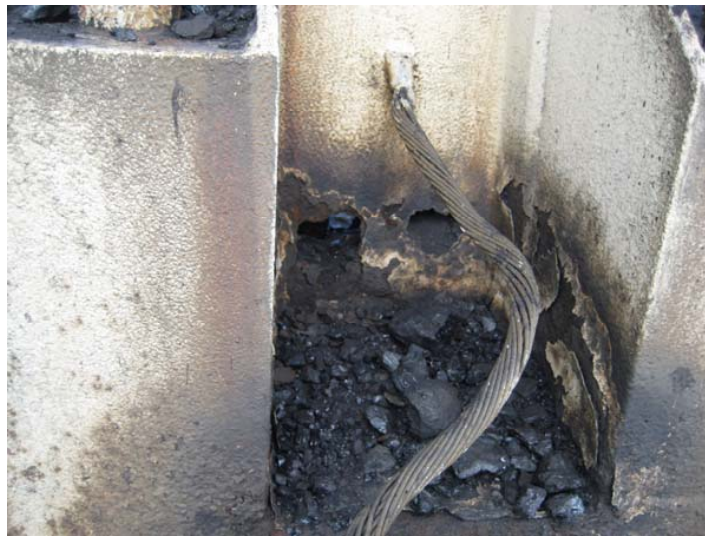
PICTURE Conv-J2-A

- C-8 Web at base of column has a 3"x6"+/- hole and should be cover plated or replaced. See included photo Conv-J2-A.

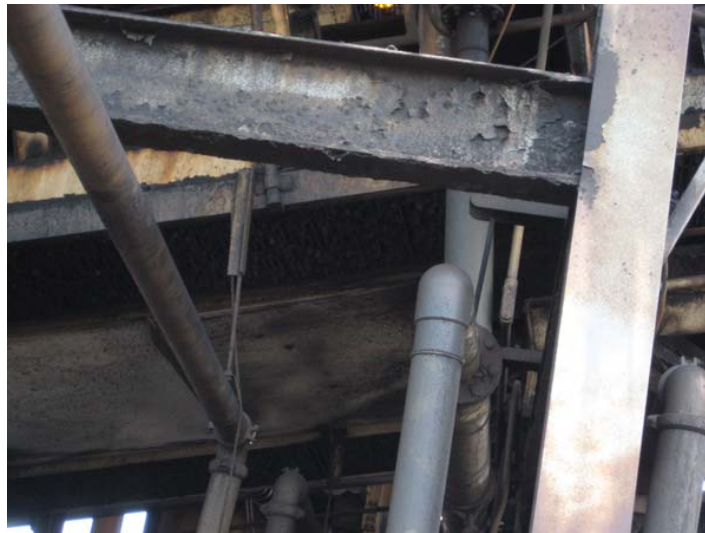
TTWR-T6-A

- C-1 At Column E-6, at El 22' – 0", the W10 framing in from the west is extremely corroded, as seen in Picture TTWR-T6-A. This member needs to be cleaned of all loose material back to solid metal to determine if it can be painted or if repairs are required before painting.

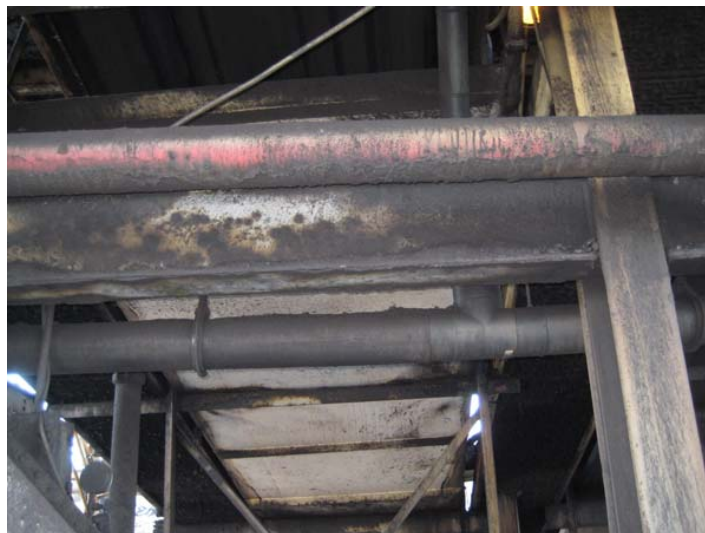
PICTURE TTWR-T6-C

- C-1 At Column G-8, at El 22' – 0", the W10's framing in from the south and the north are extremely corroded, as seen in Pictures TTWR-T6-C and TTWR-T6-D. These members need to be cleaned of all loose material back to solid metal to determine if they can be painted or if repairs are required before painting.

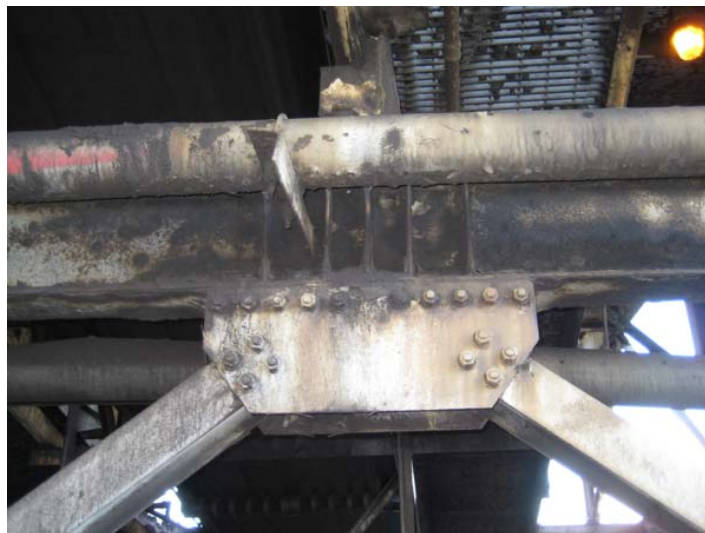
PICTURE TTWR-T6-E

- C-2 Midway between Columns G-8 and H-8 at El 22' – 0", as seen in Picture TTWR-T6-E, the W10 is extremely corroded at the intersections of the braces. This member needs to be cleaned of all loose material back to solid metal to determine if it can be painted or if repairs are required before painting.

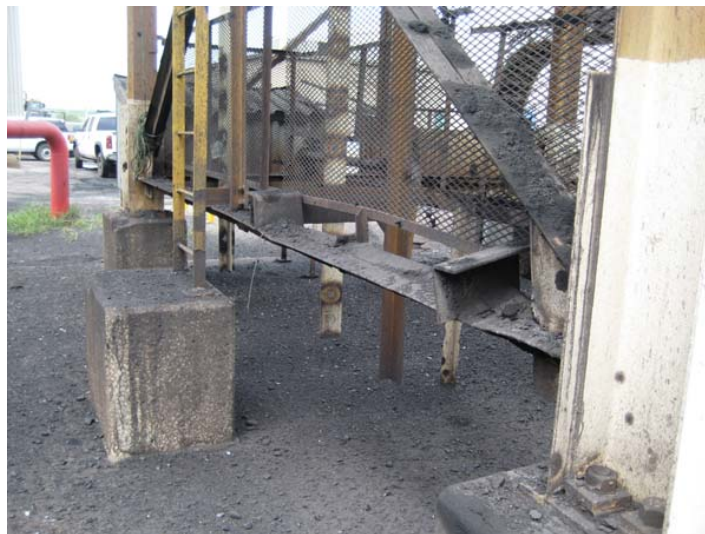
PICTURE CONV-L1-A

- M-1 The bottom of the column and the anchor bolts for Tower No. 1 have been repaired since the previous assessment and appear to be in good condition as seen in Picture CONV-L1-A.
