Manual IR302915-11 Revision A Date of Issue: 06/16/11

# CORROSION INSPECTION BIG BEND COAL DOCK

Tampa Electric (TECO) Big Bend Road Tampa, Florida

ELECTRO TECH CP© TECO BIG BEND STATION COAL DOCK CORROSION INVESTIGATION REPORT IR302915-11- PAGE 01-1

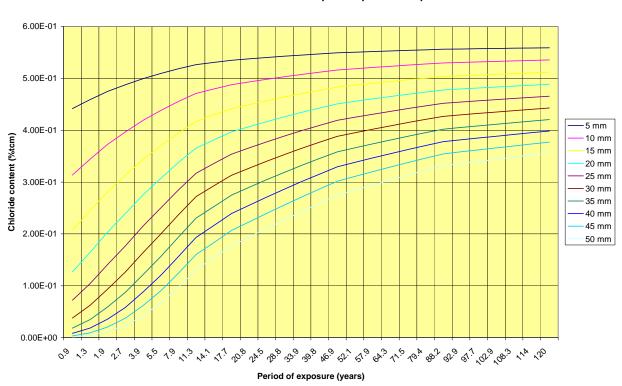
Figure 3 - Bay 1 Chloride Diffusion Model

Time to exceed Threshold 6.4 Years

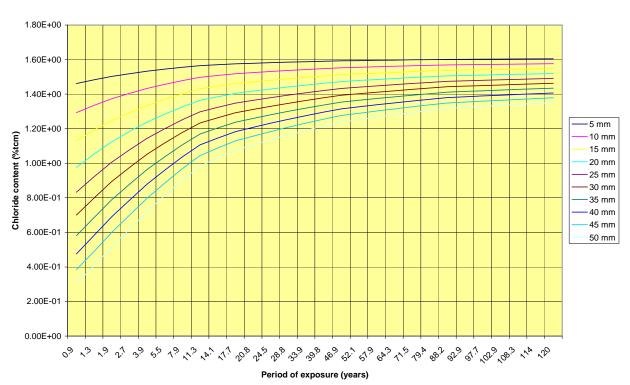
Figure 5 - Bay 4-01 Chloride Diffusion Model

Time to exceed Threshold 0.4 Years

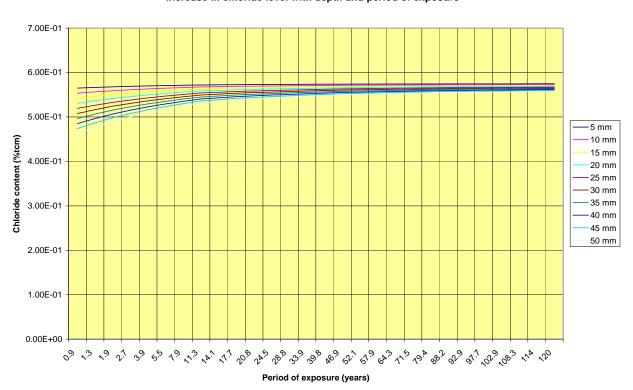
Figure 7 - Bay 4-02 Chloride Diffusion Model

Time to exceed Threshold 0.2 Years

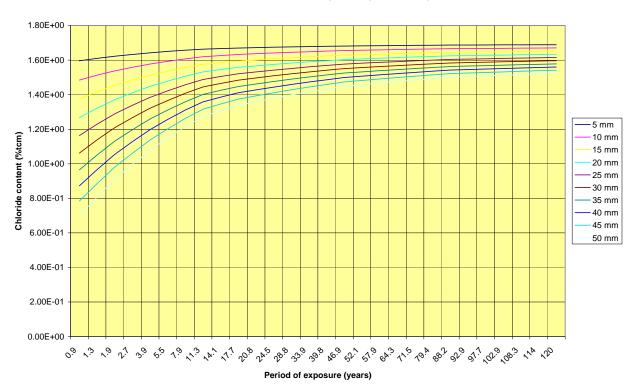
Figure 9 – Bay 6 Chloride Diffusion Model

Time to exceed Threshold 0.2 Years

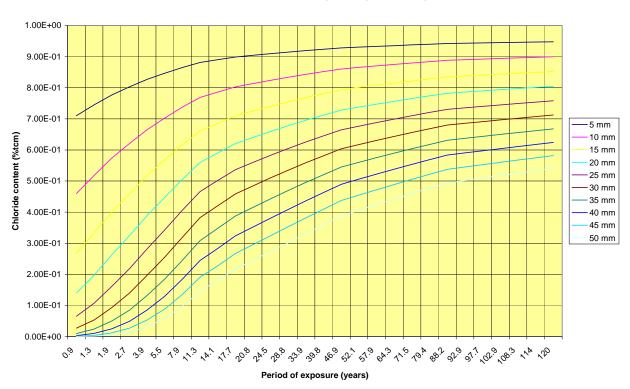
Figure 11 – Bay 9 Chloride Diffusion Model

Time to exceed Threshold 5.4 Years
