RE: Docket No.: 130180-WS; Application of Sunlake Estates Utilities, L.L.C. for Original Water and Wastewater Certificates in Lake County, Florida
Our File No.: 46096.01

Water Line Leak Detection Project for: Community Sunlake Joint Venture

Re: **Sun Lake Estates Leak Detection Project**

LEAK DETECTION EXECUTIVE SUMMARY

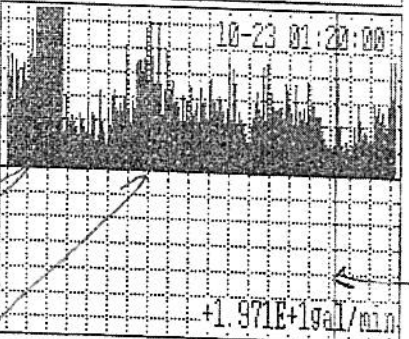
LOGGER

- David Hanna from Florida Rural Water conducted an overnight flow test. The flow to the Community dropped at night to 19.7 gallons per minute. He feels that given the age of our system and the size of the Community that this related to possibly toilets, ice makers, dishwashers running and such. This has been completed.

19.7 gallons/min
1:23 PM

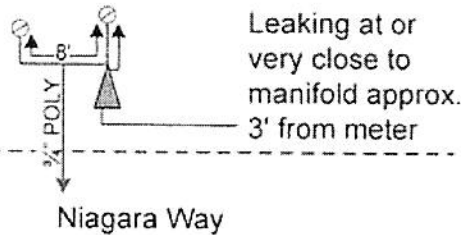
Leak Report #1- 2777 Niagara Way

This leak should be right on.

Location: 2777 Niagara Way
 Remarks: Correlated to area in front of meters close to manifold. Pinpointed with ground mic. Heard rocks / sand hitting PVC pipe easily approximately 3' from meter. Verified meter was registering properly.
 Leak Type: Service Line
 Recommendations: Excavate & Repair

Field Tech: TO
 Leak No: 1
 Leak Class: III
 Leak Rate: 5.0 GPM
 Cover Type: Soil
 Site Marked: No
 Date: 10/29/12
 Job No: 12187

Water Loss
(this leak, in gallons)
DAILY 7,200
WEEKLY 50,400
MONTHLY 201,600

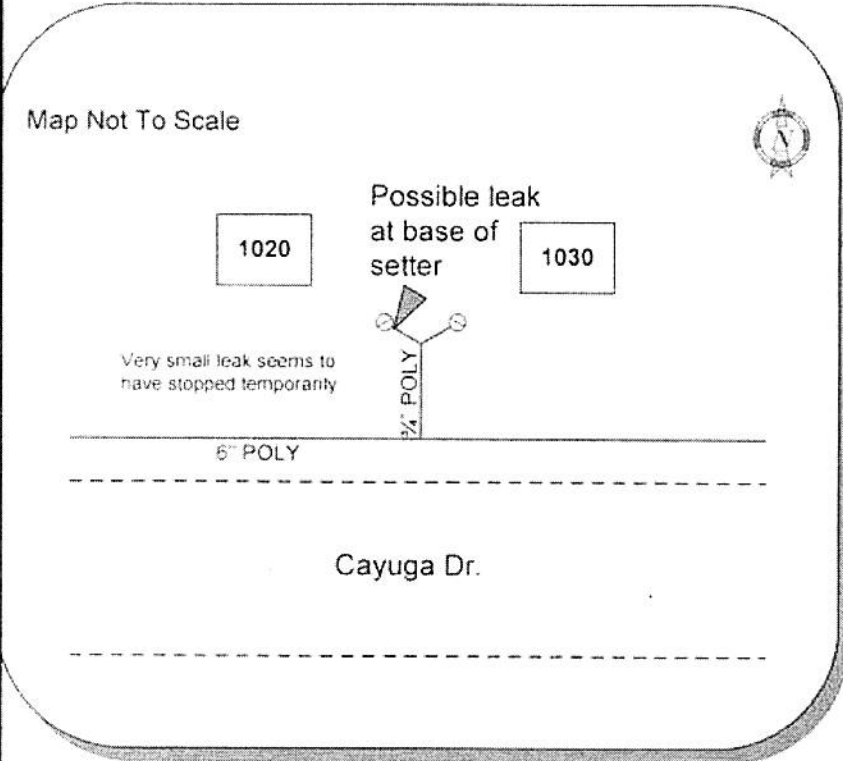
Leak Report #2 – 1020 Cayuga Dr.

This is a very small leak. We were able to stop it by shifting the meter slightly, however, it will need to be repaired to eliminate the chance for future problems.

Location: 1020 Cayuga Dr.
 Remarks: High frequency noise heard on stop. When meter was shifted slightly noise dissipated. Very small, weeping leak seems to have stopped after we moved meter. Suggest monitoring this meter box for water as leak is likely to return. Recommend tightening setter at the base.
 Leak Type: Service Line
 Recommendations: Excavate & Repair

Field Tech: TO
 Leak No: 2
 Leak Class: III
 Leak Rate: .25 GPM
 Cover Type: Soil
 Site Marked: No
 Date: 10/29/12
 Job No: 12187
