DATE: August 13, 2015
TO: Carlotta S. Stauffer, Commission Clerk, Office of Commission Clerk
FROM: Leslie Ames, Attorney, Office of the General Counsel *LA*
RE: Docket No. 140217-WU - Application for staff-assisted rate case in Sumter County by Cedar Acres, Inc.

**INSPECTION
REPORT
FOR THE
OAKLAND HILLS
WATER TREATMENT FACILITY'S
*HYDROPNEUMATIC PRESSURE TANK***

**13710 U.S. Highway 441
Lady Lake, Sumter County, Florida**

July 17, 2015

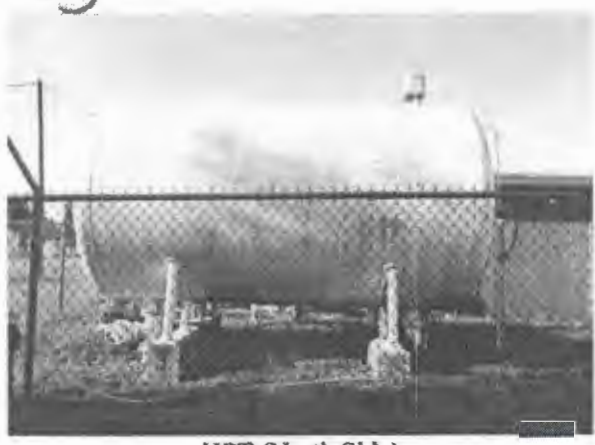
HPT (North Side)

- The exterior of the HPT was in good condition. There were no signs of deteriorated welds, pitting or structural damage.
- The concrete and steel supports were in good condition. Connections for a sight glass, relief valve, pressure switch, pressure gauge and yard piping were available and in good condition.
- The exterior protective paint coating was in fair condition as areas located throughout the HPT were observed to be deteriorating as the paint coating was cracking and surface rust was evident. These areas should be wire brushed and the entire HPT repainted with the proper exterior paint to a minimum of 4 mils thick.

- The exterior paint coating was found to be in fair condition. All of the readings were above the recommended minimum dry film thickness of 4.0 mils, however, several areas of the exterior paint coating were observed to be cracking and the surrounding surface beginning to rust. These areas should be wired brushed and the entire exterior surface of the HPT repainted with a proper exterior paint to a minimum of 4 mils thick. HPT should be repainted with a "Dark Blue" exterior paint** within the next 6 months. Typical outside coating systems are detailed in AWWA D102-11, *Coating Steel Water Storage Tanks*.
