POST STORM FORENSICS ANALYSIS

# Forensics Analysis of Hurricane Irma Data

Tampa Electric

**Date:** February 2, 2018

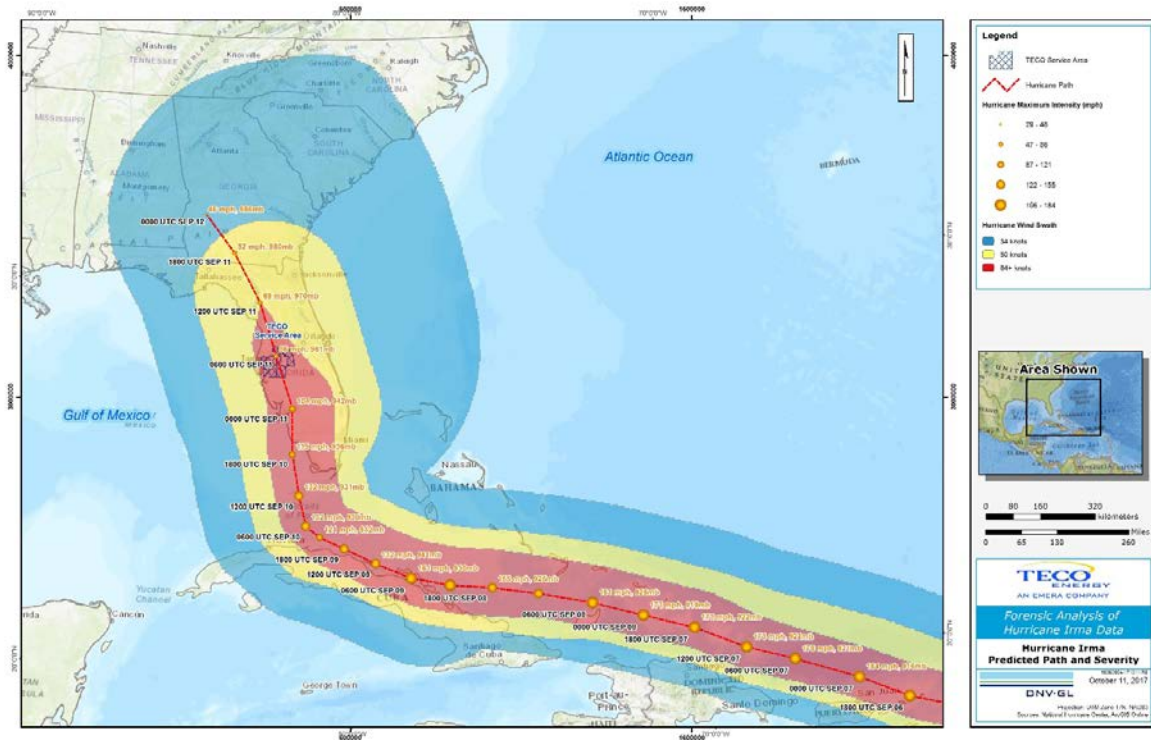
**Figure 3-7 Wind Path and Severity**

Results of this correlation were to define the post-storm wind path and speed (Figure 3-7) based on the predicted path for Hurricane Irma based on weather data available on public sources at that time.

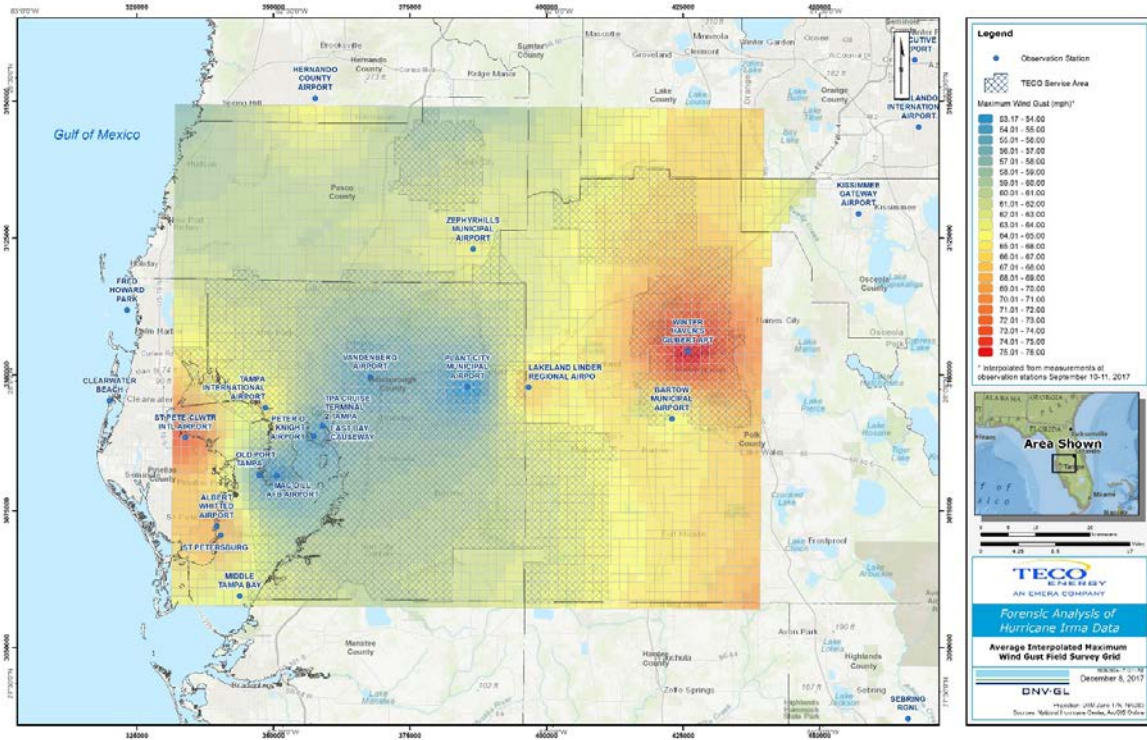
Figure 3-8 Interpolated Maximum Wind Gusts

Several months after the storm event elapsed, TECO provided DNV GL with wind gust data from their weather contractor. The provided StormGeo data enabled DNV GL to further develop a map of maximum wind gusts, illustrated in Figure 3-8 and maximum wind speed, illustrated in Figure 3-9. Data from a total of 94 stations were provided by TECO. These covered the entire State of Florida. DNV GL used this data to develop the interpolated maps shown in Figures 3-3, 3-4, 3-8 and 3-9. However, DNV GL only used data from the 11 stations related to TECO service areas for the forensics data analysis and extrapolation analysis. The data that was immediately available after the storm was used to calculate the average maximum wind gust for each service area grid cell (distance of service area from station location). Wind gust data showed slower wind pockets near Tampa and higher wind gusts near Winter Haven.

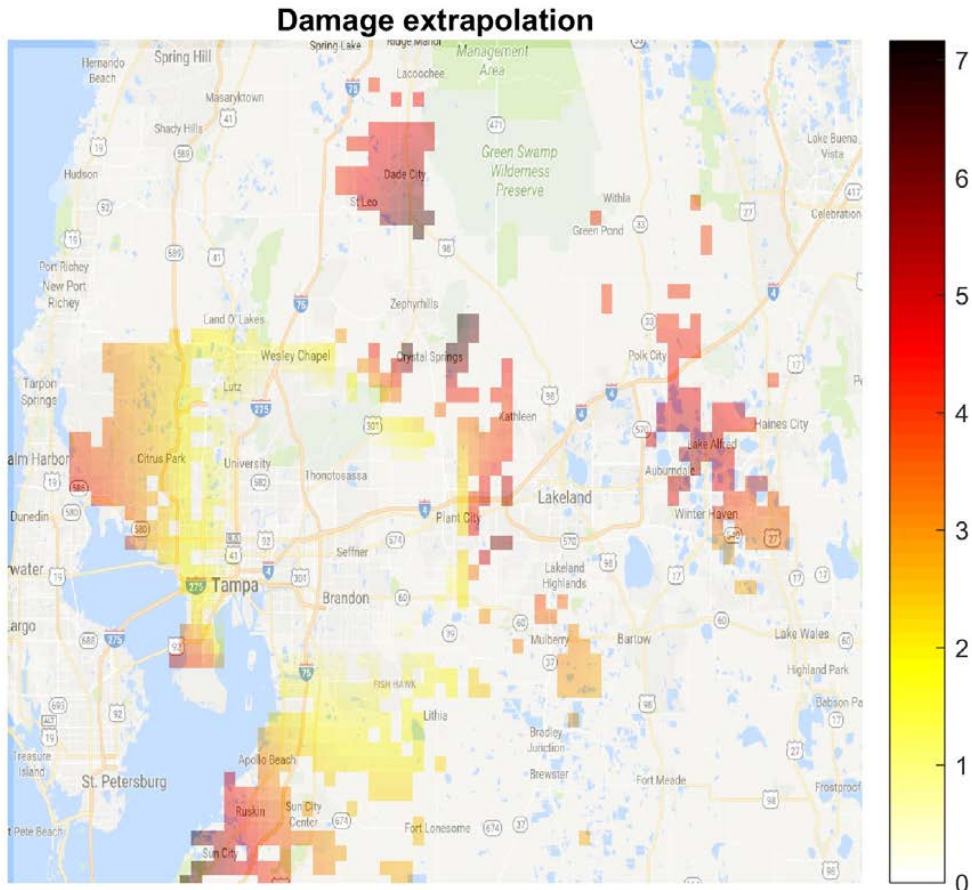
**Figure 3-10 Damage and Impacted Probability**

The probability of failure is graphically shown in Figure 3-10. This Damage and Failure Probability map clearly showed the potential damage areas and severity. This map is based on sustained wind data and not maximum wind gust data. Reported field survey failures collected by Osmose were then related to the entire TECO service area. Impacts and failures associated to pole and type were determined, using poles as the reference for damages and include pole, conductor and cross arm damages. Finally, root cause analysis of contributing factors of damage cause was performed.

Based on the wind path and severity (Figure 3-7), and the extrapolated sustained wind speed data for each grid zone in the TECO service area, a probability for damage was found for each grid zone of the TECO service area. This is illustrated above in Figure 3-10. The scale is in percentage.

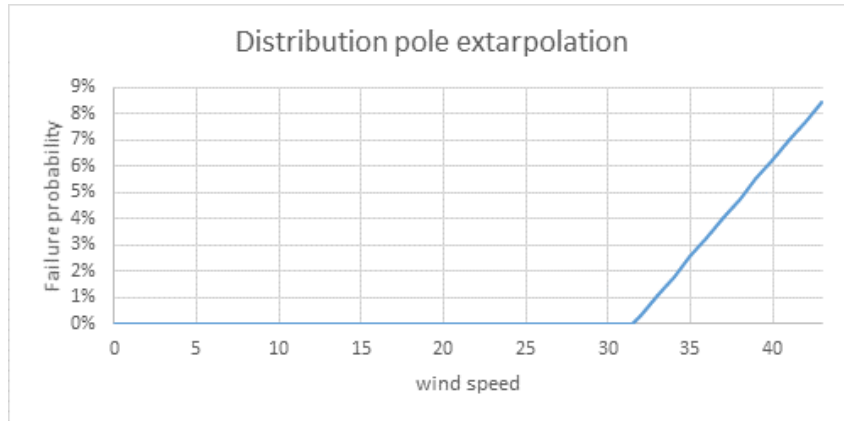
Figure 5-1 Sustained Wind Speed vs. Failure Probability Curve

The extrapolation of damaged distribution infrastructure for the entire TECO service area was performed by taking into consideration the wind speeds of each TECO map grid zone, which were also extrapolated as described earlier. The map grid zone pole population or density could be also used but with the data available, a reasonable match could not be made. For the extrapolation of the reported impact and damages, the following wind speed-failure rate curve, Figure 5-1, was considered.

Note again that the extrapolated data is statistically biased because the collected sample data concentrated on potentially high damage area. In reality, other (non-surveyed) service areas did not sustain as extensive impact or damage.

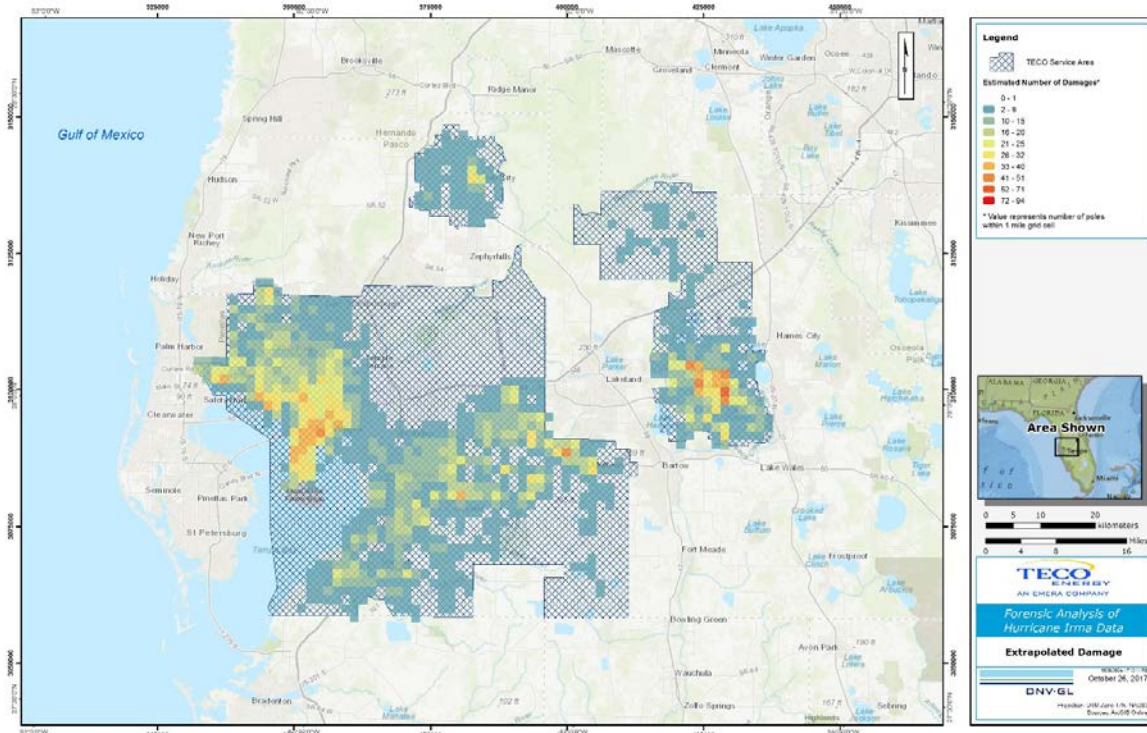
Figure 5-2 Extrapolated TECO Damages to the Entire Service Area

Based on this speed-failure rate curve, and the extrapolated wind speed data for each map grid zone in the TECO service area, a probability for impact and damage (combined) is found for each grid zone in the service area. This is illustrated by Figure 5-2. The scale is in the number of damages used as the base reference.

The figure shows that the most severe damage probability occurred in the areas surveyed by Osmose. Again, care must be taken in assuming that areas outside of the surveyed service areas sustained similar damage. In reality, less damage was sustained in these non-surveyed areas.

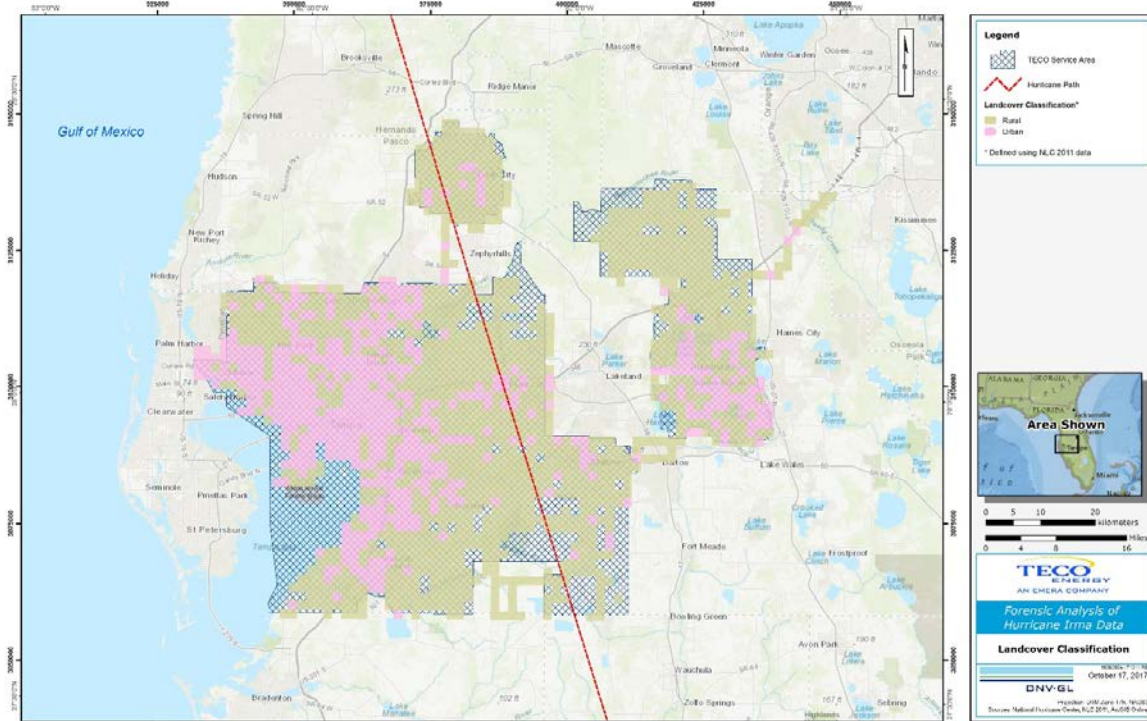
Figure 5-3 Land Cover Classification

DNV GL categorized map grids based on urban or rural to determine whether greater or less dense energy delivery infrastructure had an impact on potential storm impact and damage. Figure 5-3 is a graphic representation of urban versus rural geographic representation. The grids correspond to TECO map grid and classifications were determined based off the 2011 National Landcover Database.

No statistical correlation was found between impact or damage reported to urban or rural classifications.
