SUBJECT: Docket No. 20170215-EU – Review of Electric Utility Hurricane Preparedness and Restoration Actions – STAFF’S **THIRD DATA REQUEST**

**Lee County Electric Cooperative, Incorporated, LCEC
Report to the Florida Public Service Commission for
Docket No. 20170215-EU – Staff’s Third Data Request
Review of Electric Utility Hurricane Preparedness and Restoration Actions**

**NOTE: LCEC was not affected by Hurricanes
Hermine, Matthew, Maria, and Nate. All data request
responses are for Hurricane Irma only.**

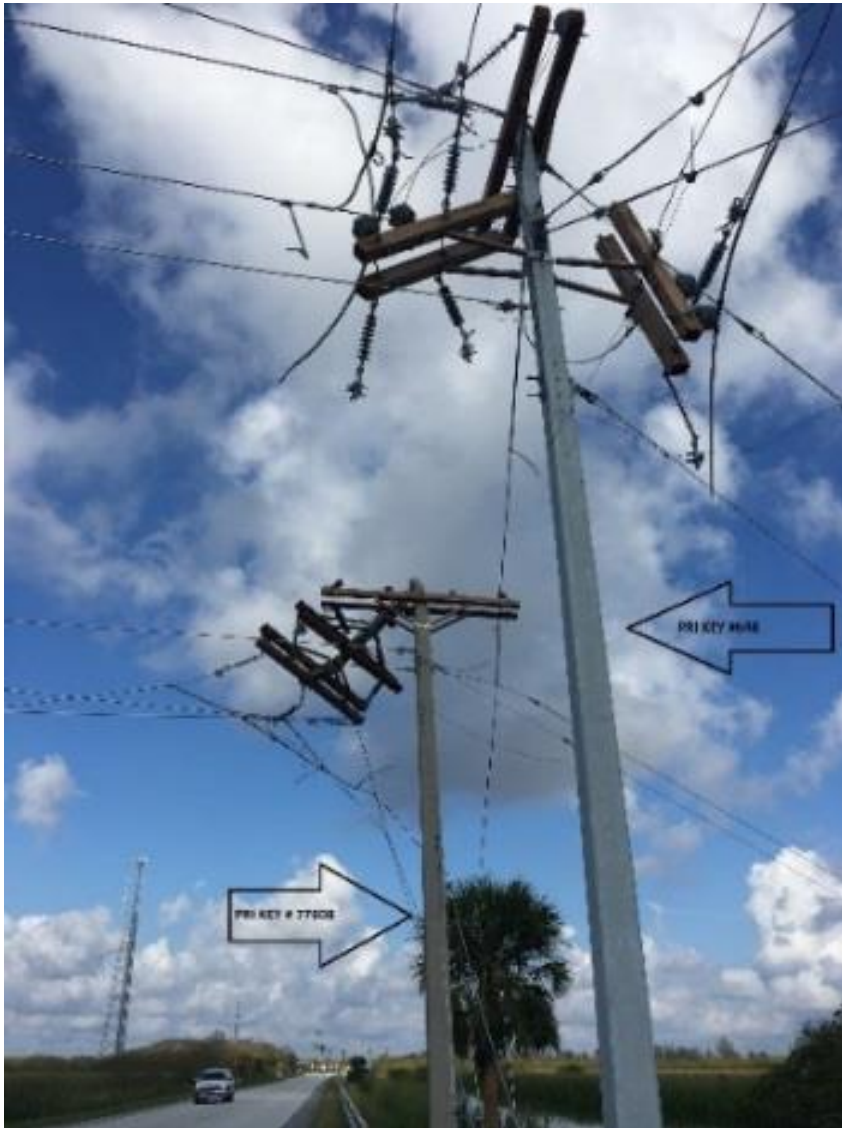
Photo1

In early 2017, twelve (12) poles outside and east of the Carnestown station on US 41 were changed out to hardened poles. One of these poles (identified as Pri Key 648) had crossarm damage as a result of Irma. The damage is shown in Photo 1 (pg. 2). Other poles changed out prior to Irma (identified as Pri Keys 77643, 77644, and 93910) did not break but were pushed over or leaned. These poles are shown in Photo 2 (pg. 2).

A hardened pole (Pri Key 648), which had sustained crossarm damage, had its crossarms replaced. Other hardened structures (Pri Keys 77643, 77644, and 93910), which were pushed over or leaned, were repositioned to stand back up.
