Kenneth M. Rubin
Senior Counsel
Florida Power & Light Company
700 Universe Boulevard
Juno Beach, FL 33408-0420
(561) 691-2512
(561) 691-7135 (Facsimile)
Ken.Rubin@fpl.com

April 23, 2018

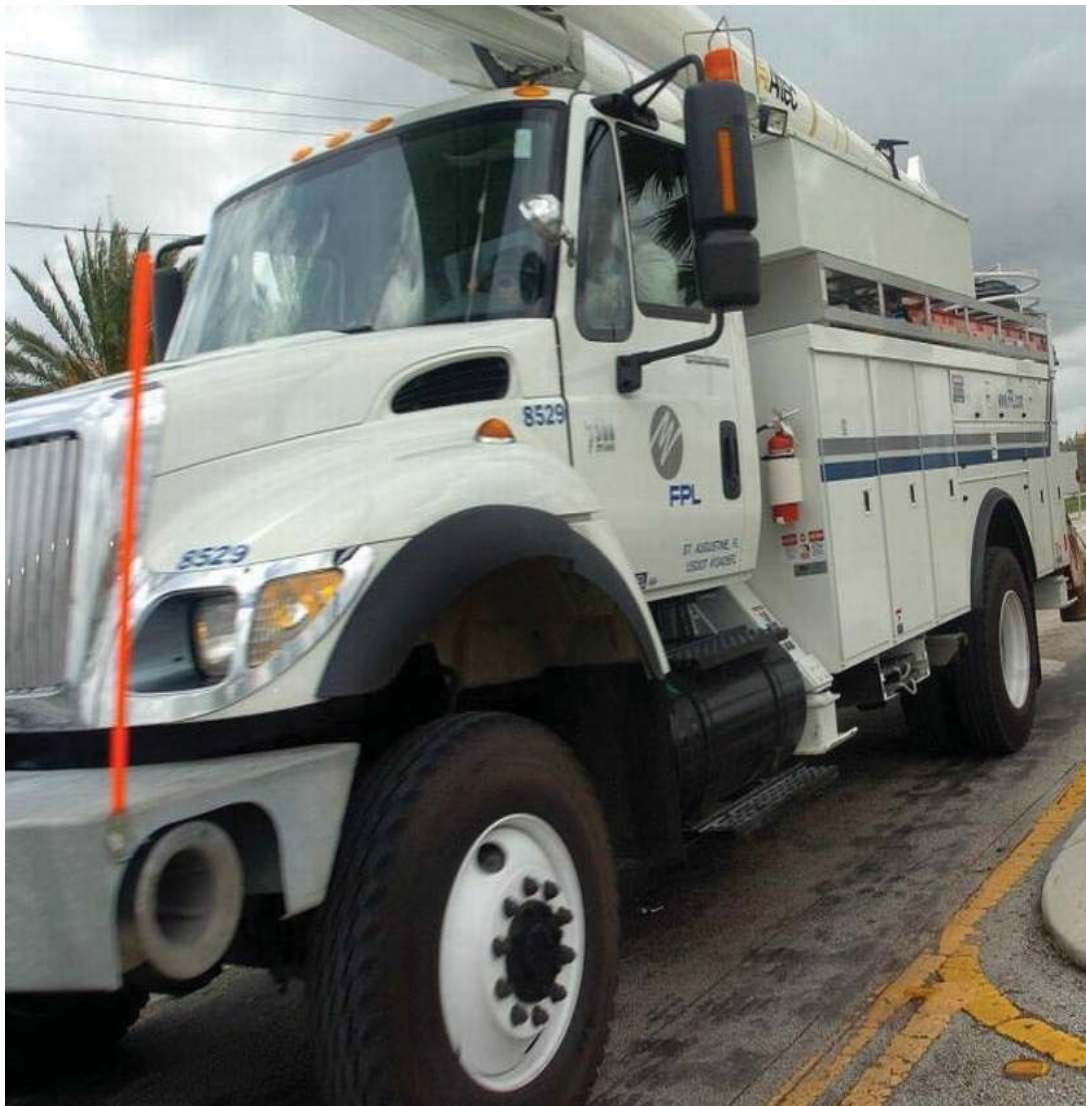
This is the Power Delivery Performance Report for Hurricane Irma. The purpose of this report is to give an overview of the performance and generalized assessment of the system with specific case studies describing conditions, damage, and system performance.

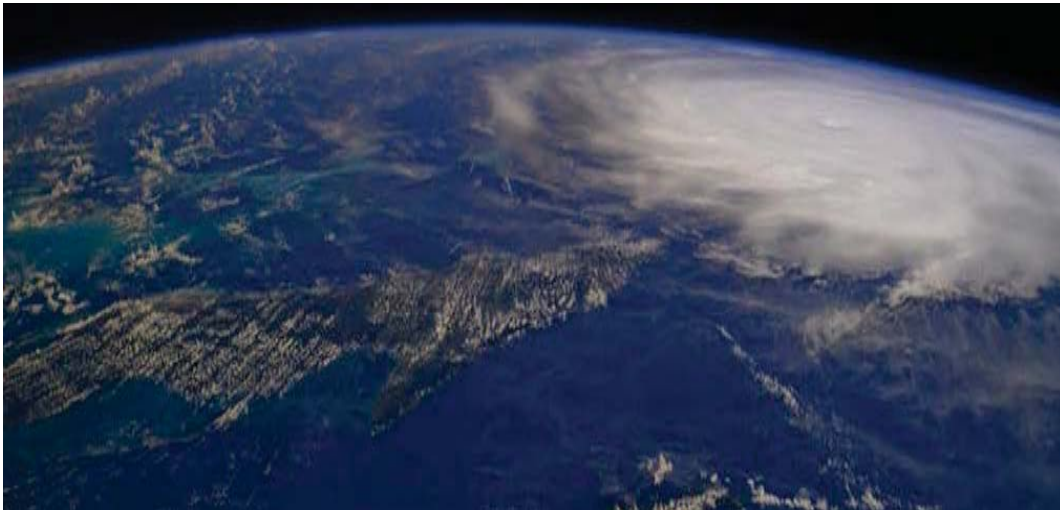
Hurricane Irma approaching Cuba and the Florida Peninsula.

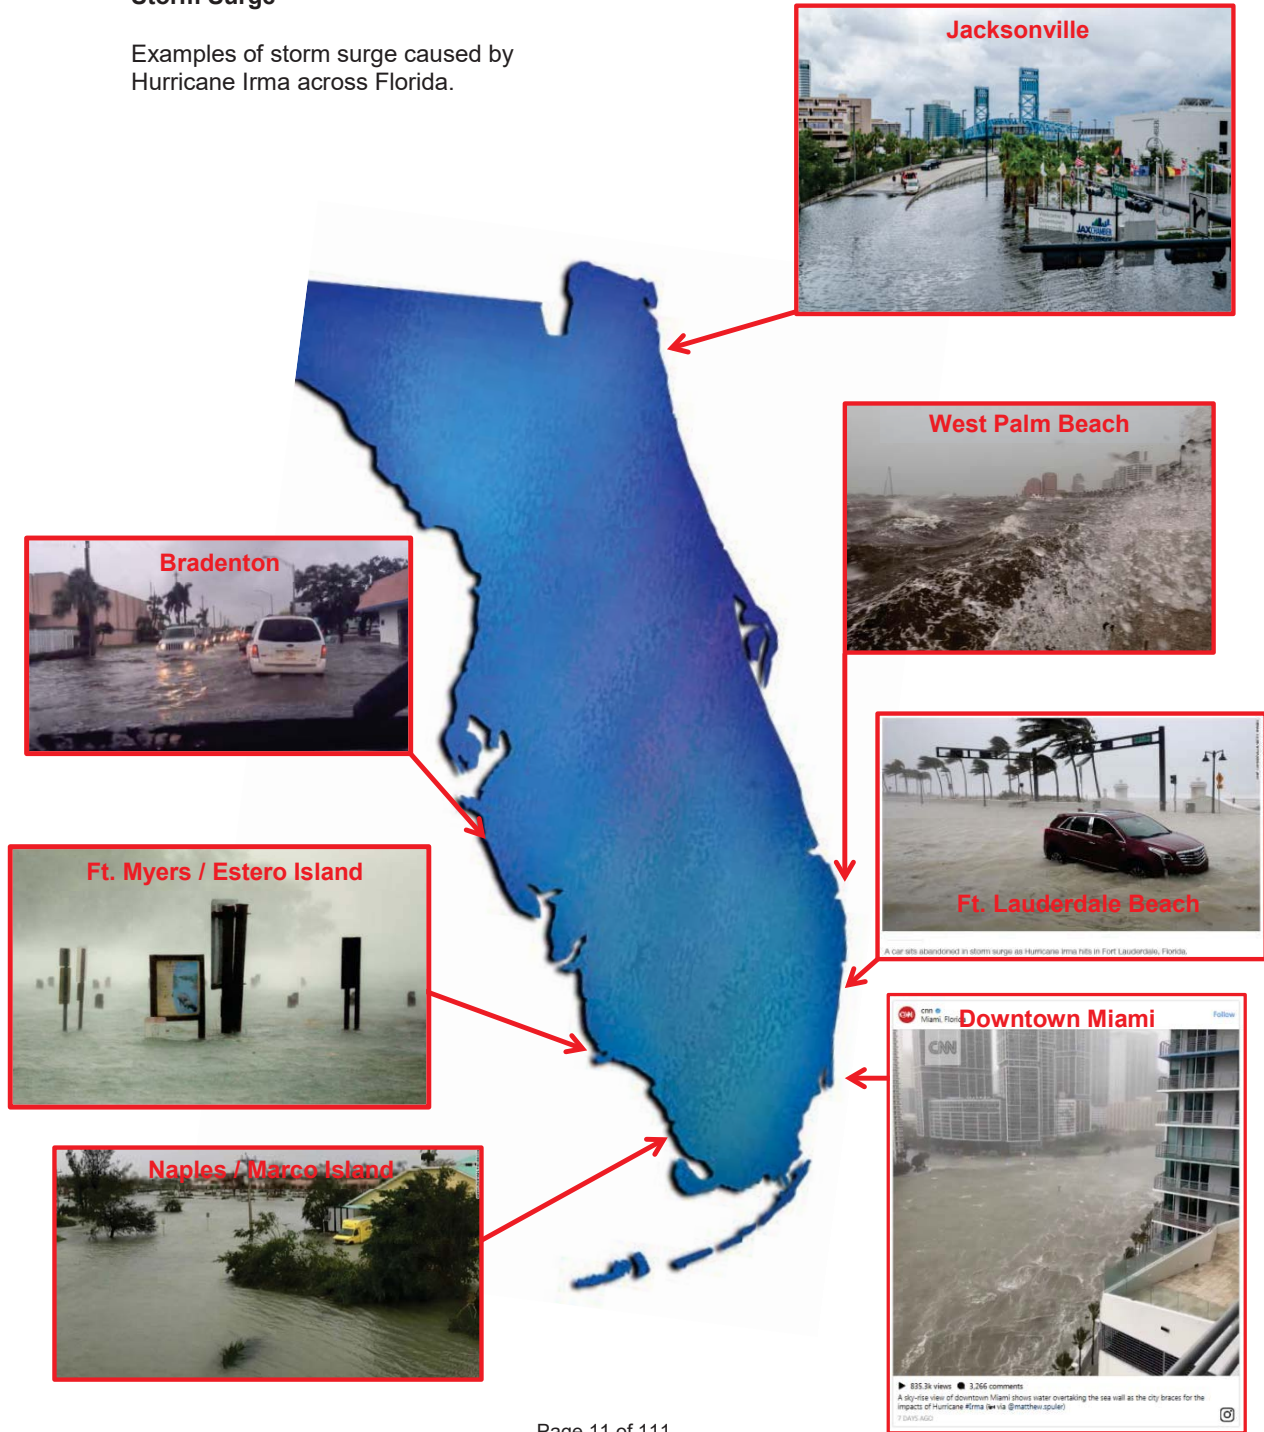
Examples of storm surge caused by Hurricane Irma across Florida.

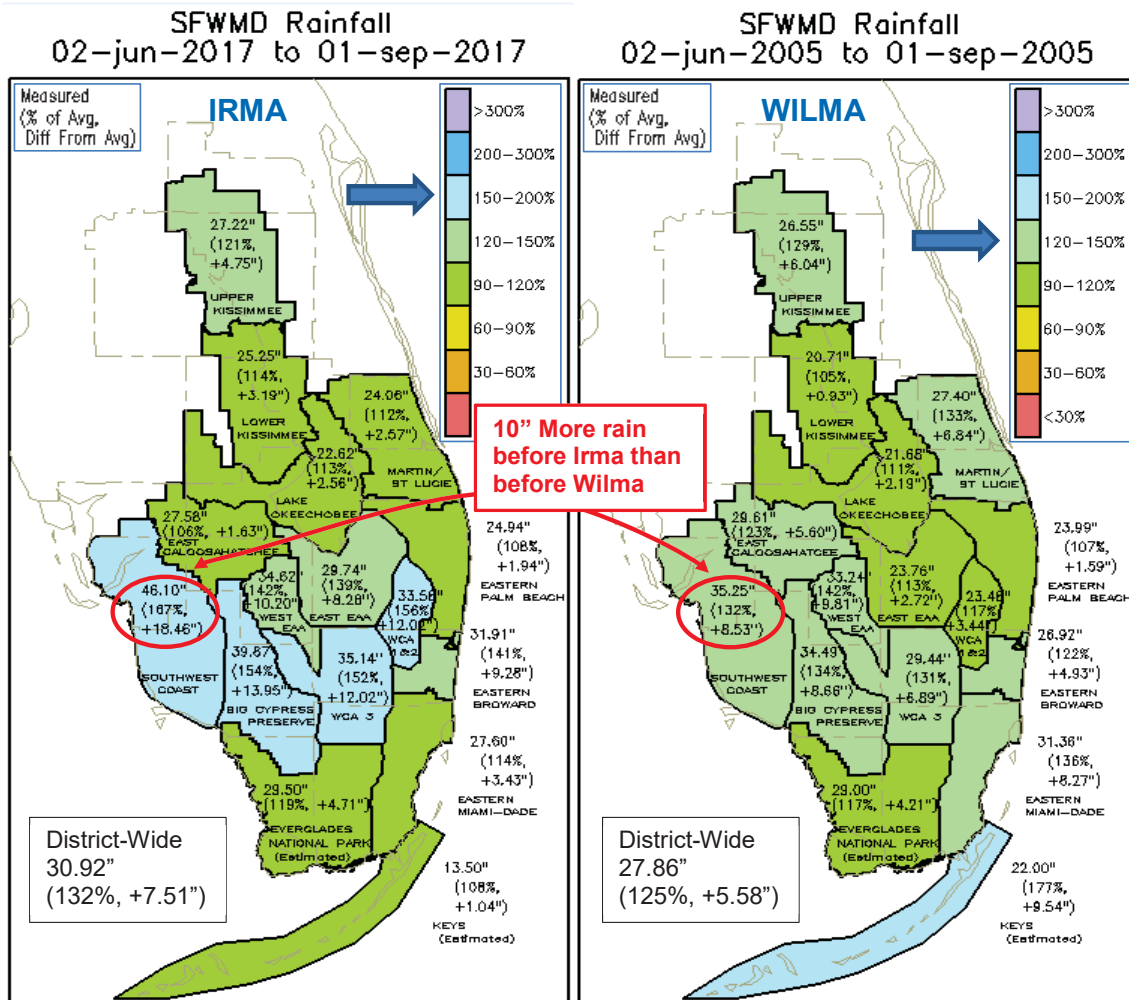
County / Region	Irma	Wilma	Difference	Circle Color
Southwest Coast	46.10	35.25	10.85	Red
SW Palm Beach & NW Broward	33.58	23.48	10.10	Purple

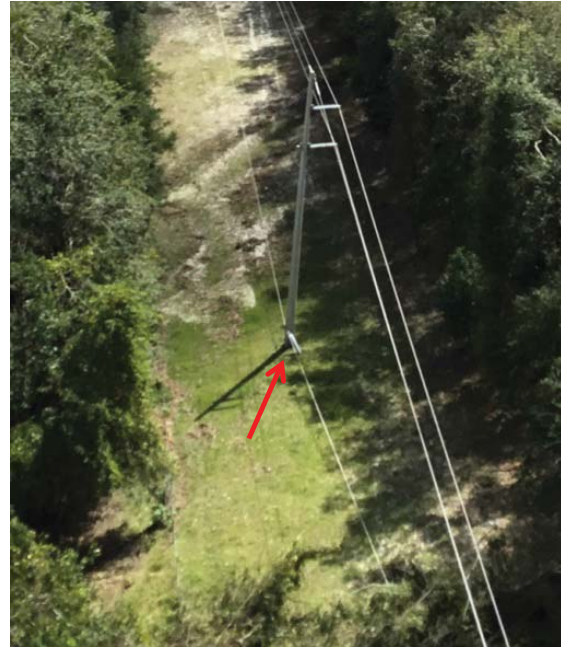
Structure 55R13A – Broken insulator

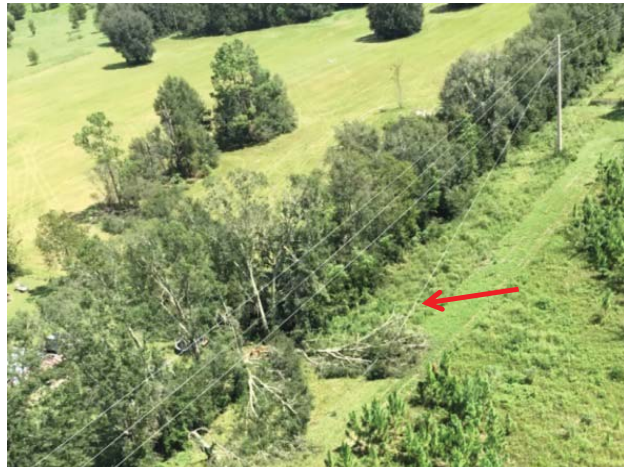
Structure 112R1 - Wire down due to vegetation

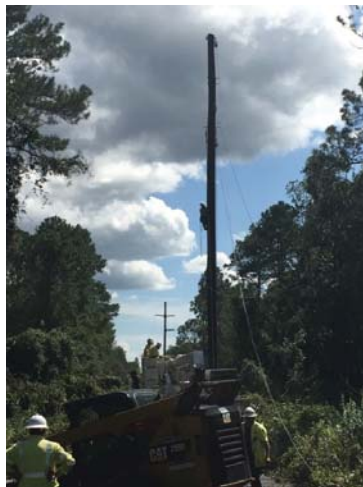
Pole Replacement of Structure 75G3 (115KV line in North area)

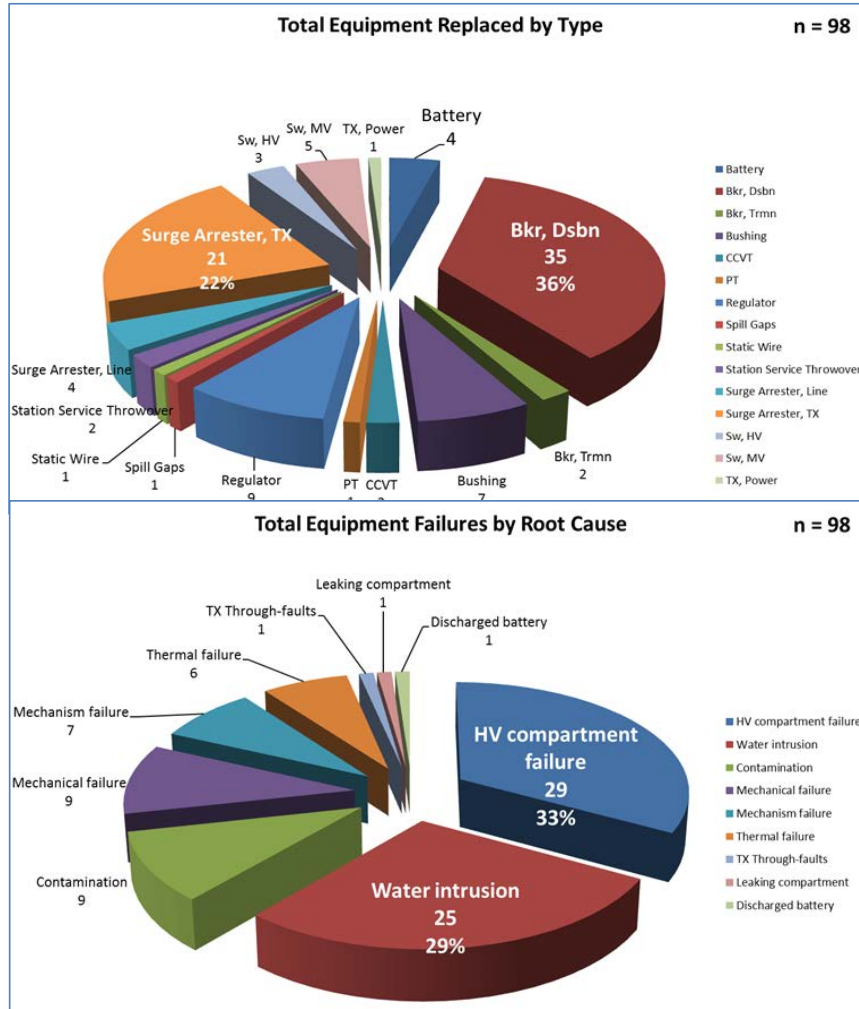
Equipment failures were dominated by feeder breaker failures during the storm and surge arrester failure post event. Most of the failures of the feeder breakers were a result of the High Voltage (HV) compartments flashing from water intrusion due to wind-blown rain. The surge arrester failures appear to be a latent failure mode with water intrusion and/or contamination due to the storm the most likely root cause of the failures occurring post storm after energization.

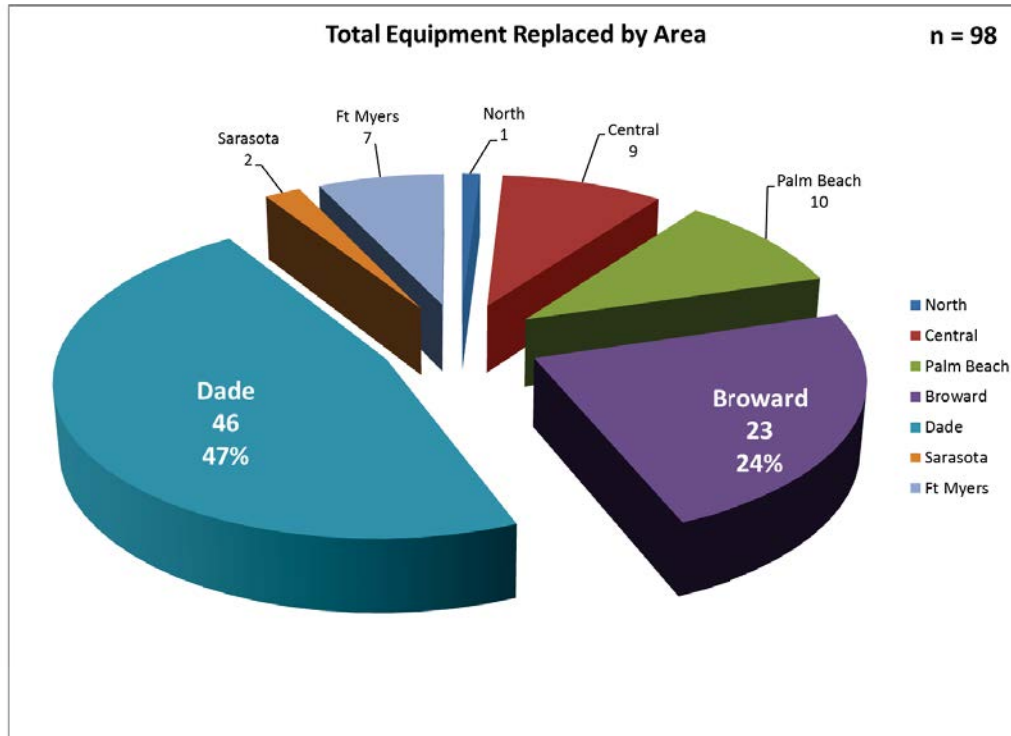
Substation performance by area was dominated by a significant impact to substations in the SE region of Florida. The importance of this impact resulted from the course of the storm as well as the duration of the event.

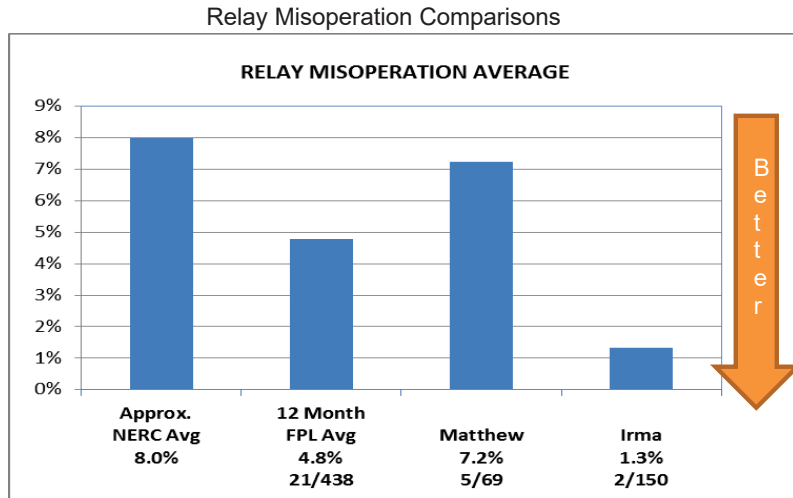
* A Relay Mis-operation is a failure to trip or tripping unnecessarily further defined by NERC PRC-004

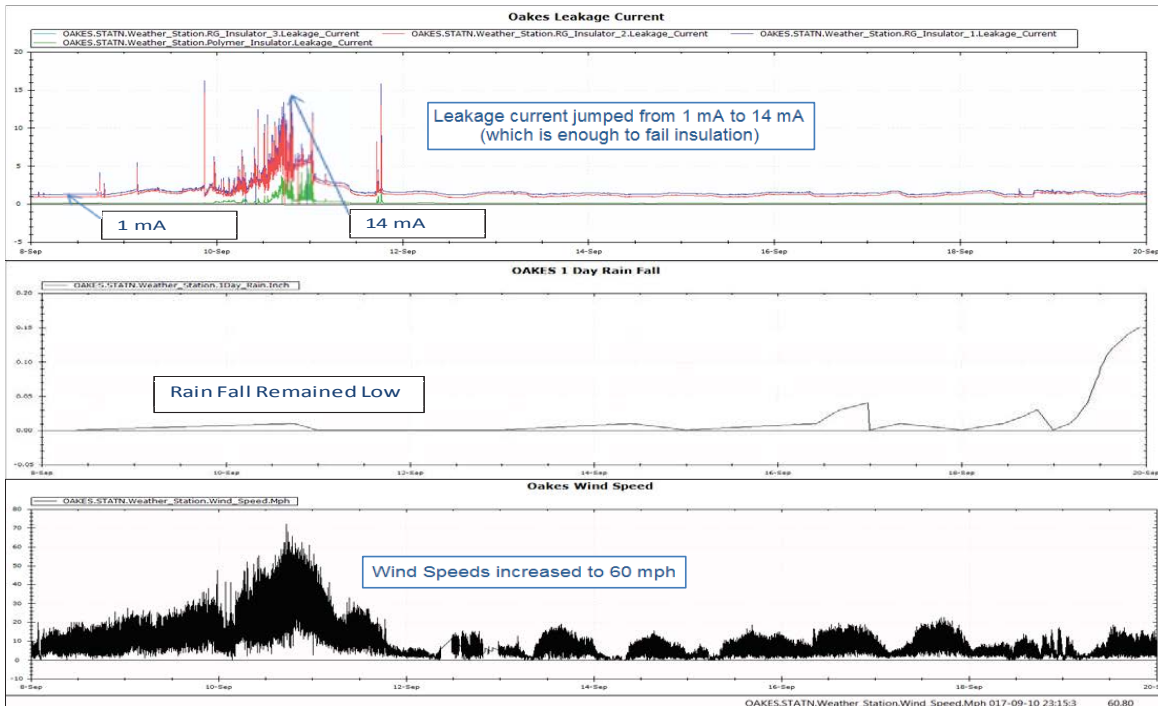
Above shows high winds and little or no rainfall caused contamination and increased leakage current to damaging levels.

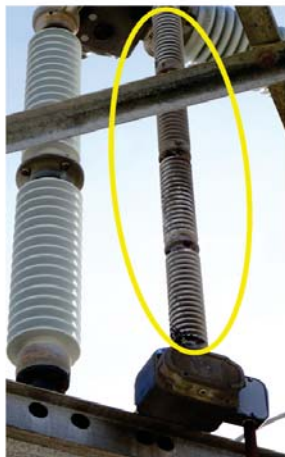
Contamination damage on F-switch

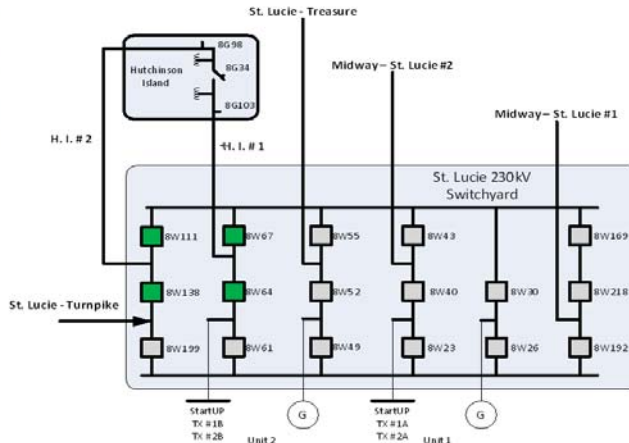
One-line showing Hutchenson Island breaker open

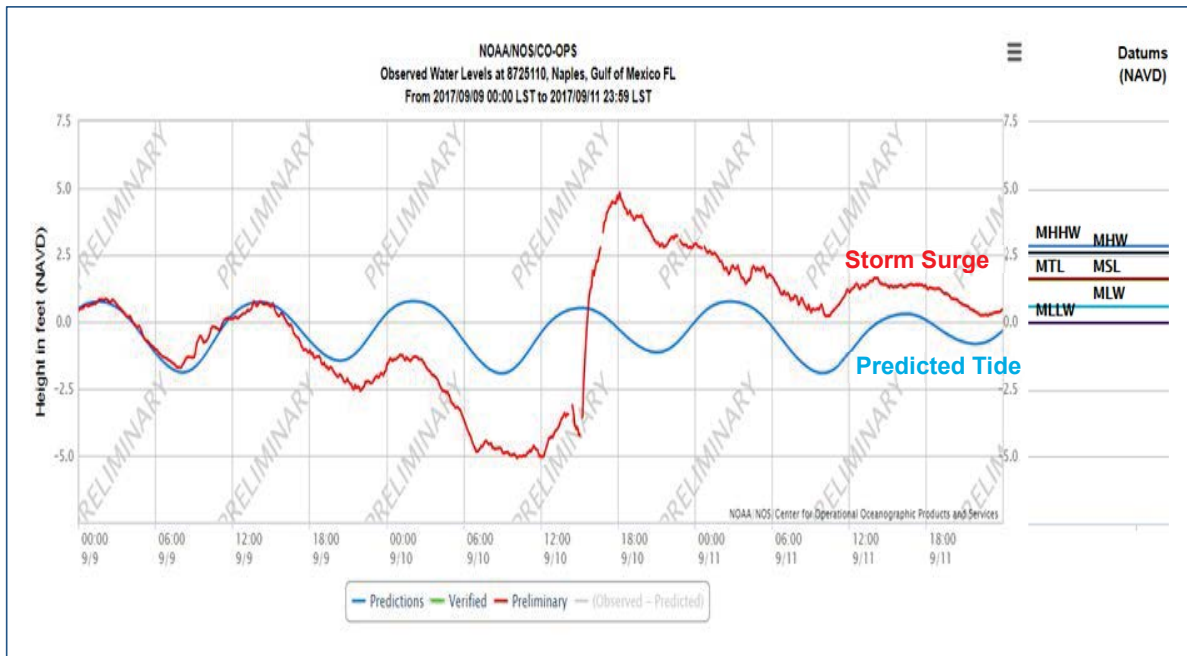
Surge peaked in a few hours and receded in more than one day. (Source: NOAA Tidal Gauge at Naples)

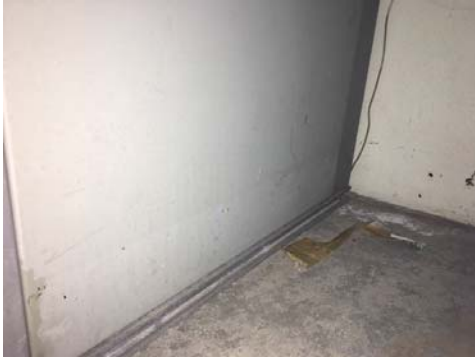
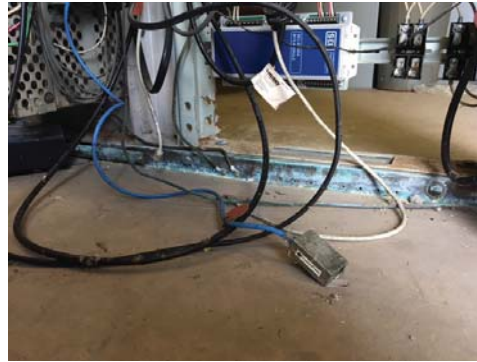
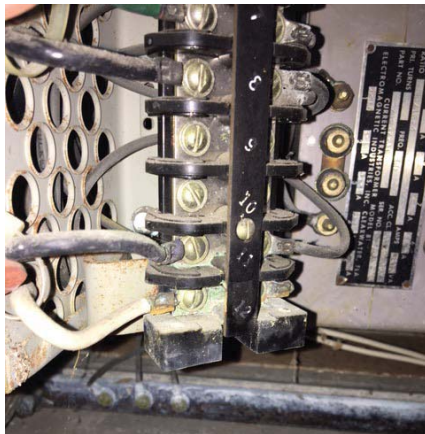
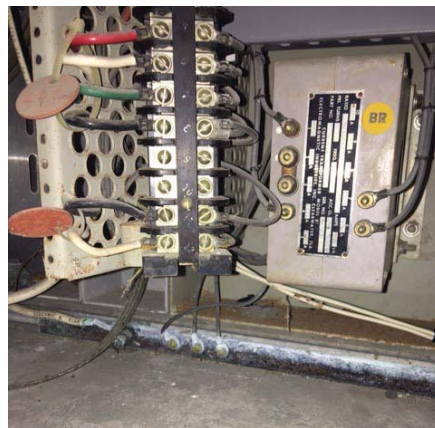
Flood waters reached 5 1/2" on the inside of the relay vault and affected ground bus and some connections

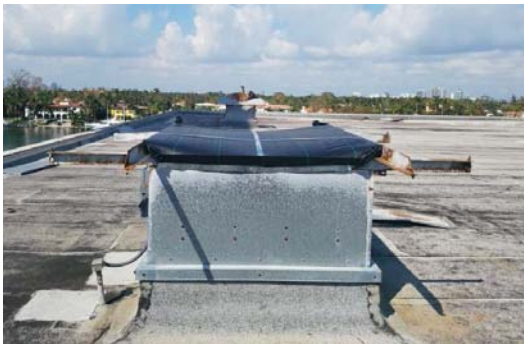
Indian Creek Substation – Roof Exhaust Fan

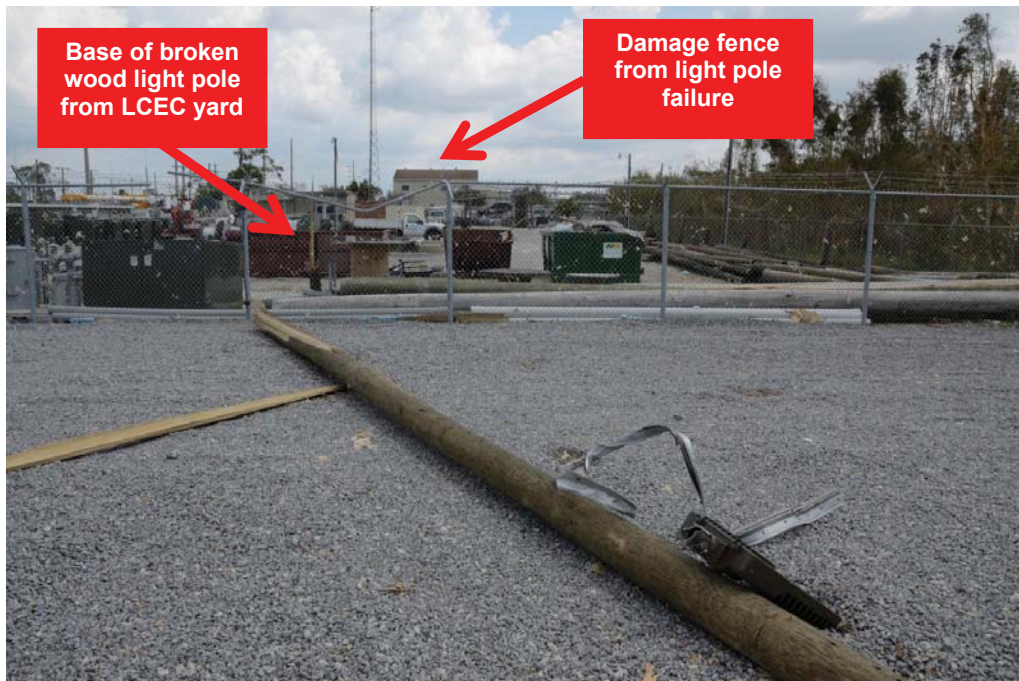
Belle Meade Substation (Looking East) adjacent to LCEC yard (Lee County Electric Coop)

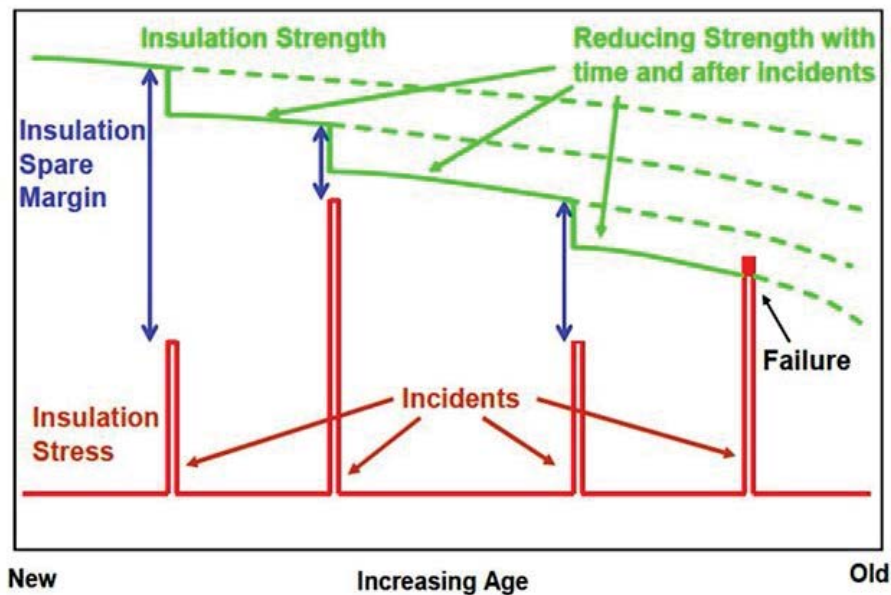
A conceptual failure model proposed by CIGRE WG 12.18 [7,8]

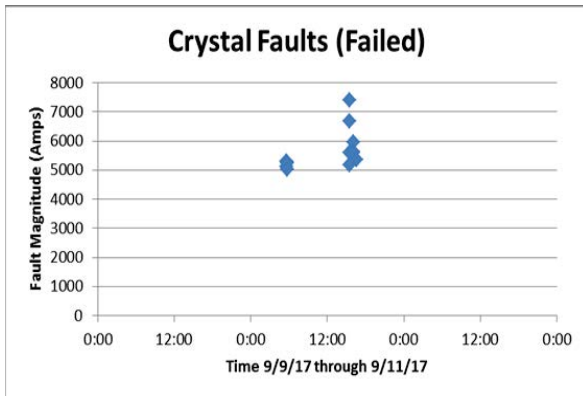
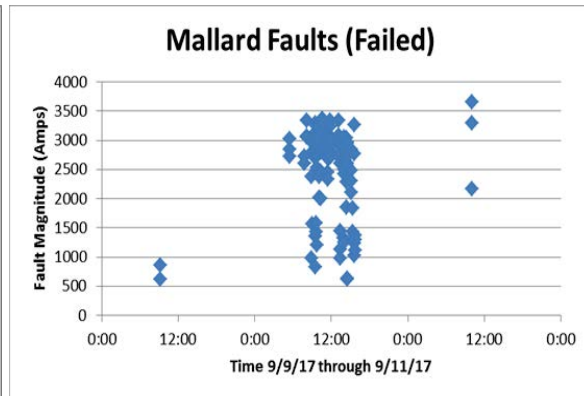
Crystal	Mallard
Total I ² t A ² seconds	3,400,249	5,669,606
Times the cumulative thermal energy that the transformers were each designed to withstand, assuming equal stress on each of the transformers	3.4	3.9

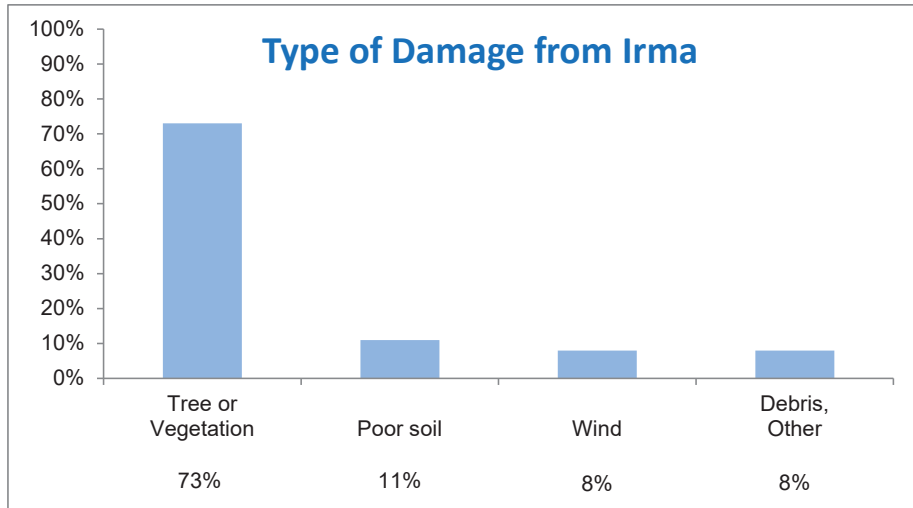
Survey of 33 Forensic Patrollers for Hurricane Irma. Damage was based on information from patrols and pictures were used to verify accurate categorization.

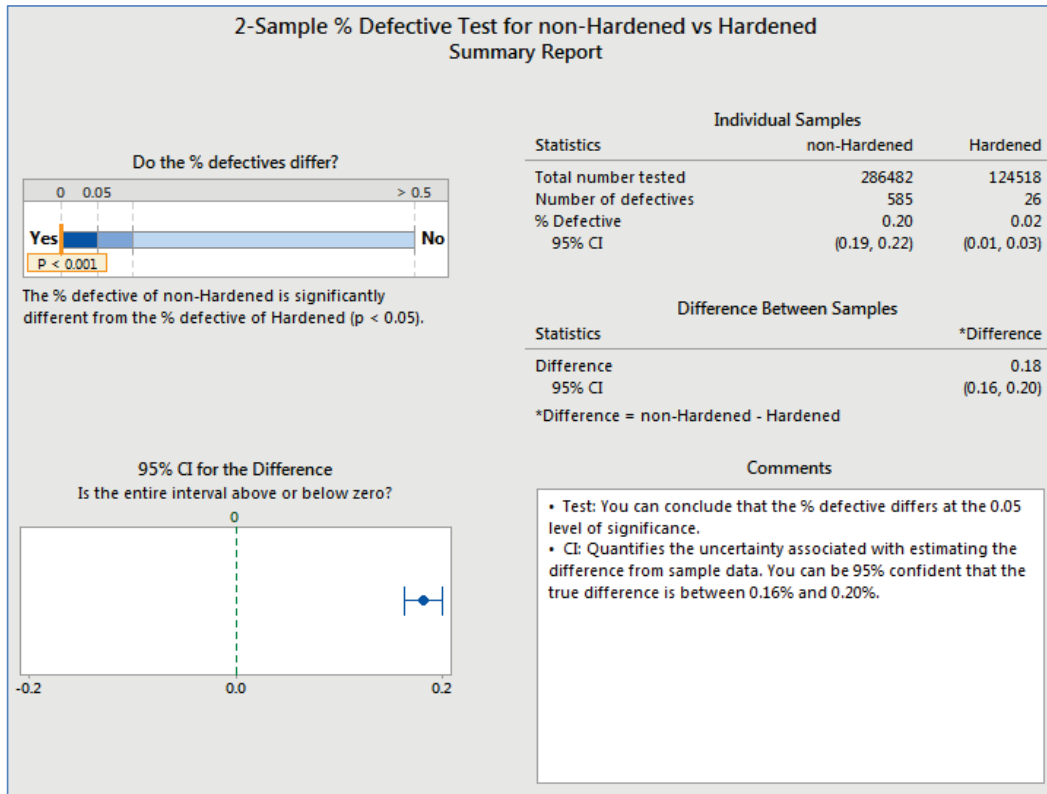
Analysis that shows the defect rate of non-Hardened and Hardened Feeder poles is significantly different.

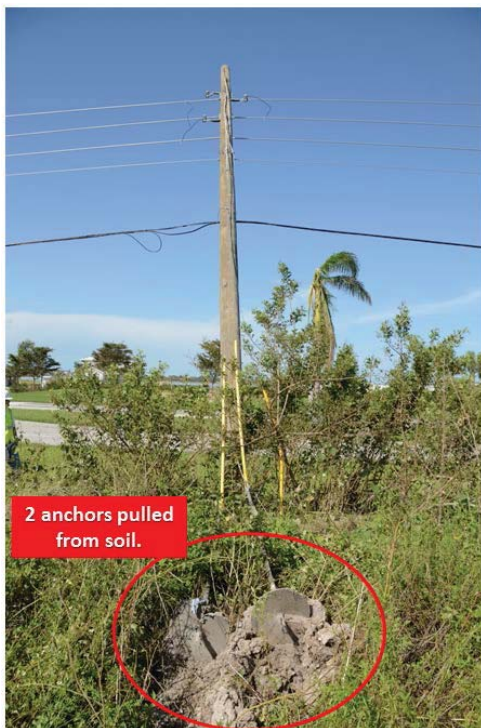
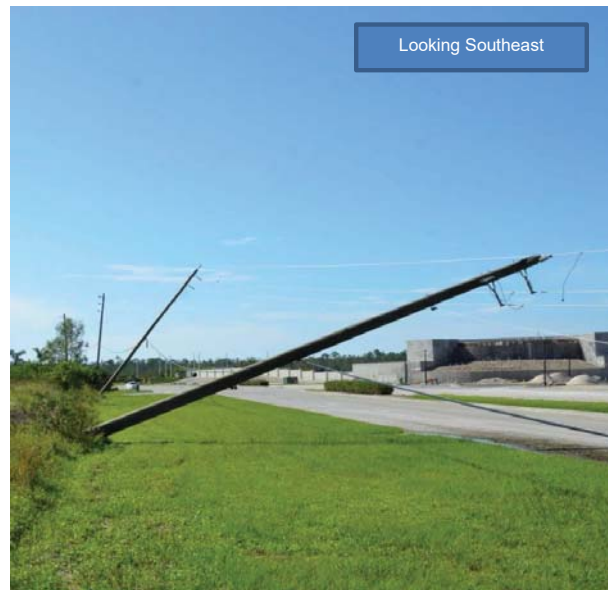
The anchors on the structure at the northern end of the failure pulled out of the soil. The anchors were set in a berm with a small pond behind. No extensions were utilized on the anchors. The shallow installation depth into a berm would significantly reduce the holding capacity of the anchor particularly in saturation soil.

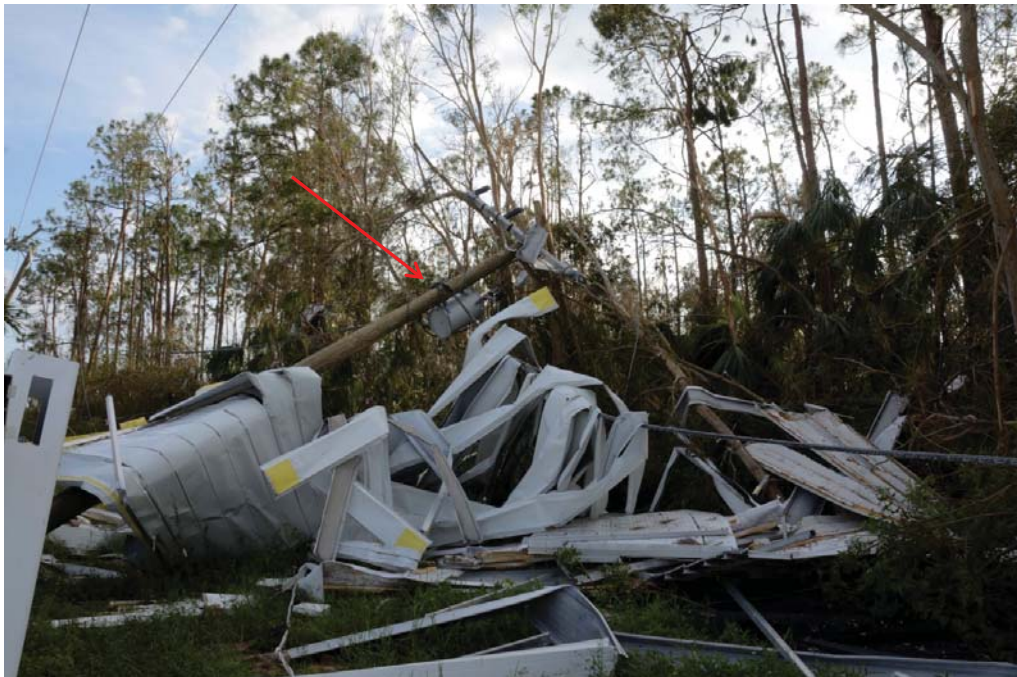
Pole down with transformer in West area due to trailer park debris

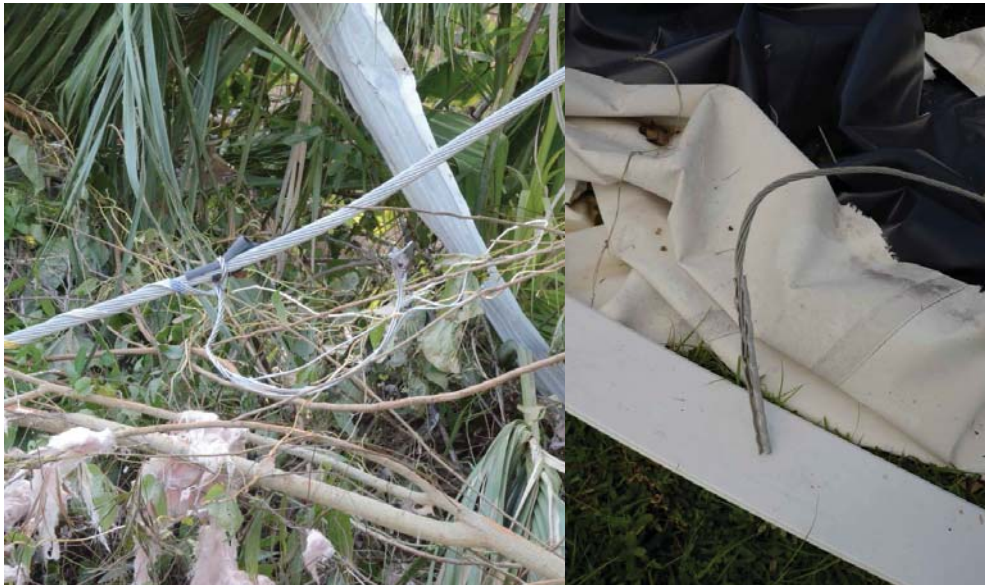
Insulator tie and failed splice. Below: ALS out of support and on ground

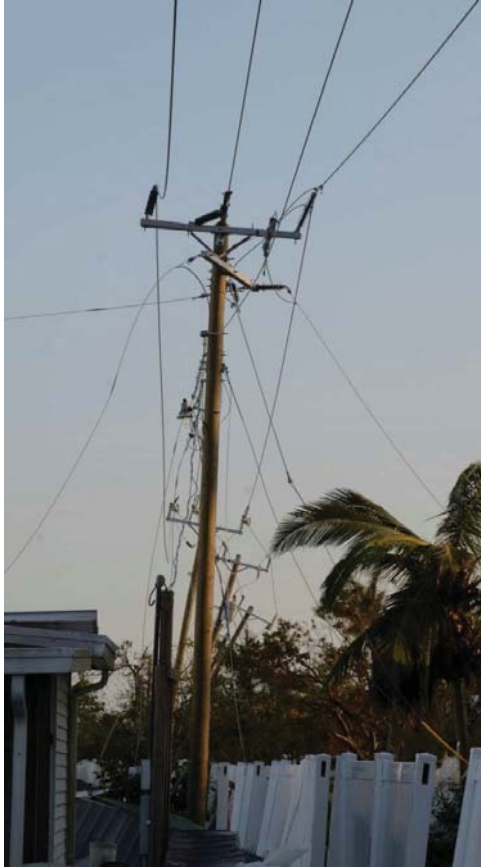
View of leaning poles

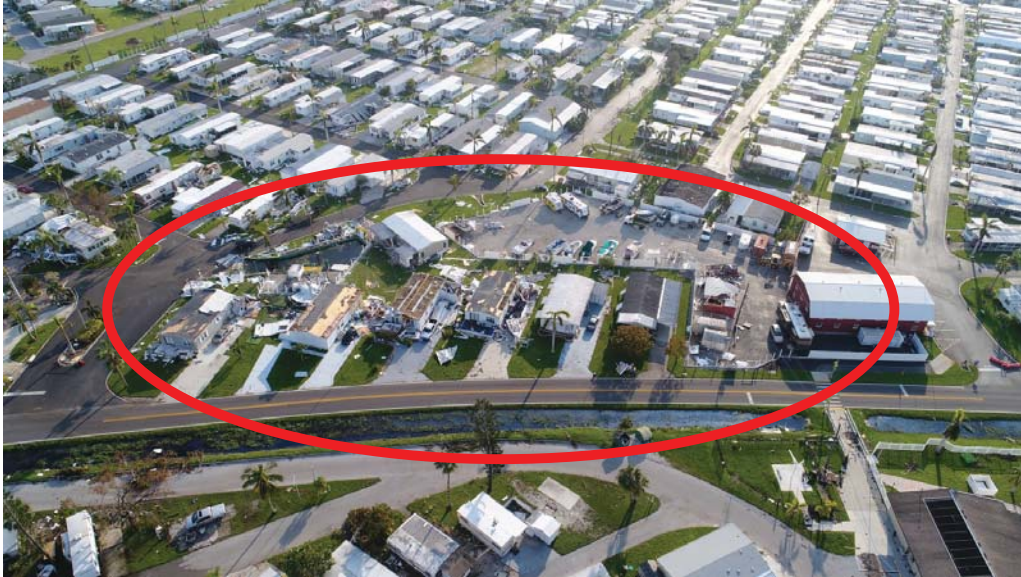
Area of concentrated damage, looking west.

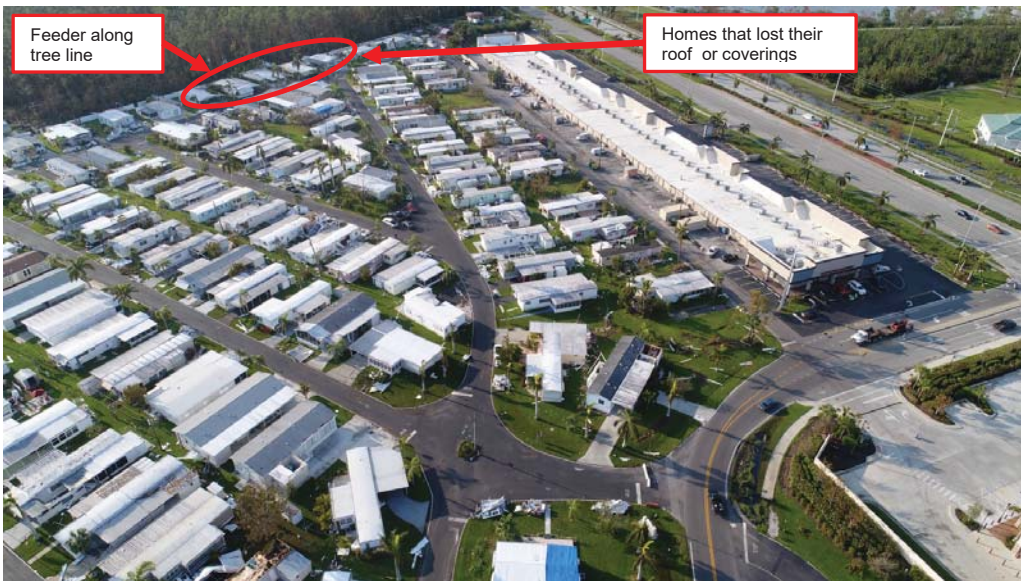
Looking northwest through the trailer park toward the feeder

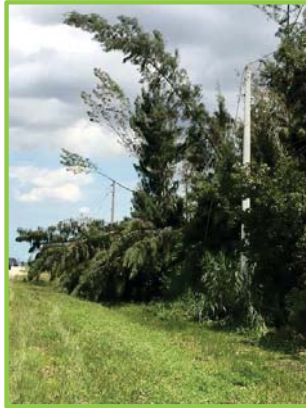
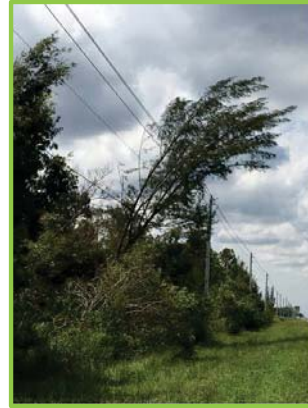
- No poles down.
- The only wires down were due to a massive tree
- However, this leaning tree did not bring down poles

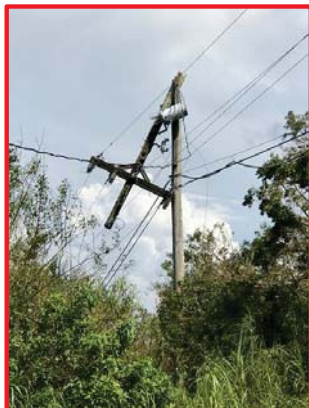
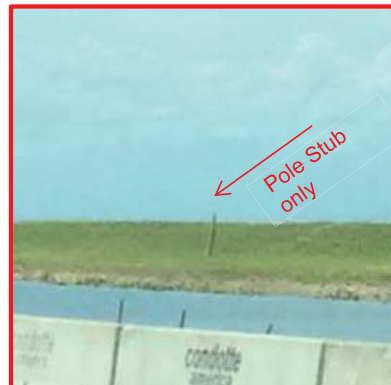
- Feeder behind the OCR had three broken poles shown below due to wind
- Two stub poles are all that remain and the rest of the poles and wires were behind the berm across the canal

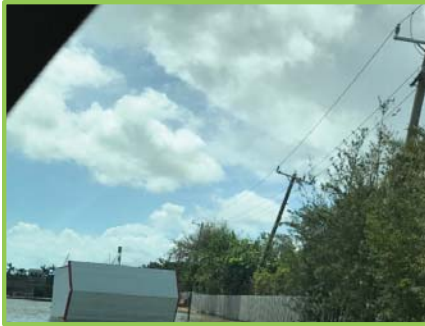
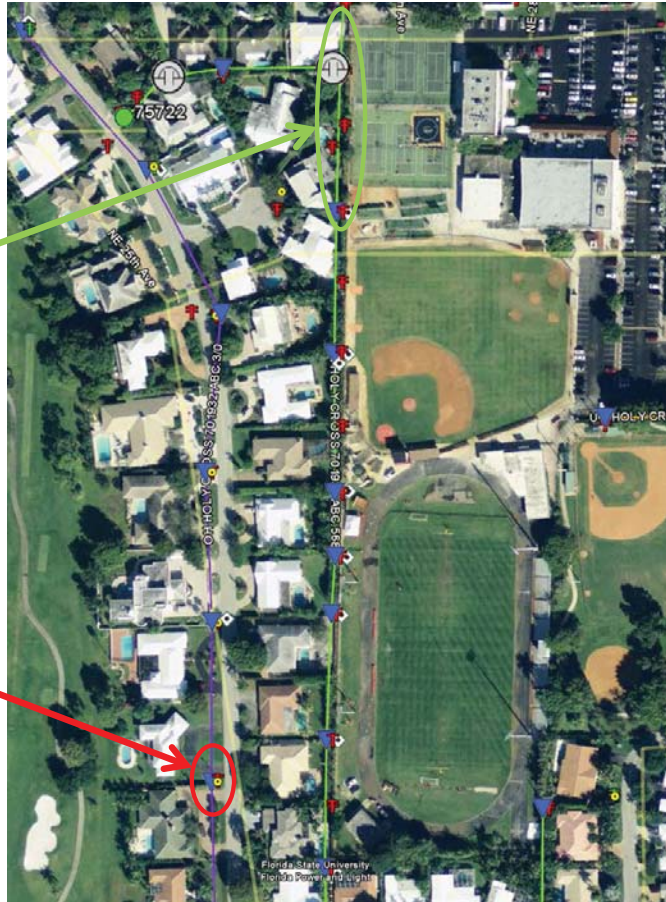
Non-Hardened (Sample 701932):

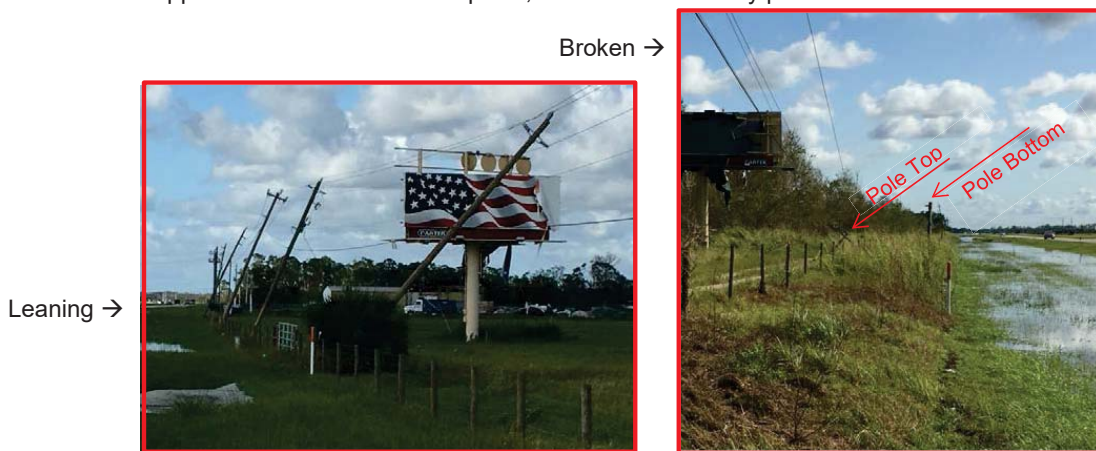
Hardened (Alva Feeder 504761 – West of switch number 20714)

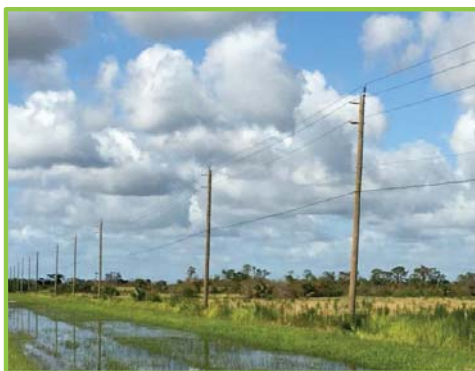
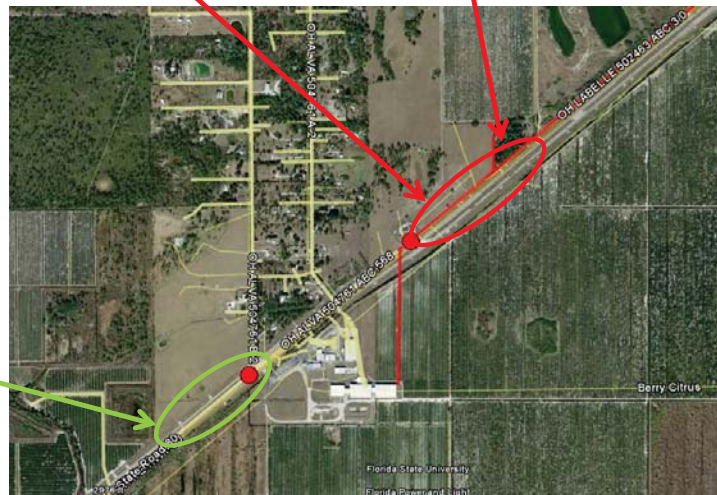
- Section of wood hardened poles that were unaffected by the storm. These poles were not leaning and showed no signs of any damage.

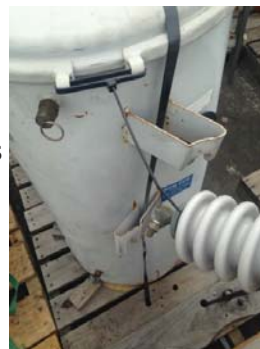
- It is estimated by Inventory Services that approximately 4000 aerial transformers were issued due to damage caused by trees, flying objects, or damaged as a result of falling with the broken pole in which they were installed.

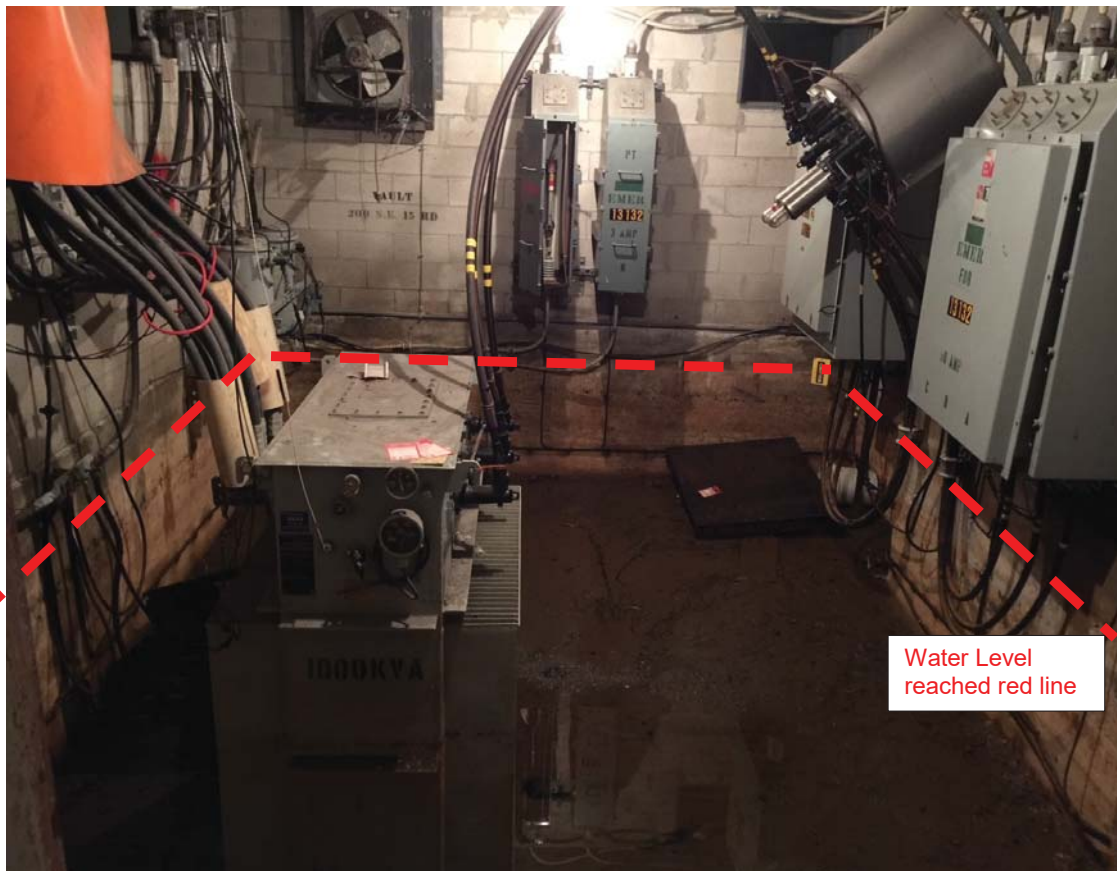
Subgrade Vault for Brickell Harbour

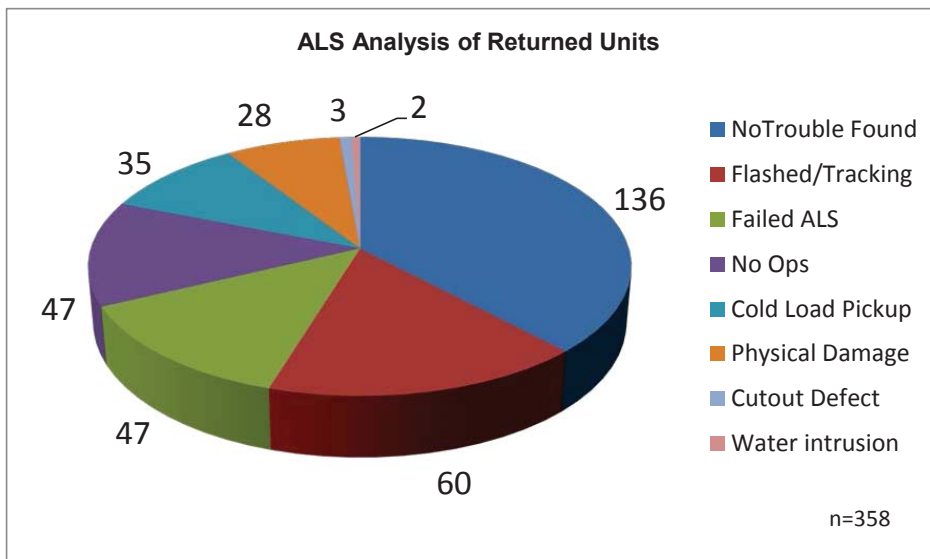
- 136 No Trouble Found
- 60 units were flashed or had evidence of tracking - most were operational
- 47 true failures
- 35 units returned due to cold load pickup concerns - operational
- 28 units had physical damage

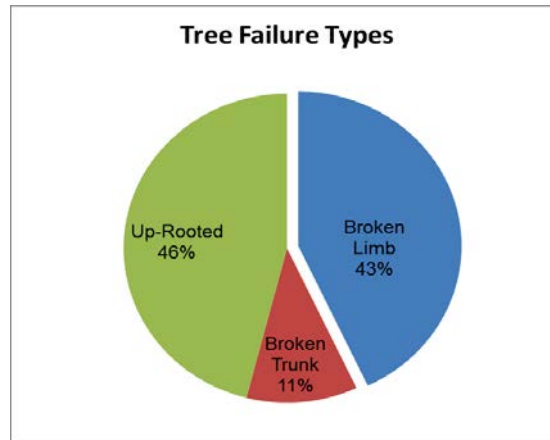
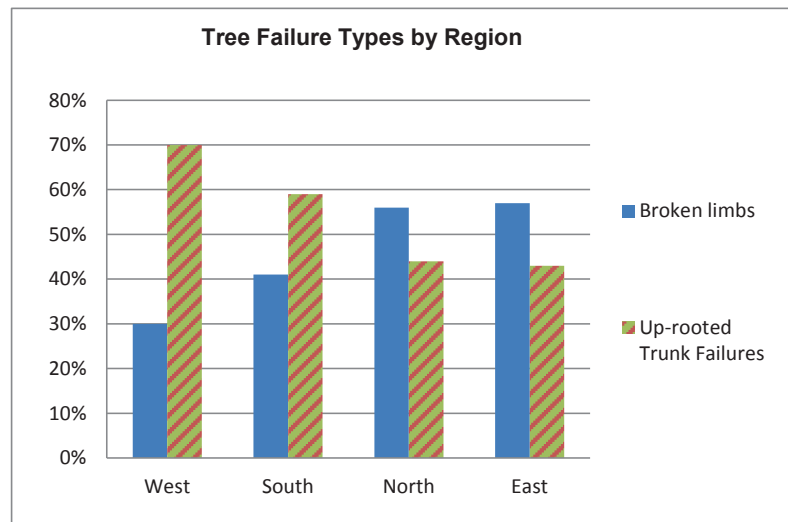
- 57% of tree failures were caused by up-rooting trees or trunk failures falling into overhead facilities
- The remaining 43% of tree failures were due to broken limbs
- Additional trimming by FPL or shorter vegetation trimming cycles would not have made a significant impact to the system performance since the majority of damage was caused by uprooted trees, broken trunks and broken limbs that fell into the lines from outside of right-of-way.
- Over 6,000 reports were reviewed in ESDA (Electric Storm Damage Assessment) and 1,700 of these observations were referred to arborists to classify.
