Kenneth M. Rubin
Senior Counsel
Florida Power & Light Company
700 Universe Boulevard
Juno Beach, FL 33408-0420
(561) 691-2512
(561) 691-7135 (Facsimile)
Ken.Rubin@fpl.com

April 23, 2018

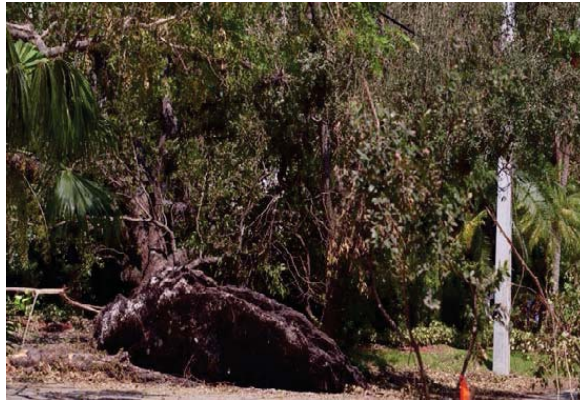
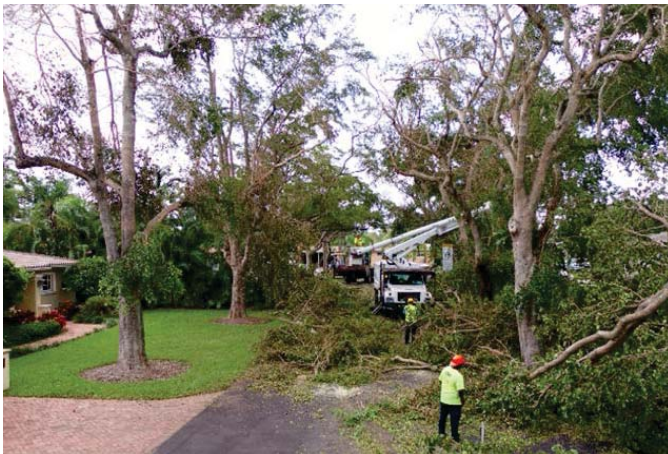
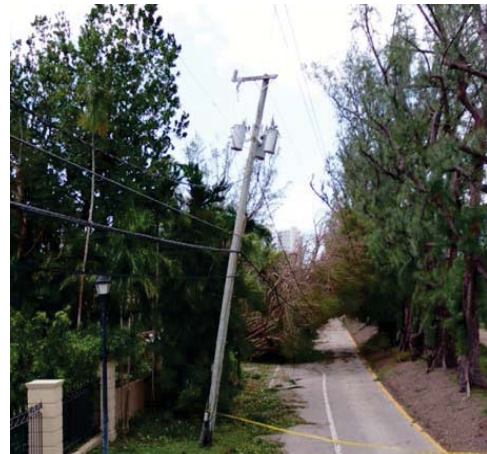
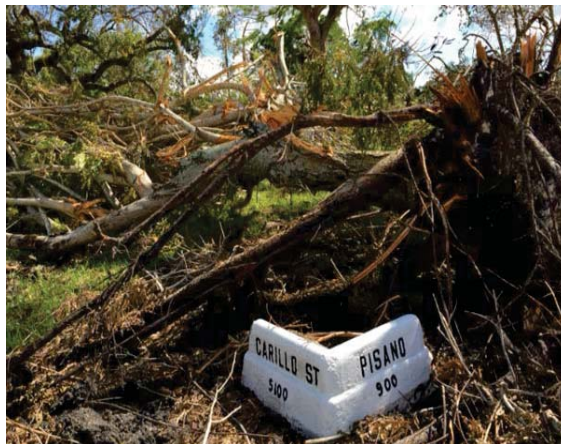
Examples of Vegetation Damage in Dade Area

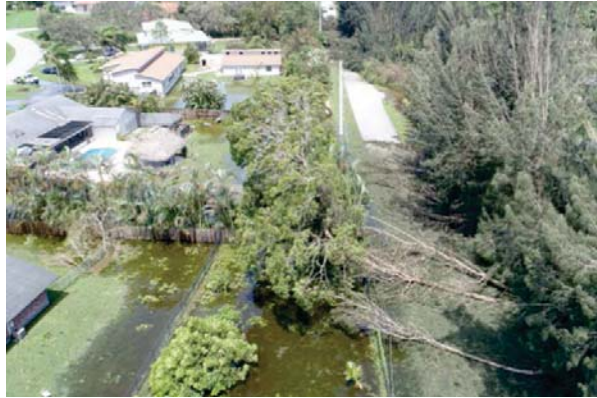
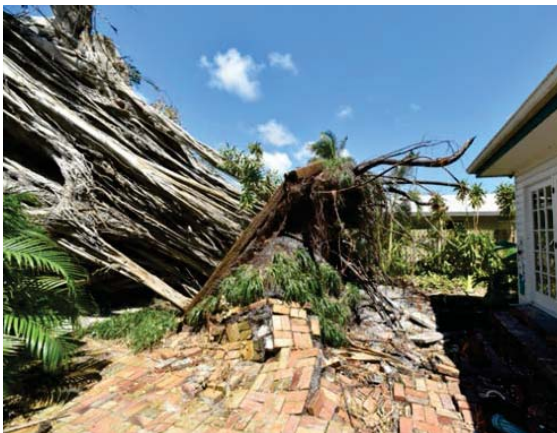
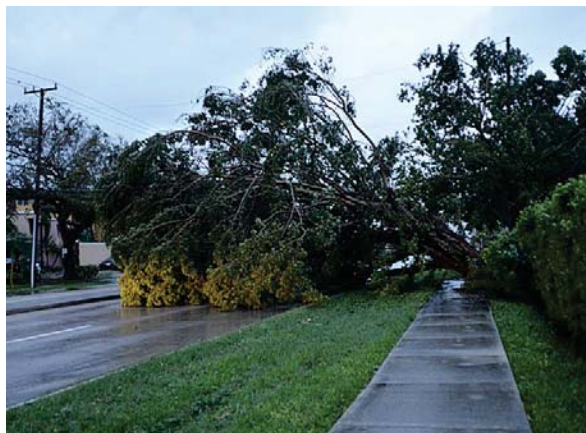
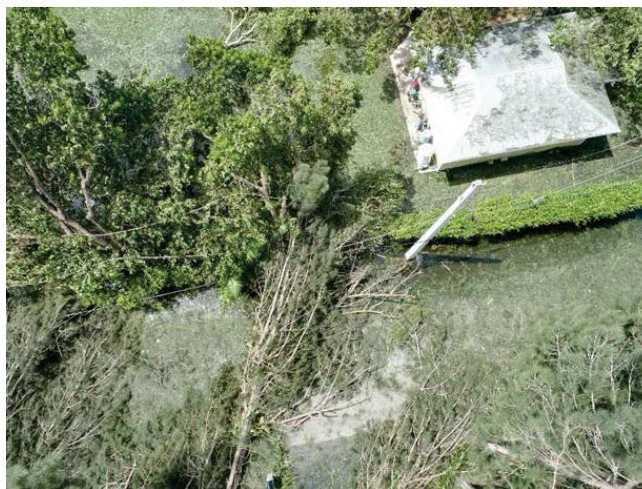
Examples of Vegetation Damage in East Area

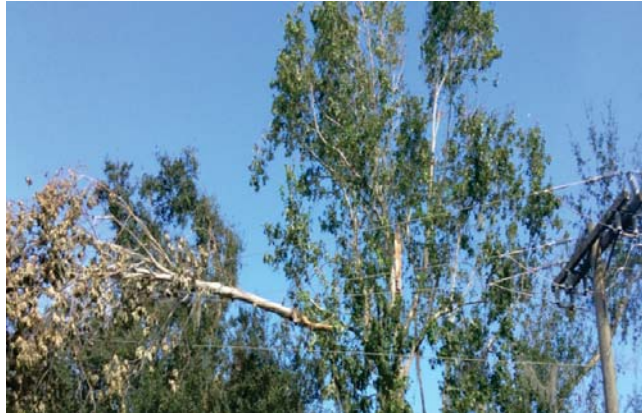
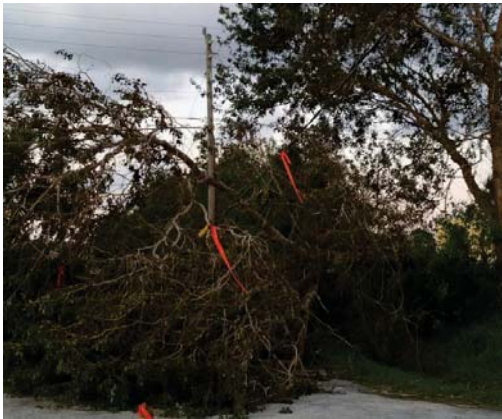
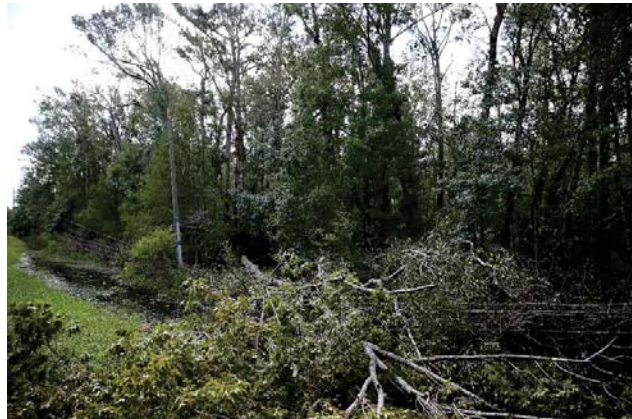
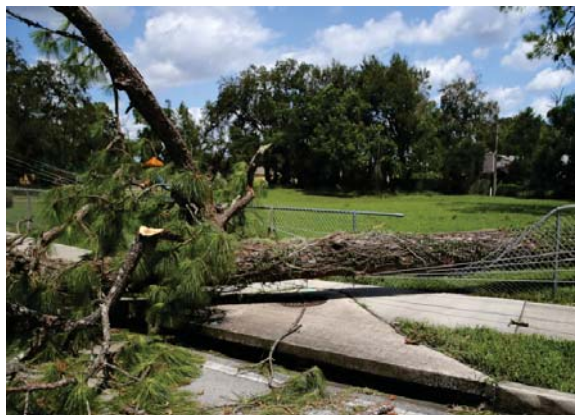
Examples of Vegetation Damage in North Area

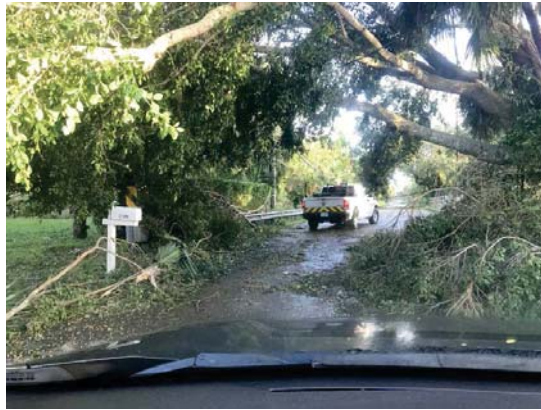
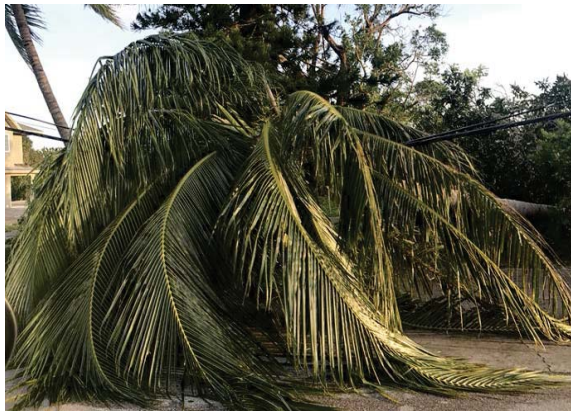
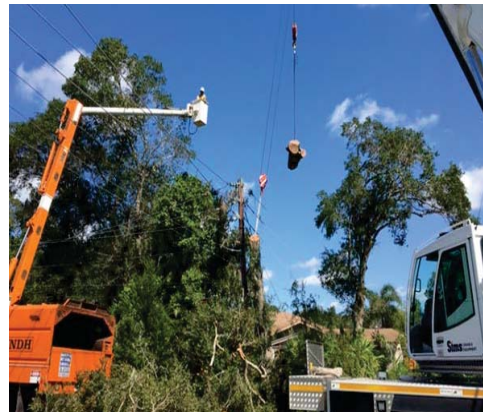
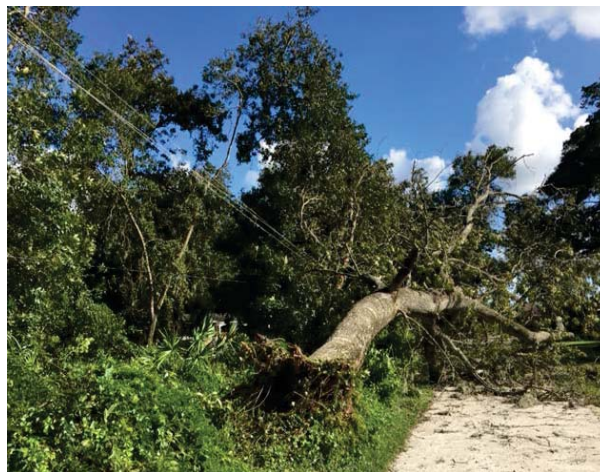
Examples of Vegetation Damage in West Area

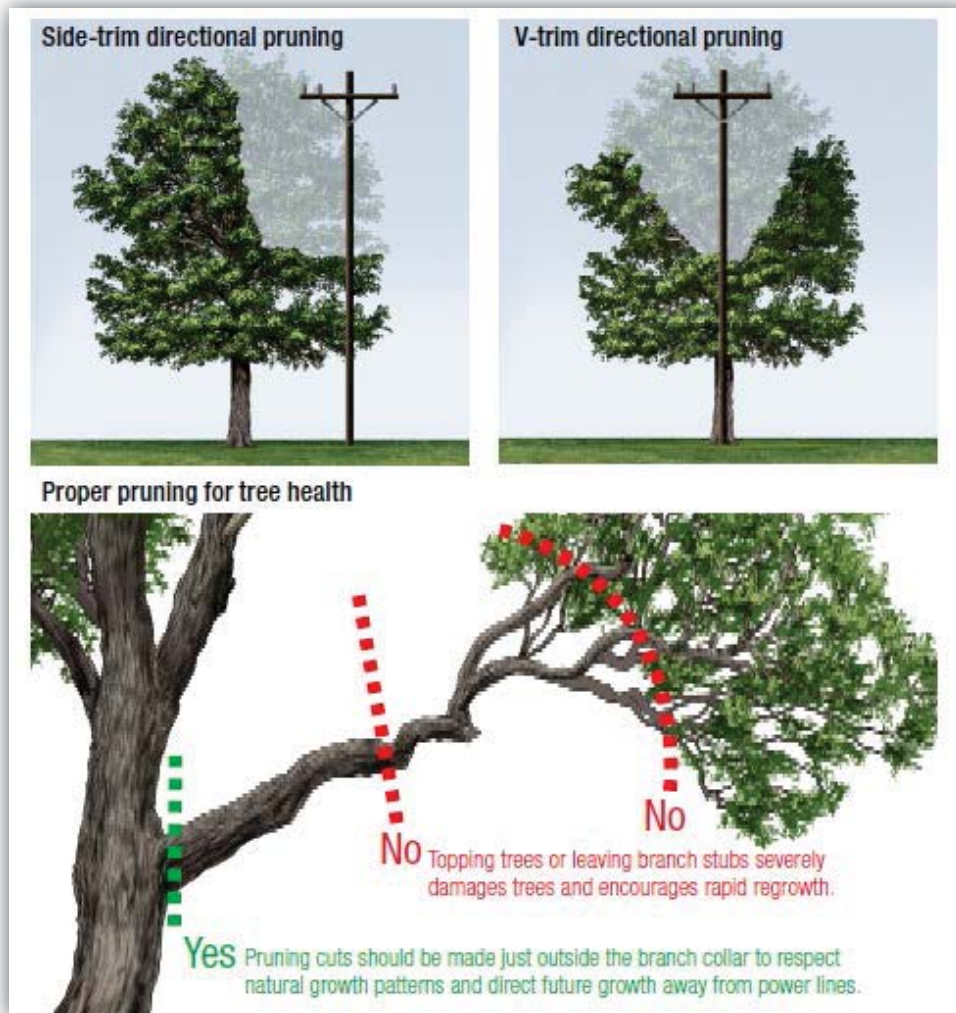
- **Directional pruning:**
 - Removes limbs growing towards the conductors
 - Trains the tree to grow away from the facilities
 - Removes limbs at natural detachment points, or laterals, to help facilitate sealing to prevent decay
- **Removal:**
 - Necessary if pruning cannot be maintained
 - Palms

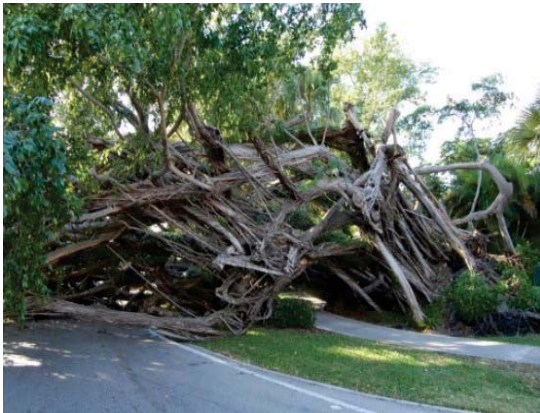
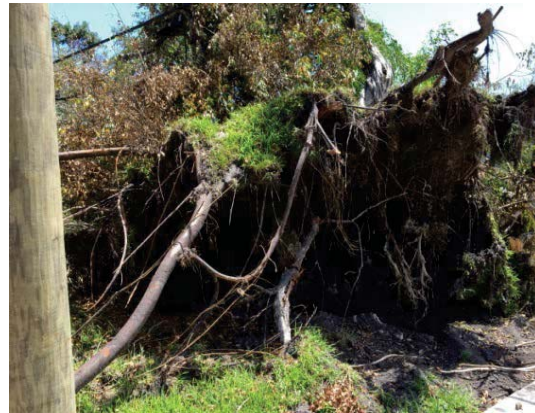
Pictures above:
Large, mature ficus trees topple over due to massive tree canopy with shallow root systems

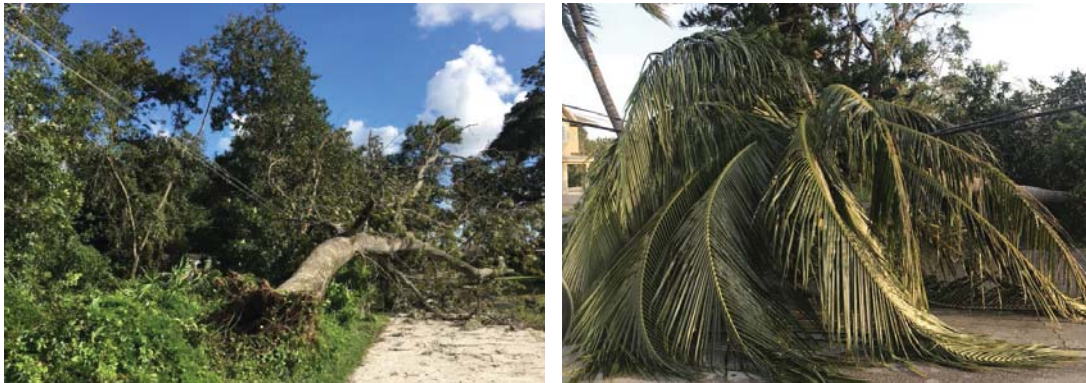
Trimming crews use a crane to remove large tree from utility lines

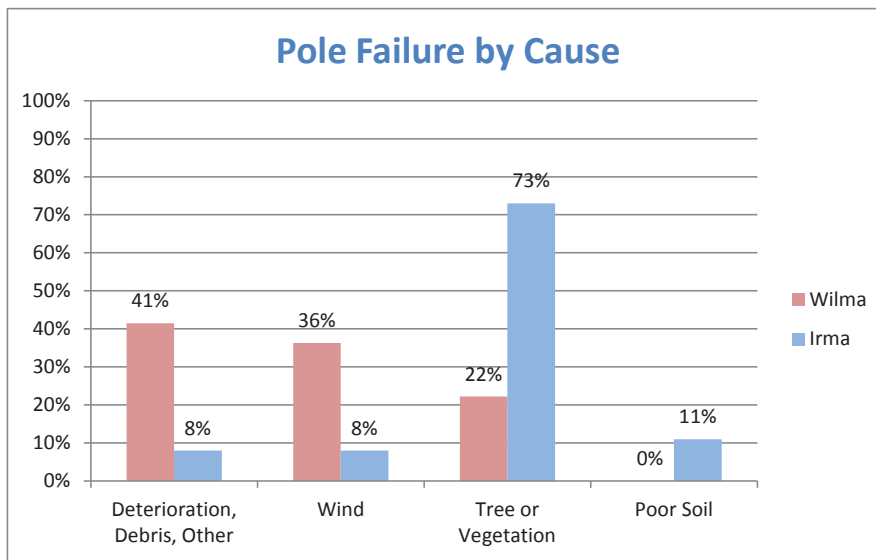
- Irma - Vegetation and Poor Soil Conditions (84%)
- Wilma - Wind and Pole Deterioration (77%)

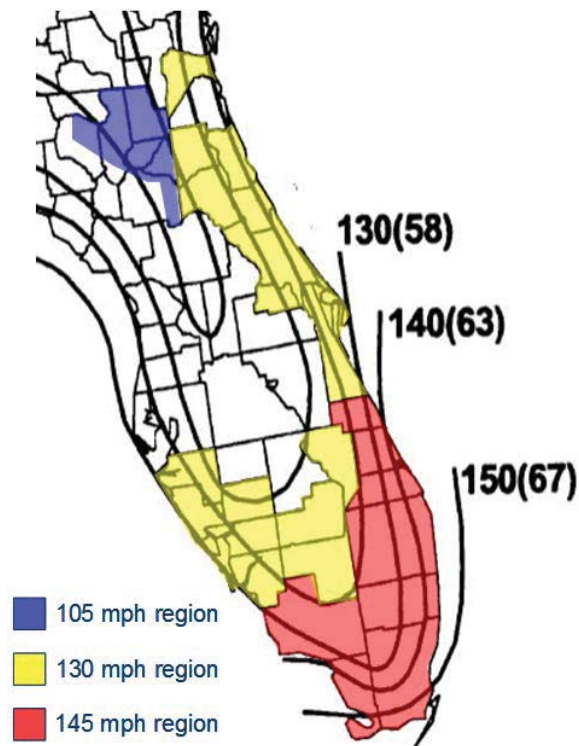
Distribution Design Gust Wind Speeds
