**From:** Office of Commissioner Brown  
**Sent:** Wednesday, April 25, 2018 4:00 PM  
**To:** Commissioner Correspondence  
**Subject:** FW: Docket No. 20170166-WS - Correspondence  
**Attachments:** Color-Wash-Summary-Phase-I.pdf; ColorWashSummaryPhase2.pdf

**Laundry Color Wash Study: Phase I**

**Mount Vernon, Ohio**

## **Laundry Color Wash Study: Phase II – Distribution System**

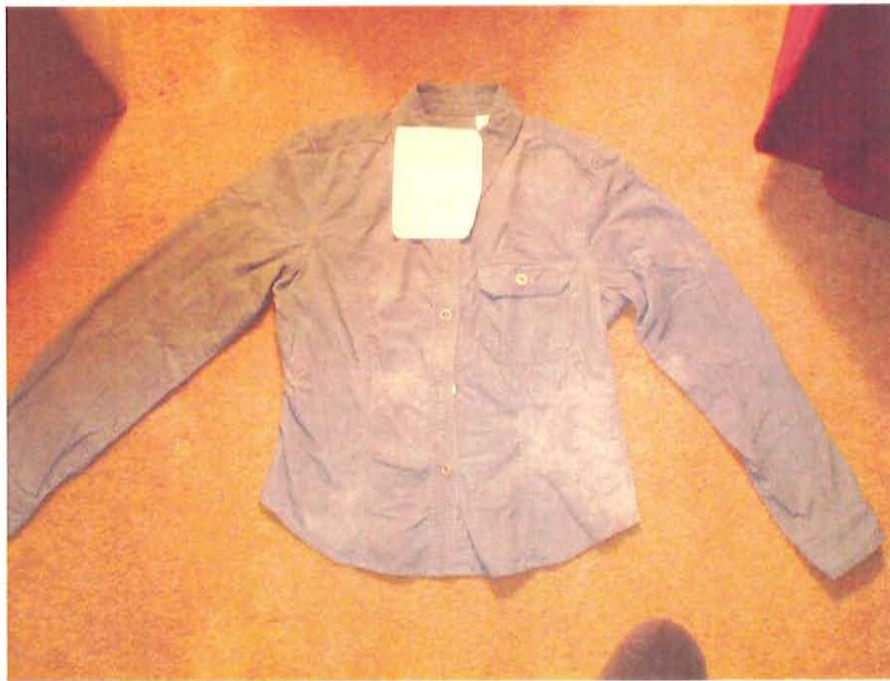
**Figure 1 – Faded areas on garment typical of the "spotching" effect**

In review and evaluation of the piping materials, there is no evidence to suggest old pipe materials are corroding due to unstable water which could possibly lead to release of mineral deposits from piping. The release of these materials was a theory of what may cause the splotching problems, but this has been ruled out. In addition, mineral releases that stain generally show up as distinct spots and not as bleached or faded areas as shown in the clothing samples illustrated in Figure 1 and Figure 2.

The conclusion to the laundry color wash study points to the clothing itself as the cause of the splotching. Sub-standard dyes and dyeing methods can lead to a faded or bleached appearance of garments when washed. The more common occurrence of clothing with unstable sulfur dyes and fabrics not as colorfast as expected due to overseas production methods are the most likely source of the splotching problems.

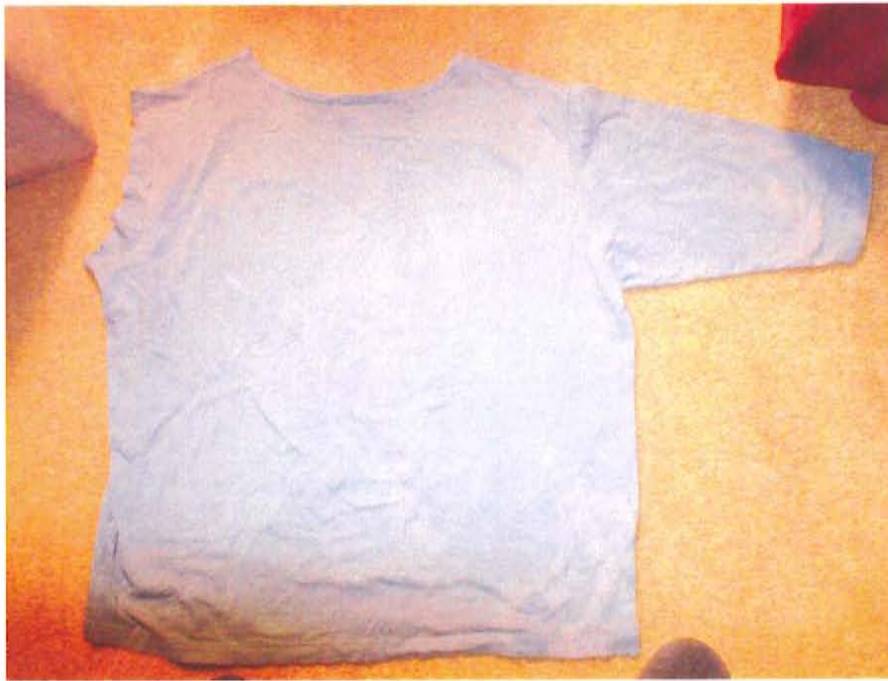
**Figure 2 – Shirt displays multiple areas of the "splotching"**

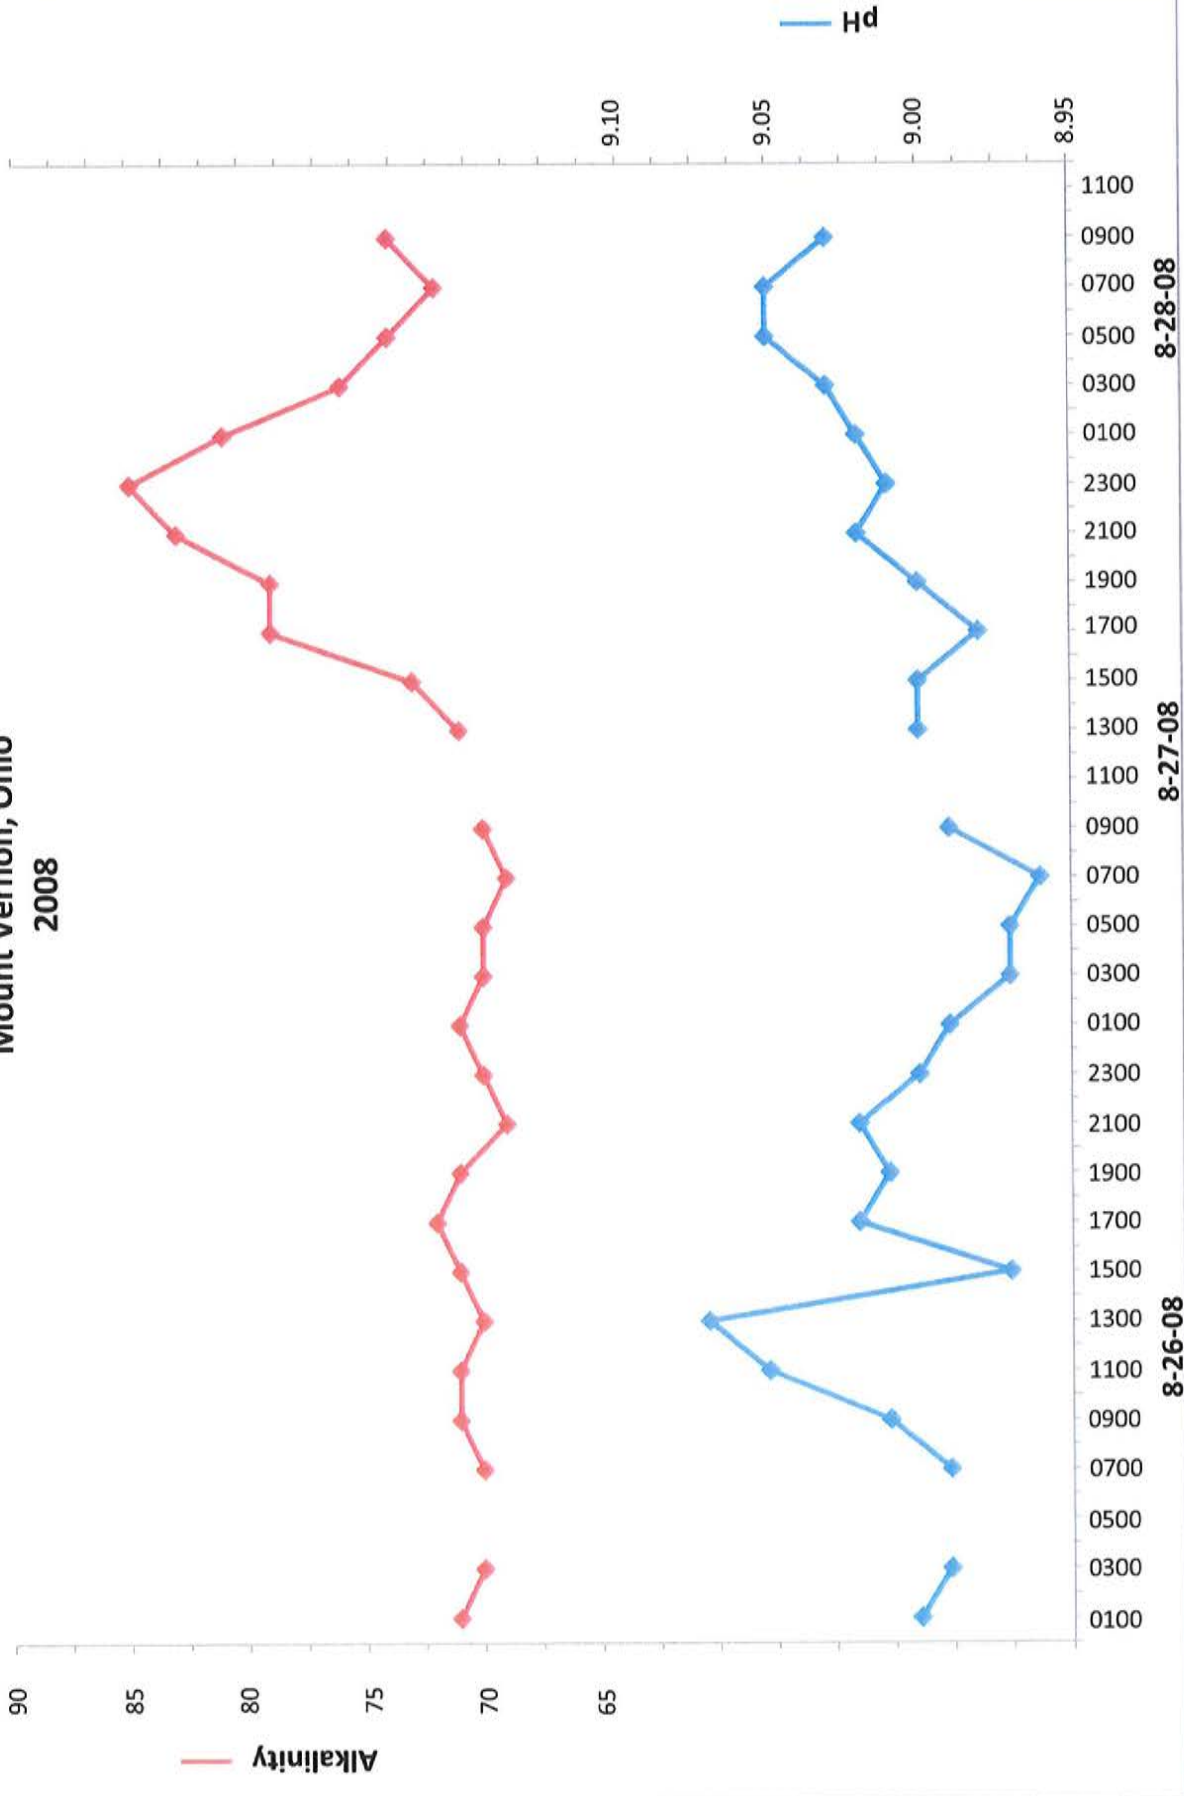
Plant Tap  
Alkalinity / pH Data  
Mount Vernon, Ohio  
2008

The Plant Tap data was initially evaluated for the two and one-half days provided by the City. A graph was developed for the pH data and is included in Appendix B. The pH data shows a very consistent level of approximately 9.0 SU with little variation

throughout the course of a day as well as between days. The pH value of 9.0 SU is reasonable and the consistency of pH is an indication that the City is very efficient in managing chemical usage to accomplish target softening goals without wasting lime. It would also suggest that some scale is forming in the system but not to a significant degree. This is a desirable condition.

The Plant Tap data for alkalinity was evaluated for the same period. A graph was also developed for the alkalinity data and is included in Appendix B. Alkalinity consistently ran at approximately 70 mg/l CaCO on August 26<sup>th</sup> and through the morning of August 27<sup>th</sup>. The afternoon and evening on August 27<sup>th</sup> showed a noticeable rise in alkalinity from approximately 70 mg/l CaCO to 85 mg/l CaCO. Over the course of the morning on the following day, August 28<sup>th</sup>, the alkalinity began to lower. It appears that the water leaving the plant is stable and therefore a slight coating of the distribution system should be occurring.

Regarding the increase in alkalinity noted in the previous paragraph, the pH remained unchanged during this increase in alkalinity on the afternoon of August 27<sup>th</sup>. Checking with plant personnel, it was discovered that a load of lime disrupted operations at the plant that day. During that time the system is shut down, which apparently caused a spike in alkalinity with no recarbonation occurring.

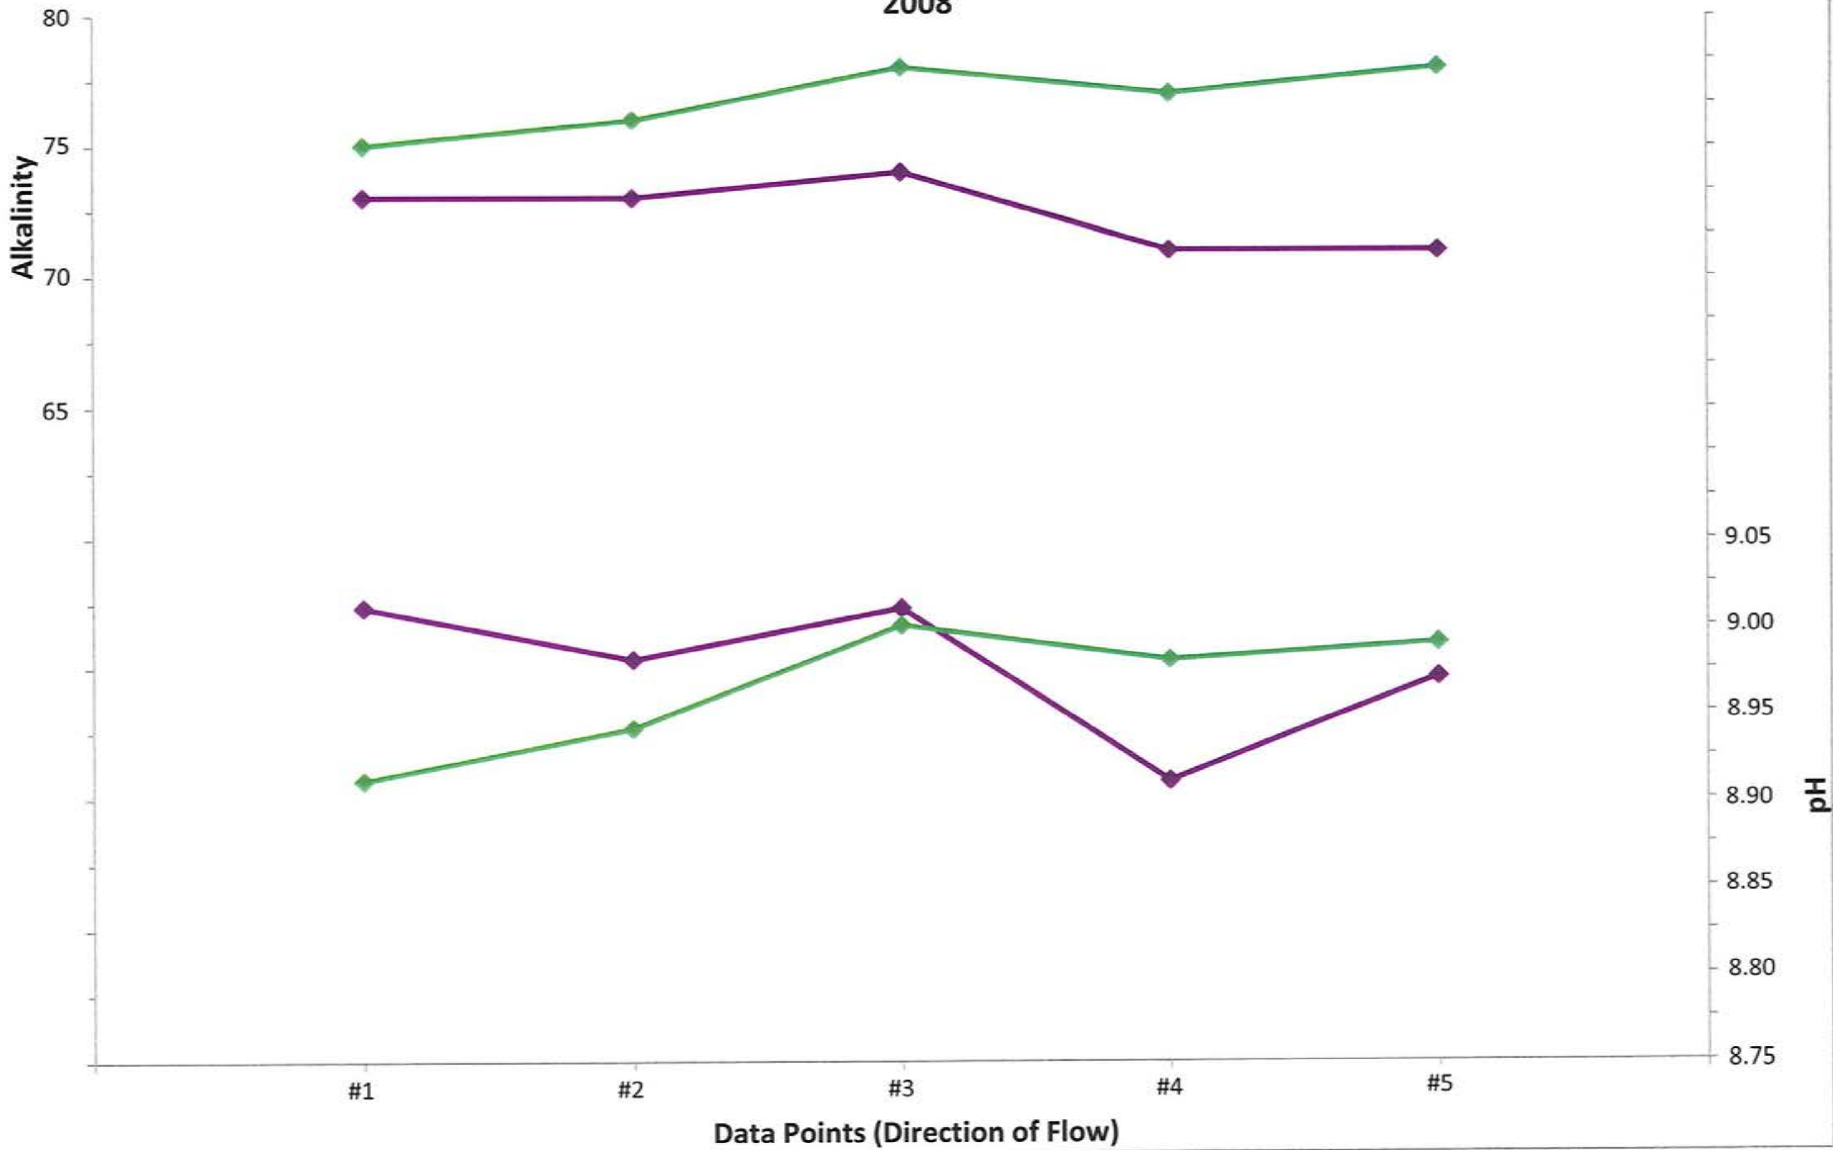
Alkalinity / pH  
Profiles  
Mount Vernon, Ohio  
2008

For the Rogers/Braddock area, the pH maintains at 9.0 SU with a slight drop between the 3<sup>rd</sup> and 4<sup>th</sup> data points. This drop corresponds to a drop in alkalinity which ranged from approximately 70-75 mg/l CaCO. However, there is no consistent pattern to suggest a gradual reduction in alkalinity as water moves through the system in this area. Also, the sampled points do not represent water moving through the system as they are from different connection points along the Pleasant Street and Coshocton Avenue water mains.

For the Chestnut area, the pH and alkalinity show a gradual increase over the initial three data points as water moves through the system from west to east, with a subsequent leveling. The alkalinity in this area ranged from 75-78 mg/l CaCO which is higher than that recorded in the Rogers/Braddock area.

For the minor variations in pH and alkalinity values measured in the system, a general observation may be made that the distribution reflects the plant consistency of water quality without any distinct departures in the parameters. This would imply a relatively stable system and there is no evidence to conclude that the distribution system experiences any water quality conditions that would lead to splotching.
