Power Delivery Performance

Hurricane Matthew

Report Date: November 17, 2017

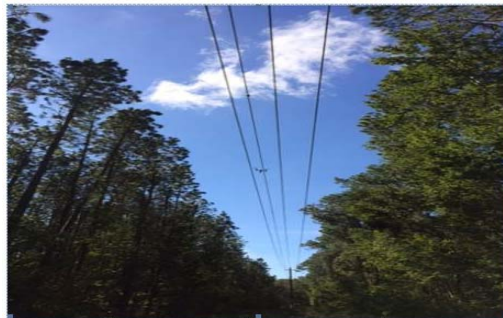
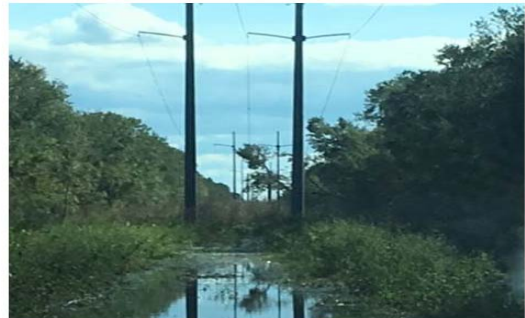
0 poles down

3 phases down

1 guy wire broken

2 OHGW down

1 pole base eroded by wave action

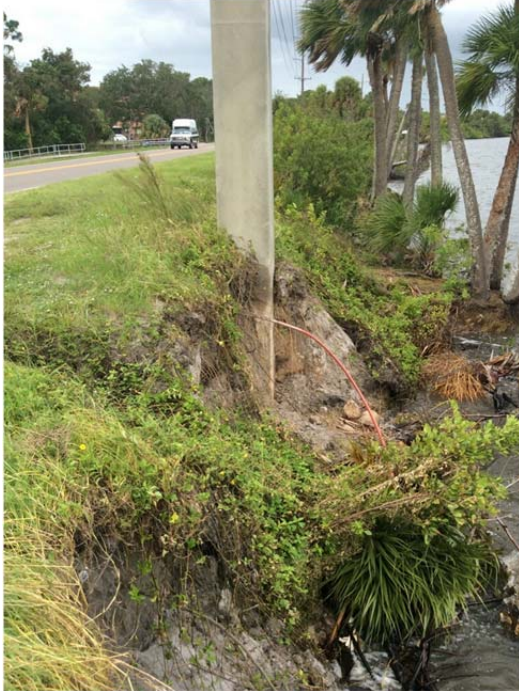
One transmission pole was replaced due to wave action washing out the foundation

This event did not cause an interruption

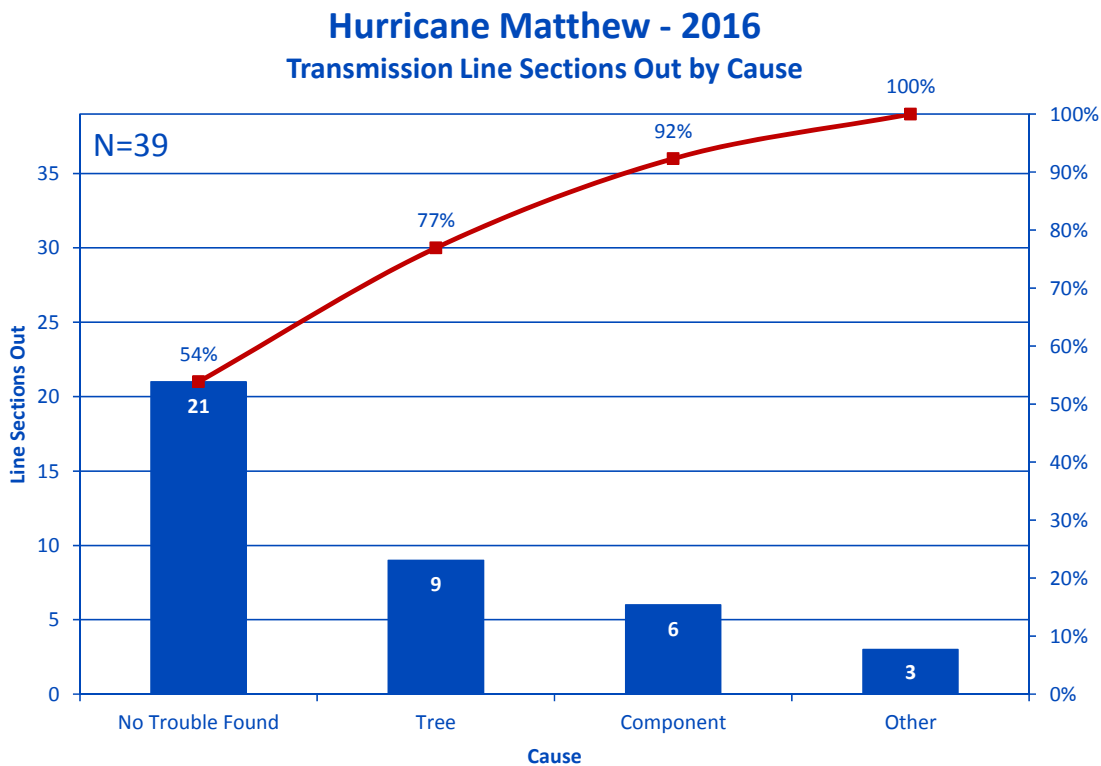
39 line sections were isolated during the storm

These are typically caused by vegetation and wind blown debris

3 phases down, 2 due to OHGW failure, 1 guy wire

2 sections de-energized to isolate St Augustine substation due to flooding

1 section de-energized to isolate a fault on a different line section due to loss of communication to a substation

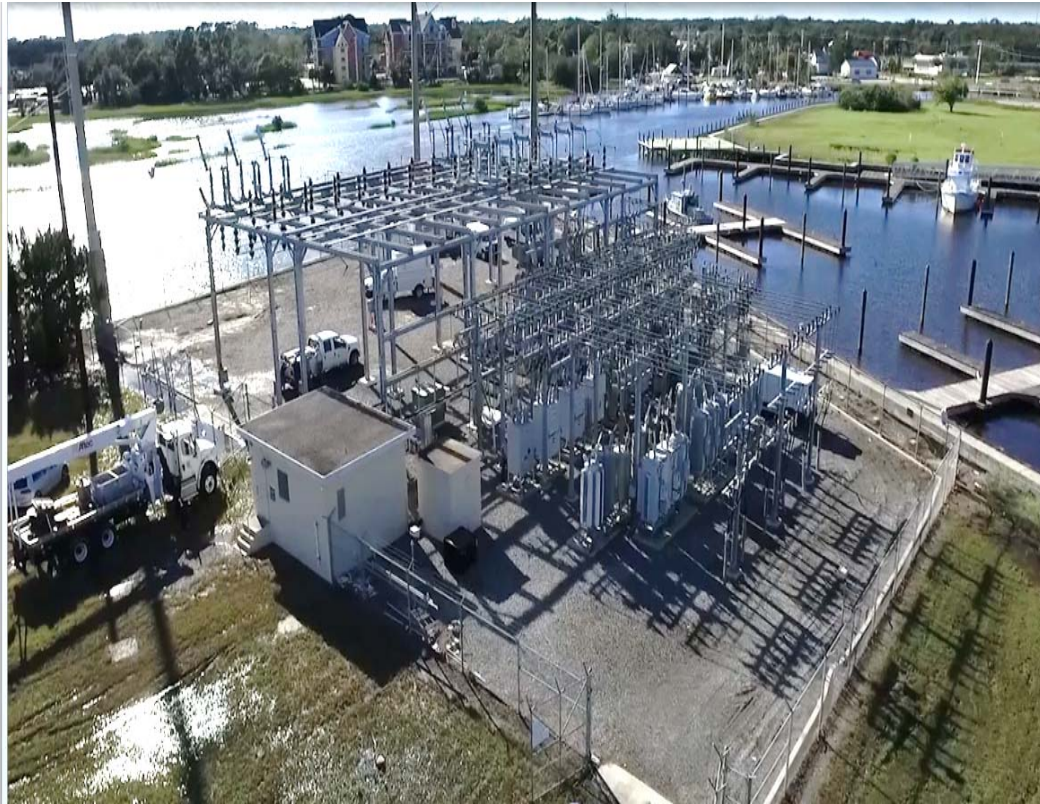
St. Augustine Case Study

St Augustine station flood monitor warning alarmed at 12:19 pm on 10/7

Station flood monitor emergency alarmed shortly after at 12:34 pm

System Operations de-energized substation around 12:53 pm

Only one feeder was in-service at the time of this event

Both outdoor flood monitor alarms cleared at 1:28 pm

Relay vault was not impacted

Both operating busses were energized at 14:37 on 10/8

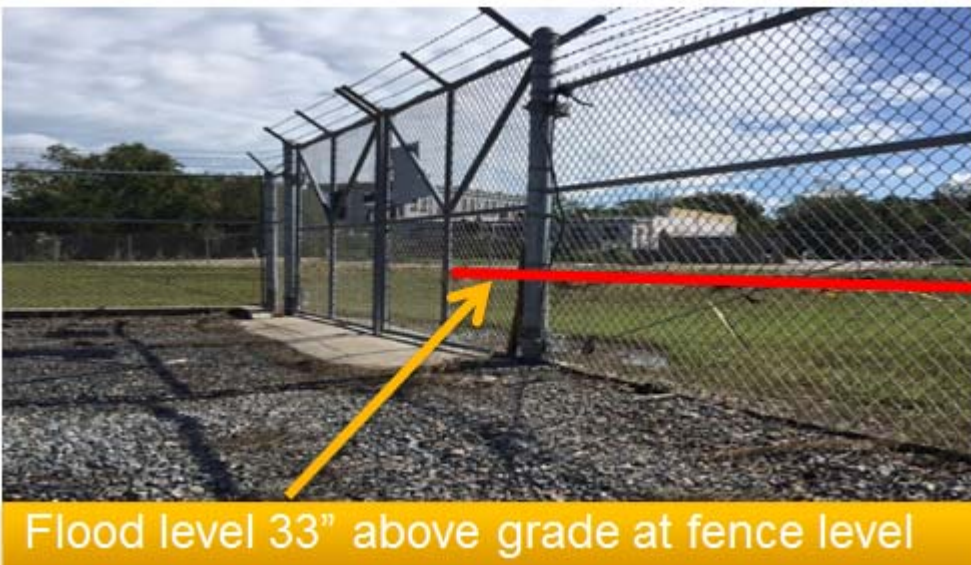
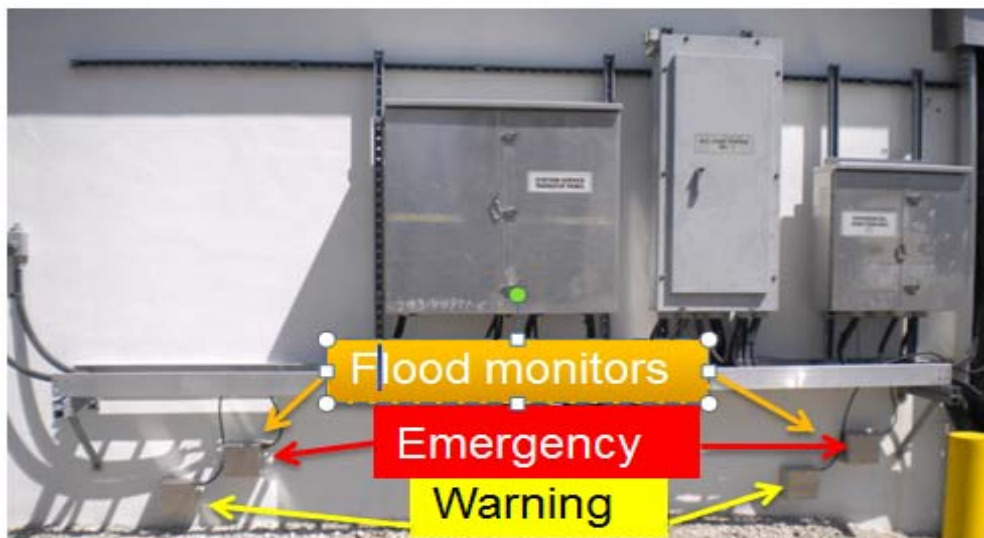
St. Augustine Case Study

Flooding level was significant

Damage was contained to the switch motor operators

2 line switches were impacted

2 transformer circuit switches were impacted

Fault bus current transformer schemes (Transformer, Feeders, Regulators)

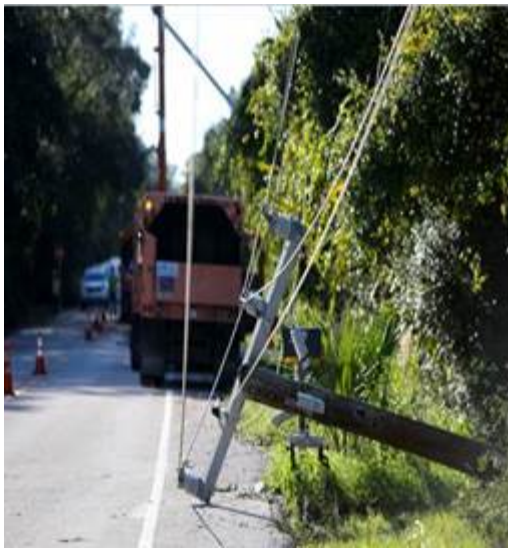
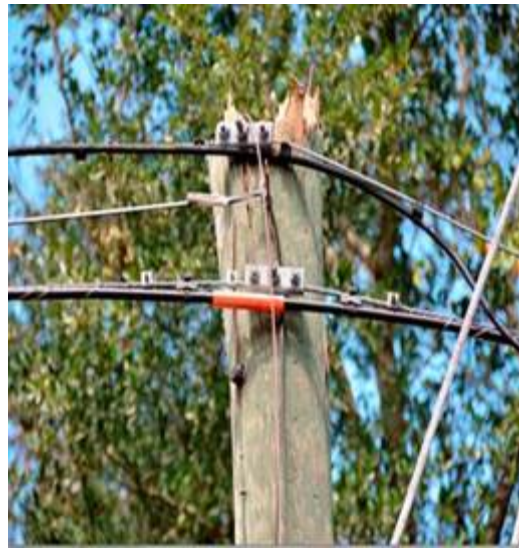
Poles down on wildwood Drive

Below are pictures and a brief analysis of the concentration of pole failures on the 7.4 mile long non-harden Feeder 3742 in St. John's County. Estimated winds were approximately 65-75 mph in this location between 11am and 3pm. The poles experienced excessive loads due to trees in the lines which caused these poles to fail; they didn't fail directly because of wind.

There were 13 broken poles on Wildwood Drive (3.7mi). The majority of the poles were 40ft Class 3 wood poles in good condition that broke approximately 1/3 to 1/2 from the top of the pole; they were last inspected in 2015 with no strength or other rejects found. The poles broke due to large trees falling into the line. Distribution poles are naturally tapered, so it is not uncommon to have the point of maximum stress (and failure) 5ft or more above ground line for overloaded conditions (such as trees or debris in the lines), these poles broke even higher due to several factors. When a tree falls on a line, the wire experiences a sudden and very large increase in tension force in that span of wire. With the steel cross arm and triangular framing that we have on this line, these forces are transferred to the very tip of the pole. The foreign utility and guy wire attachments lower down on the pole can both restrain the pole and, like the ground, transfer some of the load from the pole. This restraint can move up the point of maximum stress (and thus failure) higher up the pole. The majority of these poles failed just above the foreign utility or guy wire. Internal defects in the pole (knots, etc.) can also cause the maximum stress location to change.

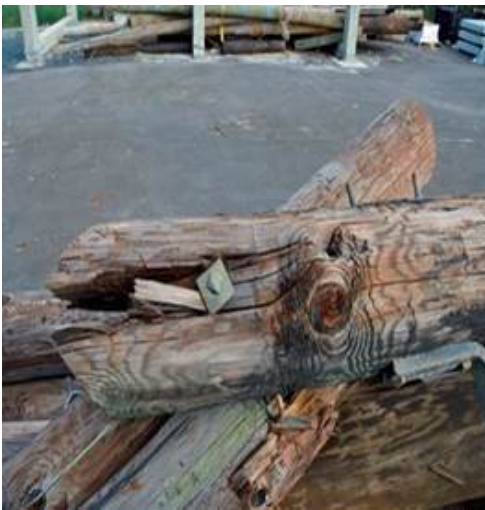
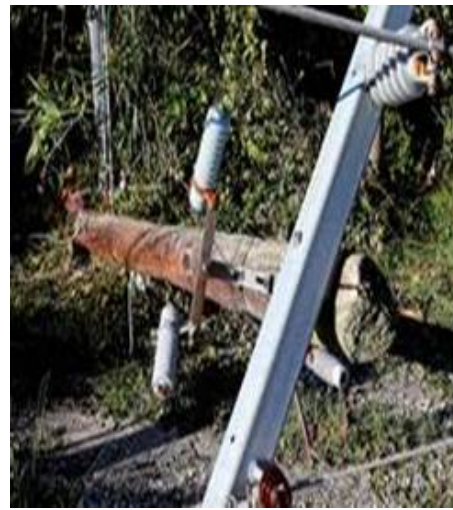
Rail Road Crossing

Two tall wood poles over a railroad crossing were both broken; east pole very close the top of the pole and west pole near the attachments near the top 1/3 of the pole. Both poles were creosote of unknown age. Inspection of these poles show they failed near the top due to trees falling on the line and the weakness at the aged top of pole when under the impact loads of trees falling on the lines and other poles failing.

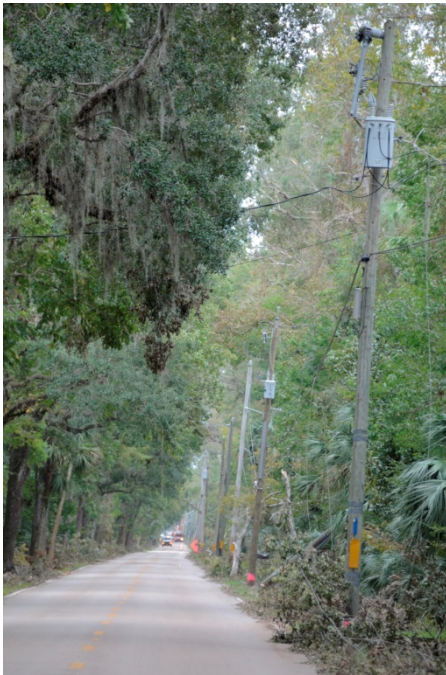
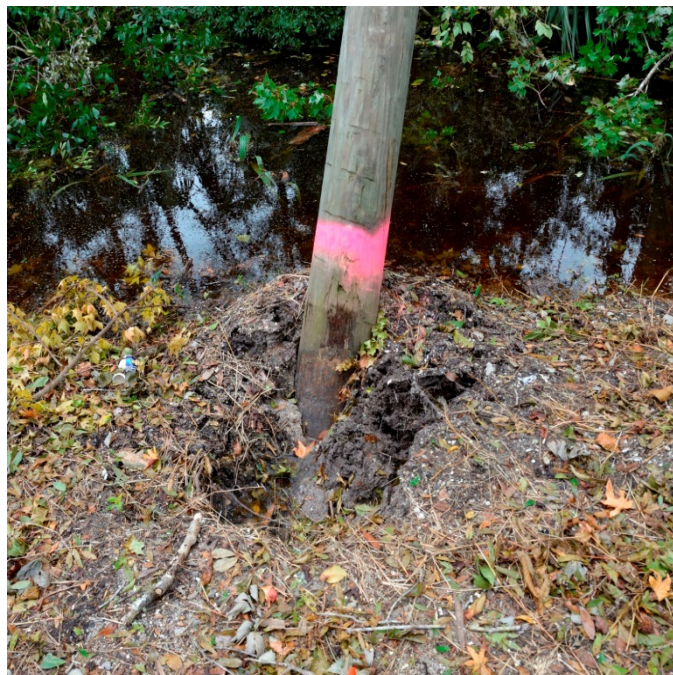
Maytown Road Lateral Case Study

The non-hardened lateral along Maytown Road through the Turnbull Hammock Conservation Area in Volusia County was seriously impacted by Hurricane Matthew on October 07, 2016. The preliminary estimated winds were around 55-65 mph and occurred between 9am and 6pm. The poles and wires experienced excessive loads due to trees in the lines or adjacent pole failures. The poles did not fail due to excessive wind.

Numerous sections of wire were down, 3 poles were broken, and 24 poles had severe leaning along the three mile section of Maytown Road. The restoration effort required five poles which were replaced with stronger poles set deeper, FPL wire down and other damage was repaired and restored. Pull-offs and services to homes were restored as quickly as possible. The line section was re-energized at approximately 6:30am on October 12, 2016.

The failed poles were 40ft Class 4 or 5 wood poles. Two were owned by AT&T and one was owned by FPL. The line was last inspected in 2011.

The poles that were leaning the most had soft soil foundations. The rain from Hurricane Matthew saturated the soils so that the foundations failed before the poles did when the trees came down and broke the wire.

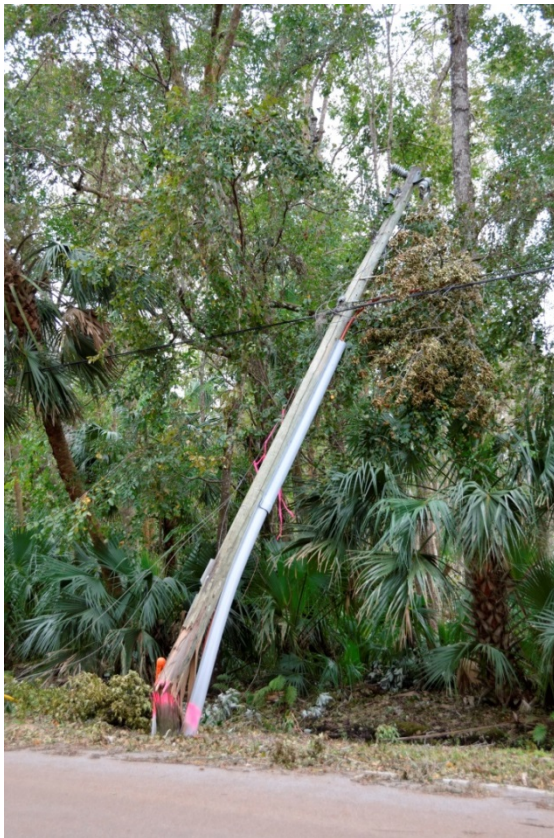
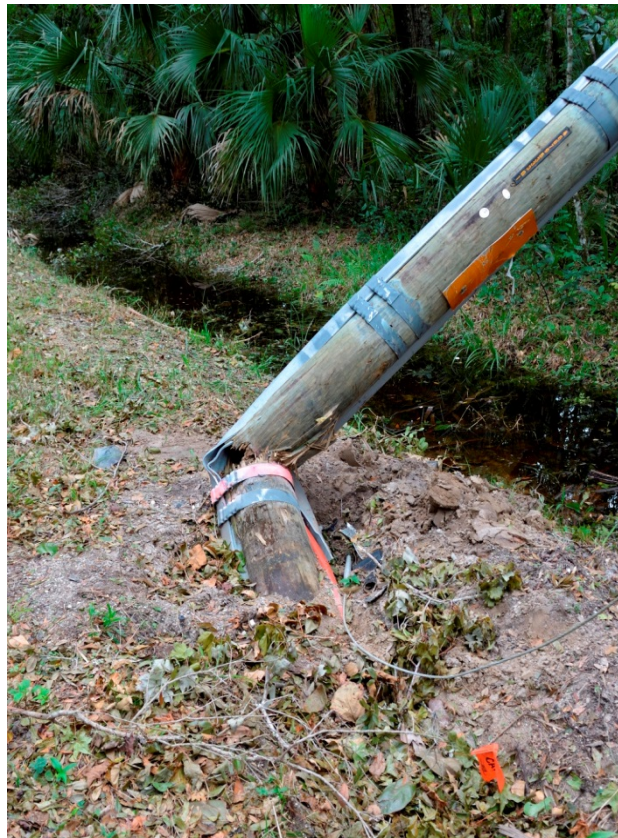
Maytown Road Lateral Case Study

The poles that failed had varying factors that caused the failure. All failed at or just above ground line. The root cause of the pole failures were the tree failures.

The AT&T pole with a pull-off to a home failed due to trees coming down on the lateral and on the pull-off to the home.

One AT&T pole that failed was in process of being replaced. The new pole had been installed and some but not all utilities had transferred their attachments to the new pole. The new pole did not fail. The old pole failed; it had significant ground line corrosion and had been reinforced

The FPL pole failed in-line due to being pulled along the line when wire broke due to tree failures. This pole was in good condition and broke just above ground line as would be expected.

Overall, the structures performed well given the loading placed on them by the tree failures.

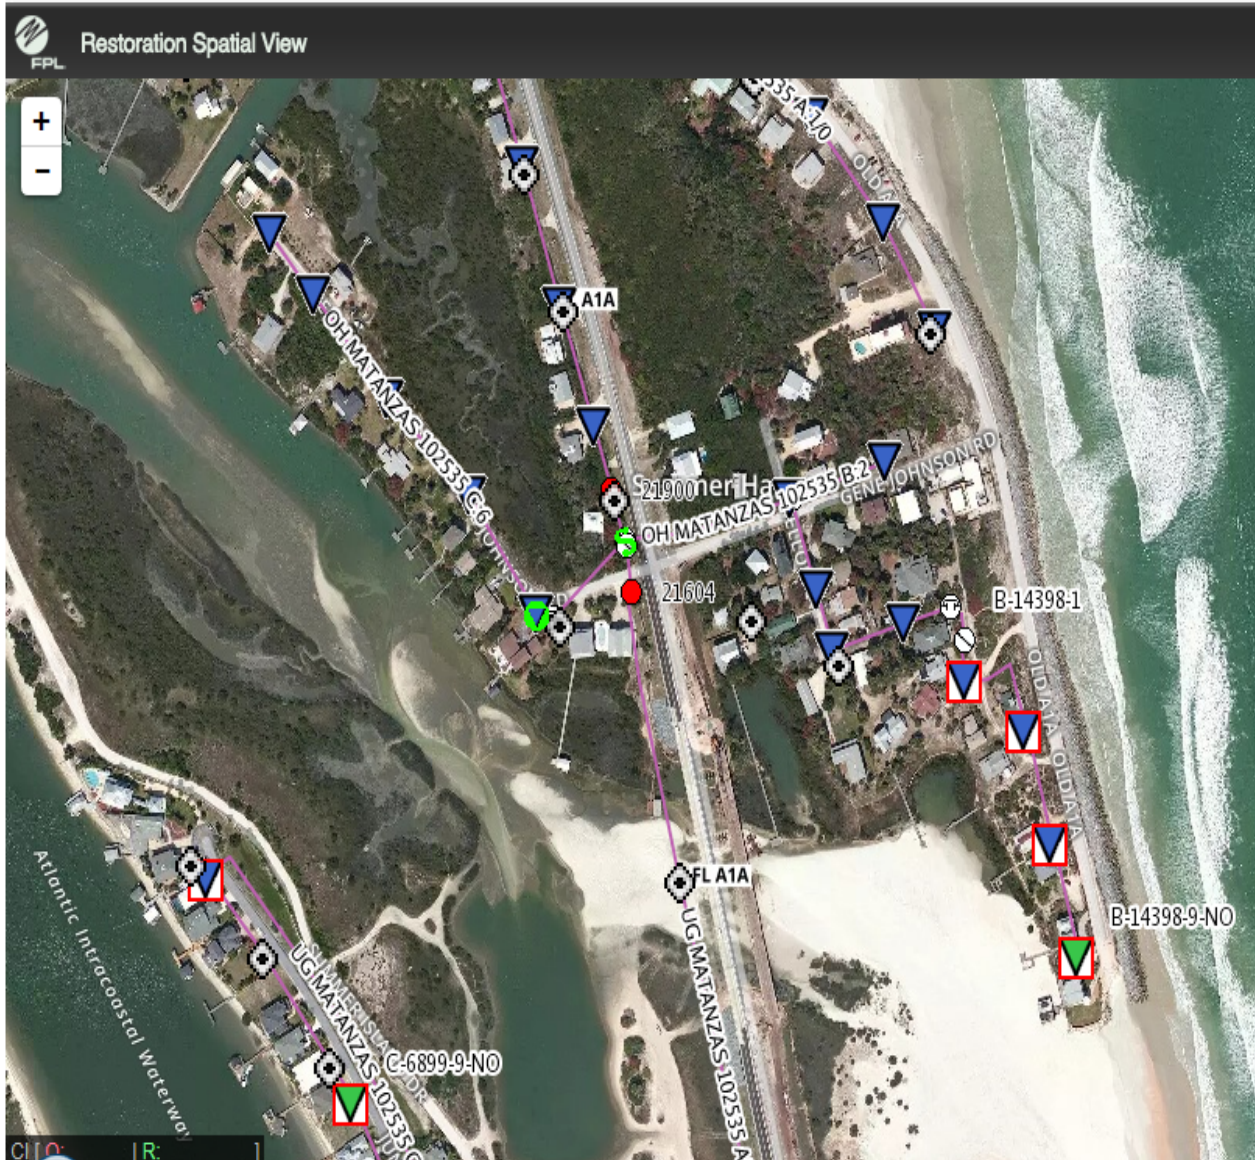
Matanzas Inlet Case Study

Matanzas Inlet is located just south of St. Augustine. The pad mounted equipment experienced severe effects of waves and scouring which resulted in the catastrophic failures of the equipment shown below. This type of failure can lead to extended restoration times.

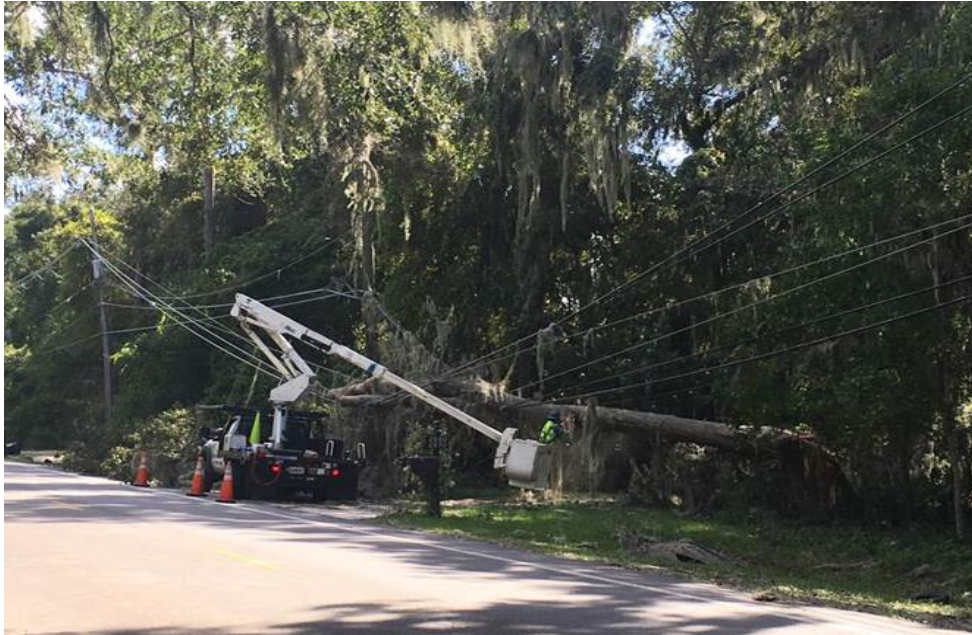
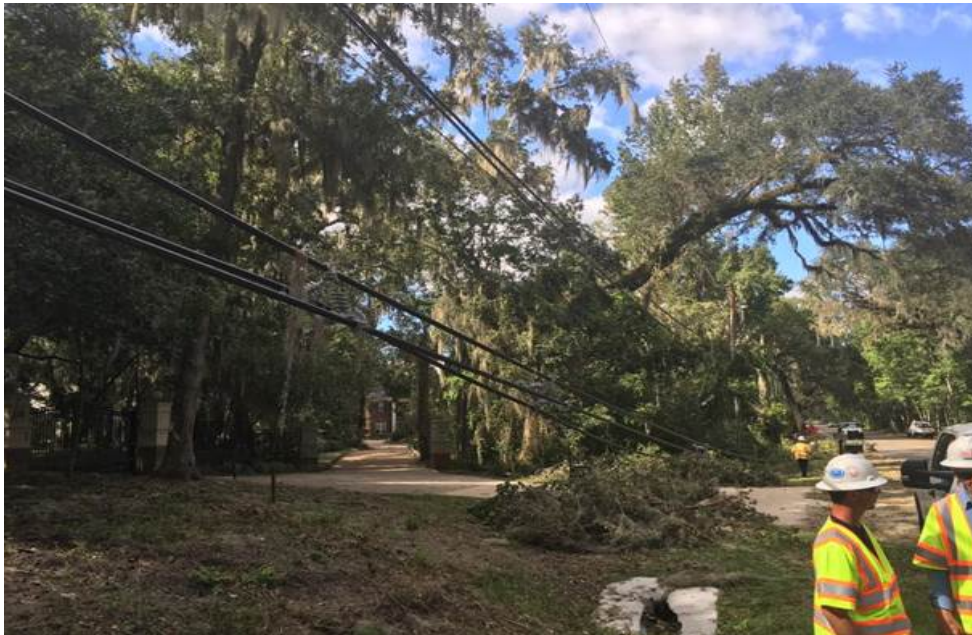
Riverton Feeder Case Study

Riverton 5761 experienced heavy winds and related tree damage. There were 4 areas each with multiple spans of Hendrix cable down or broken, 4 damaged/down poles (veg related), 20+ locations of vegetation and ~5 locations of broken Hendrix brackets/spacers. 12 line crews were engaged (around 50 line personnel from three different companies) and a sufficient amount of vegetation crews. This case is on SR 13 - scenic road along the St. John's River
