DOCUMENTS: Panel deposition of Jeffrey Swartz, Anthony Salvarezza and C. Wayne Toms, August 30, 2019.

CONFIDENTIAL**Bartow 4S Root Cause Analysis – Evaluation of Contributing Factors**

Duke and Mitsubishi Hitachi Power Systems (MHPS) have worked both independently and together over the past 12 months to determine what has caused the Bartow Unit 4S L-0 blades to crack and break during operation. During a presentation given at Bartow Station on 15 March 2017, MHPS suggested the sole root cause for Period 3 (Dec 2014-Mar 2016) was “operation in the avoidance zone”. While Duke Engineering would agree that operation in the “avoidance zone” is certainly a *contributing factor* to the shroud chipping experienced in Period 3, it is not the only driving mechanism that should be considered when trying to determine root cause for the Period 3 Bartow Unit 4S event, or any of the previous/subsequent events for that matter.

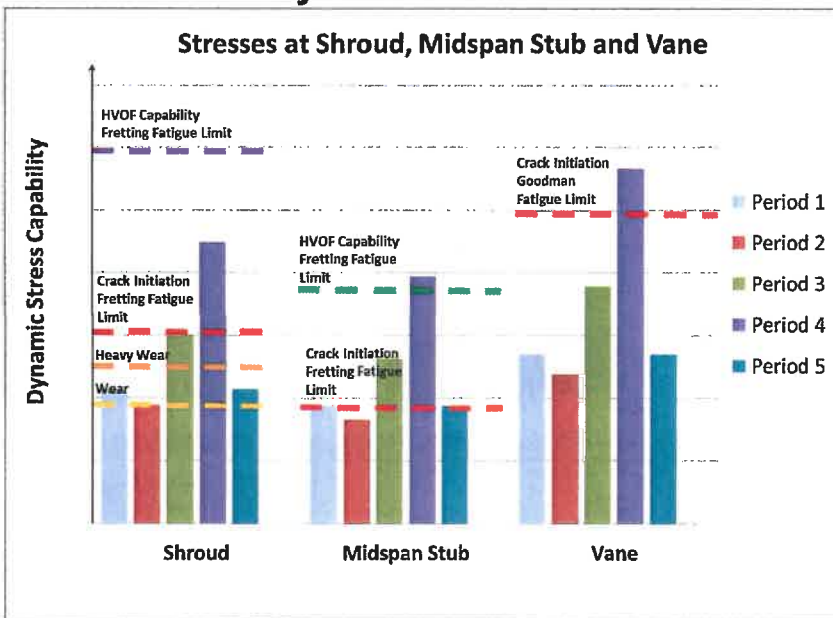
- **Period 1 – Mid Span Stub Cracking**
High LP Loading but increased mechanical damping from Type 1 blade over baseline telemetry test
- **Period 2 – No Major Damage**
Reduced LP Loading over Period 1, reduced bypass operation loading over period 5, light wear observed on shroud
- **Period 3 – Shroud Cracking**
High LP Loading identified in Telemetry Test. Mid Span Stub protected by HVOF
- **Period 4 – Vane Cracking**
Reduced Loading. Application of HVOF reduces mechanical damping increasing amplitude of response. With HVOF protecting Shroud and Stub, the limiting location becomes the Vane
- **Period 5 – Mid Span Stub Cracking**
Reduced Loading with longer periods of bypass operation at High Mach Number over Period 2. No HVOF Protection

▪ Damage observed in all 5 Periods of operation is consistent Blade Response vs Capability Model

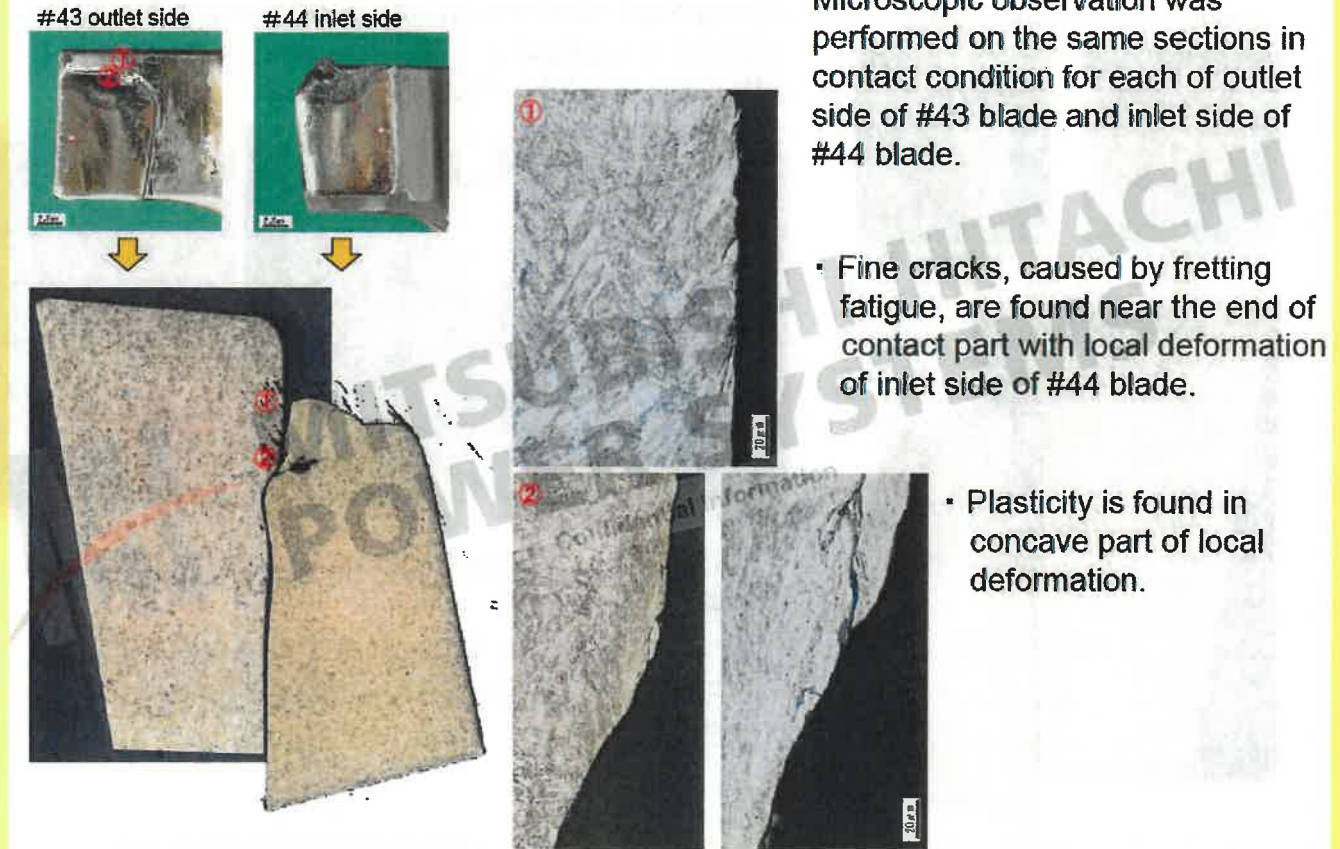
Fretting fatigue identified as crack initiation source.

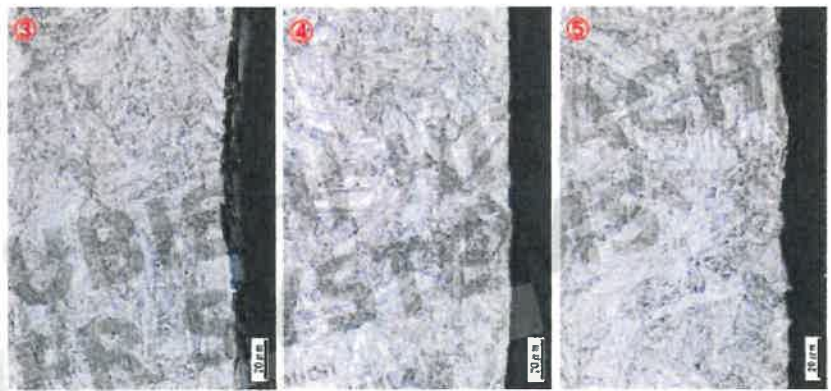
- ③: Oxide scale was found on black surface of local deformation area.
- ④: Dark brown surface of worn and thinned part is free of oxide scale and smoother than non-contact surface of ⑤.

Oxide scale with local deformation observed on black surface

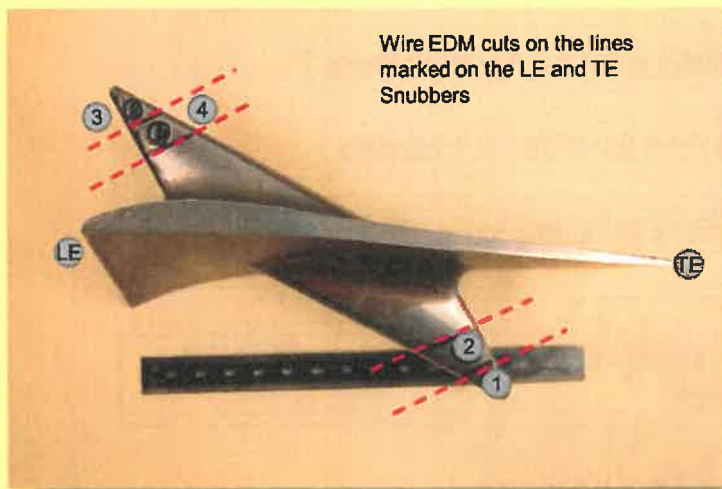
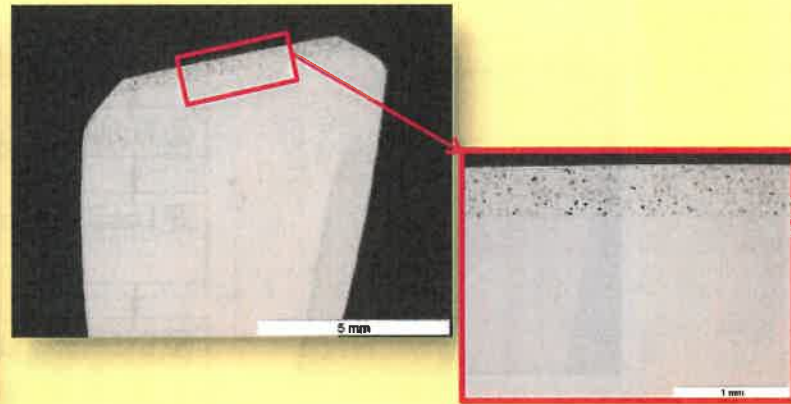
- The contact surface coating did not show any cracks, deformation or wear.
- Uniform thickness was measured on the areas of contact between the LE and TE snubbers.

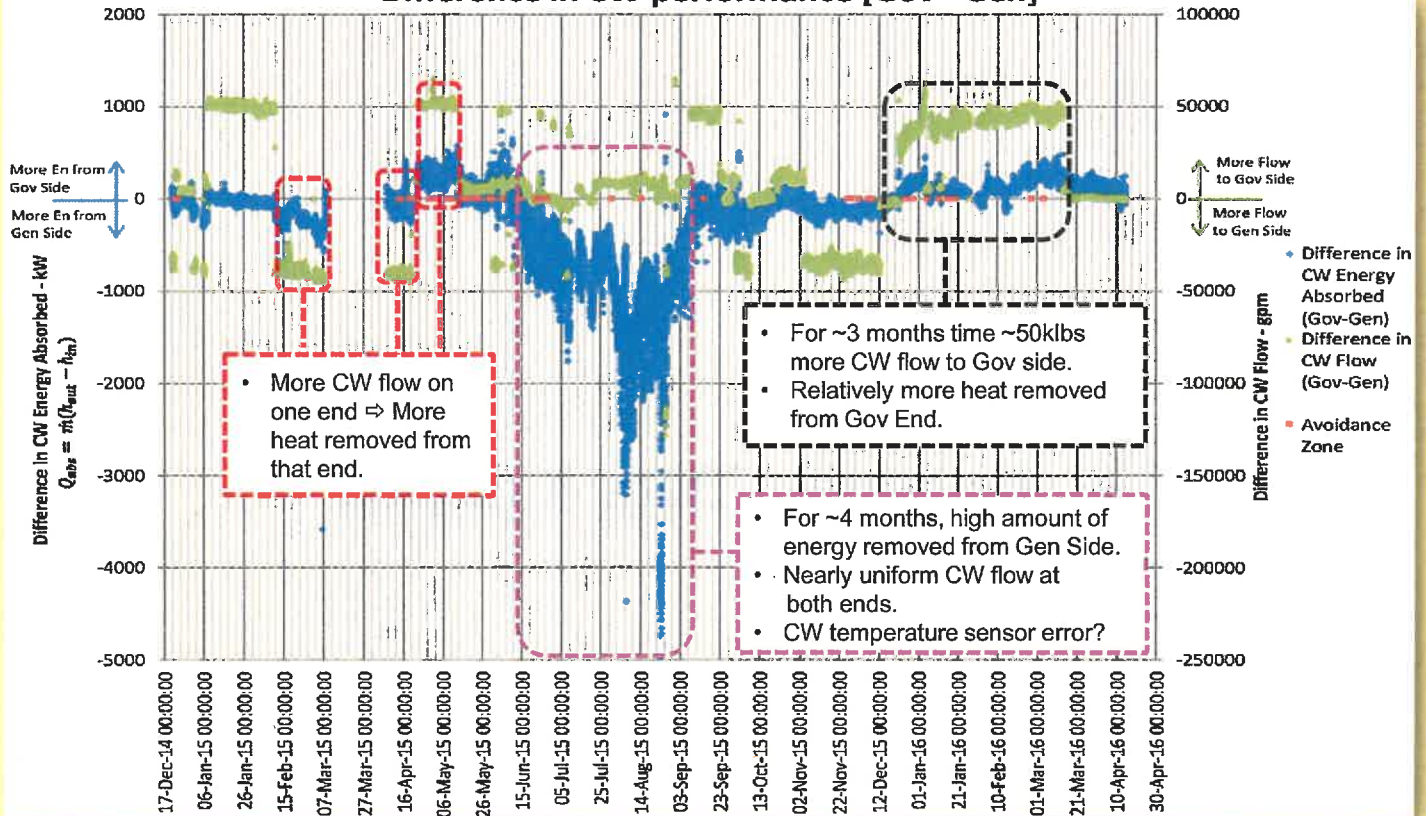
Asymmetric circulating water flow may explain difference in water erosion observed
 Not enough data to draw any conclusion on blade shroud damage

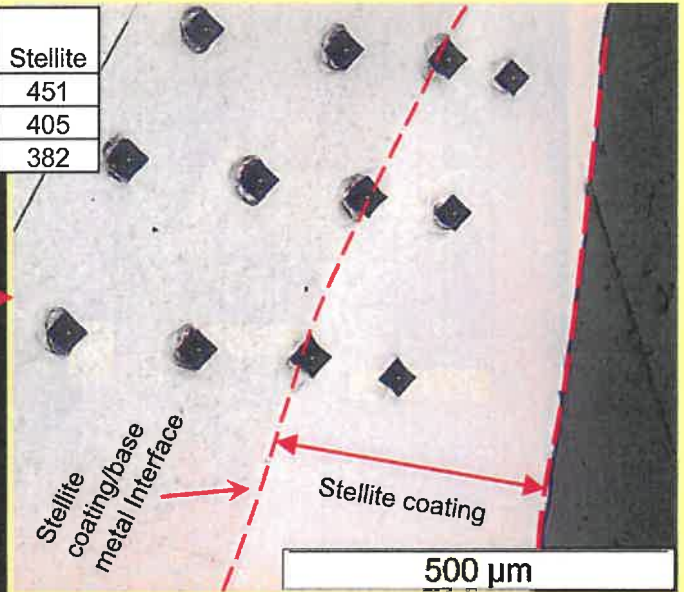
- No significant hardness variation was observed within the base metal as a result of stellite welding.

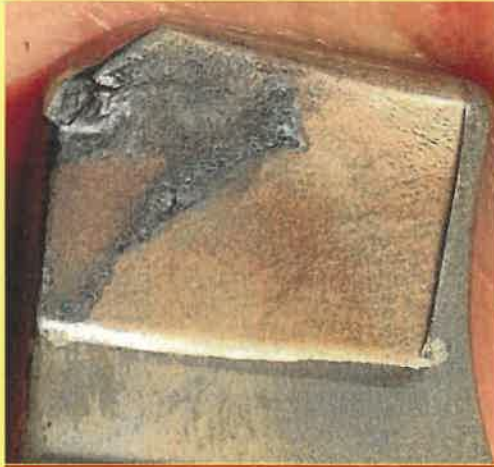
Figure XX. There was a varying degree of wear seen on the Period 5 Z-notches, however, the wear is higher than what one would expect given the relatively low operating hours.

Figure XX: Photo of Z-notch from Period 5 showing wear of contact surface

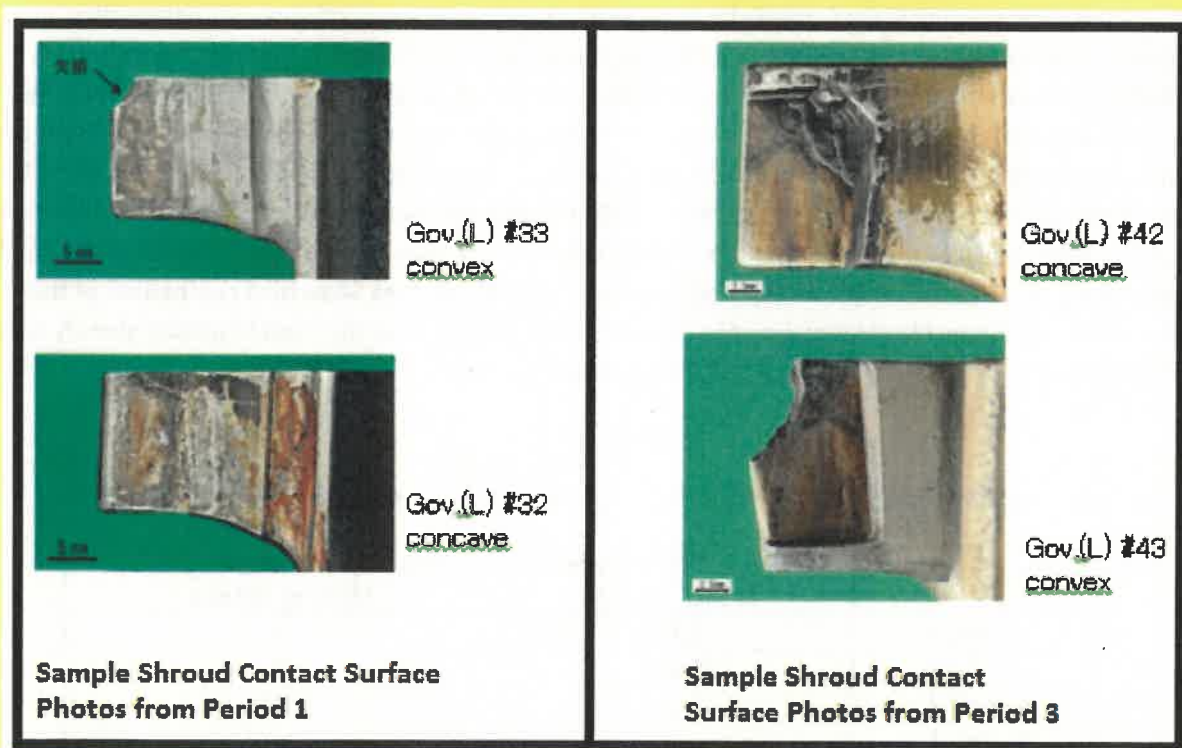
Figure 1 -- Comparative Photos of Shroud Contact Surface Wear for Periods 1 and 3

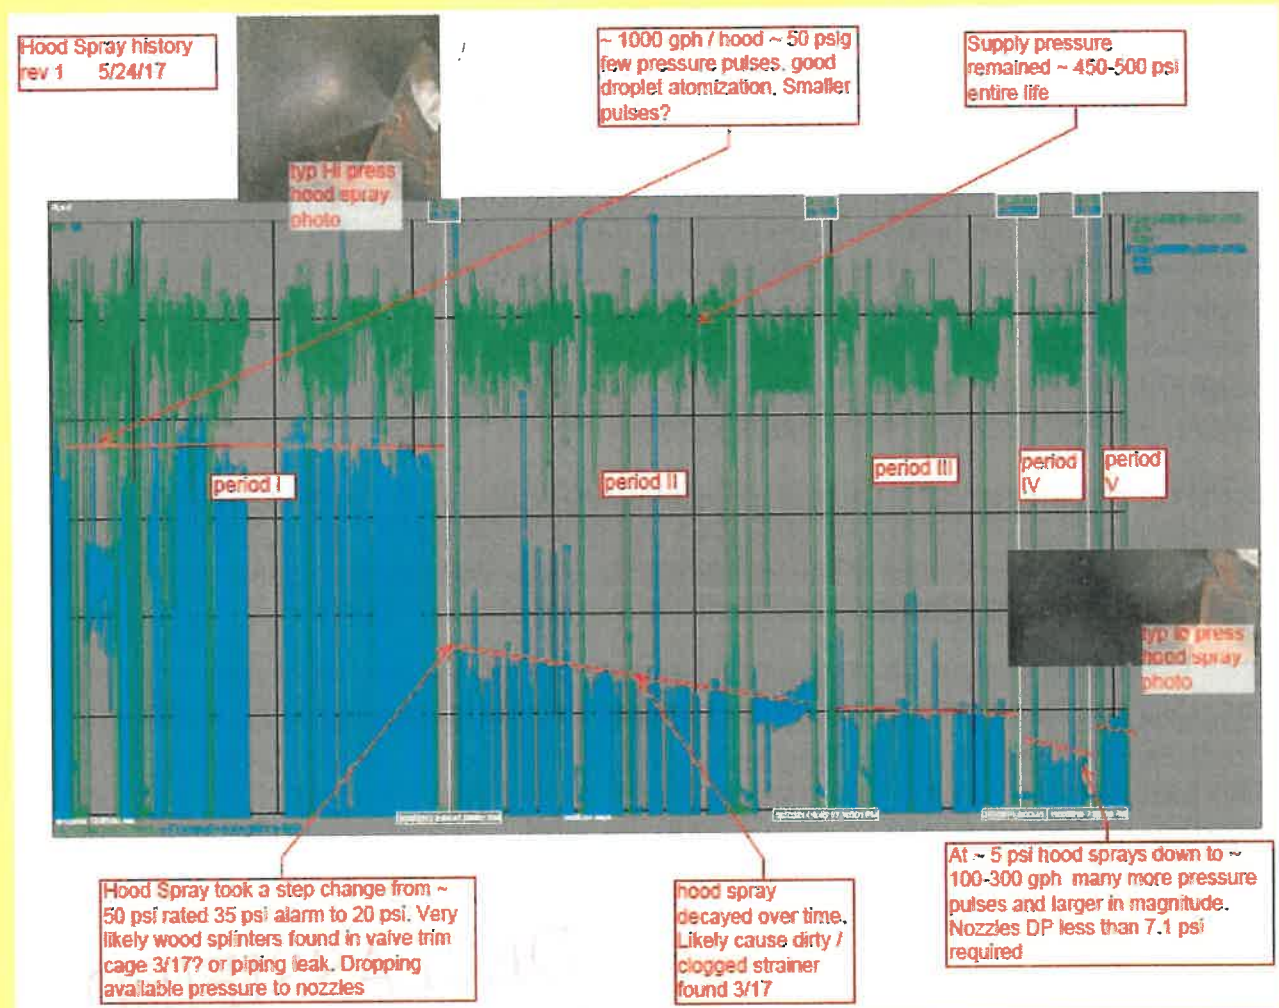
The chart below demonstrates what happened to hood spray pressure over time. The decay in water pressure at the hood spray nozzles will yield reduced atomization as these style of nozzle rely on pressure drop to create a vortex inside the nozzle that causes atomization thru centripetal force. The effect of reduced atomization was verified during a test just prior to unit restart in April 2017. A key concern of poor atomization is the effect it might have on generating dynamic pressures which the L-0 blades might see as large water droplets evaporate in the exhaust stream.

Figure 2 -- Hood Spray Pressure Degradation Over Periods 1-5

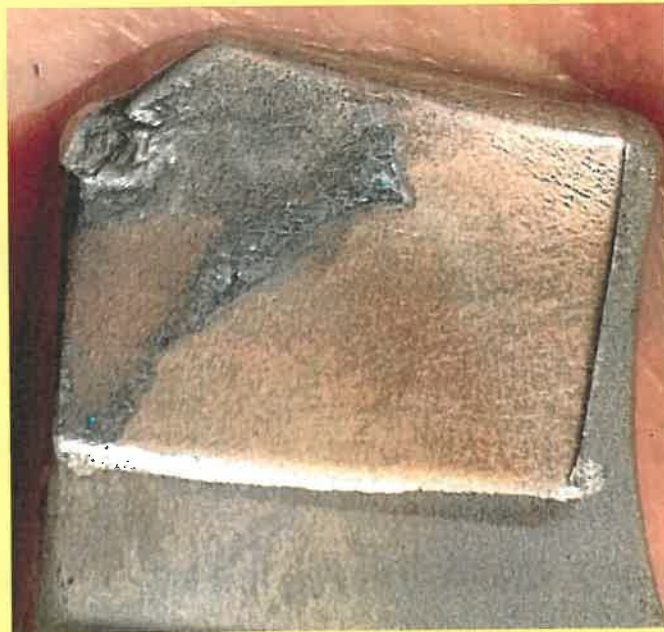
Figure 4 -- Photo of an L-0 blade Z-Lock from Period 5 Showing Contact Surface Wear

Period 5 did have its share of higher energy blends as detected by the blend energy method. However, in terms of operating hours in blend mode, Period 5 is not excessive in terms of percentage time blending. The total of 20 hours of blend time does not appear to justify the wear seen.

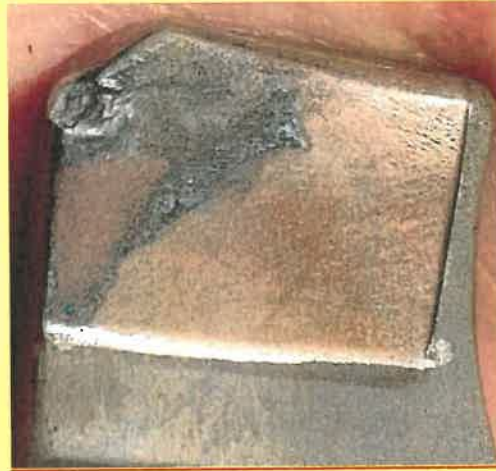
Figure XX. There was a varying degree of wear seen on the Period 5 Z-notches, however, the wear is higher than what one would expect given the relatively low operating hours.

Figure XX: Photo of Z-notch from Period 5 showing wear of contact surface

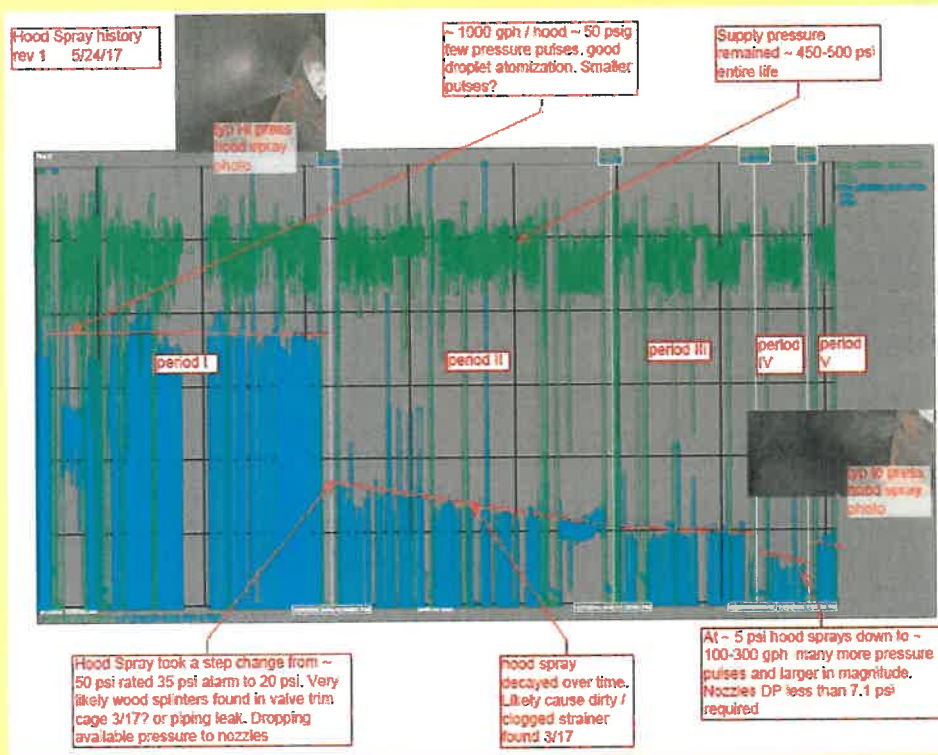
Figure 1 -- Hood Spray Pressure Degradation Over Periods 1-5

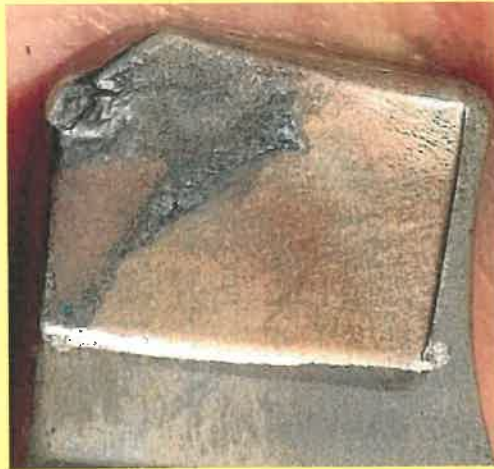
Figure 3 -- Photo of an L-0 blade Z-Lock from Period 5 Showing Contact Surface Wear

Period 5 did have its share of higher energy blends as detected by the blend energy method. However, in terms of operating hours in blend mode, Period 5 is not excessive in terms of percentage time blending. The total of 20 hours of blend time does not appear to justify the wear seen.

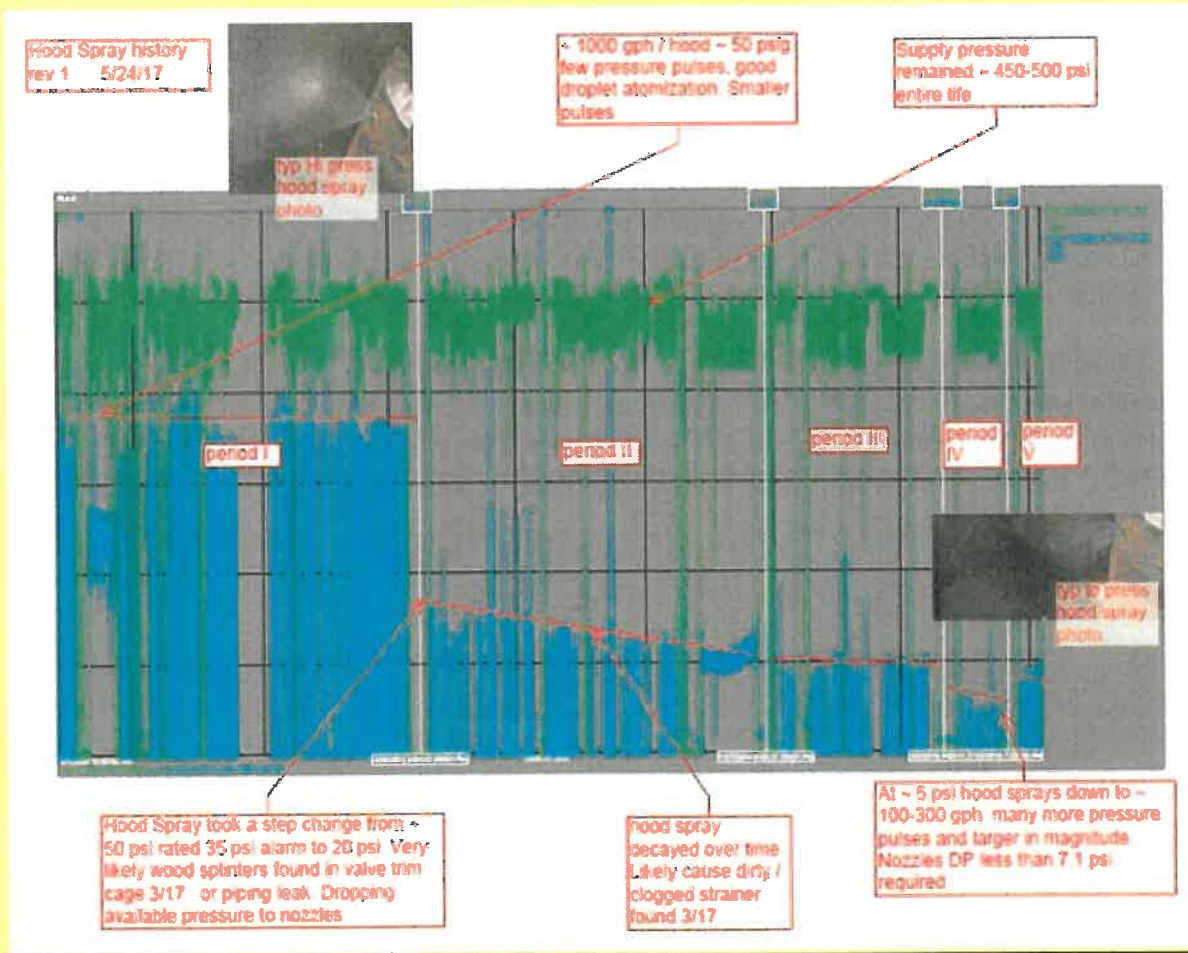
Figure 2 – Hood Spray Pressure Degradation Over Periods 1-5

Control of the hood sprays is automated within the plant-wide control system and not controlled by the operators. After a plant is commissioned, the hood sprays are not normally checked for accuracy and again, until there had been successive failures, there was no reason to focus on the hood spray system's functionality. Although the review that was conducted after the 5th failure revealed lower pressure which may have contributed to some additional wear of the blades, the Duke team does not believe this is the root cause of the failures as the design of the blades should have been robust enough to withstand some increased pressure pulses. Further, MHPS does not believe that any pressure pulses from the hood spray would have been strong enough to harm blades.

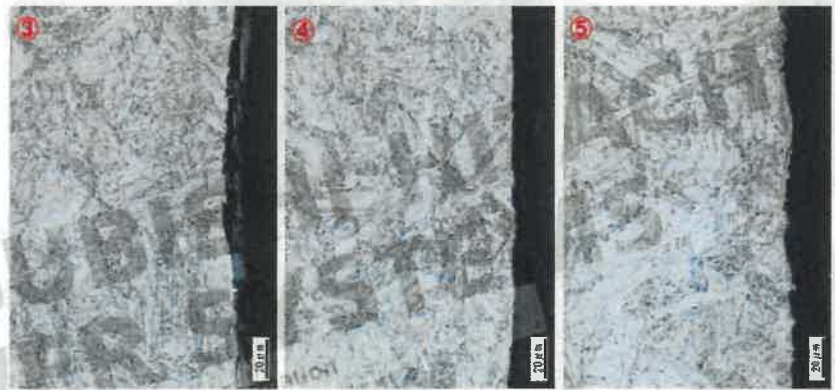
- ③: Oxide scale was found on black surface of local deformation area.
- ④: Dark brown surface of worn and thinned part is free of oxide scale and smoother than non-contact surface of ⑤.

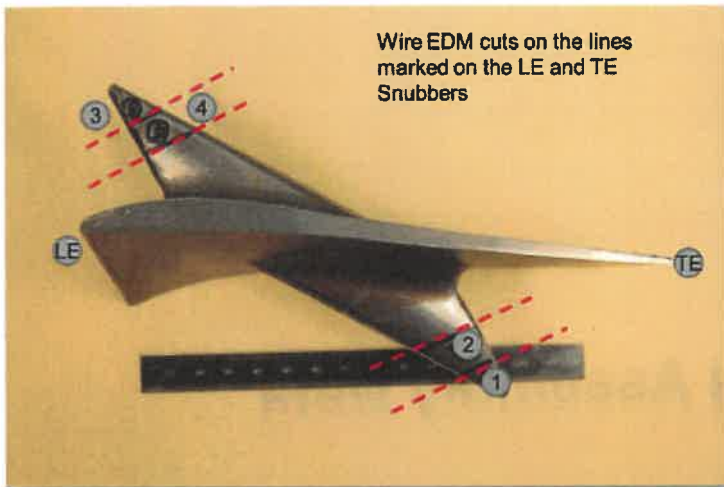
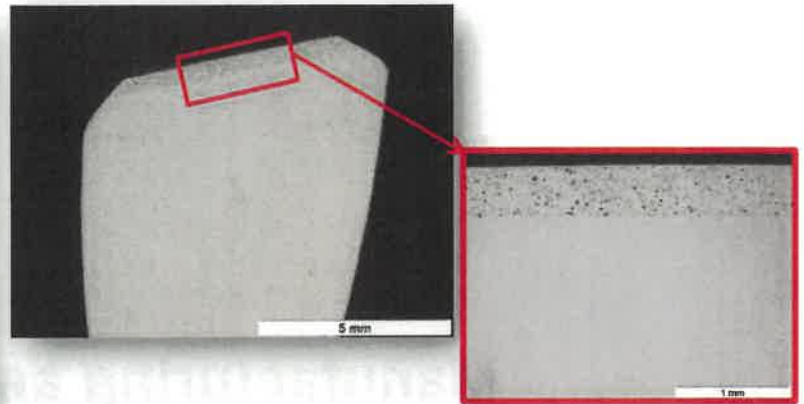
- The contact surface coating did not show any cracks, deformation or wear.
- Uniform thickness was measured on the areas of contact between the LE and TE snubbers.

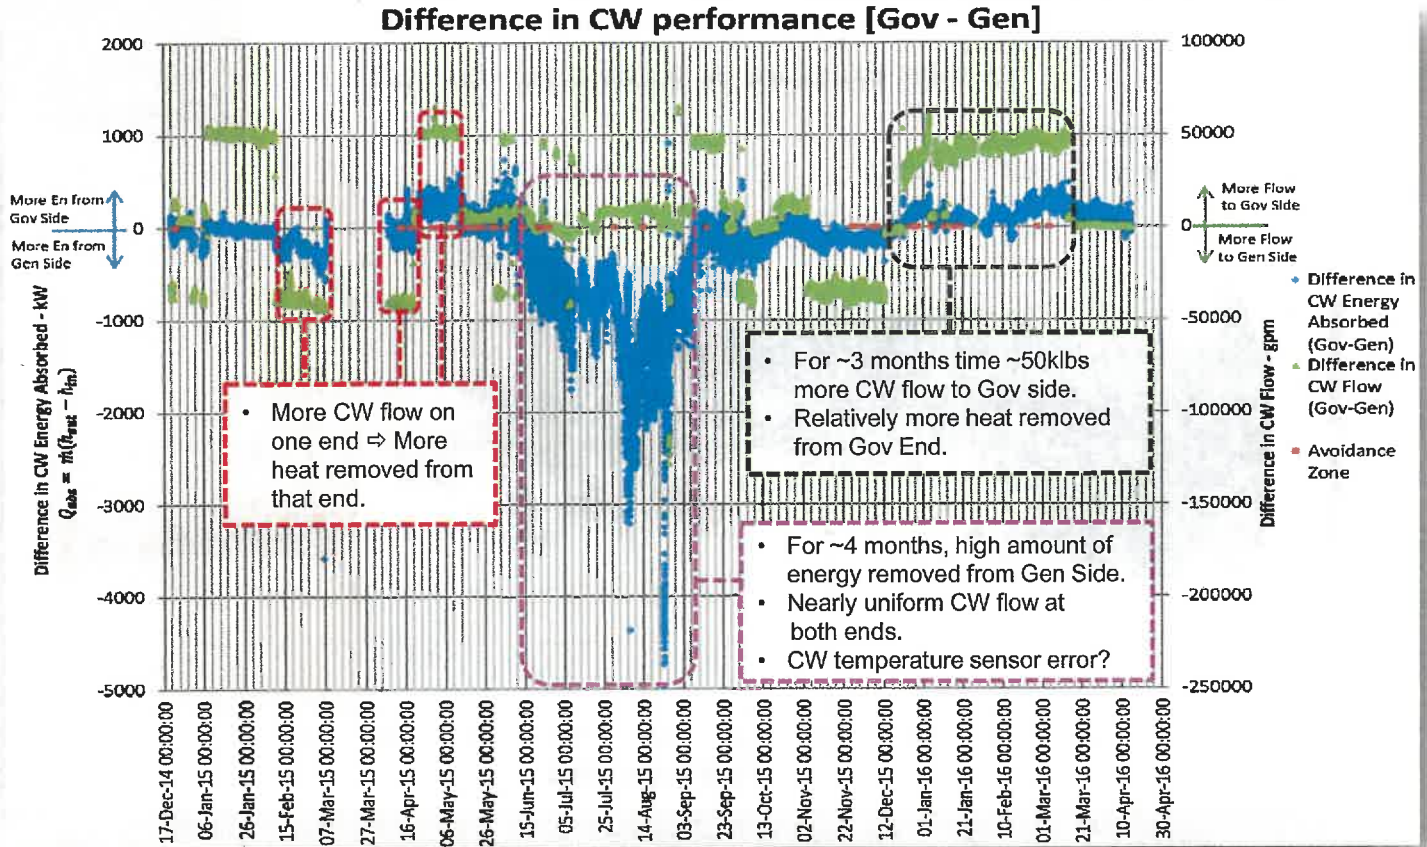
**Asymmetric circulating water flow may explain difference in water erosion observed
Not enough data to draw any conclusion on blade shroud damage**

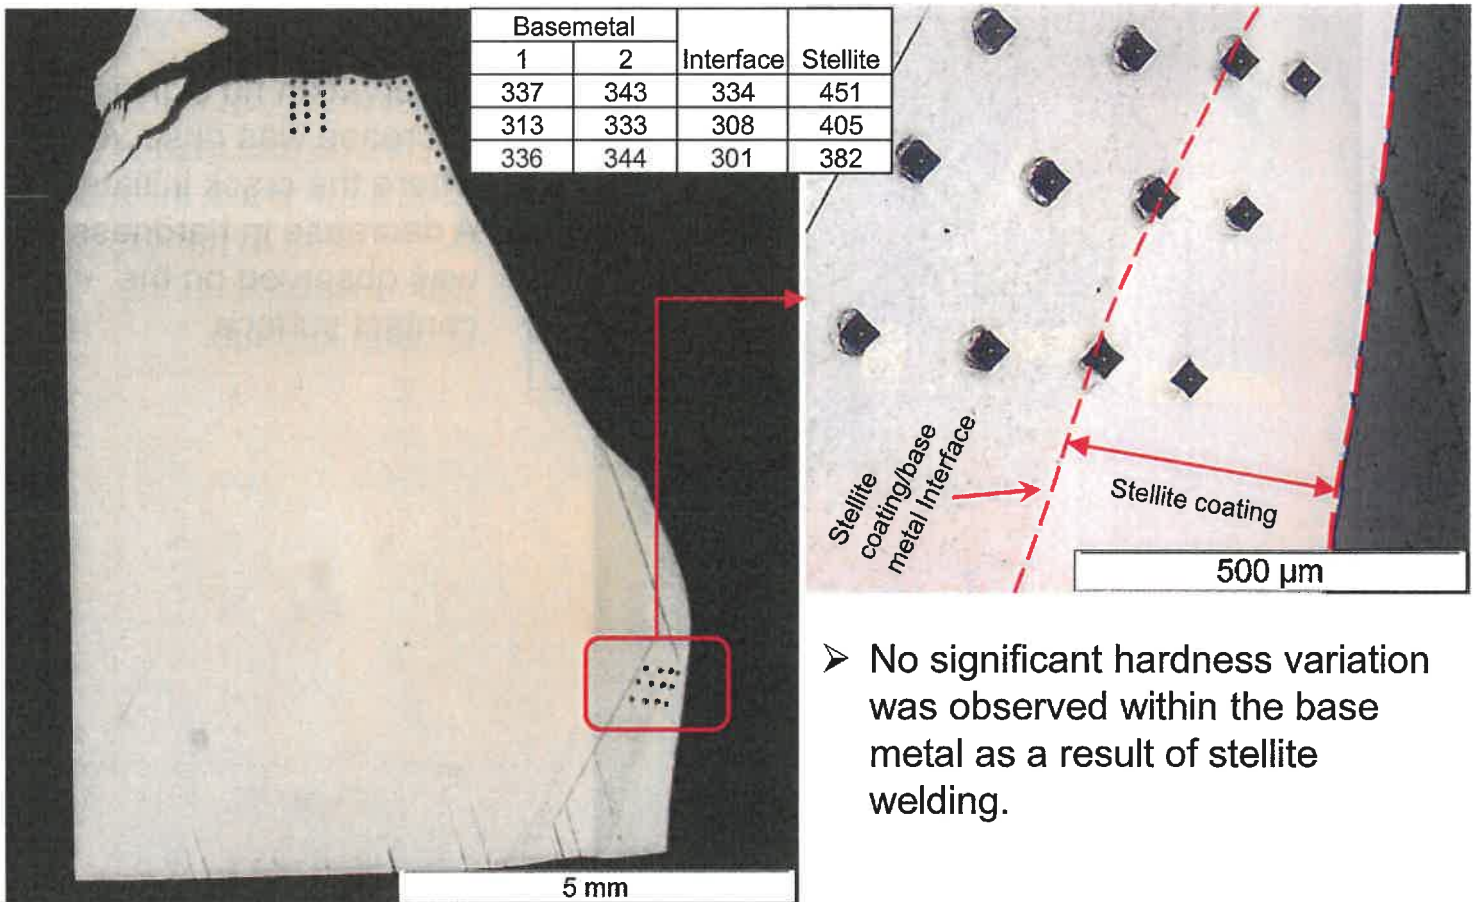
➤ No significant hardness variation was observed within the base metal as a result of stellite welding.
