**MANAGEMENT REVIEW BOARD
ATTACHMENT 1 – COMPLETED ITEM REVIEW
ST. LUCIE NUCLEAR STATION
JUNE 4, 2019**

Unit 1 Main Generator Ground Fault Interim Root Cause Evaluation Report

Event Date: 04/25/2019

CR Number: 02312208

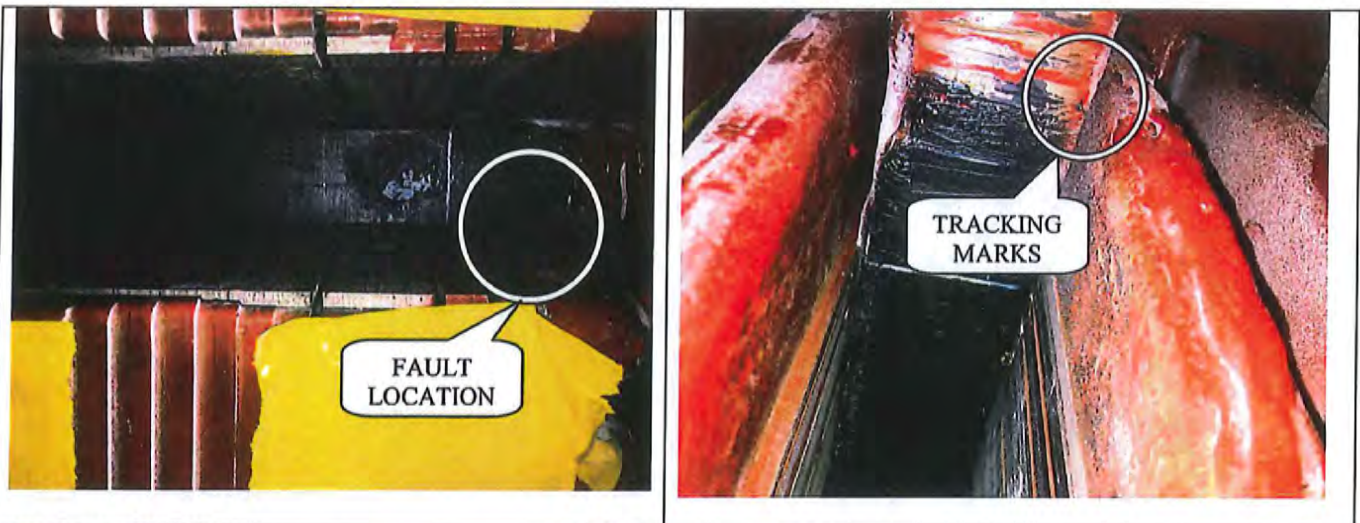
12) Stator Bar T17 was removed allowing in-situ inspection of bar B17 in the slot. At the time of inspection there was no obvious indication of the fault. [O2]

Several pictures taken during the inspection show the area subsequently confirmed to be the location of the fault just outside of the slot in the stator core laminations. Subtle tracking marks are evident from close review as shown below, though they are somewhat obscured by the gradient taping and paint applied at the end winding area.

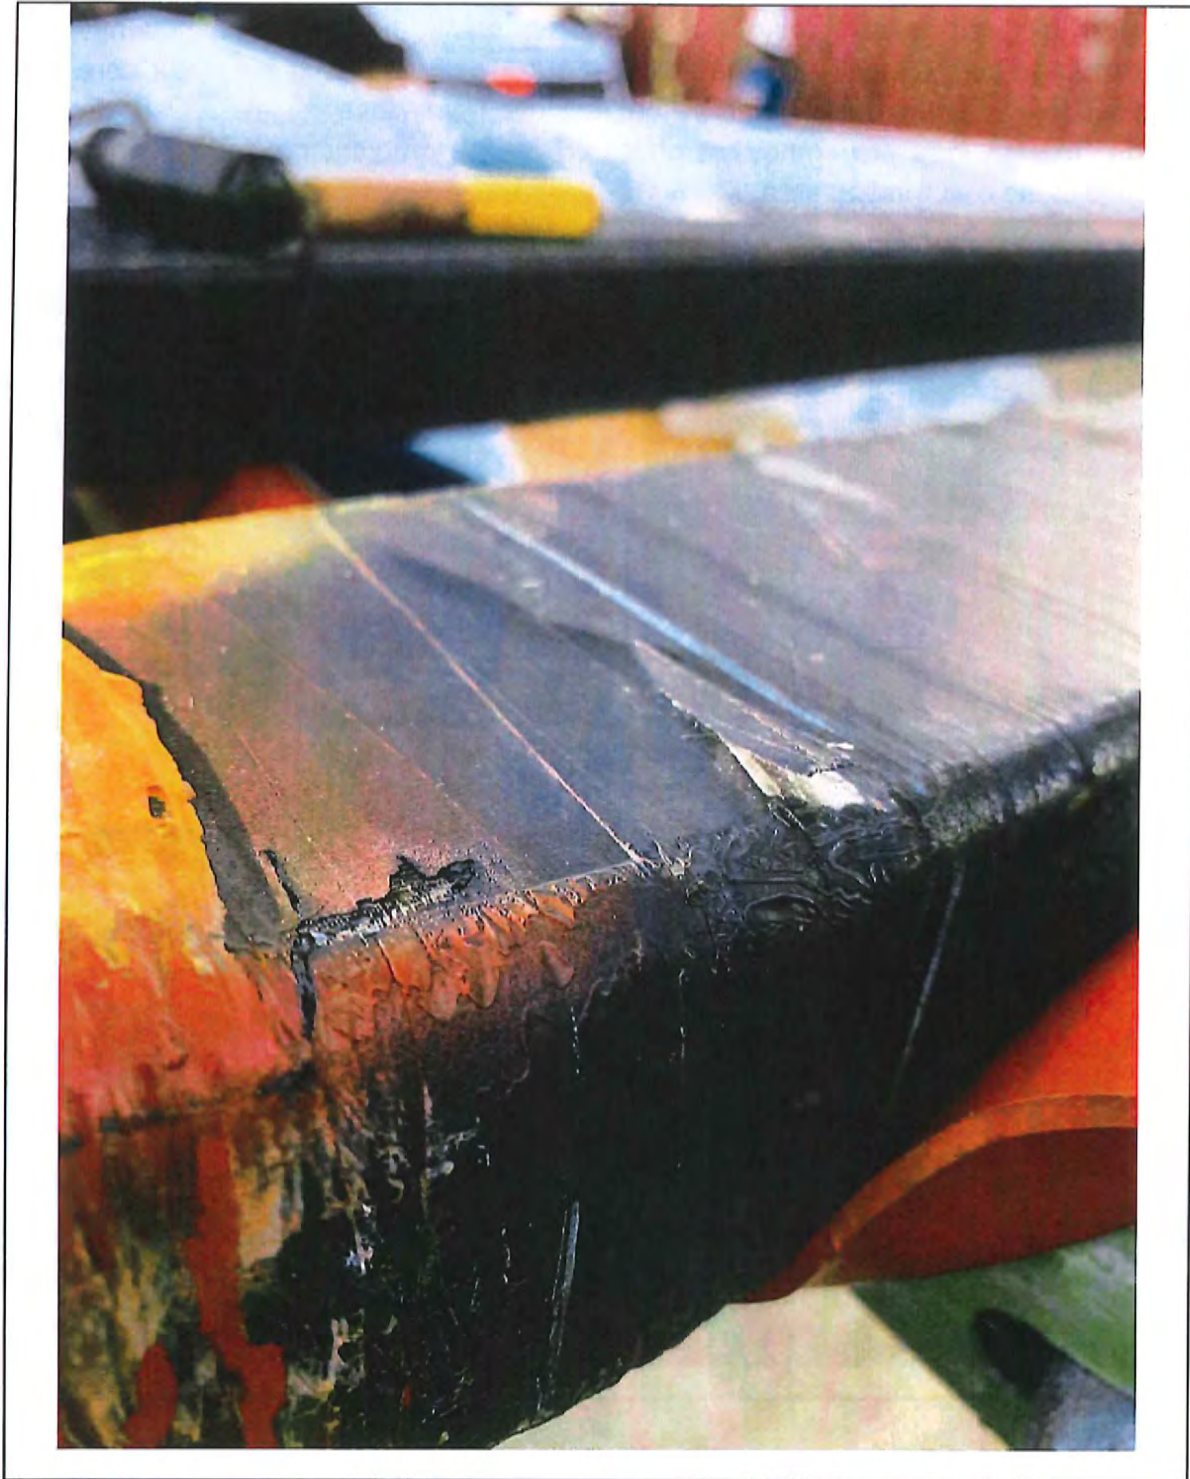
The field testing performed on the Phase C Generator Stator coils demonstrated that the ground fault was located in the bottom stator bar in slot 17 of the stator. The insulation failure resulted in a circuit path to ground from the inner corona protection (ICP) layer of the bar sufficient to operate the generator ground protective relaying. Care was used for removal of this stator bar during disassembly of the stator. Initial visual inspections and field resistance tests confirmed the fault occurred due to an insulation breach located just outside the stator slot on the turbine end. The breach has the appearance of crack in the underlying insulation. The surrounding OCP layer material was degraded and carbon tracking is noted along the adjacent surface areas.

13)After stator bar B17 was carefully removed from the generator the area of the fault was apparent from visual inspection [O3]

Complete rewind of the Unit 1 generator to restore stator winding to serviceable condition.
