Docket No. 20210001-EI

**DUKE ENERGY FLORIDA LLC'S
REQUEST FOR CONFIDENTIAL CLASSIFICATION**

Bartow 4A Generator Major Inspection Sp 19

Stator Winding Report (#112726)

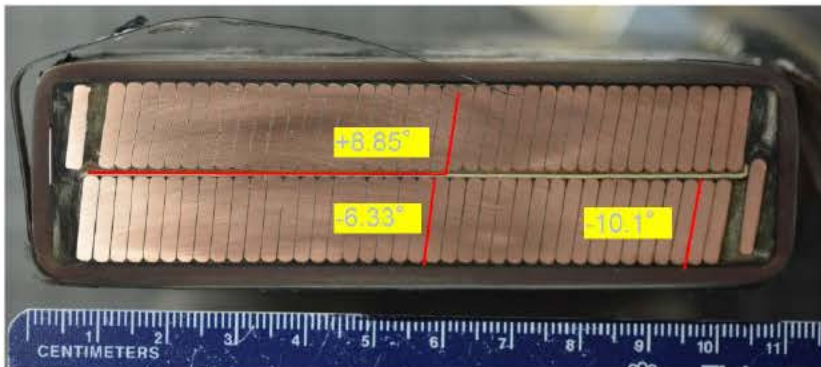
Cross Section Measurements Top Coil # 2

Top Coil 2
Top/Left stack – 8.85°
Bottom/right stack – 6.33
& 10.1°

Note this location is further in the core than CT scan. ~ 265 mm

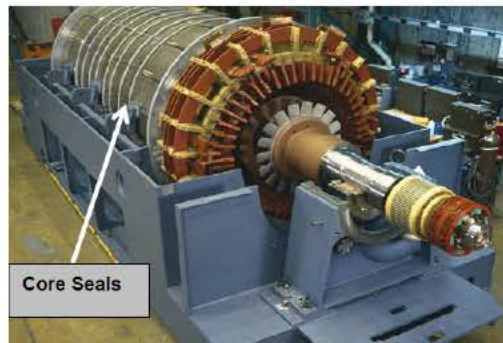
Figures 1 and 2 show the locations of the core seals in relation to the overall generator. The seals are located in 10 places; each seal is 360 degrees around the stator core.

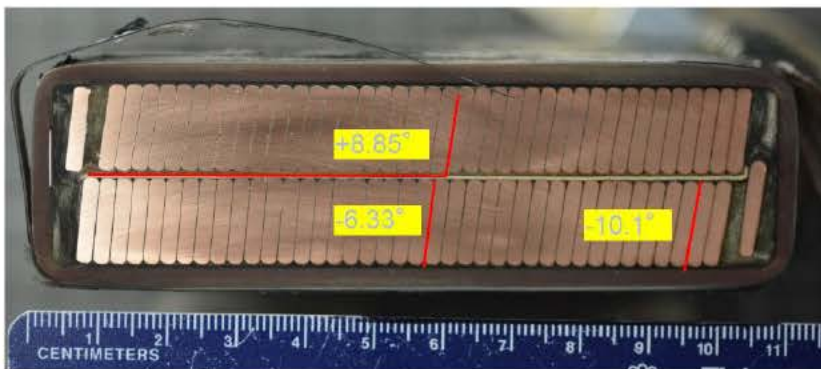
Cross Section Measurements Top Coil # 2

Top Coil 2
Top/Left stack – 8.85°
Bottom/right stack – 6.33
& 10.1°

Note this location is further in the core than CT scan. ~ 265 mm

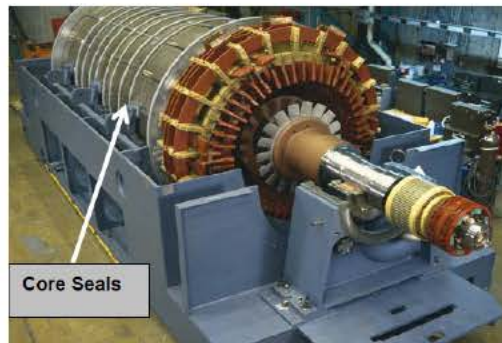
Figures 1 and 2 show the locations of the core seals in relation to the overall generator. The seals are located in 10 places; each seal is 360 degrees around the stator core.
