BEFORE THE FLORIDA PUBLIC SERVICE COMMISSION

In re: Fuel and Purchased Power Cost Recovery
Clause with Generating Performance Incentive
Factor

Docket No. 20220001-EI

**FLORIDA POWER & LIGHT COMPANY'S PROVISIONAL MOTION
FOR EXTENSION OF TIME TO FILE REBUTTAL TESTIMONY ADDRESSING
CERTAIN PORTIONS OF OPC WITNESS RICHARD A. POLICH'S TESTIMONY**

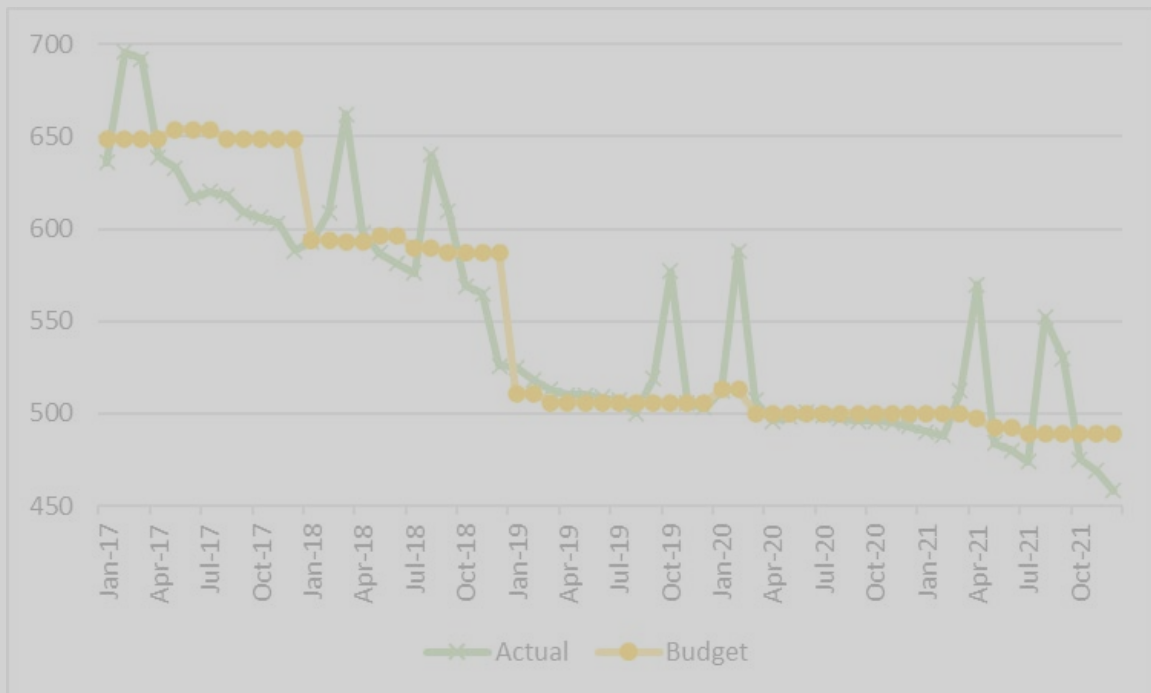
Figure 1- St. Lucie Head Count

1 since 2017 and FPL has dropped the budgeted headcount by 160 people. Considering this
 2 is a two-unit plant, there are currently only an average of 229 people per unit on site or
 3 available to the unit. Figure 1 presents a graph of the monthly changes in St. Lucie' actual
 4 and budgeted headcount since 2017.

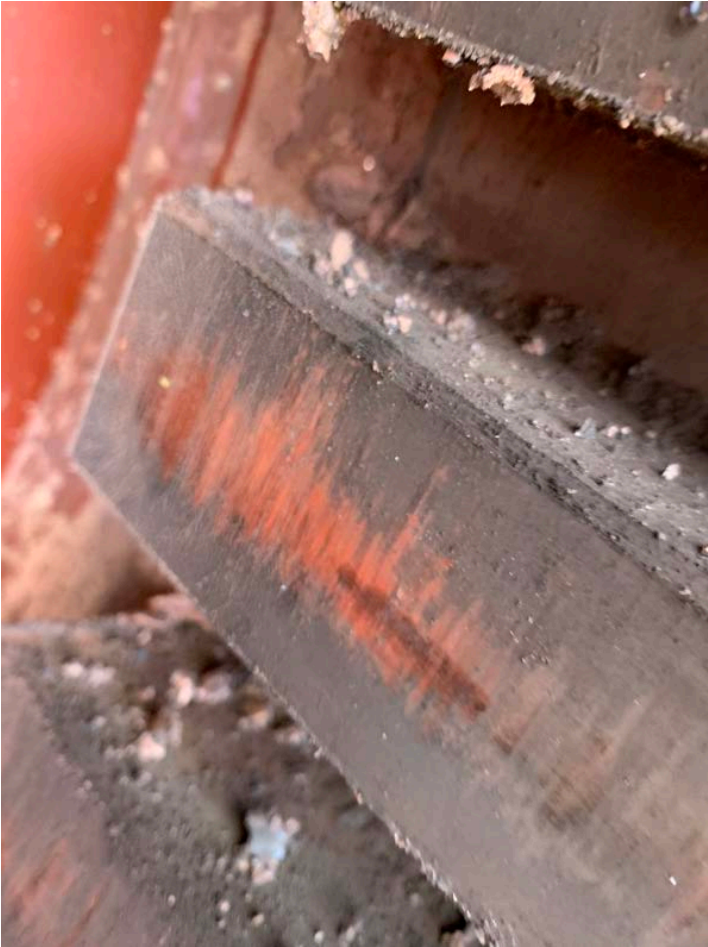
Fig. 9 PMG Magnet Rub
