BEFORE THE FLORIDA PUBLIC SERVICE COMMISSION

In re: Fuel and Purchased Power Cost Recovery
Clause with Generating Performance Incentive
Factor

Docket No. 20220001-EI

**FLORIDA POWER & LIGHT COMPANY'S
MOTION TO STRIKE PORTIONS OF TESTIMONY OF
OFFICE OF PUBLIC COUNSEL WITNESS RICHARD POLICH**

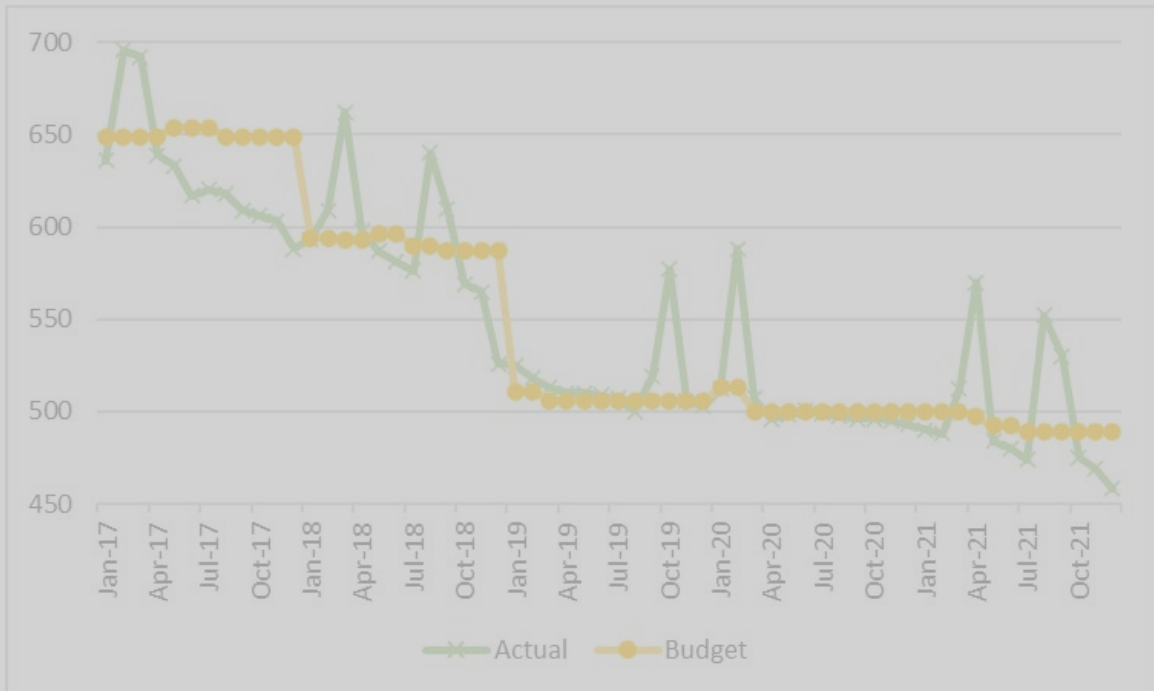
Figure 1- St. Lucie Head Count

7 **A.** In January 2017, the St. Lucie station's (encompassing Units 1 & 2) actual head count for
8 that month was 636, and its budgeted head count was 649. Based on data provided by FPL
9 in response to OPC's Interrogatory Nos. 39 and 40, Attachment 1 (Exhibit No. ____ (RAP
10 7)), St. Lucie's head count had fallen to 458 by the end of 2021 and the budgeted head
11 count had fallen to 489. This represents a 28.9% reduction in actual head count and a 24.7%
12 reduction in budgeted head count. St. Lucie has experienced a reduction of 178 people

1 since 2017 and FPL has dropped the budgeted headcount by 160 people. Considering this
 2 is a two-unit plant, there are currently only an average of 229 people per unit on site or
 3 available to the unit. Figure 1 presents a graph of the monthly changes in St. Lucie' actual
 4 and budgeted headcount since 2017.

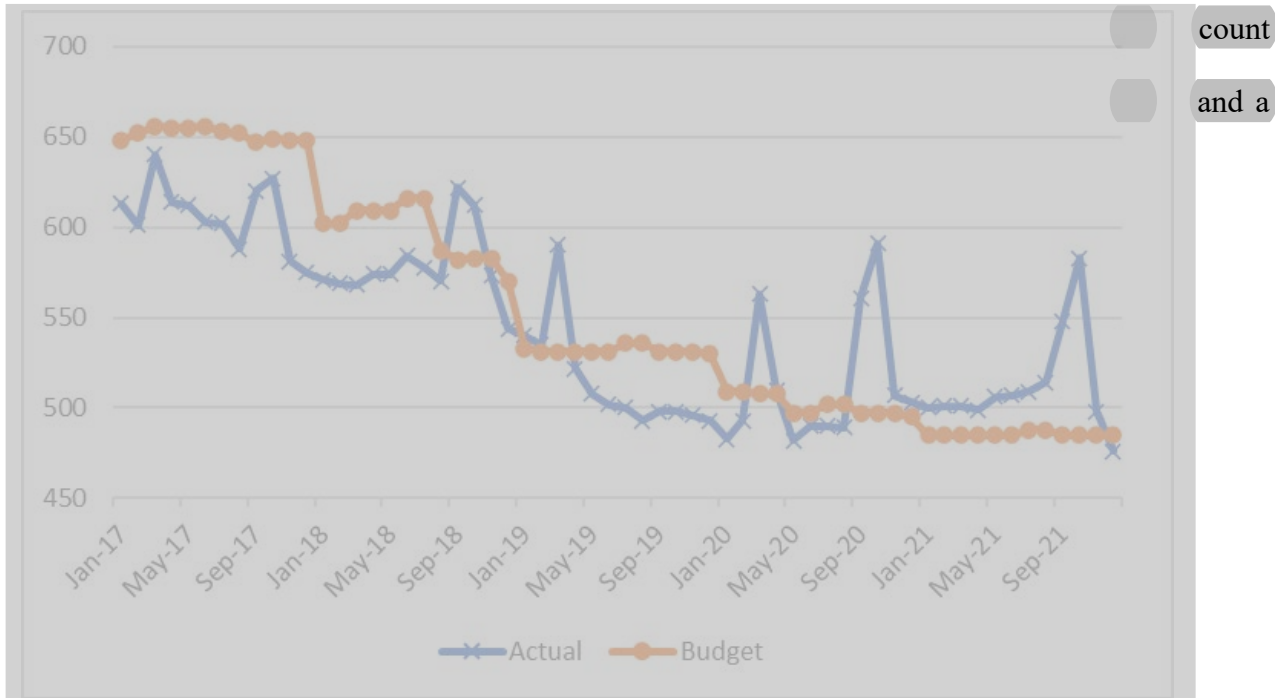
Figure 2- Turkey Point Head Count

7 **A.** In January 2017, the Turkey Point nuclear plant (encompassing both Units (3 &4), actual
 8 head count for that month was 613, and its budgeted head count was 644. Based on data
 9 provided by FPL in response to OPC's Interrogatory Nos. 37 and 38, Attachment 1 (Exhibit
 10 No. ___(RAP 7)), Turkey Point's head count had fallen to 476 by the end of 2021 and the
 11 budgeted head count had fallen to 485. This represents a 22.3% reduction in actual head

14 25.2% reduction in budgeted head count. Turkey Point has experienced a reduction of 137
 15 people since January 2017 and FPL has dropped the budgeted headcount by 163 people.

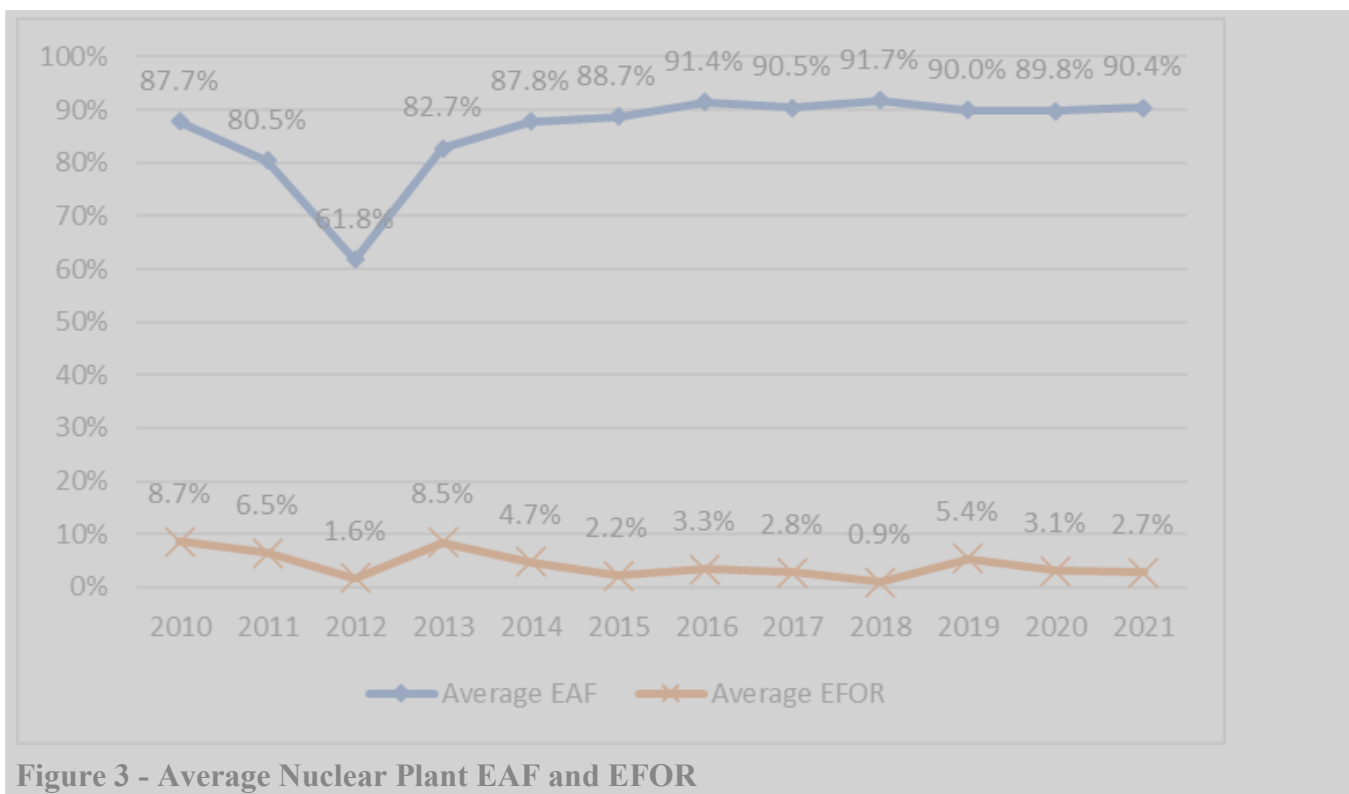
Figure 3 - Average Nuclear Plant EAF and EFOR

2 **A.** In addition to the NRC reports cited earlier, review of St. Lucie and Turkey Point GPIF
3 reports contains some indication that in recent years, plant performance has degraded.
4 Exhibit No. ___ (RAP-10), provides the five performance indicators discussed earlier, for
5 St. Lucie and Turkey Point for the 11-year period of 2010 – 2021. The data shows that
6 between 2010 and 2016, overall on average plant EAF and EFOR indicated some
7 improvement. Figure 3 provides a graph of the average EAF and EFOR for all four of
8 FPL’s nuclear units. The data shows that starting in 2016, average EAF and EFOR

9 improved significantly, peaking in 2018. Since 2018, average EAF and EFOR have
10 declined. This degradation generally corresponds with FPL’s headcount reduction shown
11 in Figures 1 and 2, assuming some lagging effect as the reductions were implemented. The
12 data in Exhibit No. ___ (RAP-10) shows that Turkey Point Unit 3 EAF and EFOR for 2020

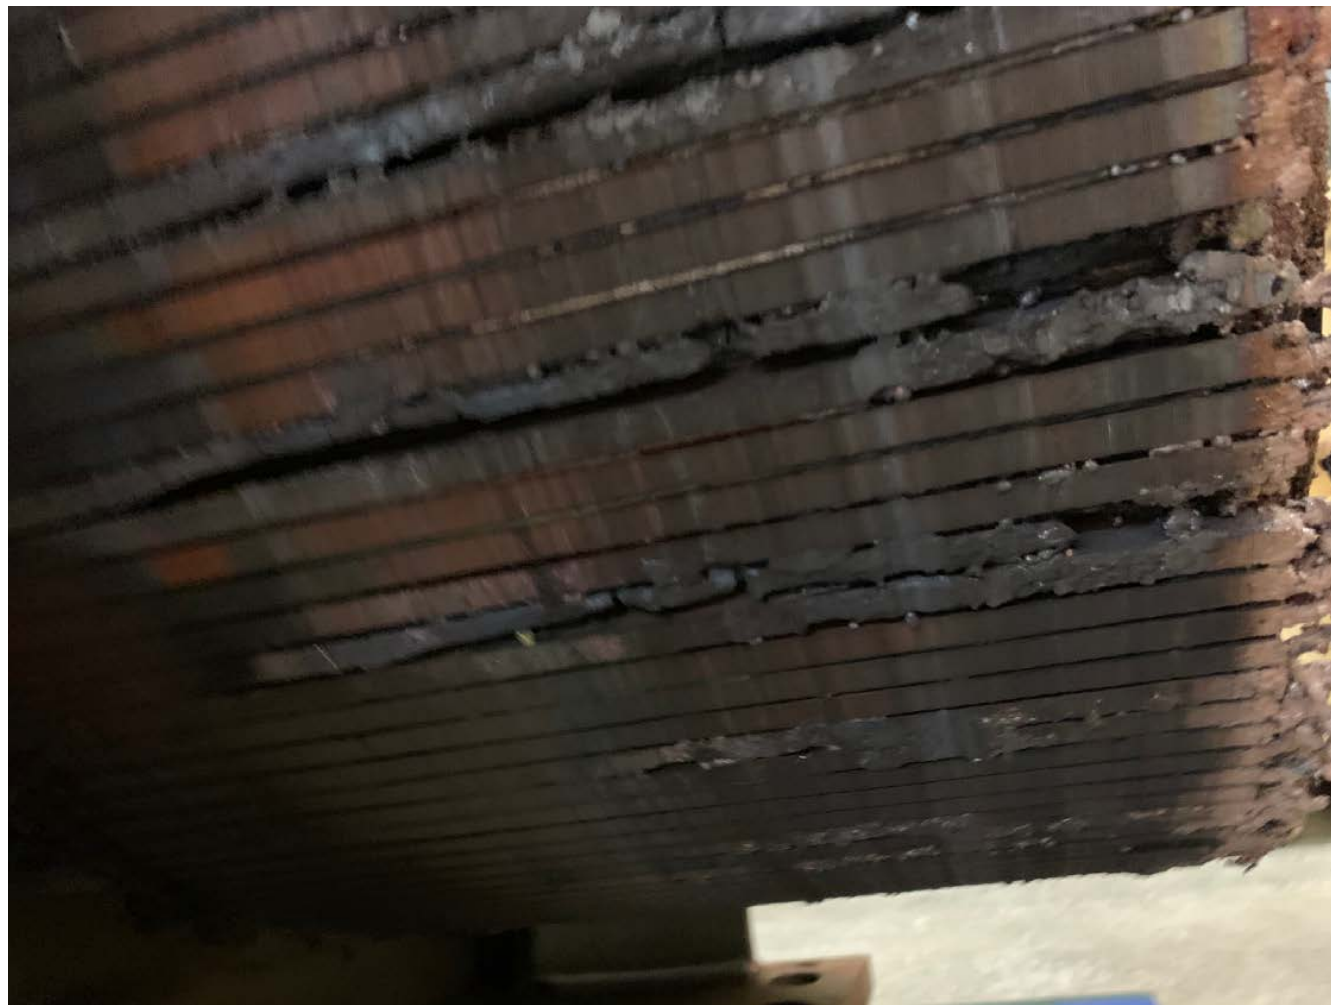
Fig. 6 PMG Stator Core – Coil Melt in Slots

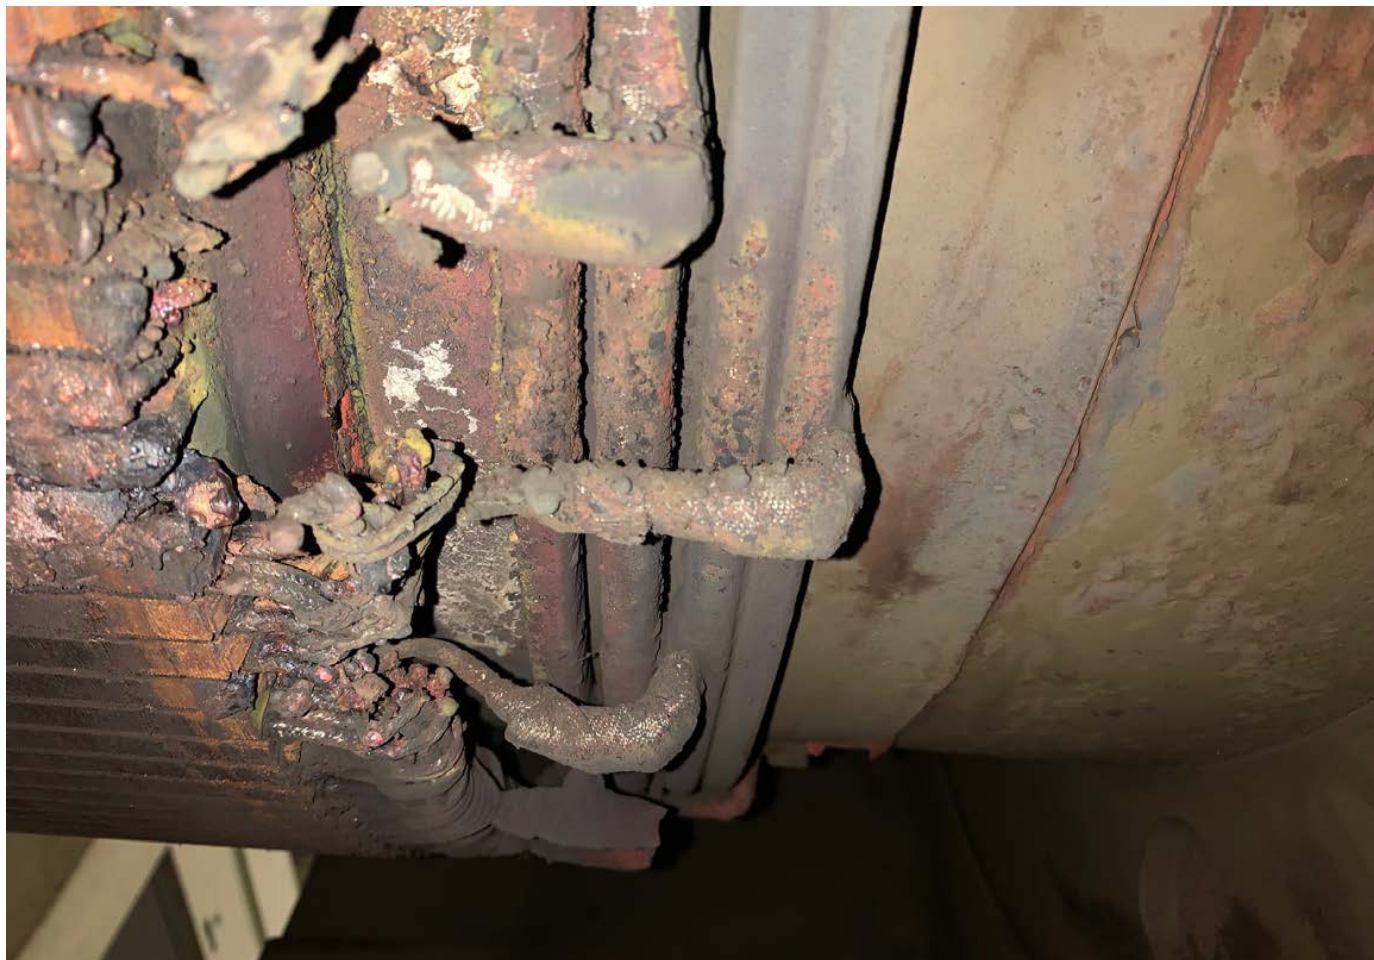
Fig. 7 PMG Stator Coil Connection Ring Failures

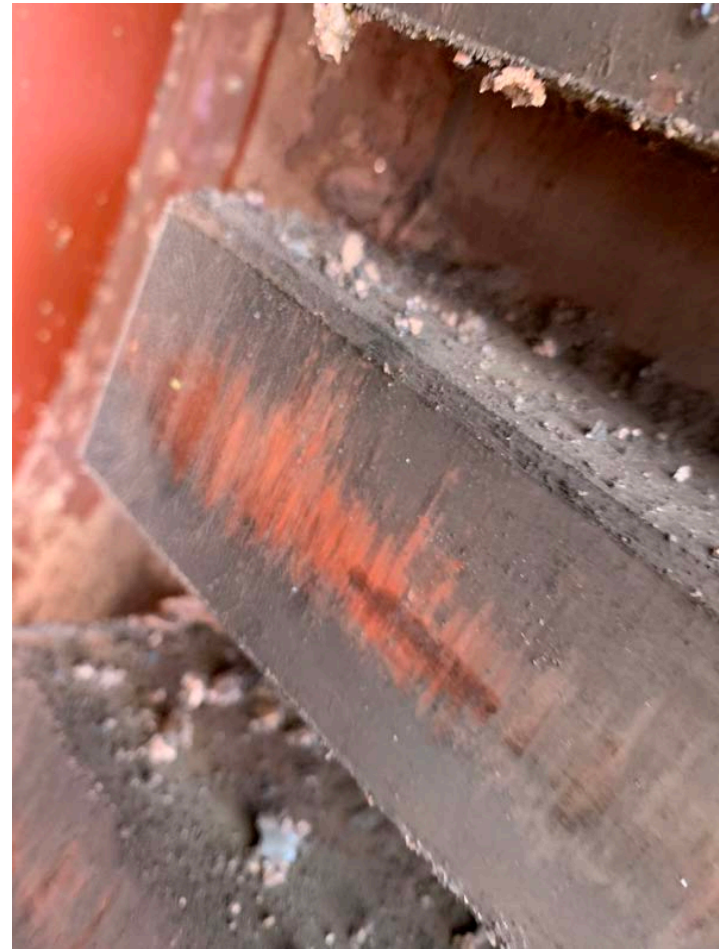
Fig. 9 PMG Magnet Rub

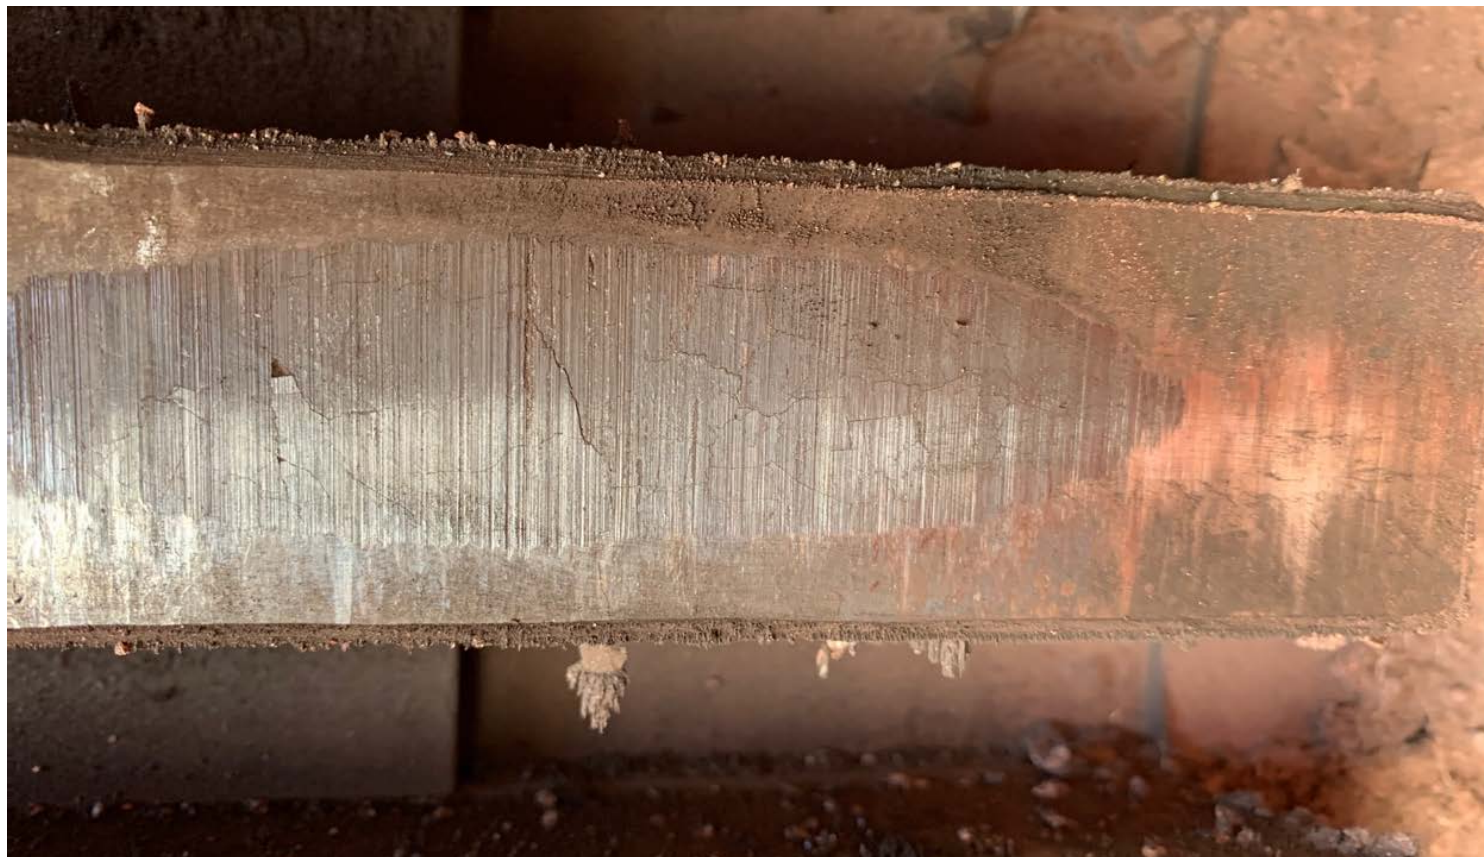
Fig. 10 PMG Magnet Cracking

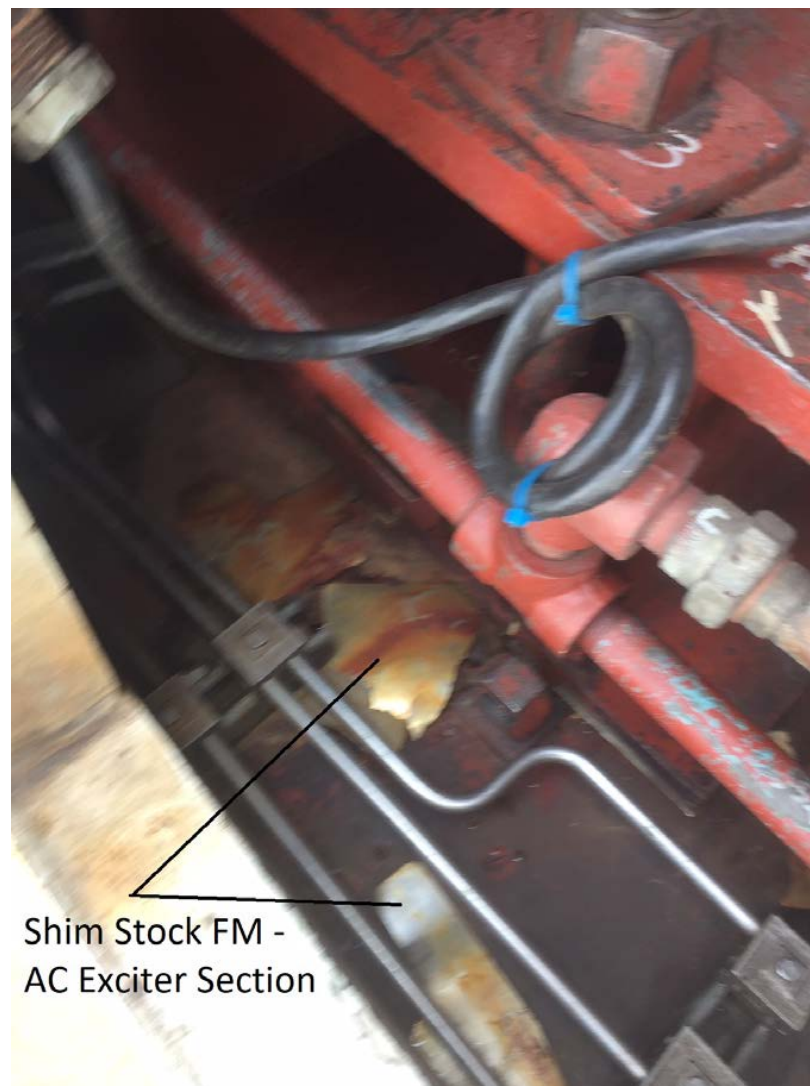
Fig. 11 Foreign Material (Shims) Found in AC Exciter Section

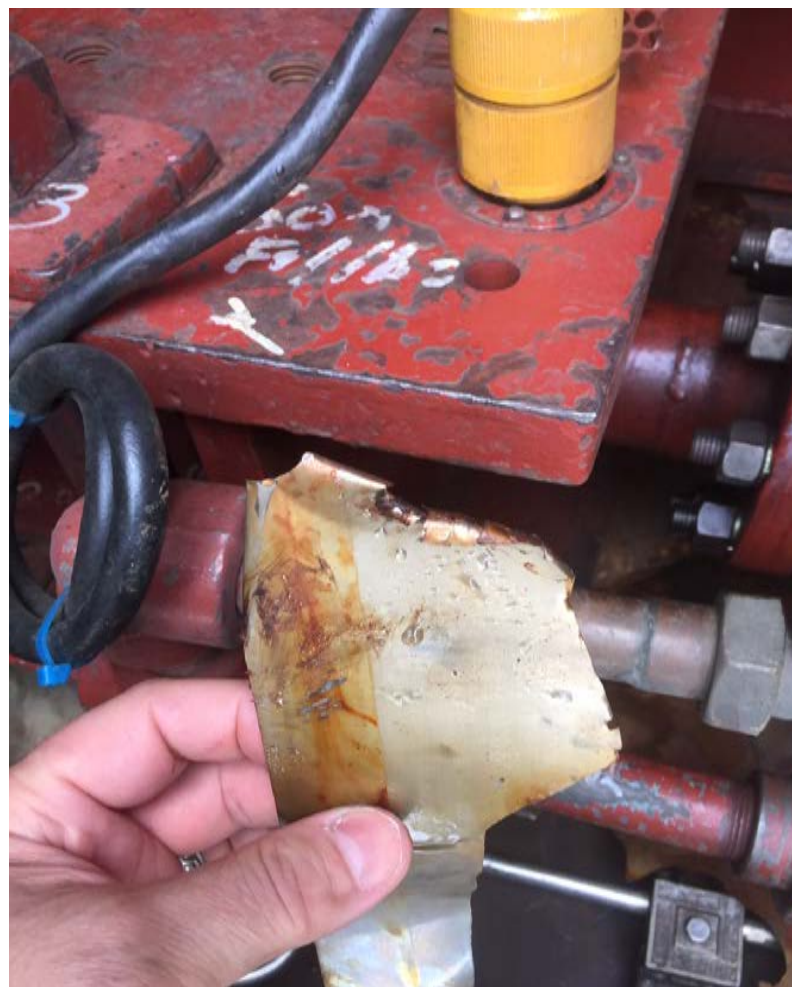
Fig. 12 Liberated Shim Stock Found in AC Exciter Section

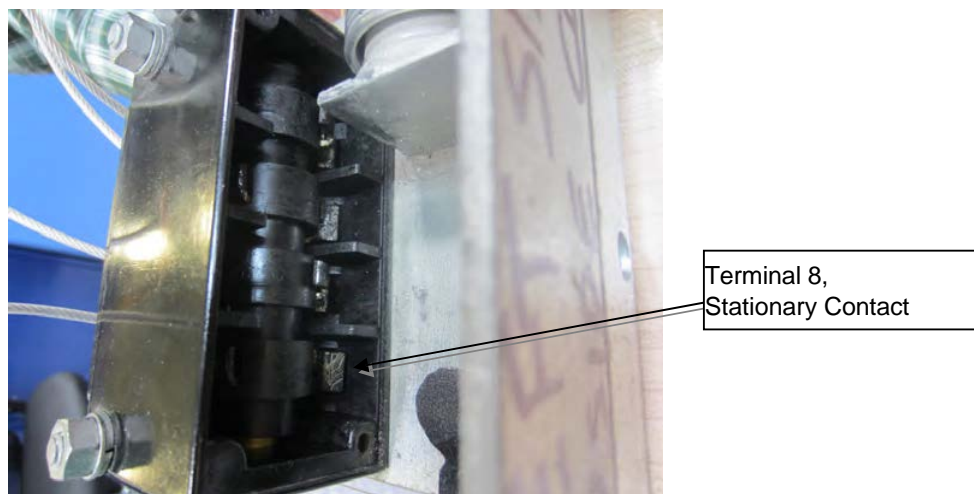
Left Side Switch - Switch Contact 4, Terminal 8

The rear cover of the switch was removed, the contact rotor can be seen moving. The resistance was then measured between the terminal screws and the stationary contacts. It was a closed circuit between terminal 7 and the top stationary contact, it was an open circuit between terminal 8 and the bottom stationary contact. The switch plunger was cycled 50 times while monitoring the switch contacts. Switch contacts 1, 2 and 3 changed state each time the plunger was cycled. Switch contact 4 (terminals 7 & 8) remained open for each of the cycles. The bottom stationary contact associated with terminal 8 appears to be out of place as seen in the photo below.

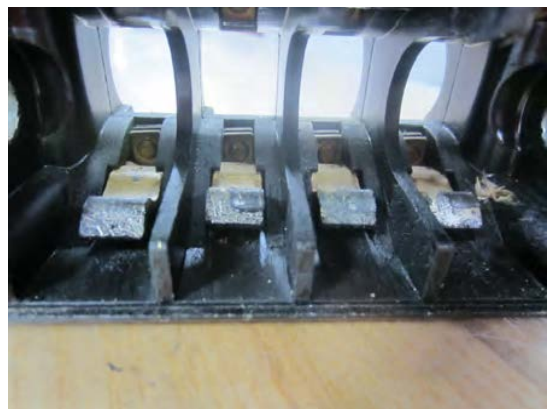
Left-Side Switch Stationary Contacts

The switch rotors were removed from each of the switches and the bottom stationary contact finger in each case had come loose from the terminal point as shown here (left-hand switch and right)

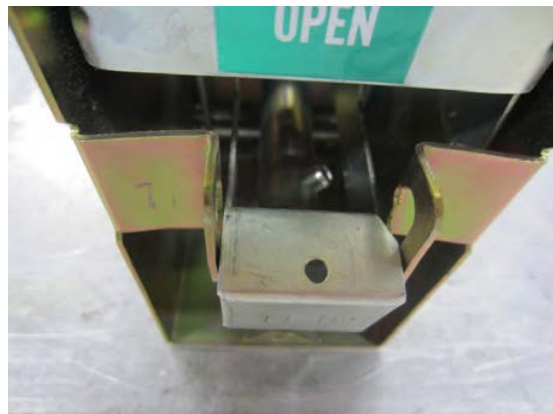
Bent Breaker Lock-Out Tabs

The breaker lock-out tabs on the front of the operating mechanism were found to be slightly bent, however the breaker operated without incident during all mechanical and electrical testing. If these tabs had been bent enough to prevent the Push to Trip button from fully returning to the reset position the linkage within the mechanism could prevent the breaker from closing or could cause a situation that the breaker might close, but not remain closed. These photos show that without the face plate attached to the operating mechanism the Push to Trip button is free to fall below its normal position. This is not a concern as it shows that the tabs are not tight enough to hold the Push to Trip button.

It is recommended that the breaker be handled outside the switchgear cubicle with additional care. The breaker lock-out tabs on the front of the operating mechanism can cause the breaker not to function properly. When a breaker is shipped from Westinghouse the breaker lock-out tabs will include an operating mechanism lock-out bar as shown below.

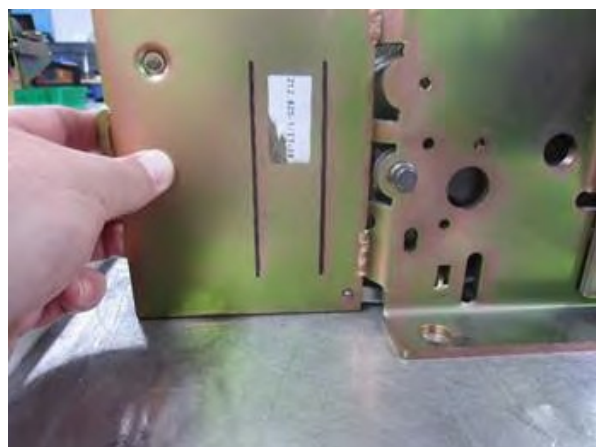
Operating Mechanism Inspection Hole

If the Push to Trip button is held in like shown below, or if the breaker lock-out tabs on the front of the operating mechanism are bent sufficiently to hold this button in the Push to Trip lever would make contact with the rear of the trip pan. This scenario could cause the breaker to be trip free and it would not close, or if the trip pan was only partially held down the breaker may have closed, but the operating mechanism trip faces may not have been completely seated and a shock in the area of the breaker cell could cause the breaker to open. Either of these cases could cause the breaker to open unexpectedly.
