Review of
Electric Service Quality of Florida
Investor-Owned Utilities
Florida Public Utilities Company

March 2005

RR-04-07-001

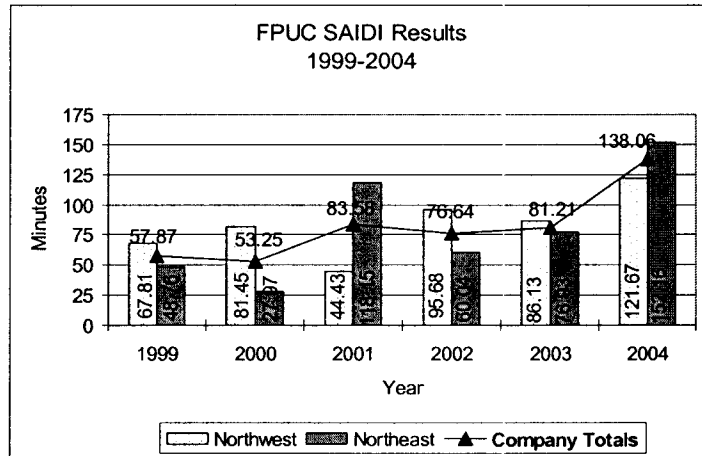
EXHIBIT 5 Source: Annual Service Reliability Reports Document Request 4.10

Exhibit 5 shows that SAIDI results increased during the study period. The SAIDI numbers increased in 2001 and remained fairly constant in 2002 and 2003. In 2004, the SAIDI results increased 70 percent beyond the previous high of 2001. The company has not been able to reduce its system average minutes over the past four years to the levels it maintained during 1999-2000.

The exhibit also shows SAIDI results for each division. The Northwest division SAIDI results have fluctuated during the review period, with an overall increase in outage minutes. The division's three lowest SAIDI results were during the first half of the review period, with its three highest results occurring in 2002 through 2004. This trend shows the system average for outage minutes is on the increase in the Northwest division.

The Northeast division experienced its lowest SAIDI results during the review period in 1999-2000. The division has not been able to reduce its system average back to these levels in 2001 through 2004. The highest results occurred during 2004, with an increase of 98 percent from the previous year's results. Over the review period, the system average outage times have increased for the Northeast division.

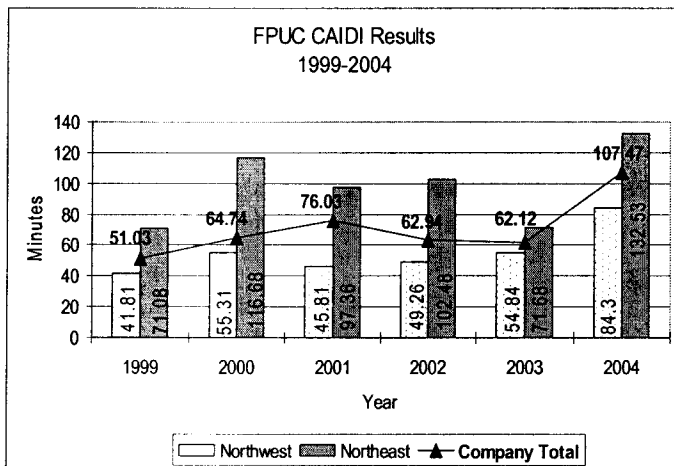
EXHIBIT 6 Source: Annual Service Reliability Reports Document Request 4.10

51.03 minutes from 1999, or an average annual increase of 22.1 percent.

Overall, the Northwest division CAIDI results have also increased during the review period. The division experienced increased CAIDI results each year since 2001, with the highest jump in 2004. The Northwest division customers' outages lasted over 42 minutes longer in 2004 than in 1999, an increase of approximately 101 percent.

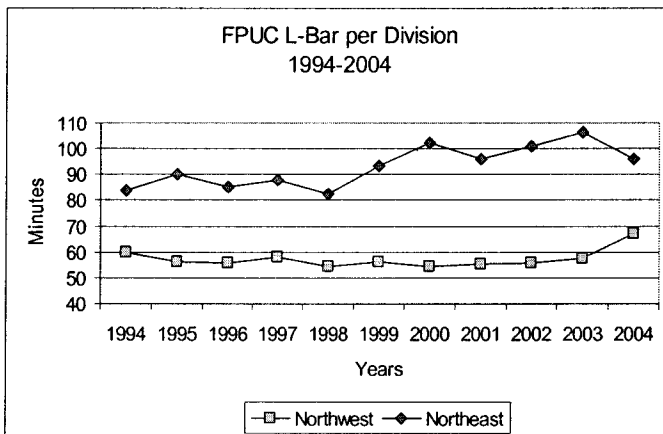
EXHIBIT 8 Source: Annual Service Reliability Reports Document Request 4.10

The company's L-Bar results, the simple average duration of interruptions, peaked in 2004 after several years of increasing results. The Northwest division maintained consistent L-Bar results during the review period with the exception of 2004. **Exhibit 7** tracks each divisions' L-Bar results for the review period. The Northwest division's 2004 results were the highest for the review period, increasing 17 percent from the previous year. The Northeast division's L-Bar results increased in 2002 and 2003 and then decreased in 2004. Overall, the division's lowest L-Bar results were in 1999.

Staff also reviewed the company's previous Annual Service Reliability Reports to trend the 11-year L-Bar results for FPUC. **Exhibit 8** outlines the trend for both divisions. The Northwest division showed consistent L-Bar results, with a difference of only 5.3 minutes from its lowest to highest results during 1994-2003. The Northeast division showed an overall increasing trend in its L-Bar results over the past ten-year period. Although 2004 results were lower than in 2001 through 2003, they were 15 percent higher than the 1994 results.

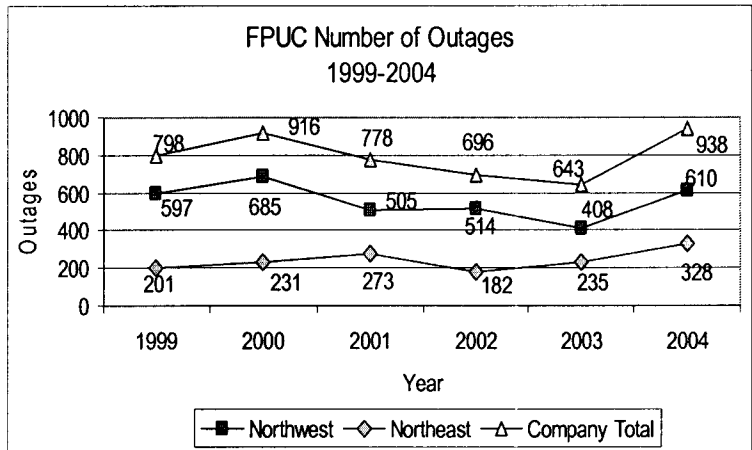
EXHIBIT 10 Source: Annual Service Reliability Reports Document Request 4.10

As Exhibit 10 shows, FPUC’s number of outages (N) decreased each year from 2001 through 2003 after two years of higher outages in 1999 and 2000. However, in 2004, the company posted its highest number of outages of the period with 938, this represents a 46 percent increase from the previous year. In 2004, the Northwest division experienced nearly a

50 percent increase in outages from its six-year low of 2003. Prior to 2004, the division had reduced its number of outages each of the previous three years.

Overall, the Northeast division has fewer outages as compared to the Northwest division, possibly due to its lower exposure in terms of distribution line miles. The Northeast division had an upward trend in outages from 1999 through 2001, reduced the number of outages in 2002, and then increased the number of outages in 2003 and 2004. In 2004, the Northeast division's numbers grew by 39 percent over the previous year

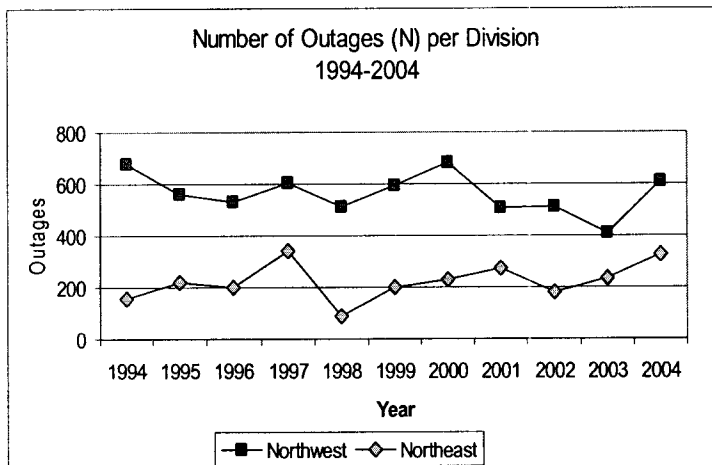
EXHIBIT 11 Source: Annual Service Reliability Reports Document Request 4.10

Exhibit 11 tracks the division results for the 11-year period 1994 through 2004. As the chart shows, the Northwest division increase in 2004 followed the three best annual results during the 11-year period. Both divisions have experienced periods of increases and decreases. The Northeast division's increase in 2004 follows two years of nearly average performance for the 11-year period, but overall trend is upward from the low in 1998.

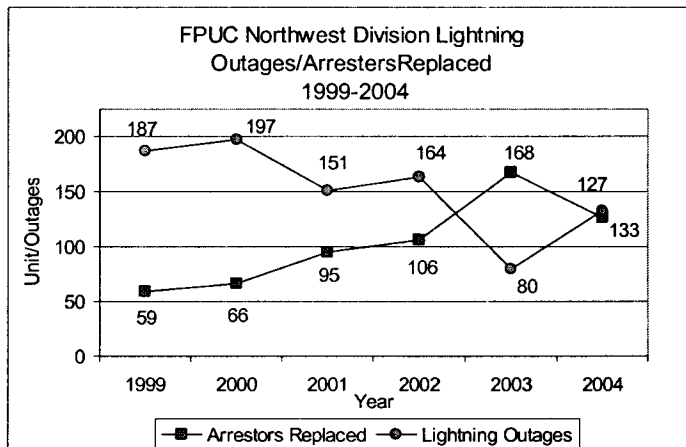
EXHIBIT 18 Document Request 1.13, 3.8 & 4.10

Exhibit 18 shows that, in 1999 and 2000, the Northwest division had a higher number of lightning-related outages during the review period, while it replaced fewer arresters during these years. FPUC increased the number of arresters replaced by the Northwest division in 2001-2003, with a peak in 2003. The division reduced the number of arresters replaced in 2004 back to the 2002 level. In general, an increase in arrester replacement appears to have caused a decrease in lightning outages.

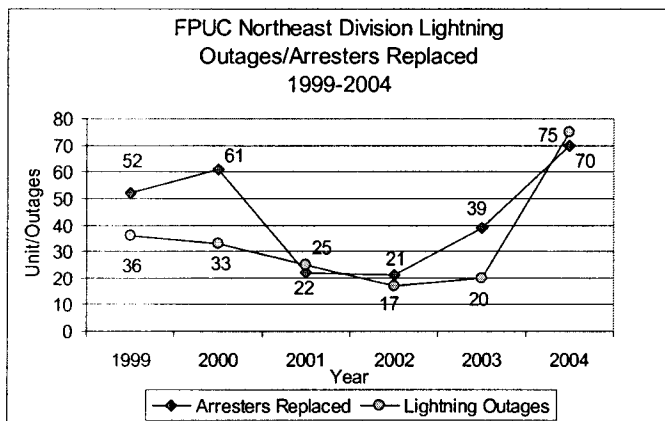
EXHIBIT 19 Document Request 1.13, 3.8 & 4.10

In the Northeast division, the geographic area is smaller and a higher percentage of the system is underground; thus having less exposure to lightning events. Lightning outages are still in the top five causes of outages for the division. Exhibit 19 shows that in 2004, the Northeast division’s lightning-related outages more than doubled from the previous high in 1999. The company has not conducted any analysis of weather patterns for 2004 to determine if there were an abnormally high number of lightning strikes in the region during the year or if the increase was system related.

During 2001-2003, the division reduced the number of arresters replaced each year. While the company did increase the number of arresters replaced in 2004, 48 of the replaced arresters were part of a maintenance upgrade on a specific section of line. This work was not in response to the increased lightning during the year. These replacements may reduce future outages.

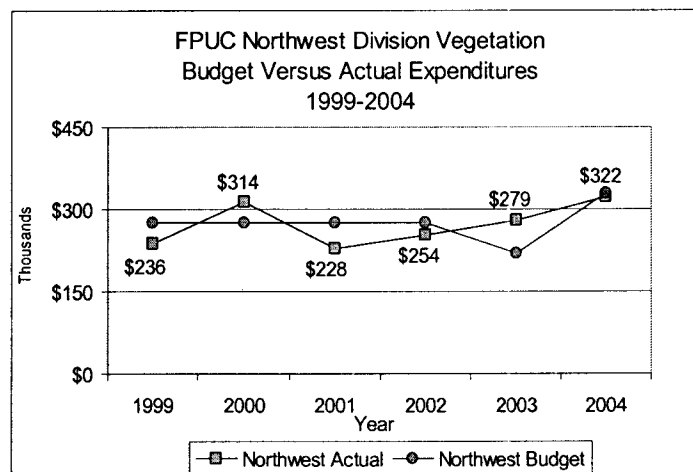
EXHIBIT 21 Source: Document Request 2.7 & 4.10

During the review period, the Northwest division did not maintain a consistent tree-trimming cycle. In 1999-2001, the Northwest division did not trim specific feeders and laterals, but conducted hot-spot trimming within its service area. Hot-spot trimming

involves monitoring and trimming sections of vegetation that are in direct contact with, or encroaching on, a line or equipment. Hot-spot trimming can occur in response to a vegetation outage, customer calls, or company personnel identifying an area where vegetation is encroaching on the lines.

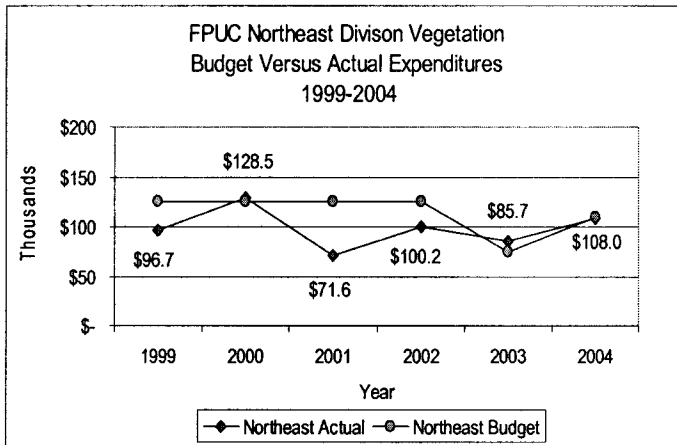
EXHIBIT 22 Source: Document Request 1.7 & 4.10

The division has changed its vegetation management from yearly hot-spot trimming to a two-year trim cycle. While the company states it is placing greater emphasis on tree-trimming in 2004, the budget for that year was still below the 1999 through 2002 amounts.

During three of the six years, the division spent less on vegetation management than originally budgeted by the company. When asked about these three years, the company states that sometimes productivity is lost due to absenteeism because it utilizes just one tree crew in the division. Also, the company stated that it did not meet its budget amounts at times because the tree crews conducted more right-of-way clearing, which is less costly than tree removal.
