Re: *2021 Annual Service Reliability Report; Undocketed*

Please find enclosed for electronic filing on behalf of Duke Energy Florida, LLC ("DEF"), its 2021 Annual Service Reliability Report. DEF also provided two (2) hard copies and two (2) CDs of its Annual Service Reliability Report to the Division of Engineering. Due to the implementation of Rule 25-6.030, Florida Administrative Code, the storm-hardening activities were excluded from this year's Reliability Report filing, and that the information will be filed by June 1, 2022, instead.

**I. OVERALL RELIABILITY PERFORMANCE – 2021 (Rule 25-6.0455, F.A.C.)**

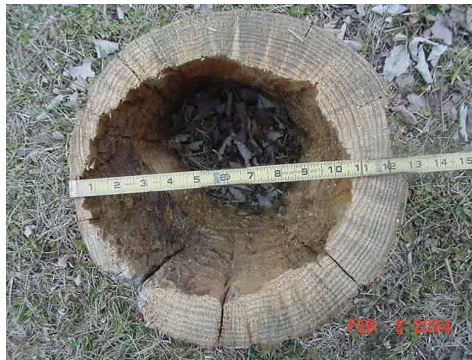
Priority 1 Internal Decay  
(Shell thickness less than 1 inch)

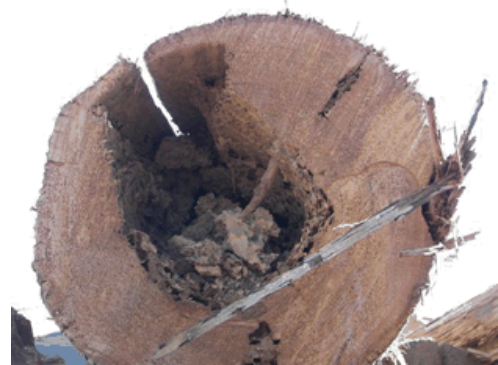
Priority 1 Internal Decay  
(Deep decay pocket)

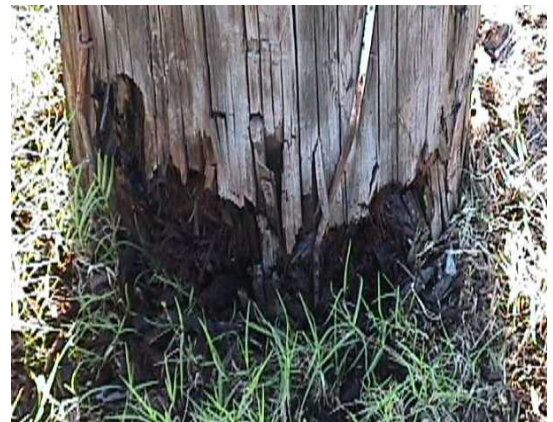
Priority 1 Groundline Pole Decay

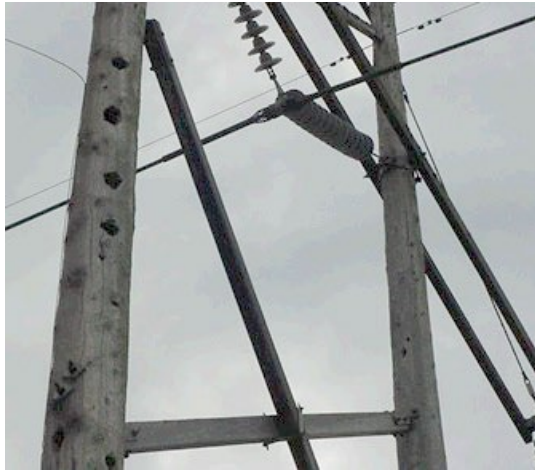
Priority 1 Woodpecker holes with large internal cavities

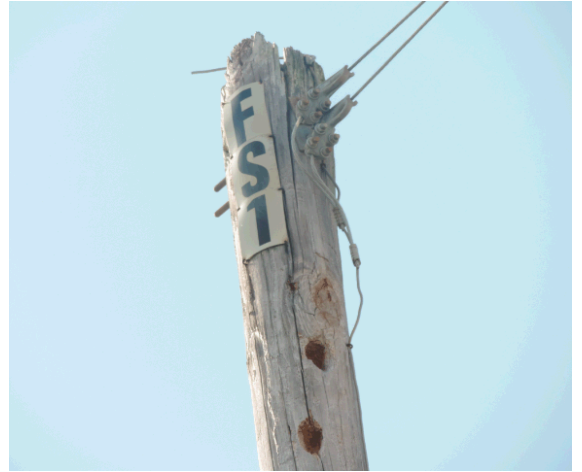
Priority 2 Split Pole Top & Vertical Woodpecker Holes

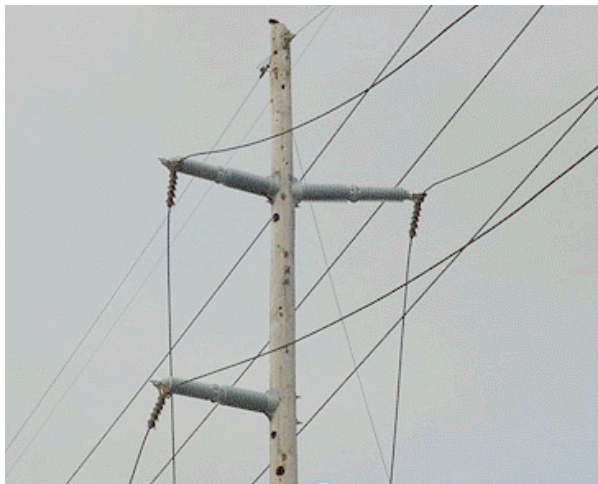
Priority 2 Woodpecker Holes (Located in critical spots)

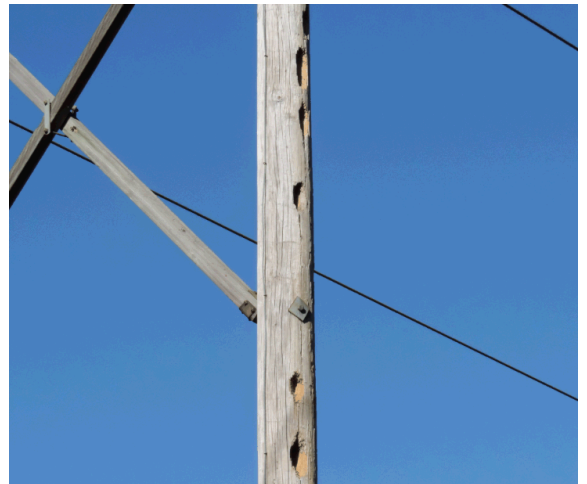
Priority 2 Woodpecker Holes - Quantity & orientation indicates significant decay

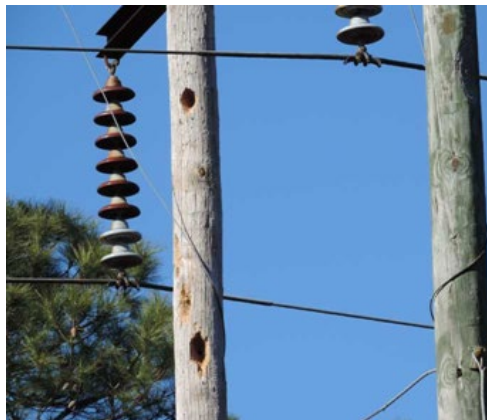
Priority 9 Woodpecker Holes (Not in a critical location)

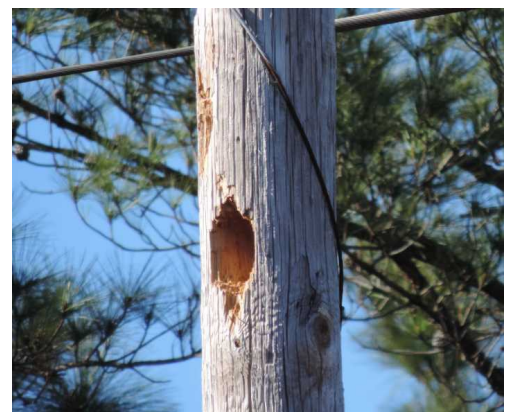
Priority 9 Woodpecker Holes (Does not hold water & can be repaired)

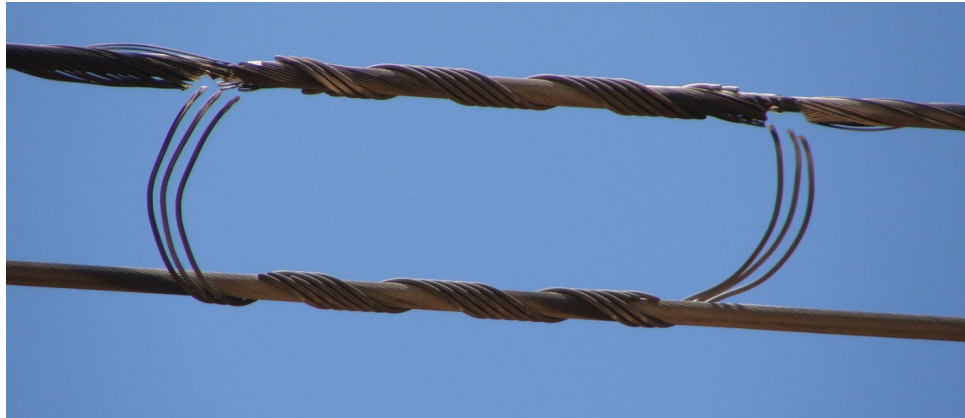
Priority 1 broken “Hair-pin” with >20% broken strands. Viewed from the ground.

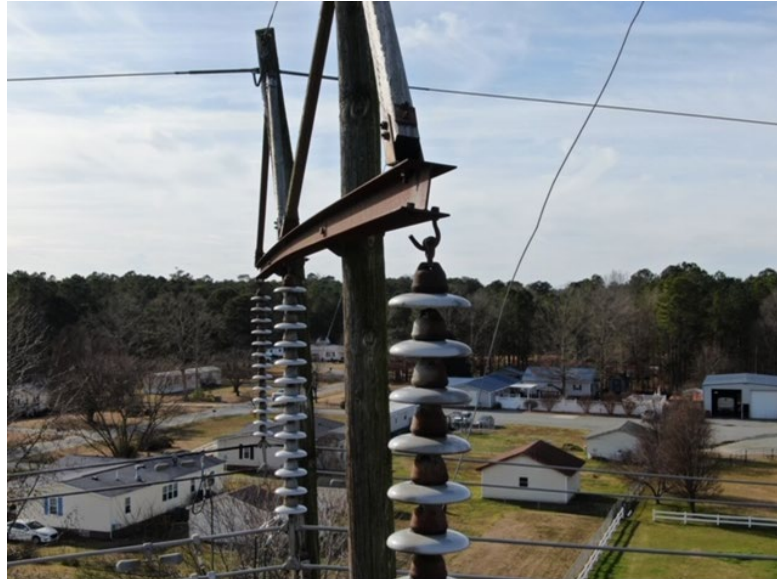
Priority 0 – Failed U-bolt detached on one end.

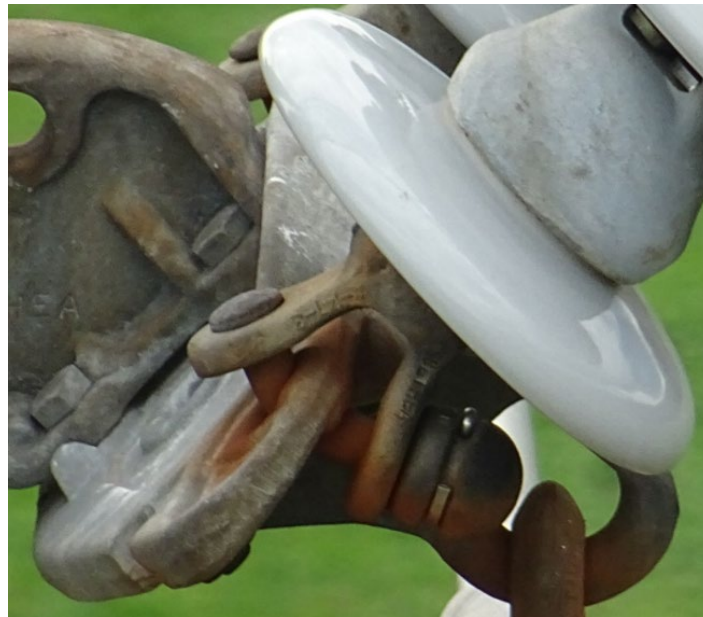
Priority 1 – Heavily rusted hardware suspected of wearing through pin.

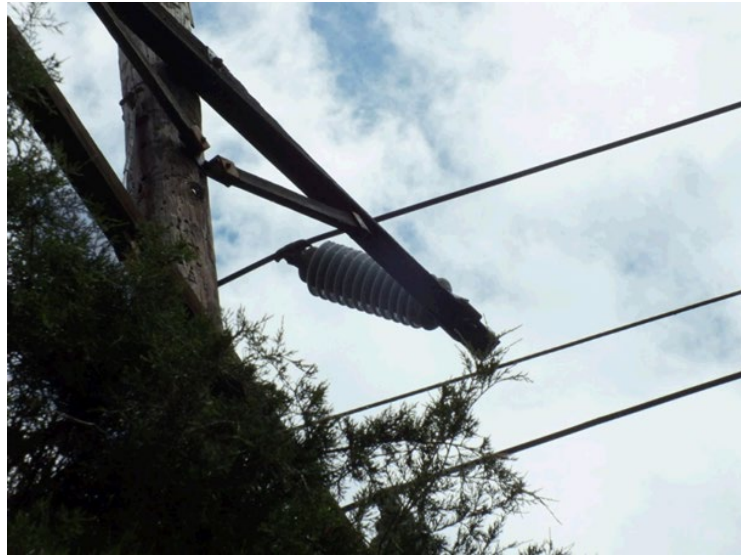
Priority 2 – Rolled pin insulator greater than 30 degrees

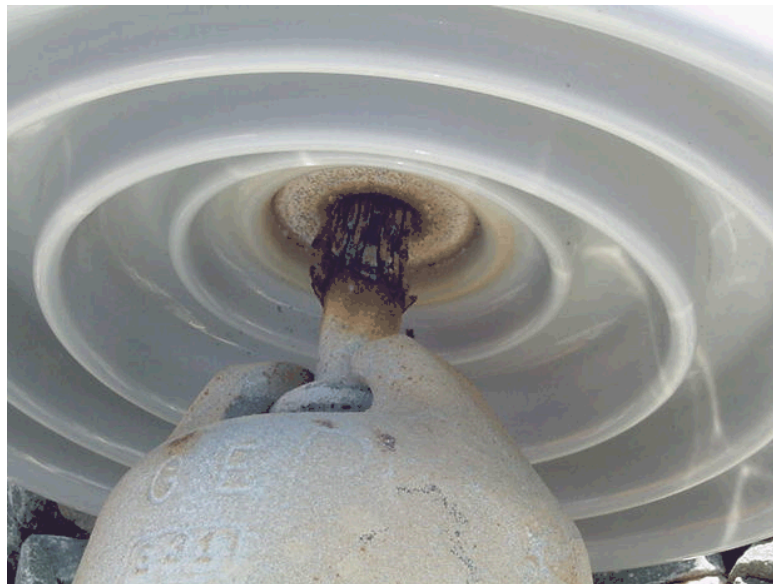
Priority 1 Porcelain Spark Erosion

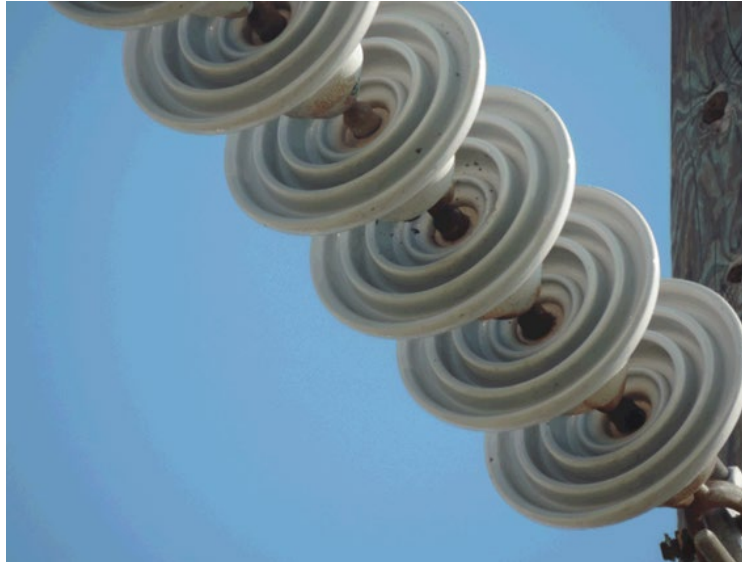
Priority 1 “Ball and Socket” insulator pin erosion

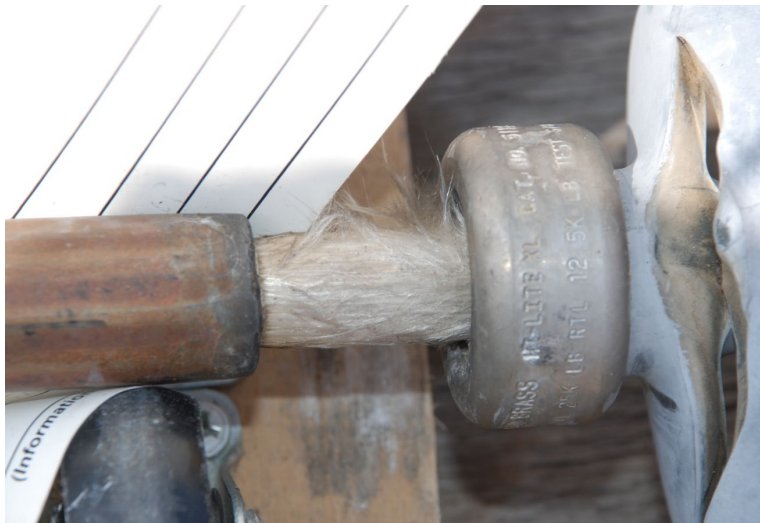
Priority 1 Polymer with exposed fiberglass rod

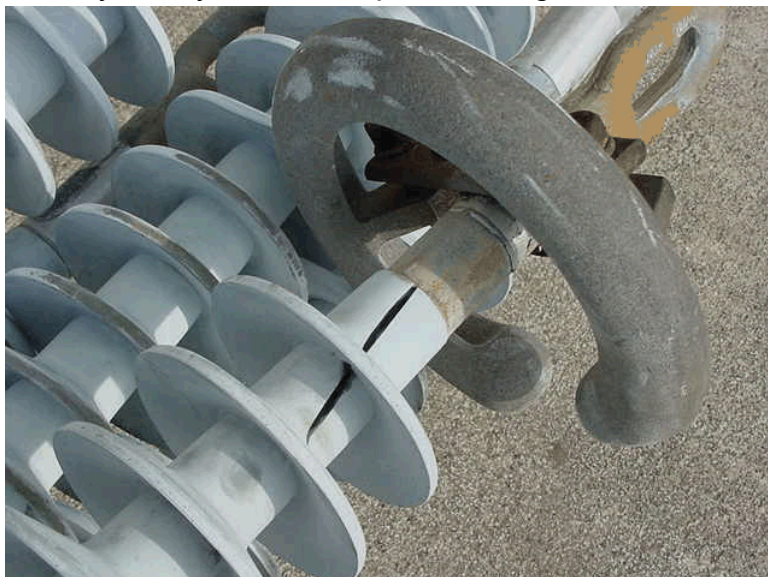
Priority 1 Polymer insulator with split housing.

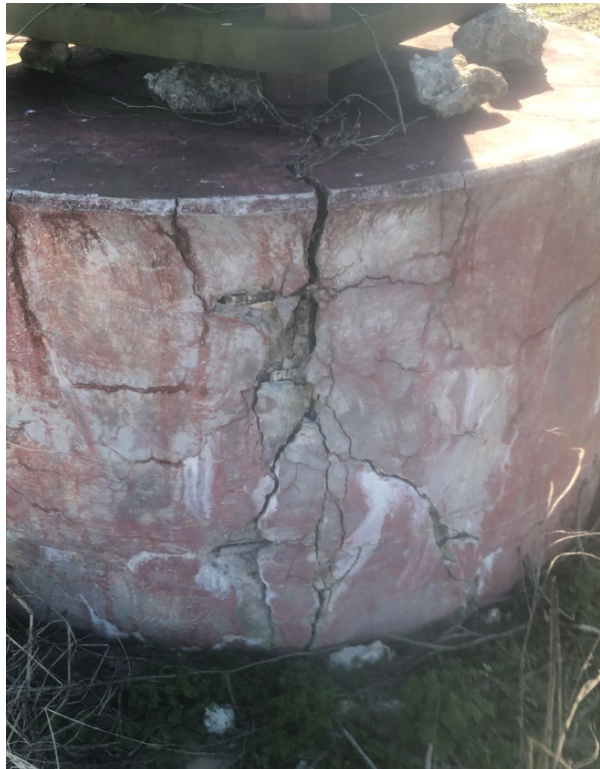
Priority 2 – Concrete foundation with cracking greater than ¼”

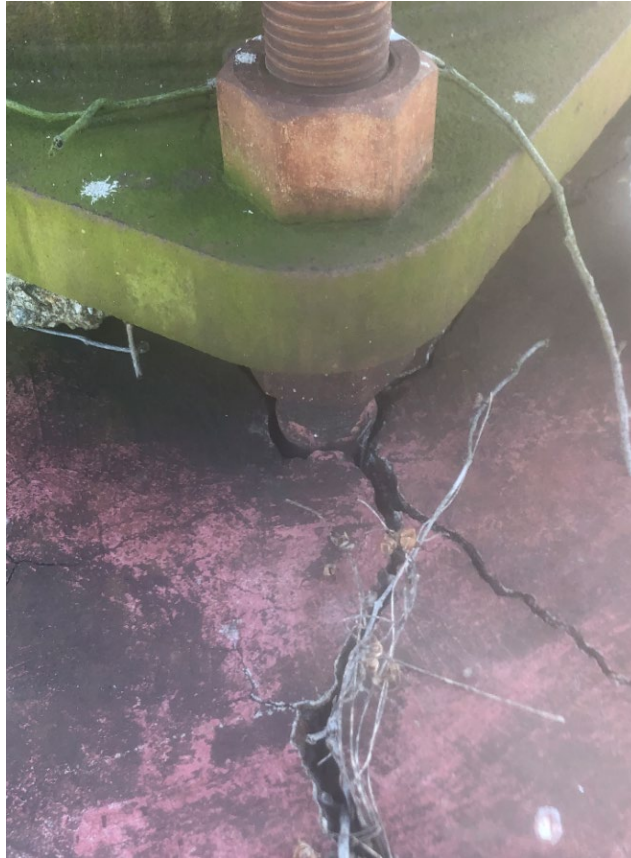
Priority 1 – Concrete foundation with cracks greater than ¼” and exposed anchor rods

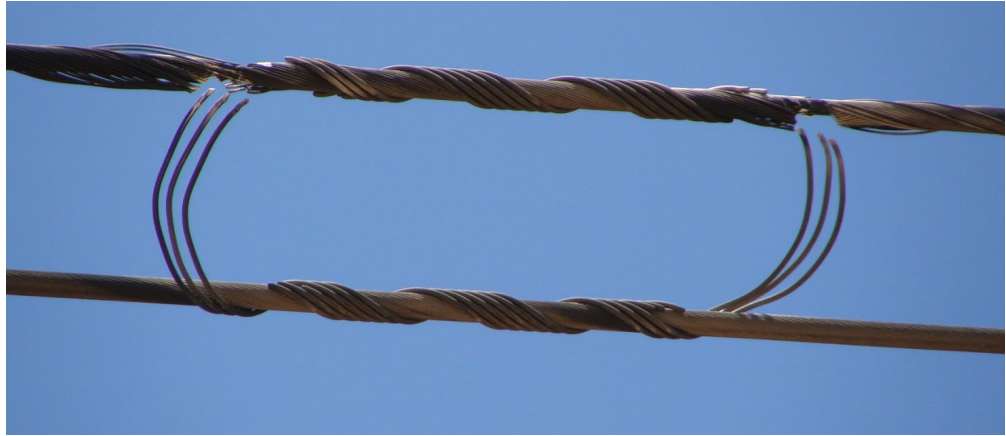
Priority 1 broken “Hair-pin” with >20% broken strands. Viewed from the ground.

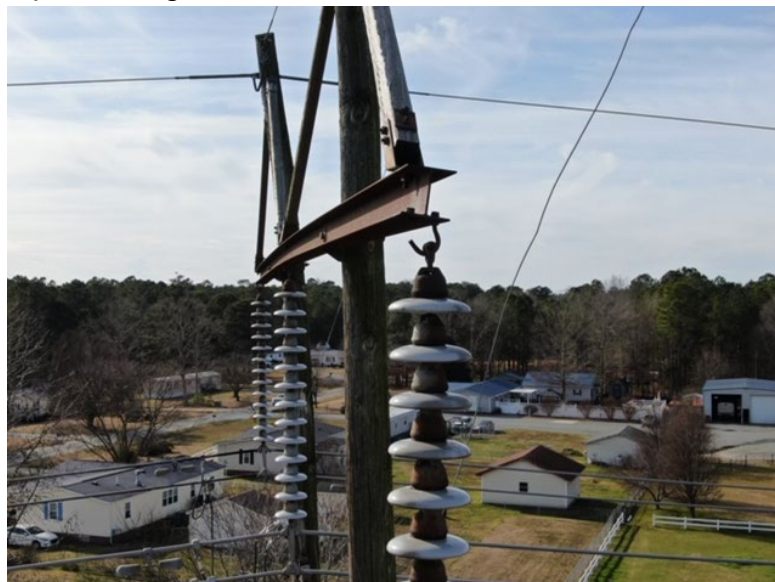
Priority 0 – Failed U-bolt detached on one end.

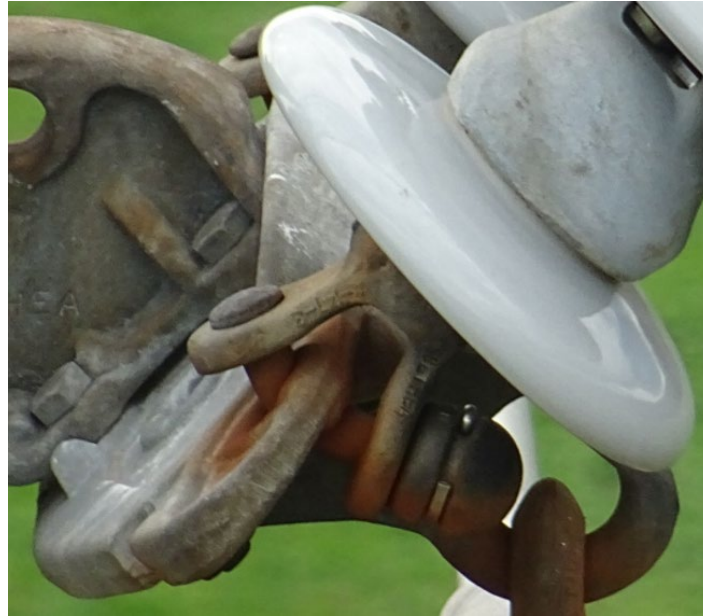
Priority 1 – Heavily rusted hardware suspected of wearing through pin.

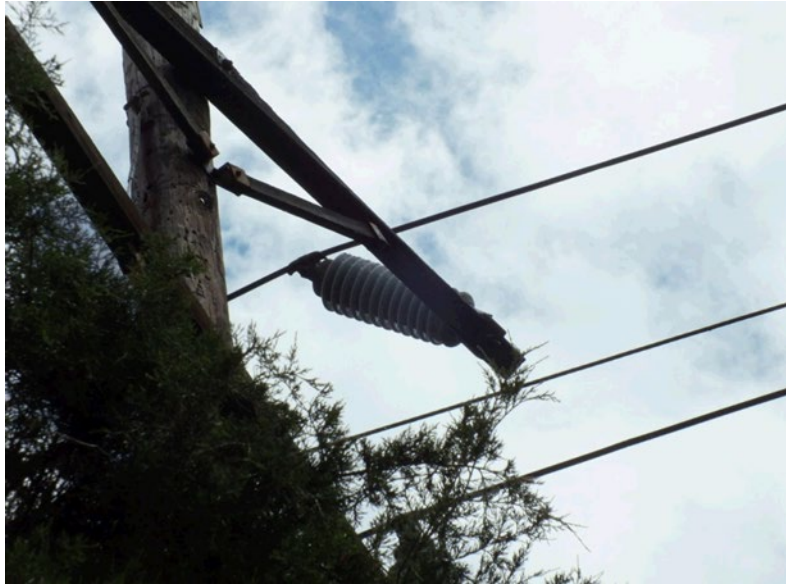
Priority 2 – Rolled pin insulator greater than 30 degrees

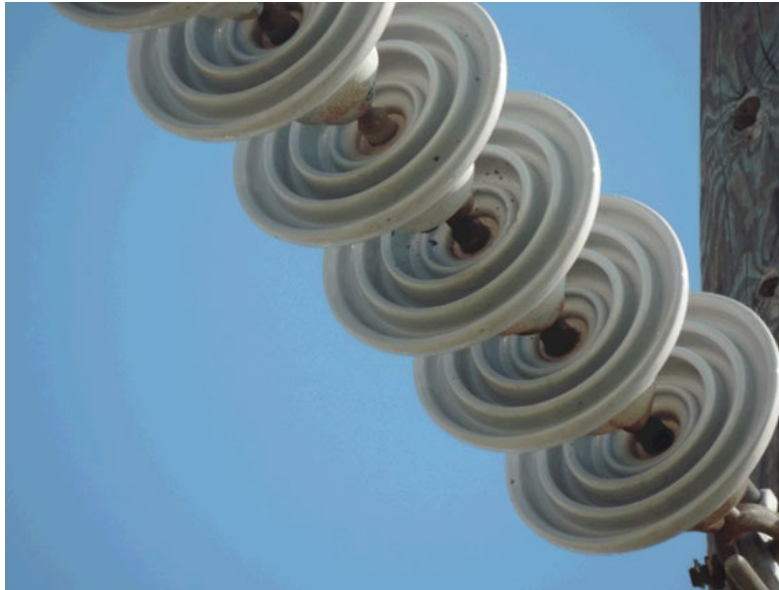
Priority 1 Porcelain Spark Erosion

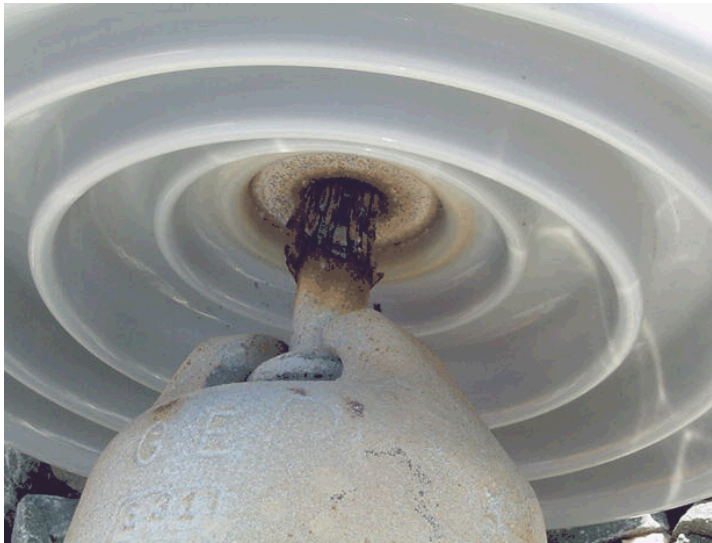
Priority 1 "Ball and Socket" insulator pin erosion

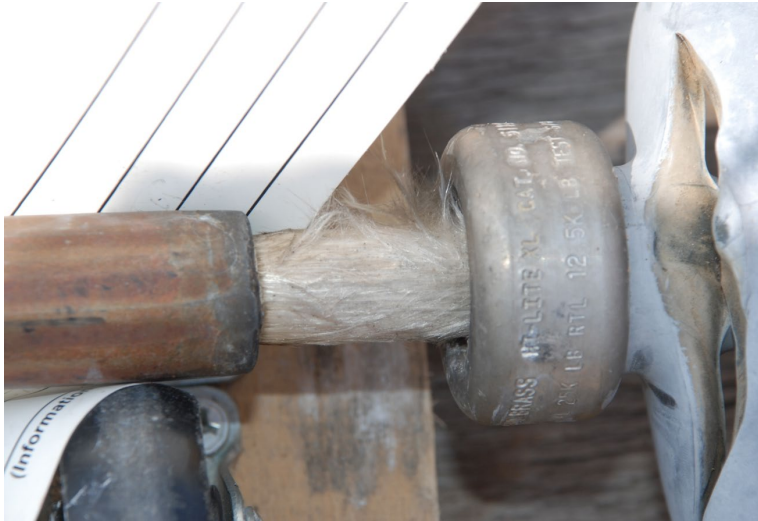
Priority 1 Polymer with exposed fiberglass rod.

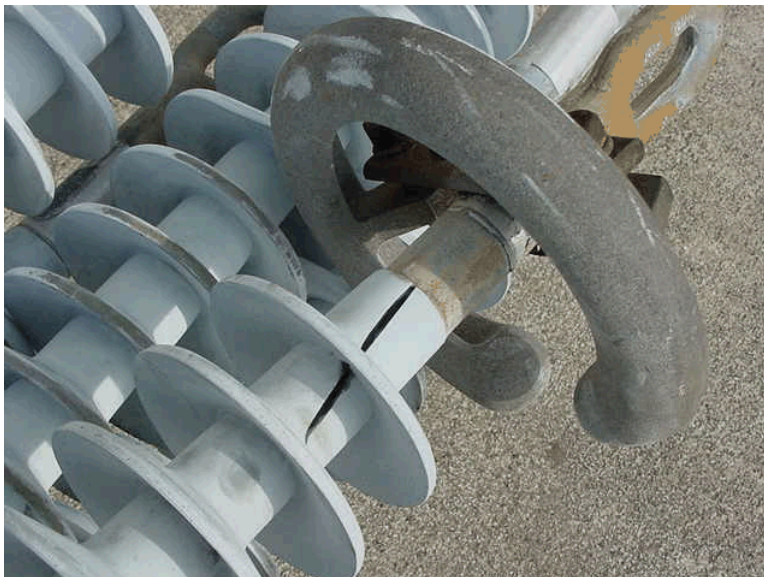
Priority 1 Polymer insulator with split housing.

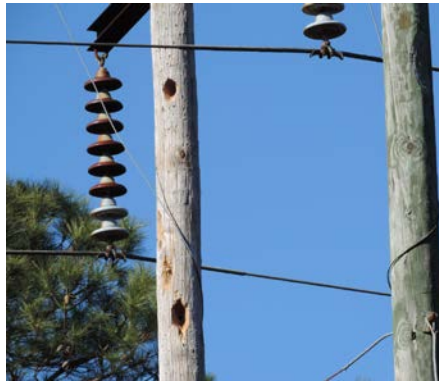
Priority 9 Woodpecker Holes  
(Not in critical locations)

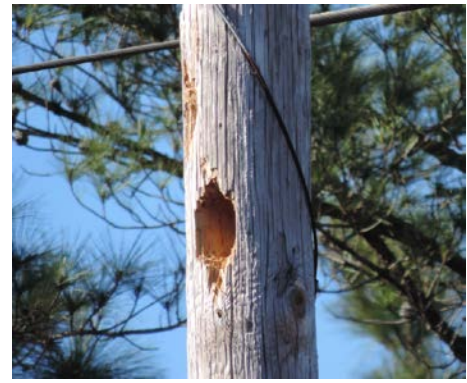
Priority 9 Woodpecker Hole  
(Does not hold water & can be repaired)

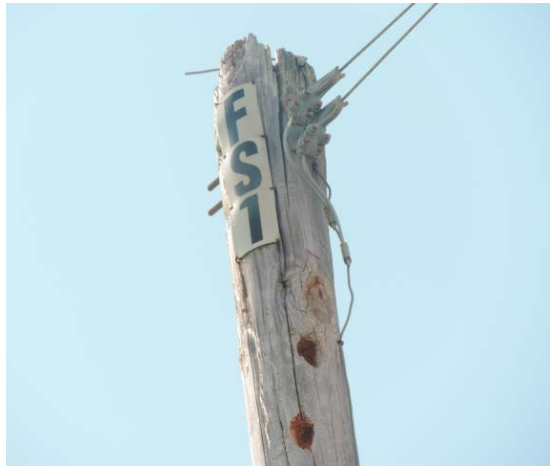
Priority 2 Split Pole Top & Vertical Woodpecker Holes

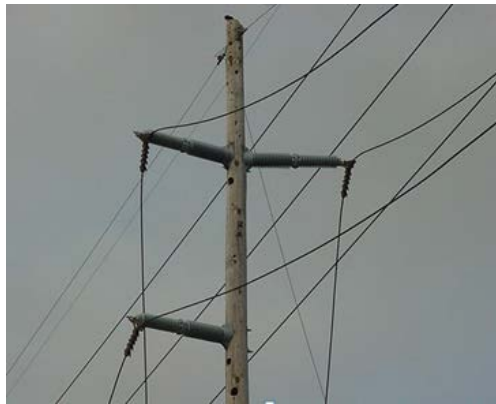
Priority 2 Woodpecker Holes  
(located in critical spots)

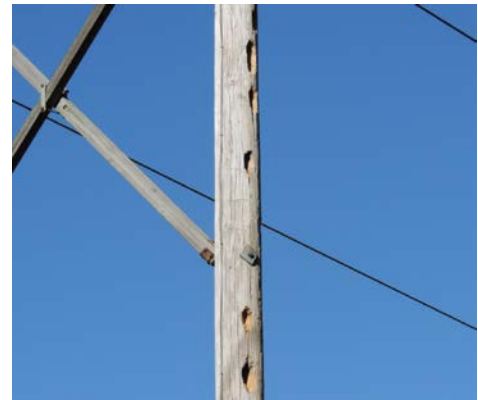
Priority 2 Woodpecker Holes  
(Quantity and orientation indicates  
significant pole decay)

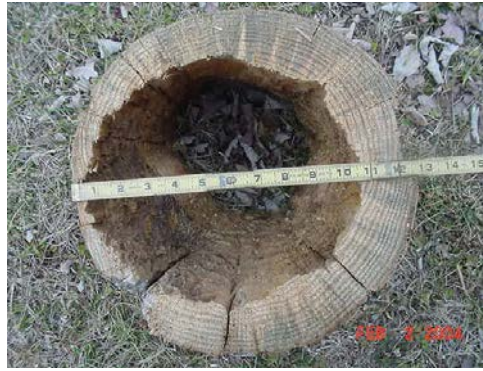
Priority 1 Internal Decay  
(Shell thickness less than 1 inch)

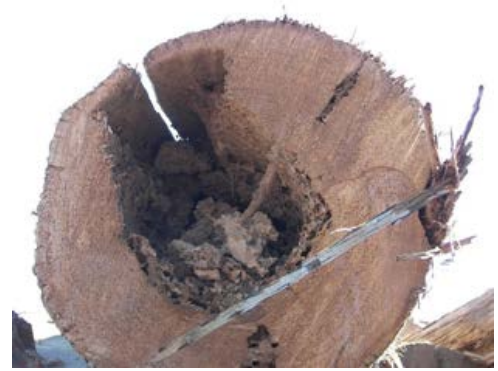
Priority 1 Internal Decay  
(Deep decay pocket)

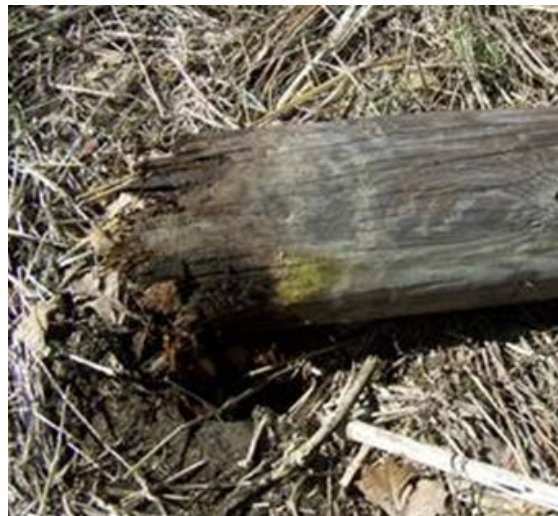
Green Growth  
(May be an indicator of substantial pole decay)

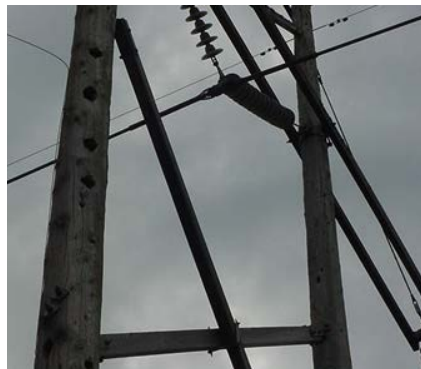
Priority 1 Woodpecker holes  
with a large internal cavity

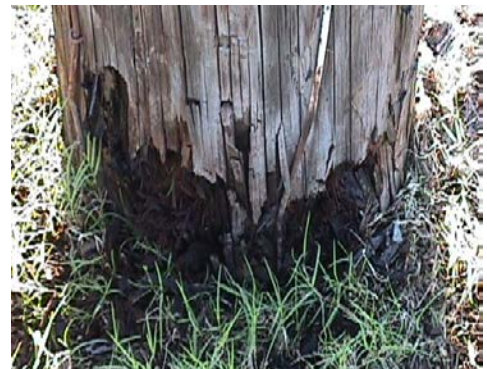
Priority 1 Groundline Pole Decay

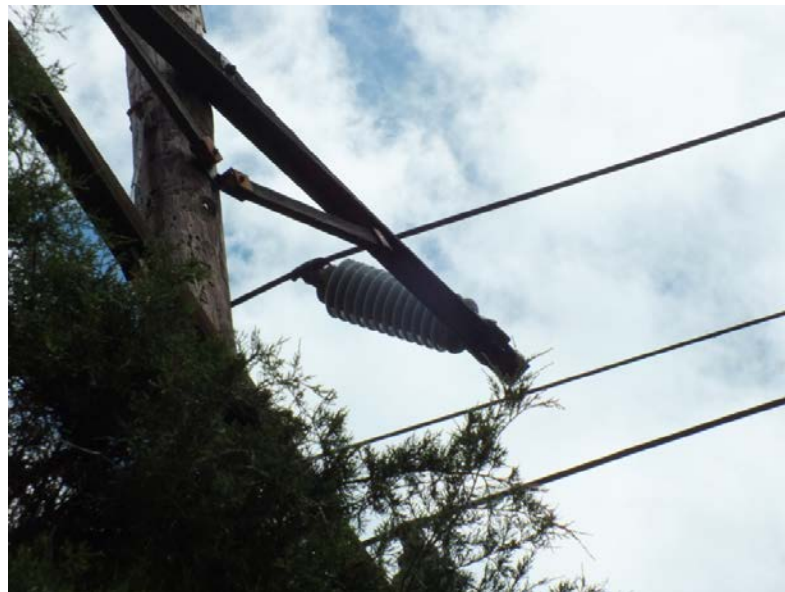
Priority 2 Rolled Pin Type Insulator Mounted above Wood Arm

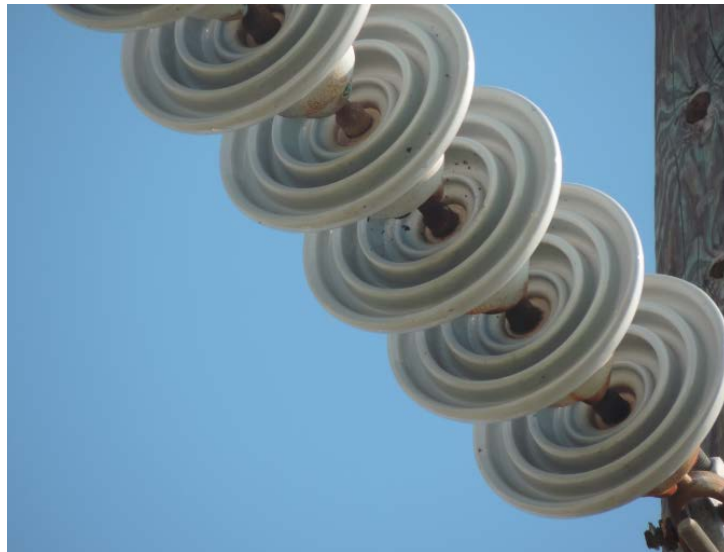
Priority 1 Porcelain Spark Erosion  
These can be difficult to see/evaluate

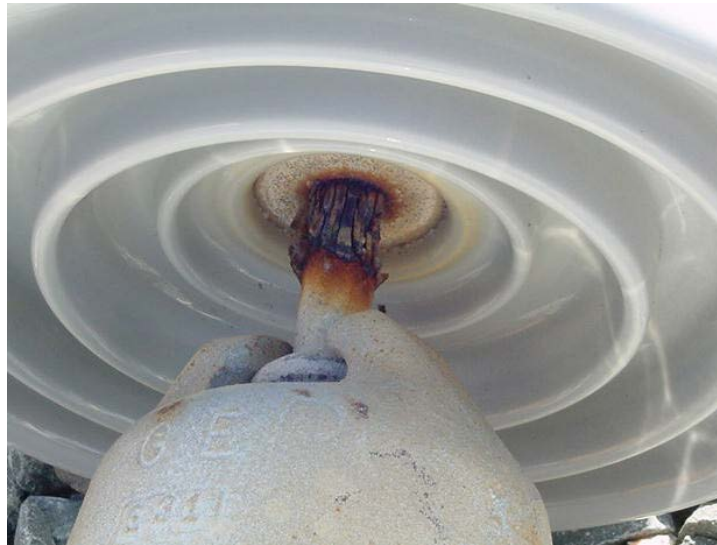
Typical Priority 1 "Ball & Socket" Insulator

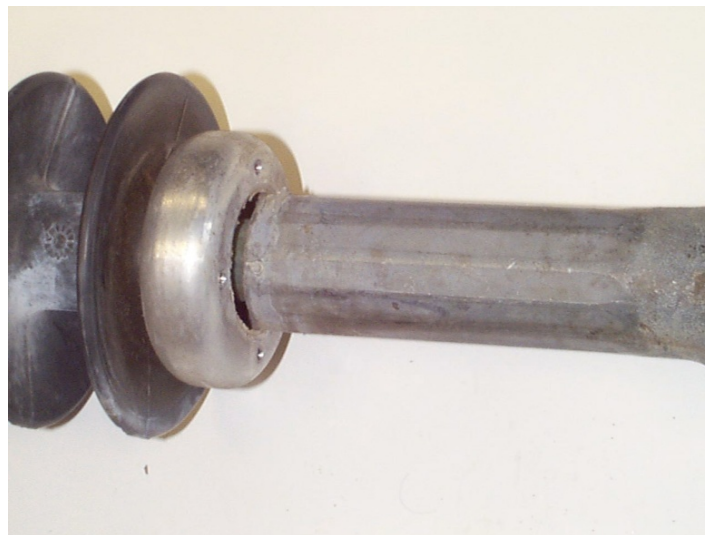
Priority 2 Polymer Insulator  
Exposed Fiberglass Rod (Ohio Brass)

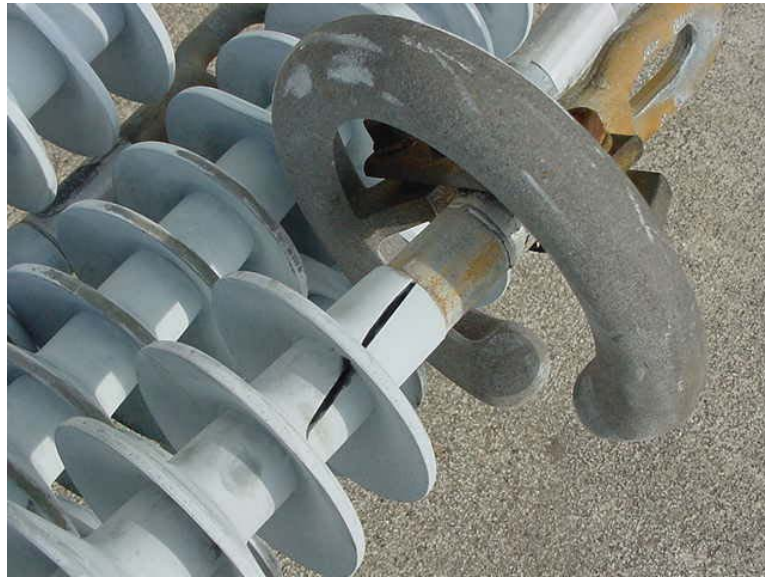
Priority 2 Polymer Insulator  
Split Housing (Ohio Brass)
