SECO Energy Report to the Florida Public Service Commission Pursuant to Rule 25-6.0343, F.A.C.

SECO Energy P.O. Box 301 330 South US Highway 301 Sumterville, FL 33585-0301

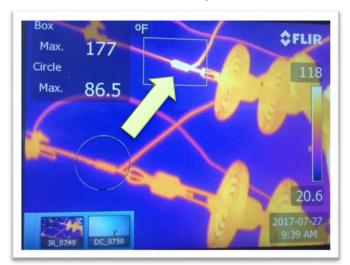
As illustrated by the following infrared photos of distribution pole equipment, this proactive approach allows SECO to detect hotspots and identify devices before they fail in order to minimize service interruptions to its members.
