RE: SECO Energy Report to the Florida Public Service Commission Pursuant to Rule 25-6.0343,  
F.A.C. Calendar Year 2019

# SECO Energy Report to the Florida Public Service Commission Pursuant to Rule 25-6.0343, F.A.C. Calendar Year 2019

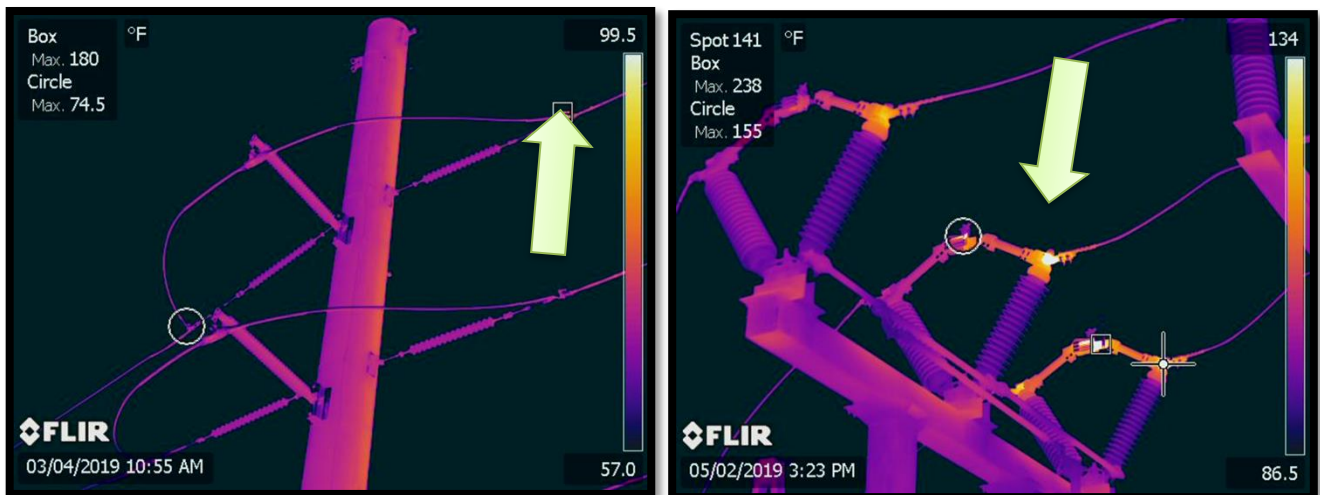
As illustrated by the following infrared photos of a transmission pole connection (left) and a substation switch (right), this proactive approach allows SECO to detect even the slightest of hotspots and identify devices before they fail in order to minimize service interruptions to its members.
