RE: SECO Energy Report to the Florida Public Service Commission Pursuant to Rule 25-6.0343, F.A.C. Calendar Year 2020

SECO Energy Report to the Florida Public Service Commission Pursuant to Rule 25-6.0343, F.A.C. Calendar Year 2020

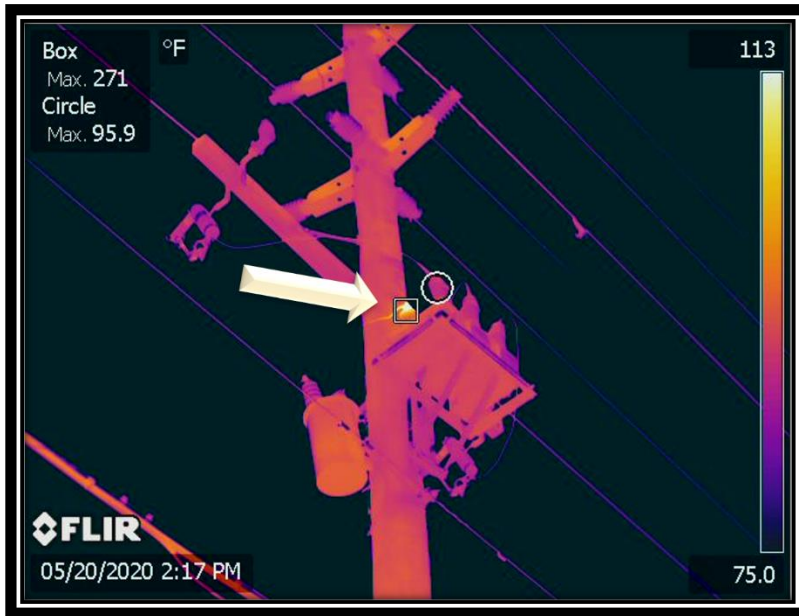
As illustrated by the following infrared photo of a distribution pole capacitor bushing, this proactive approach allows SECO to detect even the slightest of hotspots and identify devices before they fail in order to minimize service interruptions to its members.
