RE: SECO Energy Report to the Florida Public Service Commission Pursuant to Rule 25-6.0343, F.A.C. Calendar Year 2021

# SECO Energy Report to the Florida Public Service Commission Pursuant to Rule 25-6.0343, F.A.C. Calendar Year 2021

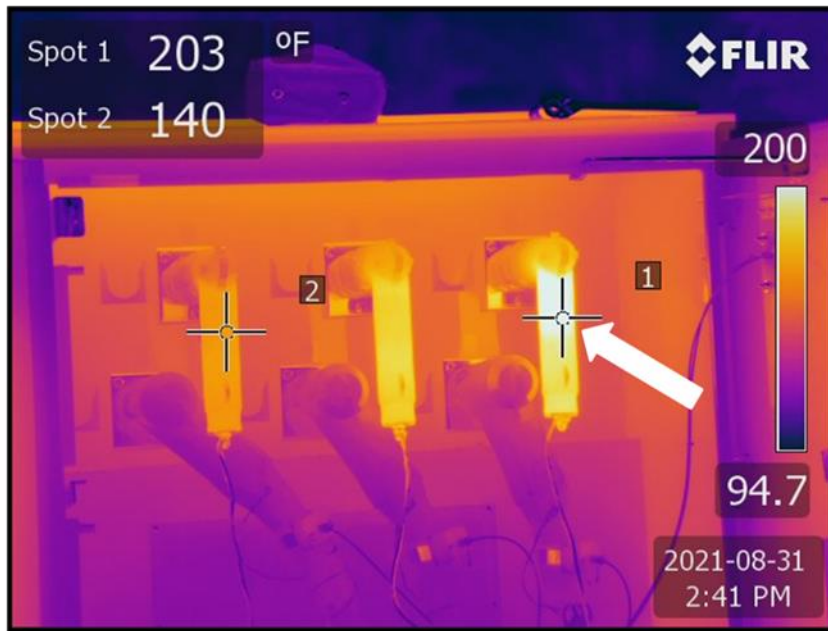
As illustrated by the following infrared photo of a lightning arrester mounted in an underground switchgear cabinet, this proactive approach allows SECO to detect even the slightest of hotspots and identify devices before they fail to minimize service interruptions to its members.
