RE: SECO Energy Report to the Florida Public Service Commission Pursuant to Rule 25-6.0343,
F.A.C. Calendar Year 2022

SECO Energy Report to the Florida Public Service Commission Pursuant to Rule 25-6.0343, F.A.C. Calendar Year 2022

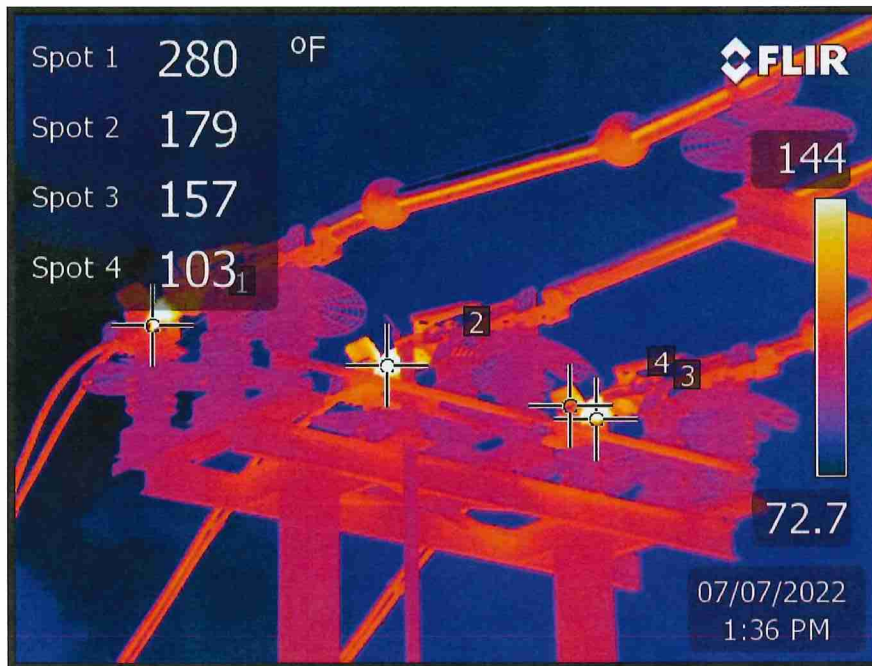
As illustrated by the following infrared photo of a 3-phase switch located inside a SECO substation, this proactive approach allows SECO to detect even the slightest of hotspots and identify devices before they fail to minimize service interruptions to its members. Spots 1-3 in the following infrared photo distinguish heat-related concerns, whereas Spot 4 shows the expected temperature of a similar piece of equipment for comparison.
