RE: SECO Energy Report to the Florida Public Service Commission Pursuant to Rule 25-6.0343, F.A.C. Calendar Year 2023

SECO Energy Report to the Florida Public Service Commission Pursuant to Rule 25-6.0343, F.A.C. Calendar Year 2023

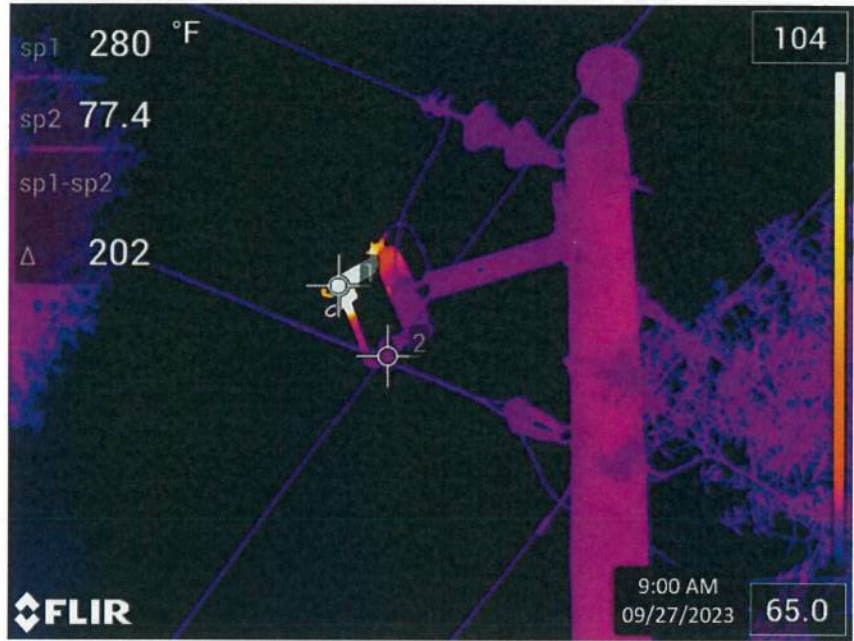
In addition, SECO performs annual visual and infrared inspections for SECO and Seminole Electric Cooperative (SECI) owned transmission lines. As illustrated by the following infrared photo of a 200-amp fused cut out, this proactive approach allows SECO to detect even the slightest of hotspots and identify devices before they fail to minimize service interruptions to its members. Spot 1 in the following infrared photo distinguishes a heat-related concern, whereas Spot 2 shows the expected temperature of a similar piece of equipment for comparison.
