RE: SECO Energy Report to the Florida Public Service Commission Pursuant to Rule 25-6.0343, F.A.C. Calendar Year 2025

SECO Energy Report to the Florida Public Service Commission Pursuant to Rule 25-6.0343, F.A.C. Calendar Year 2025

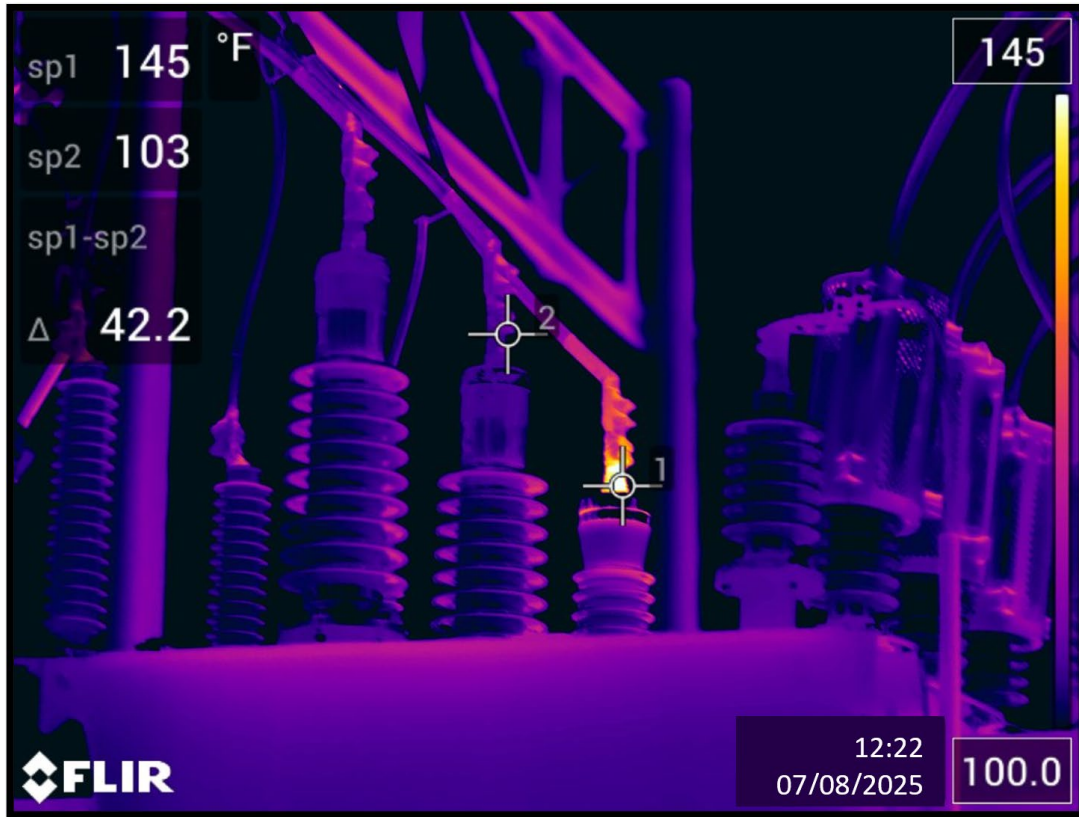
In addition, SECO performs annual visual and infrared inspections for SECO and Seminole Electric Cooperative (SECI) owned transmission lines. As shown in the following infrared image of a primary bushing on a substation power transformer, this proactive approach enables SECO to detect even minor hot spots and identify potential equipment issues before failure occurs—helping to minimize service interruptions for its members. In the image, Spot 1 highlights a heat-related concern, while Spot 2 shows the expected operating temperature of comparable equipment for reference.
